The Road Inventory of Colonial National Historical Park COLO - 4290

Road Inventory Program

Prepared By:
Federal Highway Administration
Eastern Federal Lands Highway Division
Cycle 3

Colonial National Historical Park in Virginia

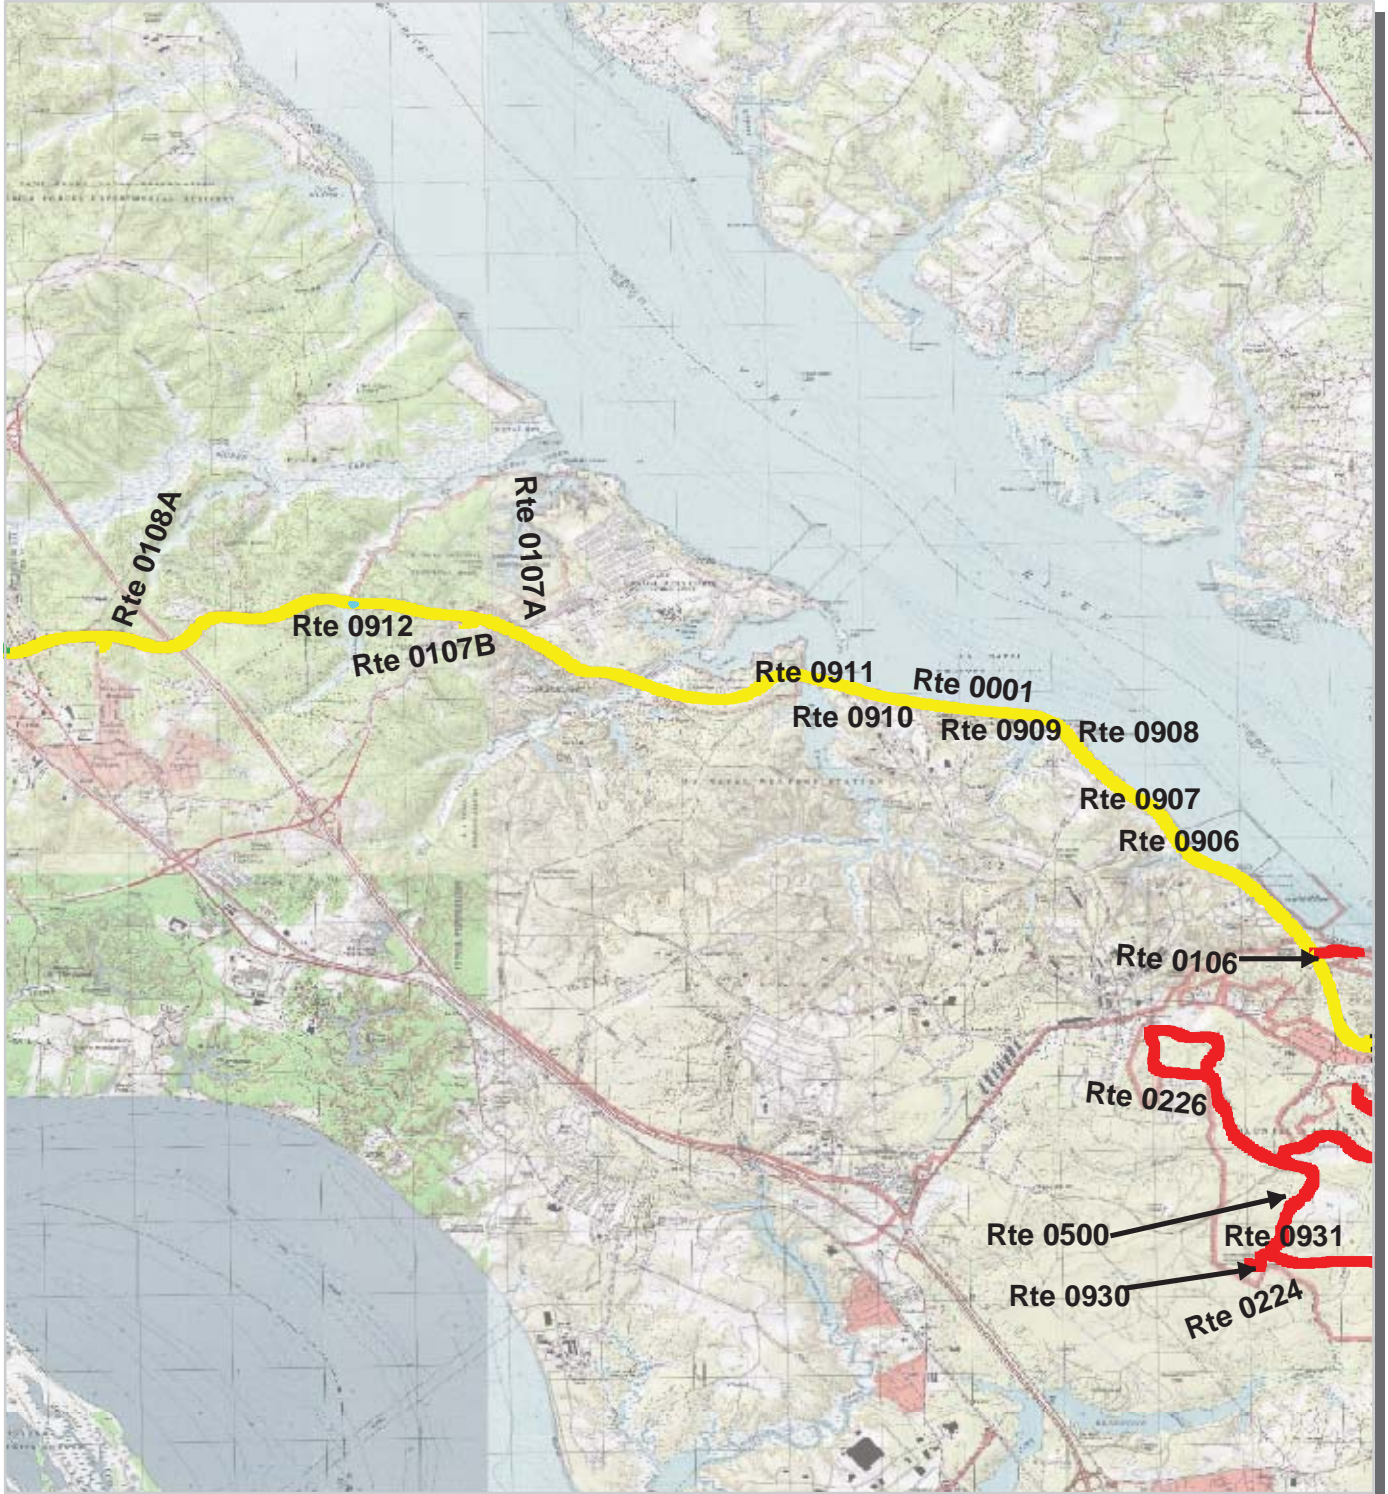
Colonial National Historical Park Route Condition Area Map 2 PCR - Mile by Mile

PCR	Poor	Fair	Good	Excellent
	(≤ 60)	(61 - 84)	(85 - 94)	(95 - 100)

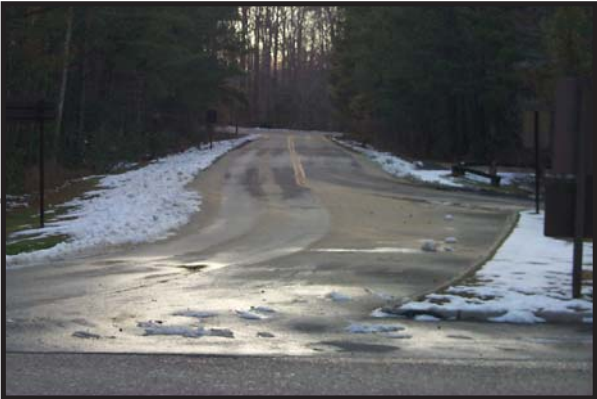
Route 0111B

Route	Length (mi)	Width (ft)	Area (sq ft)	Lane Miles *	Condition / PCR	Surface Type
0111B	0.19	12.00	11848	0.20	GOOD / 90	AS

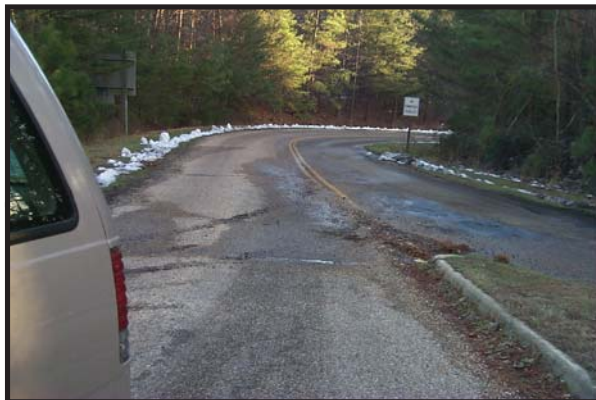
Route 0111C

Route	Length (mi)	Width (ft)	Area (sq ft)	Lane Miles *	Condition / PCR	Surface Type
0111C	0.14	12.00	8617	0.15	GOOD / 90	AS

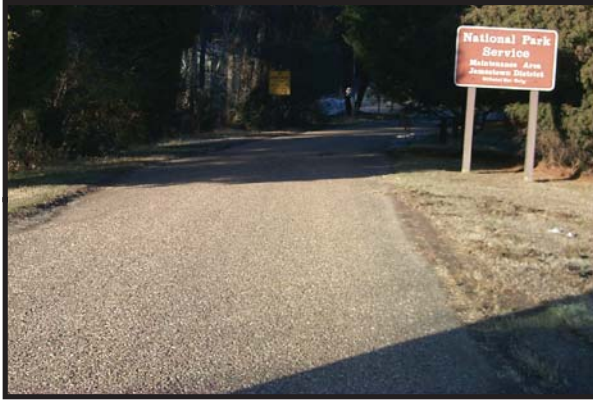
Colonial National Historical Park
Route 0901
YORKTOWN VISITOR CENTER PARKING
 Adjacent to Route 0010 at End of loop

Route	Public / NonPublic	Date Visited	Area (sq ft)	Lane Miles *	Surface Type	Condition / PCR
0901	Public	1/8/2002	84224	1.45	OC	FAIR / 73

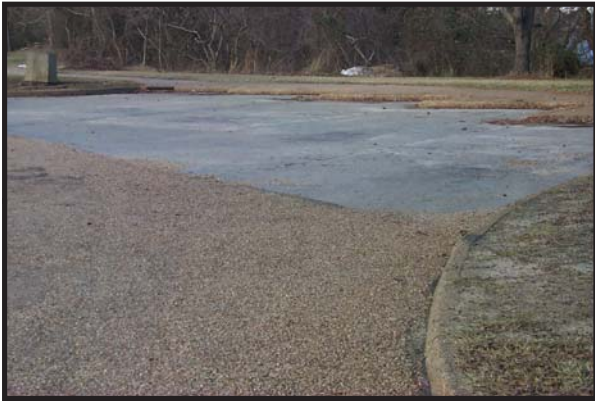
Route 0902

Route	Public / NonPublic	Date Visited	Area (sq ft)	Lane Miles *	Surface Type	Condition / PCR
0902	Public	1/8/2002	2484	0.04	OC	FAIR / 73

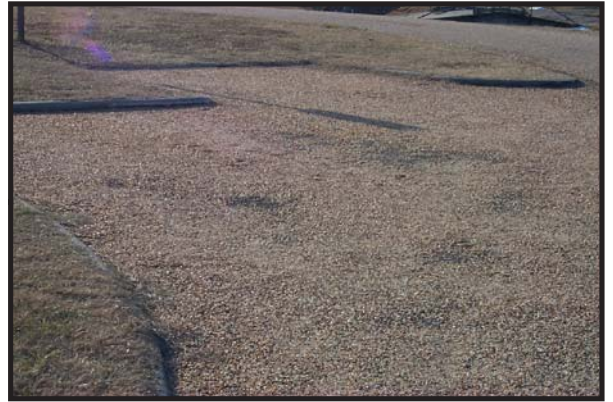
Colonial National Historical Park
Route 0903
 UNTOUCHED REDOUBT LOOP/PARKING
 At End of Route 0100

Route	Public / NonPublic	Date Visited	Area (sq ft)	Lane Miles *	Surface Type	Condition / PCR
0903	Public	1/8/2002	11113	0.19	OC	GOOD / 90

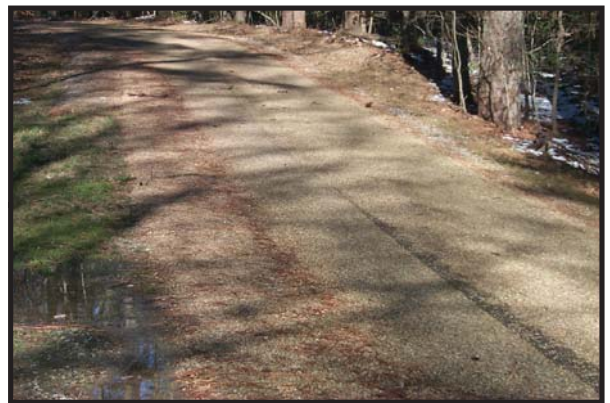
Route 0904

Route	Public / NonPublic	Date Visited	Area (sq ft)	Lane Miles *	Surface Type	Condition / PCR
0904	Public	1/8/2002	41428	0.71	AS	FAIR / 73

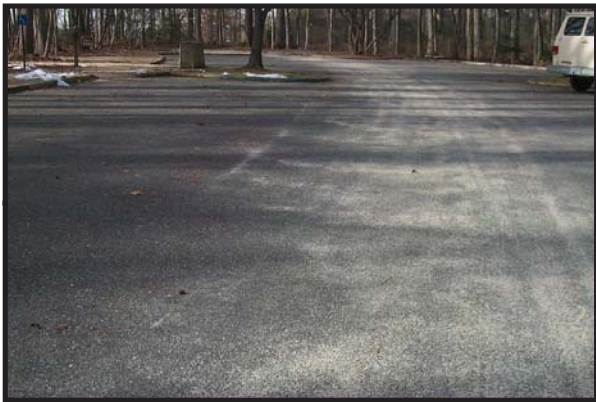
Route 0905

Route	Public / NonPublic	Date Visited	Area (sq ft)	Lane Miles *	Surface Type	Condition / PCR
0905	Public	1/8/2002	14193	0.24	NC	GOOD / 90

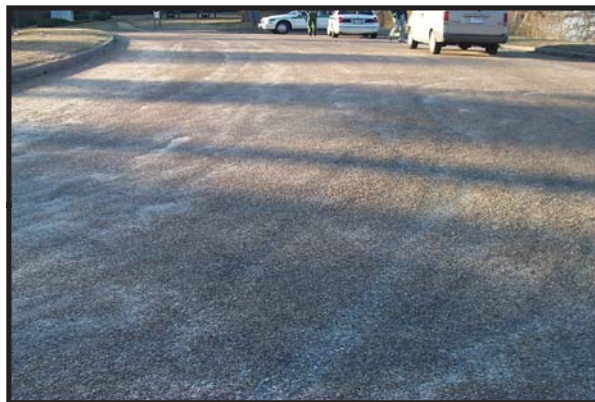
Route 0906

Route	Public / NonPublic	Date Visited	Area (sq ft)	Lane Miles *	Surface Type	Condition / PCR
0906	Public	1/8/2002	10837	0.19	CO	GOOD / 90

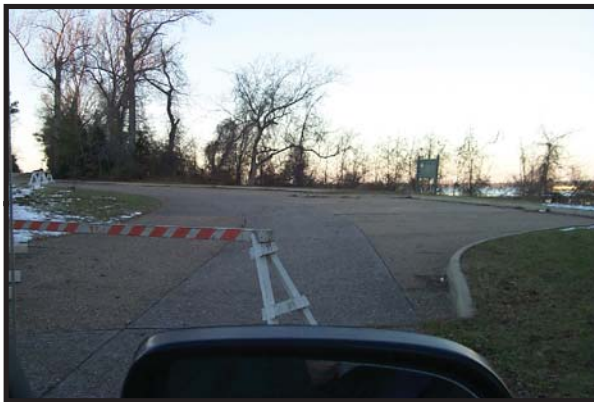
Route 0907

Route	Public / NonPublic	Date Visited	Area (sq ft)	Lane Miles *	Surface Type	Condition / PCR
0907	Public	1/8/2002	7265	0.13	CO	GOOD / 90

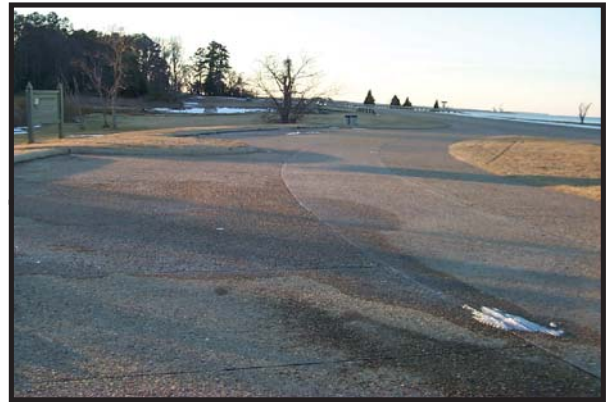
Route 0910

Route	Public / NonPublic	Date Visited	Area (sq ft)	Lane Miles *	Surface Type	Condition / PCR
0910	Public	1/8/2002	9040	0.16	CO	GOOD / 90

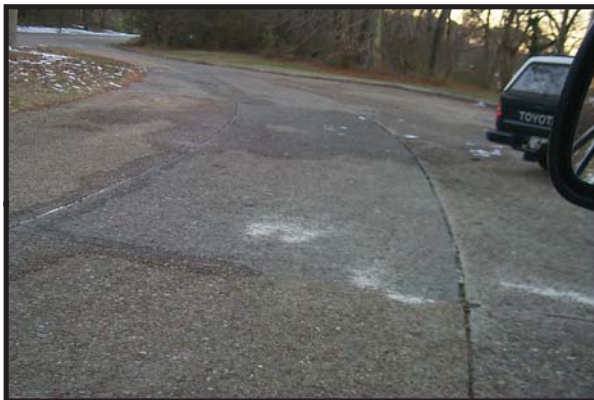
Route 0911

Route	Public / NonPublic	Date Visited	Area (sq ft)	Lane Miles *	Surface Type	Condition / PCR
0911	Public	1/8/2002	15034	0.26	CO	GOOD / 90

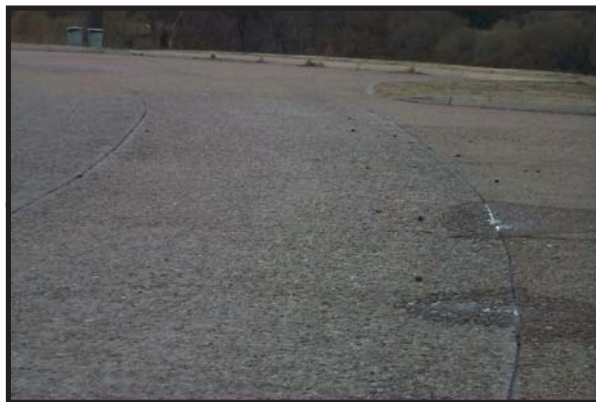
Route 0912

Route	Public / NonPublic	Date Visited	Area (sq ft)	Lane Miles *	Surface Type	Condition / PCR
0912	Public	1/8/2002	8310	0.14	CO	GOOD / 90

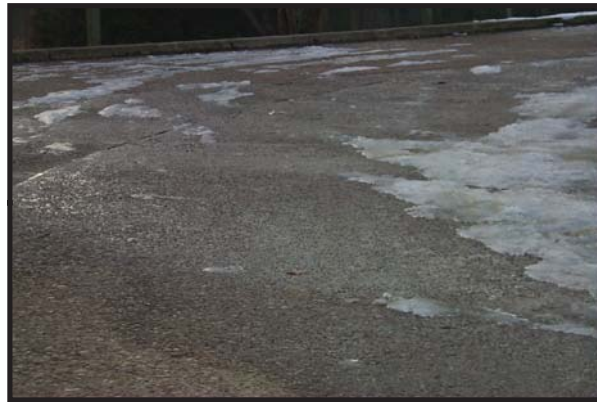
Route 0913

Route	Public / NonPublic	Date Visited	Area (sq ft)	Lane Miles *	Surface Type	Condition / PCR
0913	Public	1/8/2002	11493	0.20	CO	GOOD / 90

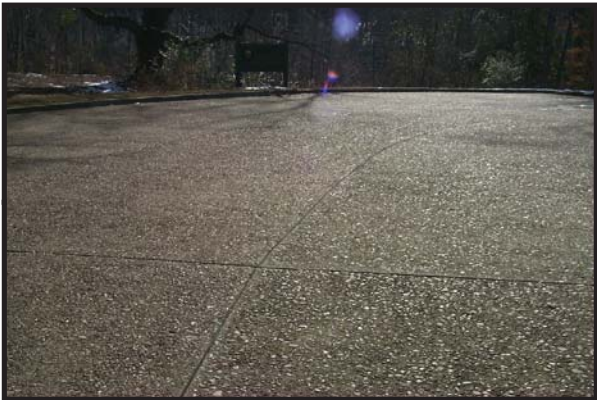
Route 0914

Route	Public / NonPublic	Date Visited	Area (sq ft)	Lane Miles *	Surface Type	Condition / PCR
0914	Public	1/8/2002	9824	0.17	CO	GOOD / 90

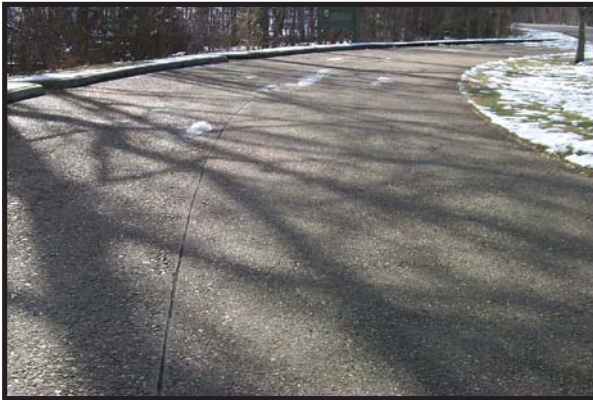
Route 0915

Route	Public / NonPublic	Date Visited	Area (sq ft)	Lane Miles *	Surface Type	Condition / PCR
0915	Public	1/8/2002	22701	0.39	CO	GOOD / 90

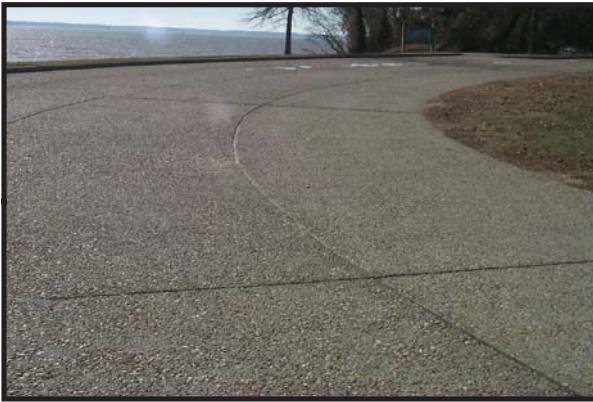
Route 0917

Route	Public / NonPublic	Date Visited	Area (sq ft)	Lane Miles *	Surface Type	Condition / PCR
0917	Public	1/8/2002	20538	0.35	CO	GOOD / 90

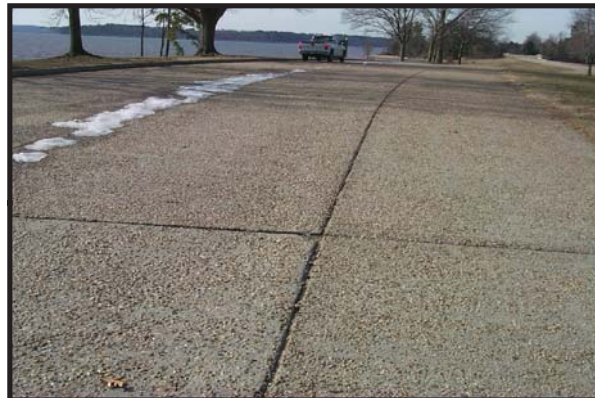
Colonial National Historical Park
Route 0918
 JAMESTOWN ISLAND/GLEBE LAND PARKING
 Adjacent to Route 0001 at MP 19.11

Route	Public / NonPublic	Date Visited	Area (sq ft)	Lane Miles *	Surface Type	Condition / PCR
0918	Public	1/8/2002	26205	0.45	CO	GOOD / 90

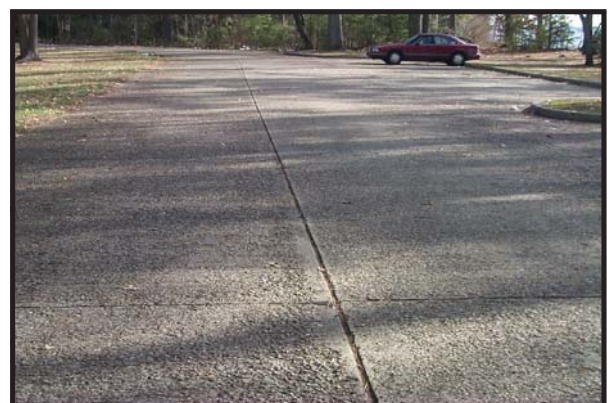
Route 0919

Route	Public / NonPublic	Date Visited	Area (sq ft)	Lane Miles *	Surface Type	Condition / PCR
0919	Public	1/8/2002	10466	0.18	CO	GOOD / 90

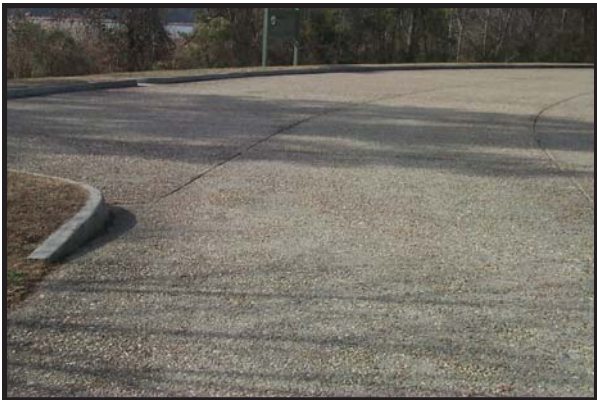
Route 0920

Route	Public / NonPublic	Date Visited	Area (sq ft)	Lane Miles *	Surface Type	Condition / PCR
0920	Public	1/8/2002	20160	0.35	CO	GOOD / 90

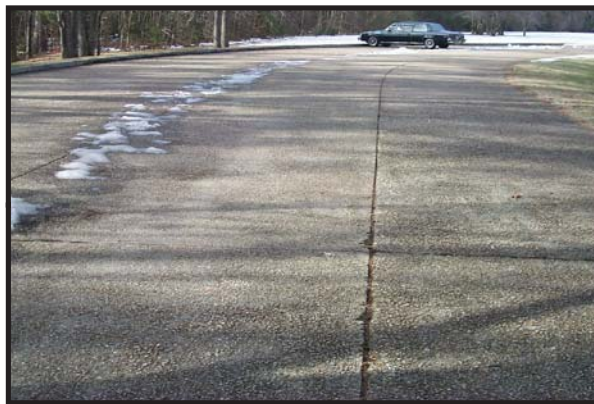
Route 0921

Route	Public / NonPublic	Date Visited	Area (sq ft)	Lane Miles *	Surface Type	Condition / PCR
0921	Public	1/8/2002	25374	0.44	CO	GOOD / 90

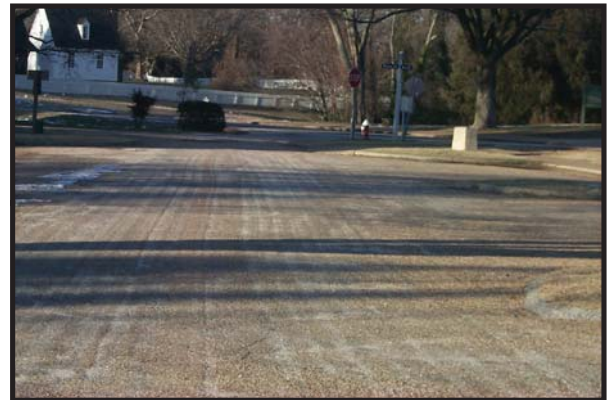
Route 0924

Route	Public / NonPublic	Date Visited	Area (sq ft)	Lane Miles *	Surface Type	Condition / PCR
0924	Public	1/8/2002	47855	0.82	AS	FAIR / 73

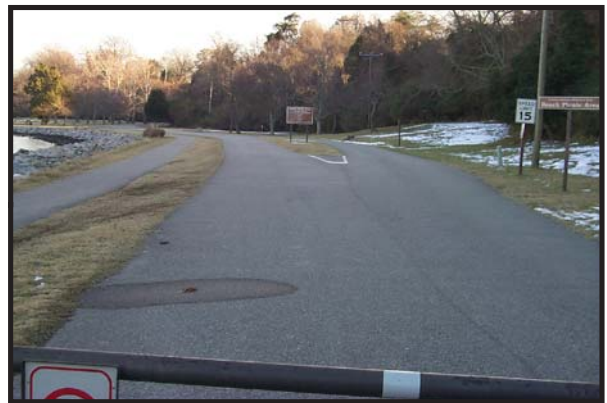
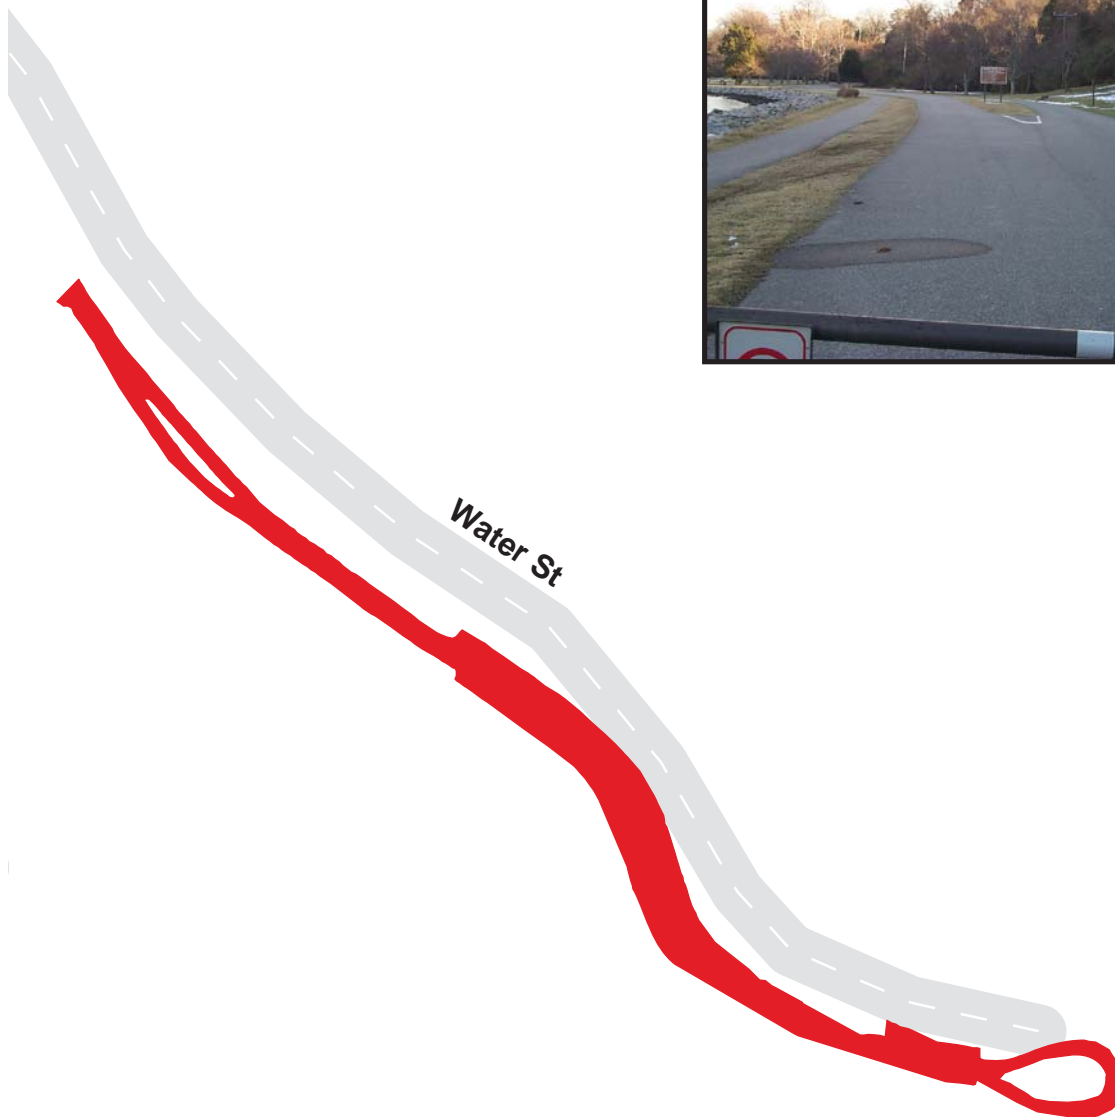
Route 0925

Route	Public / NonPublic	Date Visited	Area (sq ft)	Lane Miles *	Surface Type	Condition / PCR
0925	Public	1/8/2002	1113	0.02	AS	FAIR / 73

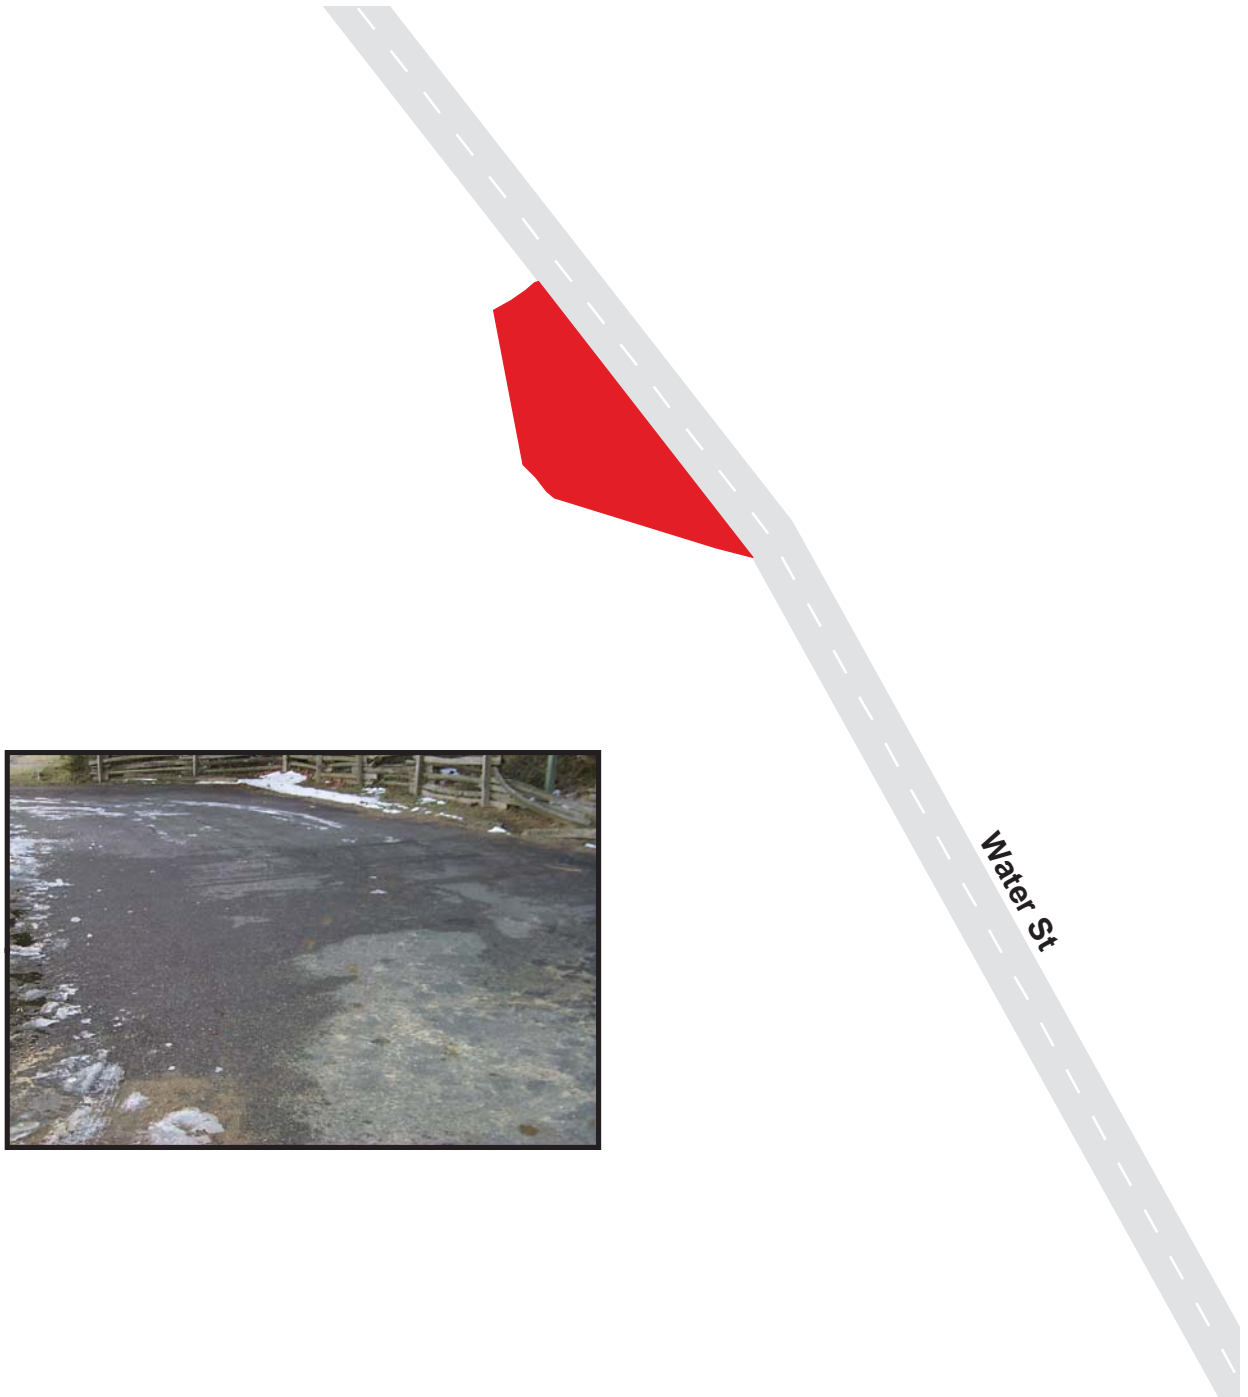
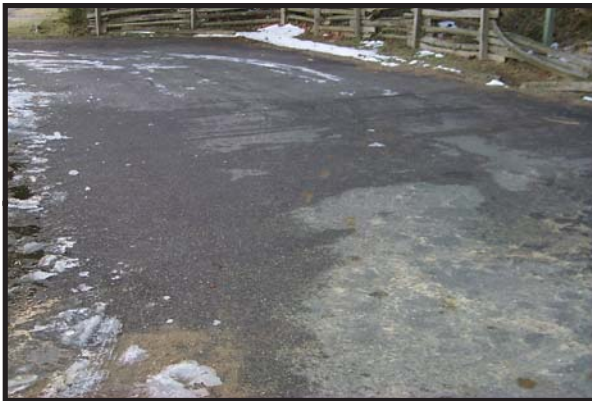
Route 0926

Route	Public / NonPublic	Date Visited	Area (sq ft)	Lane Miles *	Surface Type	Condition / PCR
0926	Public	1/8/2002	9709	0.17	NC	GOOD / 90

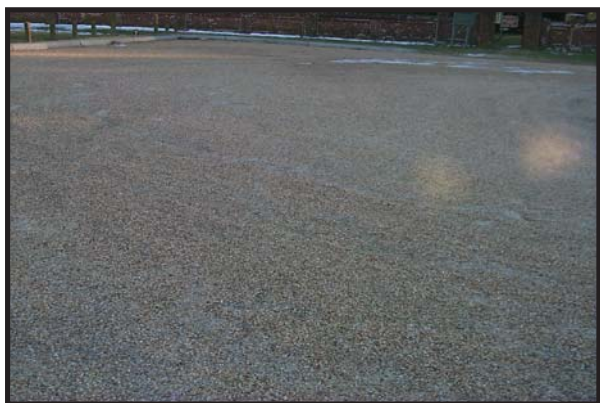
Route 0927

Route	Public / NonPublic	Date Visited	Area (sq ft)	Lane Miles *	Surface Type	Condition / PCR
0927	Public	1/8/2002	2555	0.04	OC	FAIR / 73

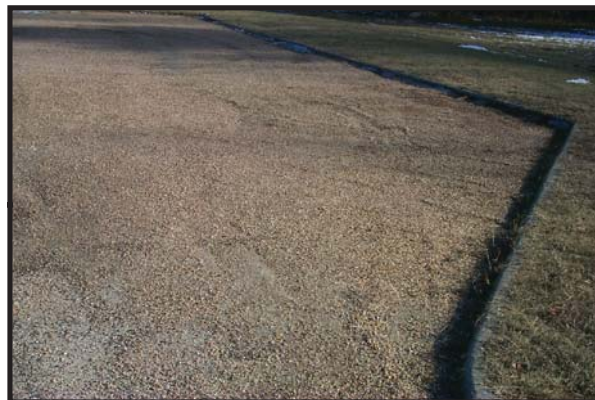
Route 0928

Route	Public / NonPublic	Date Visited	Area (sq ft)	Lane Miles *	Surface Type	Condition / PCR
0928	Public	1/8/2002	7899	0.14	OC	FAIR / 73

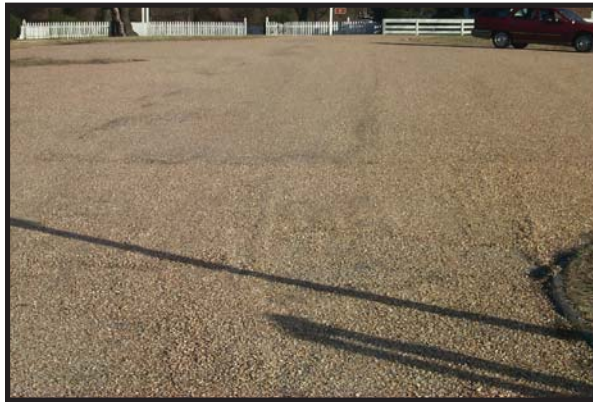
Route 0929

Route	Public / NonPublic	Date Visited	Area (sq ft)	Lane Miles *	Surface Type	Condition / PCR
0929	Public	1/8/2002	17296	0.30	OC	FAIR / 73

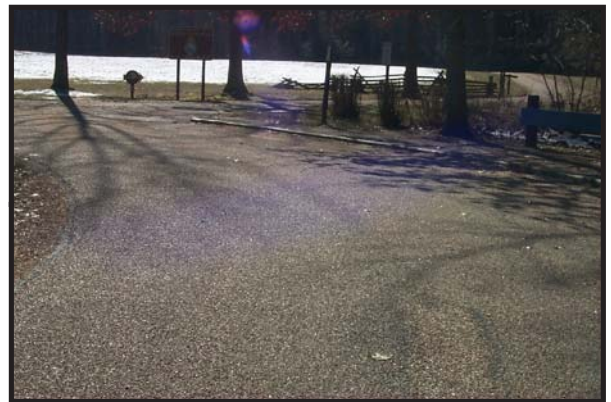
Colonial National Historical Park
Route 0930
WASHINGTON'S HEADQUARTERS PARKING
At End of Route 0224

Route	Public / NonPublic	Date Visited	Area (sq ft)	Lane Miles *	Surface Type	Condition / PCR
0930	Public	1/8/2002	4745	0.08	OC	FAIR / 73

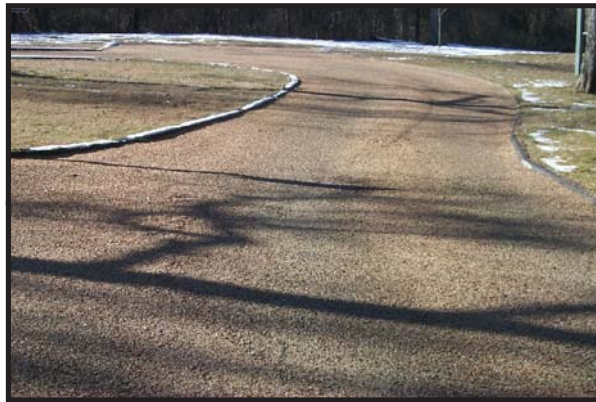
Route 0931

Route	Public / NonPublic	Date Visited	Area (sq ft)	Lane Miles *	Surface Type	Condition / PCR
0931	Public	1/8/2002	1737	0.03	OC	GOOD / 90

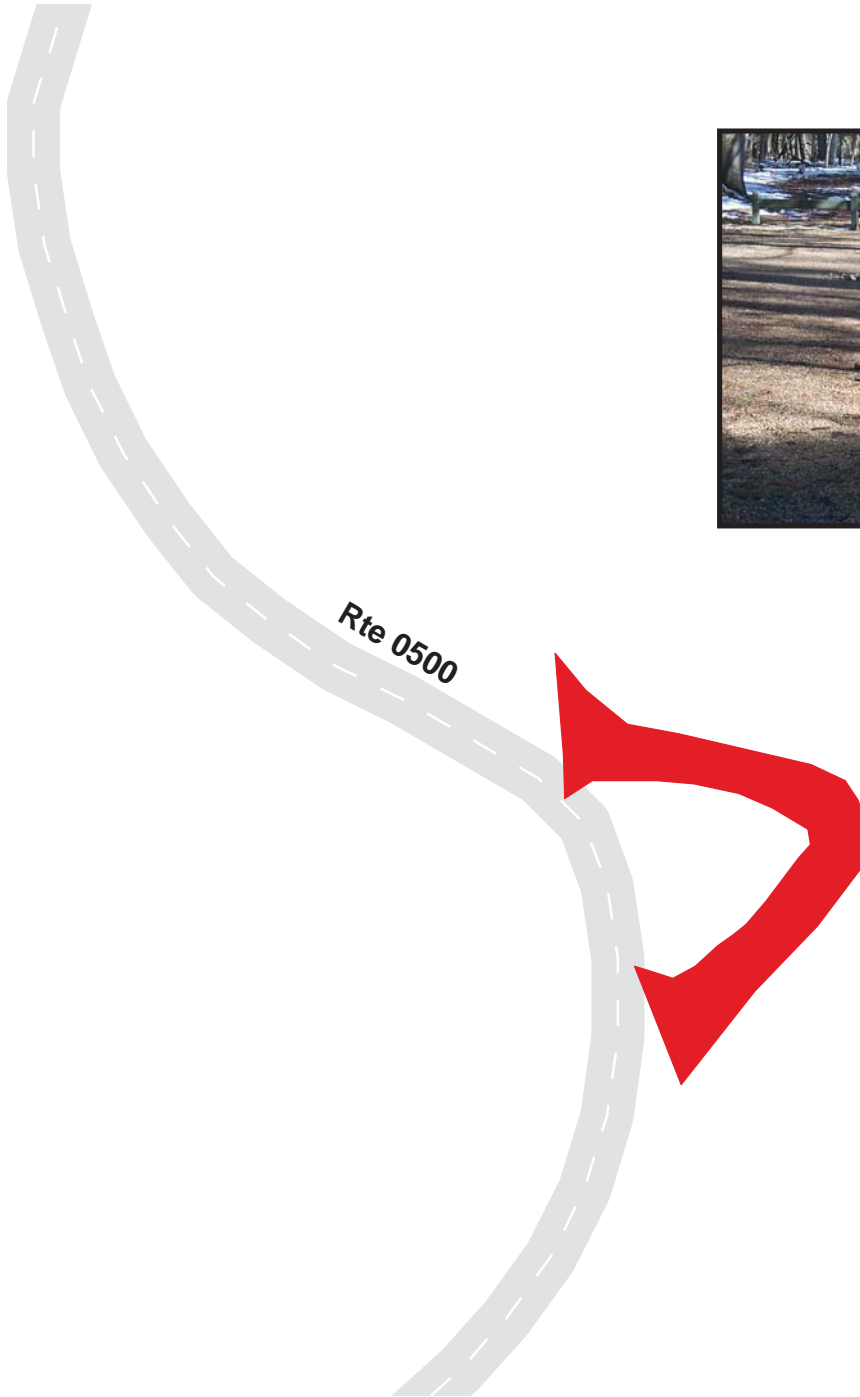
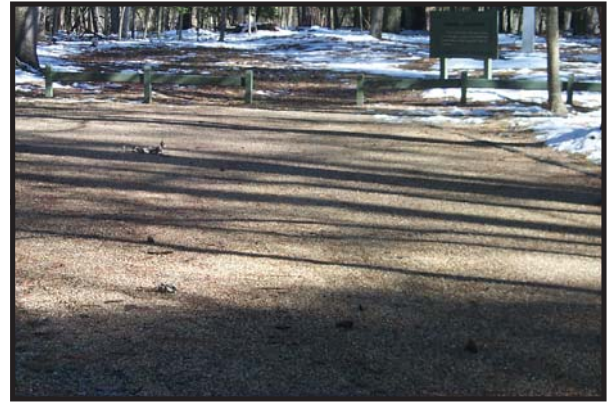
Route 0940

Route	Public / NonPublic	Date Visited	Area (sq ft)	Lane Miles *	Surface Type	Condition / PCR
0940	Public	8/12/2004	31146	0.54	AS	POOR / 45

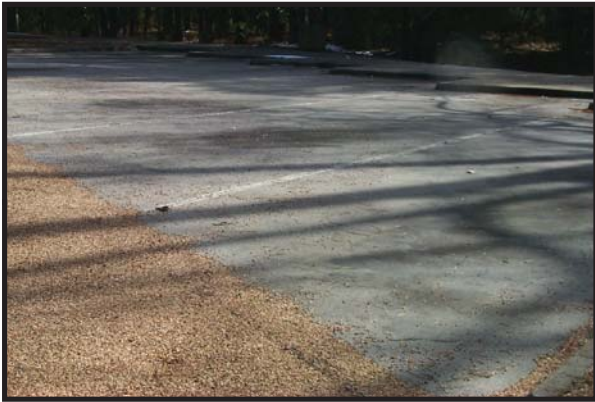
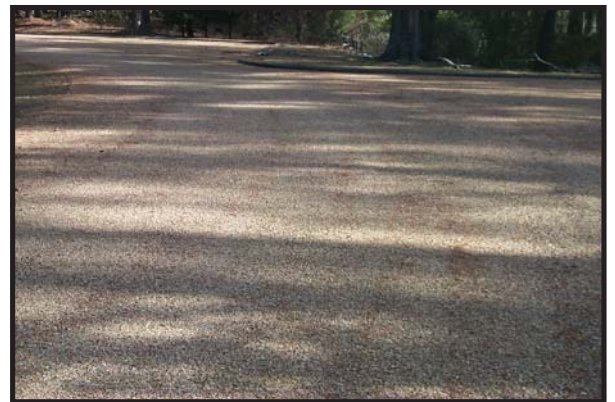
Route 0990

Route	Public / NonPublic	Date Visited	Area (sq ft)	Lane Miles *	Surface Type	Condition / PCR
0990	Public	1/8/2002	14856	0.26	AS	FAIR / 73

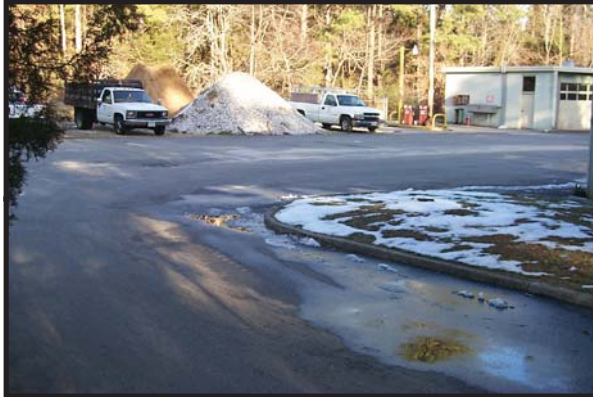
Route 0999

Route	Public / NonPublic	Date Visited	Area (sq ft)	Lane Miles *	Surface Type	Condition / PCR
0999	Public	1/8/2002	191886	3.30	AS	FAIR / 73
