# The Road Inventory of Congaree National Park COSW - 5240

## Road Inventory Program

Prepared By:  
Federal Highway Administration  
Eastern Federal Lands Highway Division  
Cycle 3

# Congaree National Park in South Carolina

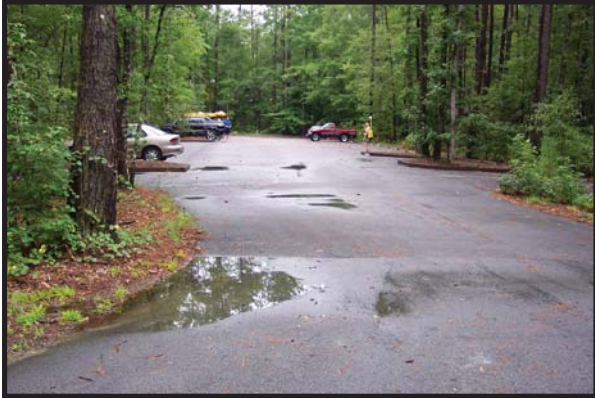
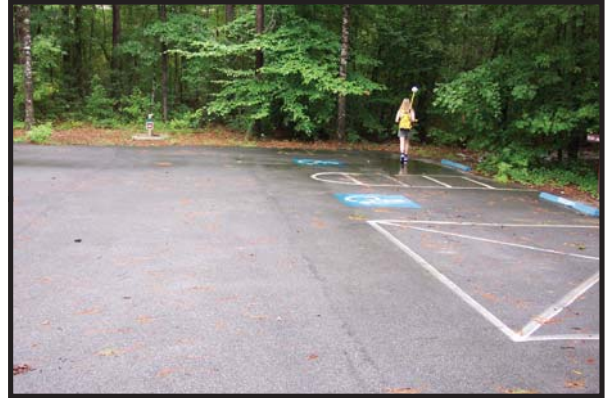
Route	Public / NonPublic	Date Visited	Area (sq ft)	Lane Miles *	Surface Type	Condition / PCR
0900	Public	8/15/2004	27144	0.47	AS	GOOD / 90

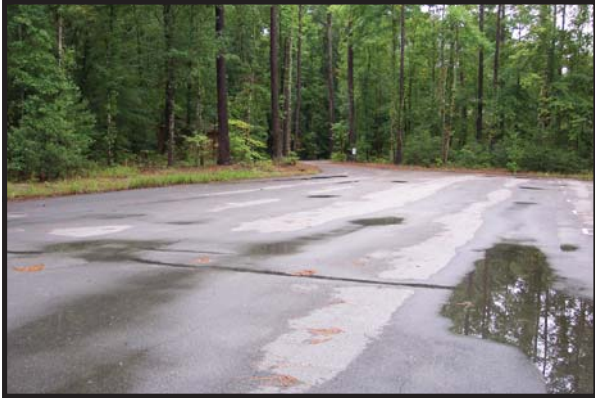
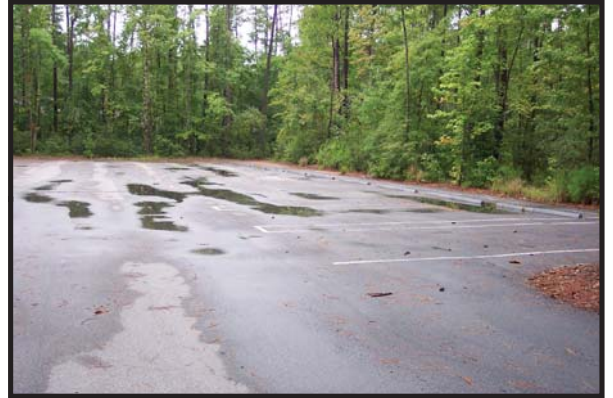
## Route 0901

Route	Public / NonPublic	Date Visited	Area (sq ft)	Lane Miles *	Surface Type	Condition / PCR
0901	Public	8/15/2004	17096	0.29	AS	GOOD / 90

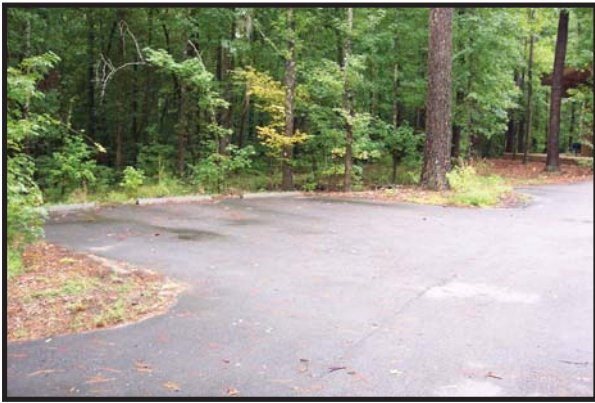
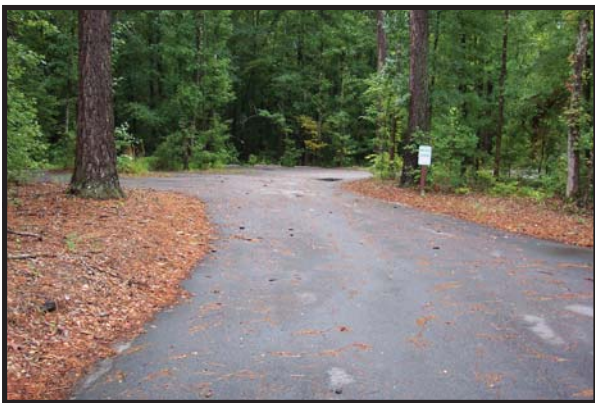
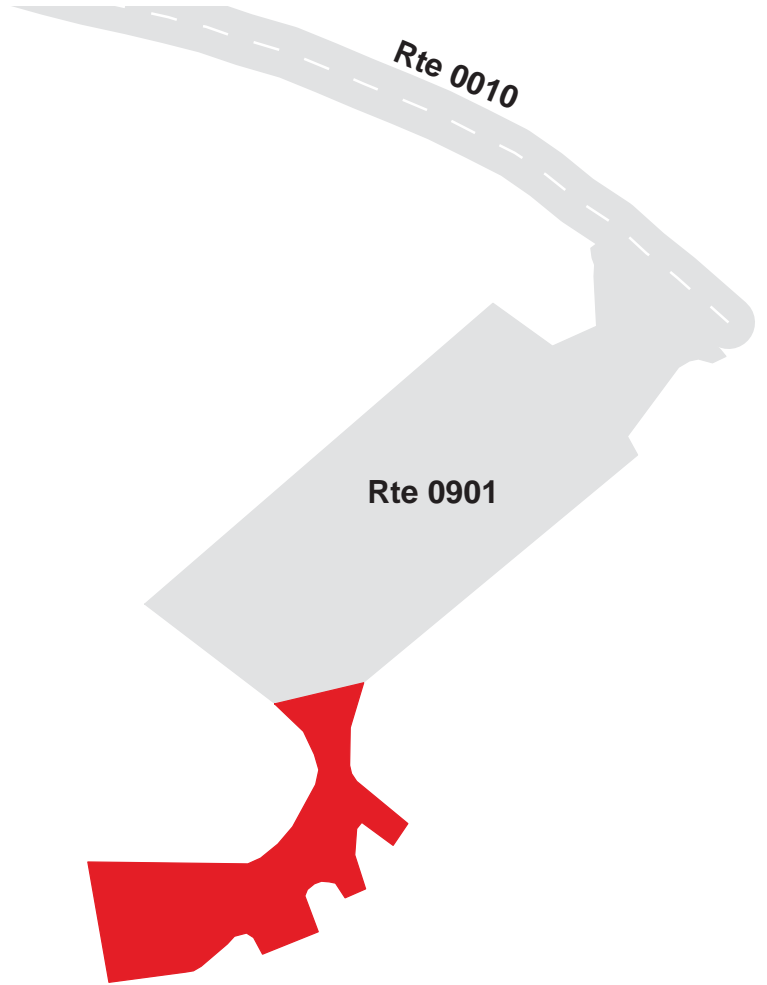
## Route 0902

Route	Public / NonPublic	Date Visited	Area (sq ft)	Lane Miles *	Surface Type	Condition / PCR
0902	NonPublic	8/15/2004	5402	0.09	AS	GOOD / 90
