The Road Inventory of Coronado National Memorial CORO - 8630

Road Inventory Program

Prepared By:
Federal Highway Administration
Eastern Federal Lands Highway Division
Cycle 3

Coronado National Memorial in Arizona

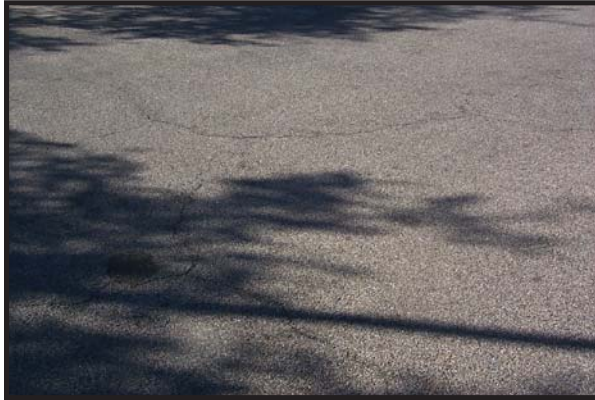
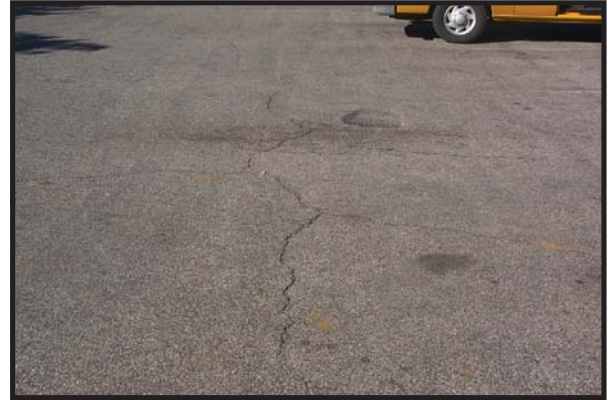
Route	Public / NonPublic	Date Visited	Area (sq ft)	Lane Miles *	Surface Type	Condition / PCR
0900	Public	3/7/2003	10409	0.18	OC	GOOD / 90

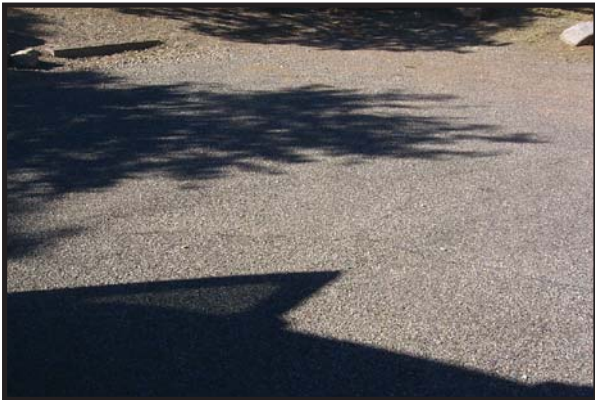
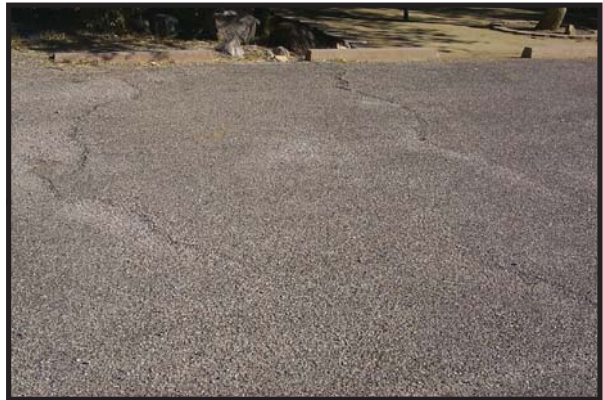
Route 0903A

Route	Public / NonPublic	Date Visited	Area (sq ft)	Lane Miles *	Surface Type	Condition / PCR
0903A	Public	3/7/2003	1475	0.03	OC	GOOD / 90

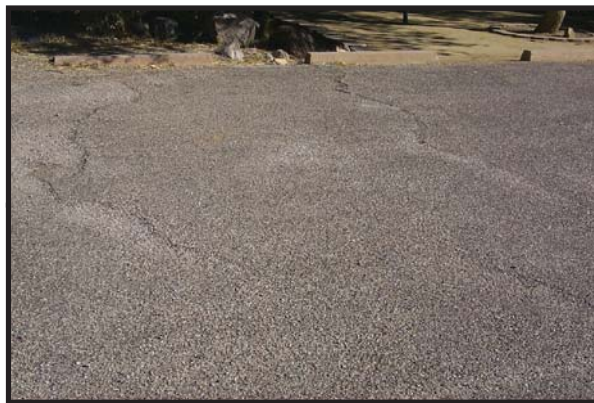
Route 0903B

Route	Public / NonPublic	Date Visited	Area (sq ft)	Lane Miles *	Surface Type	Condition / PCR
0903B	Public	3/7/2003	1566	0.03	OC	GOOD / 90

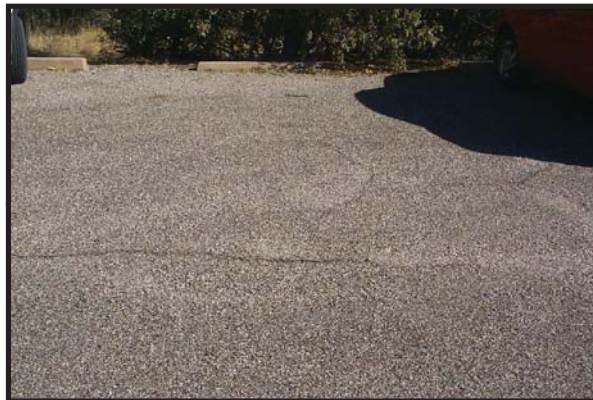
Route 0903C

Route	Public / NonPublic	Date Visited	Area (sq ft)	Lane Miles *	Surface Type	Condition / PCR
0903C	Public	3/7/2003	1562	0.03	OC	GOOD / 90

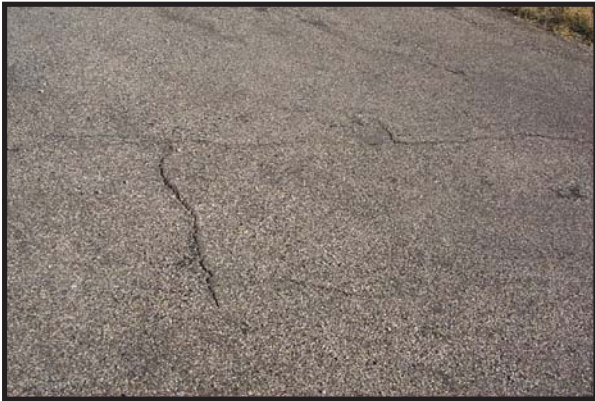
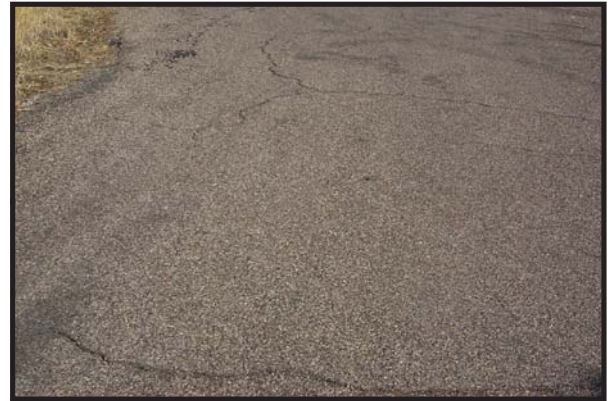
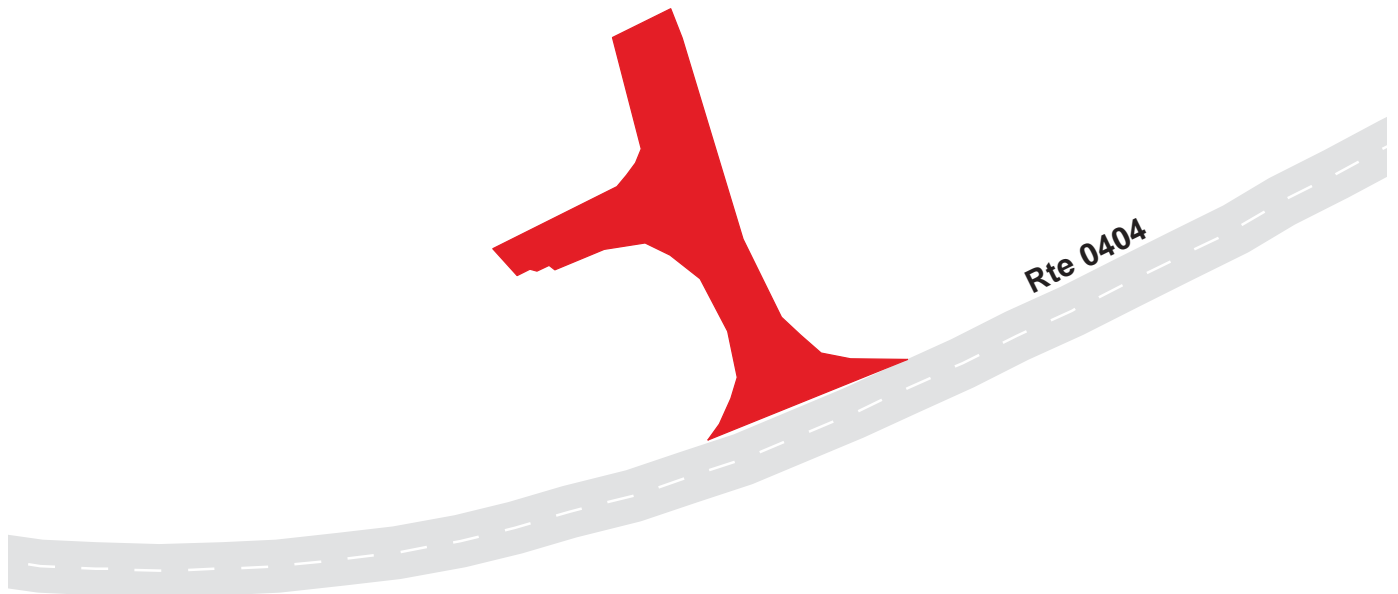
Route 0906

Route	Public / NonPublic	Date Visited	Area (sq ft)	Lane Miles *	Surface Type	Condition / PCR
0906	NonPublic	3/7/2003	3145	0.05	OC	FAIR / 73

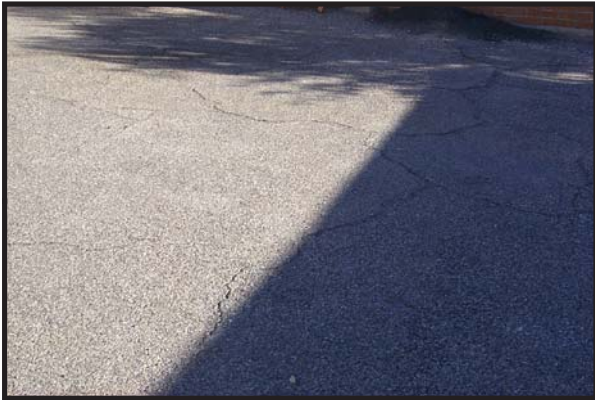
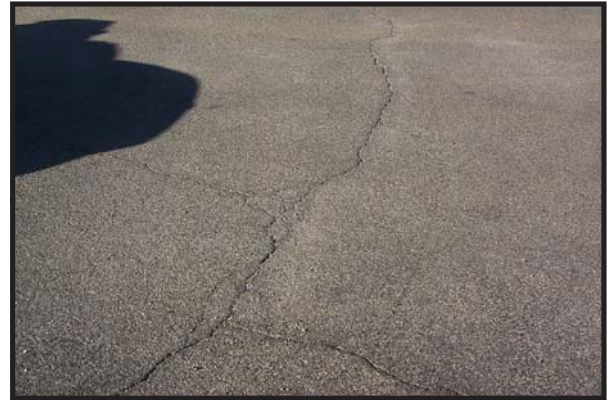
Route 0907

Route	Public / NonPublic	Date Visited	Area (sq ft)	Lane Miles *	Surface Type	Condition / PCR
0907	NonPublic	3/7/2003	7119	0.12	OC	FAIR / 73
