# The Road Inventory of Cowpens National Battlefield COWP – 5510

## Road Inventory Program

Prepared By:  
Federal Highway Administration  
Eastern Federal Lands Highway Division  
Cycle 3

# Cowpens National Battlefield in South Carolina

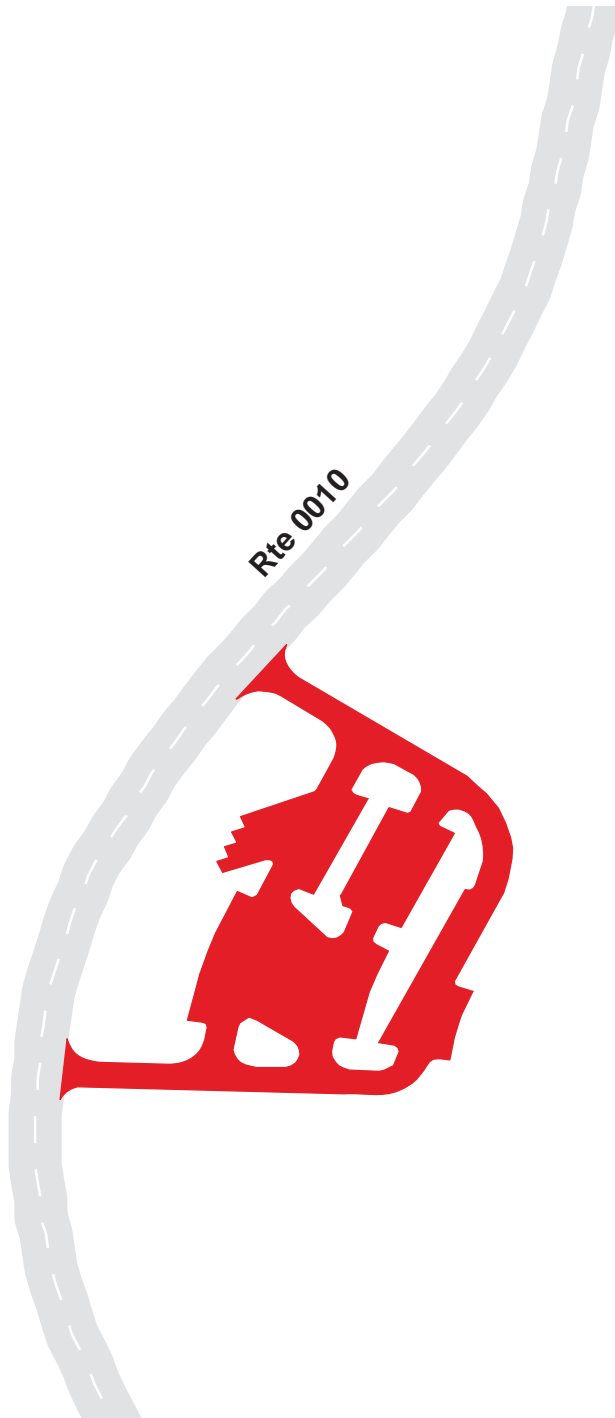
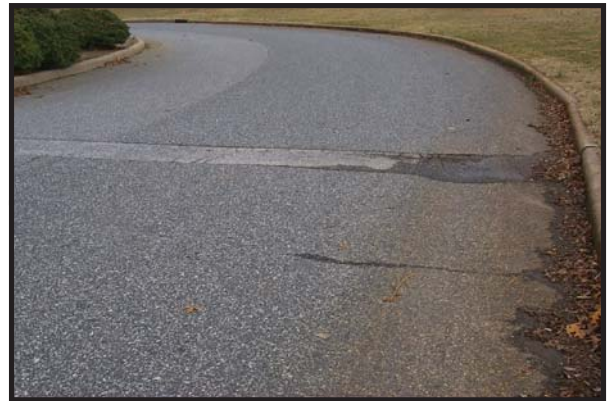
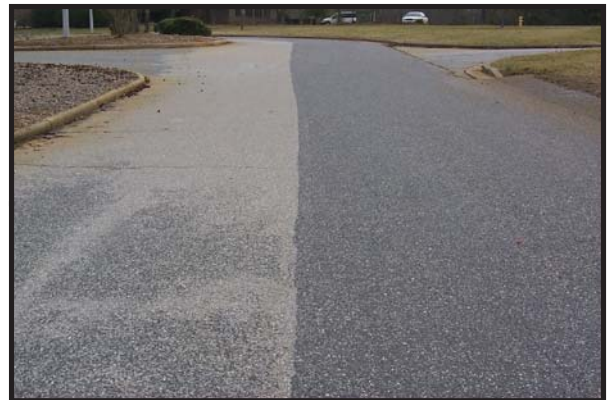
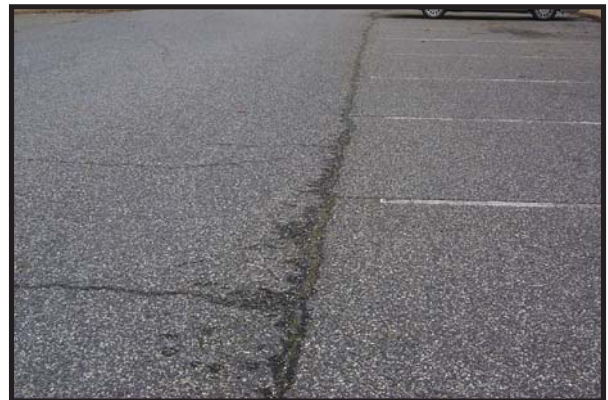
Route	Public / NonPublic	Date Visited	Area (sq ft)	Lane Miles *	Surface Type	Condition / PCR
0900	Public	3/12/2002	62529	1.08	AS	FAIR / 73

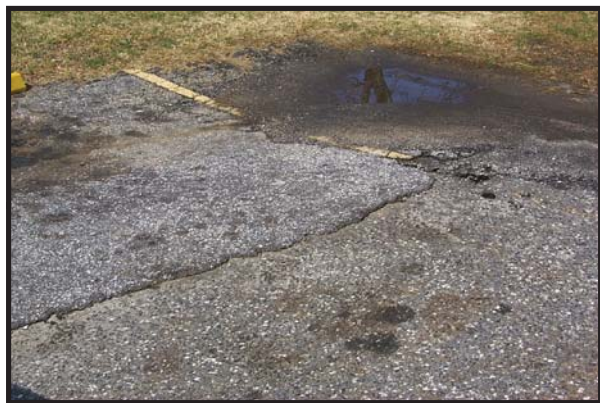
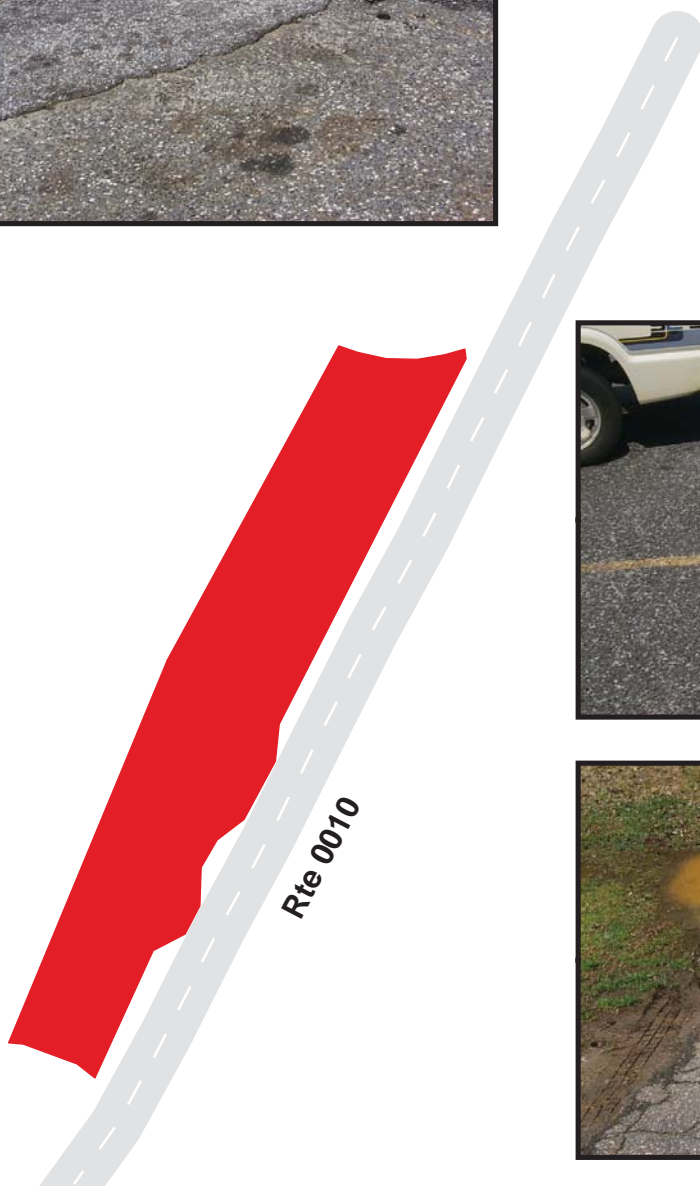
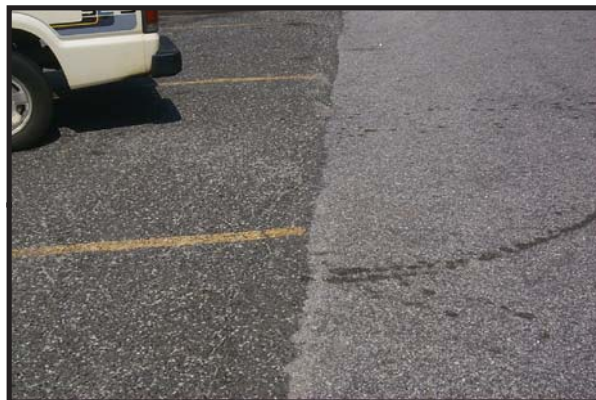
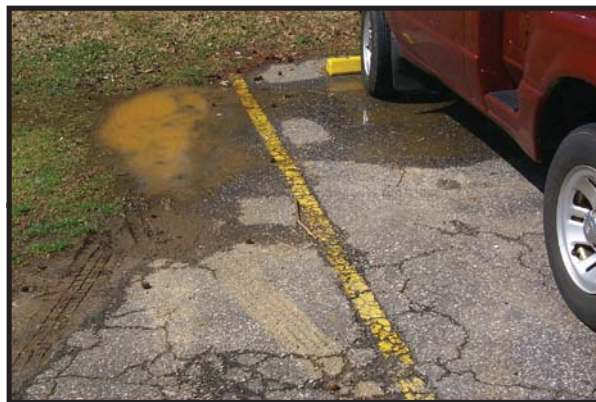
## Route 0901

Route	Public / NonPublic	Date Visited	Area (sq ft)	Lane Miles *	Surface Type	Condition / PCR
0901	Public	3/13/2002	2041	0.04	AS	FAIR / 73

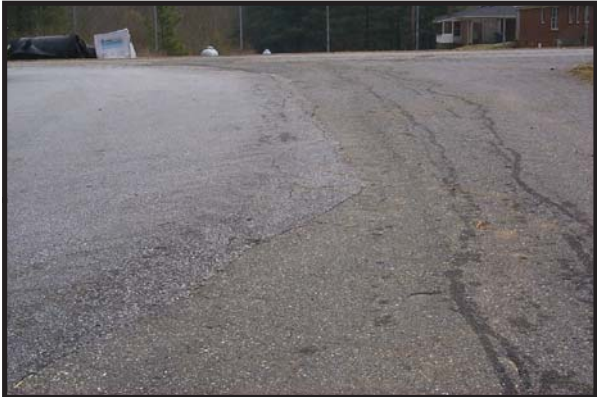
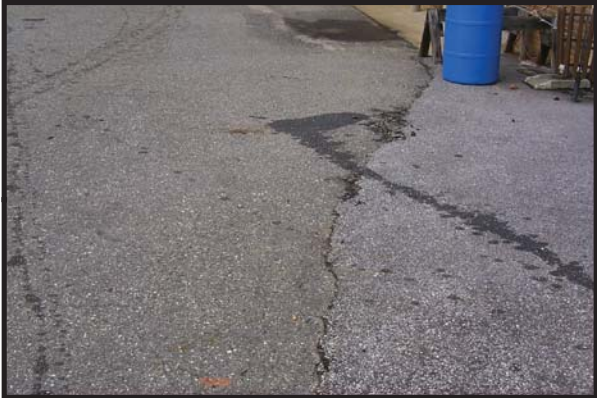
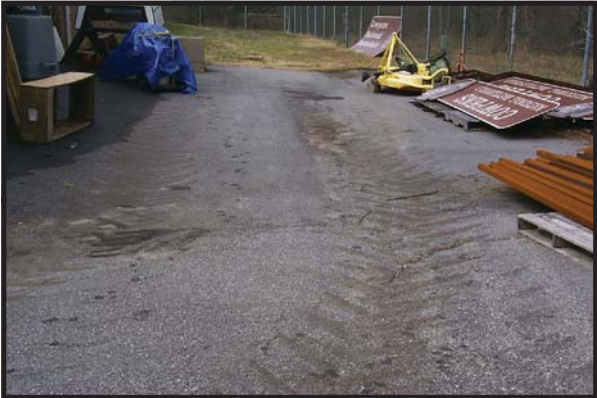
## Route 0902

Route	Public / NonPublic	Date Visited	Area (sq ft)	Lane Miles *	Surface Type	Condition / PCR
0902	NonPublic	3/13/2002	13496	0.23	AS	FAIR / 73

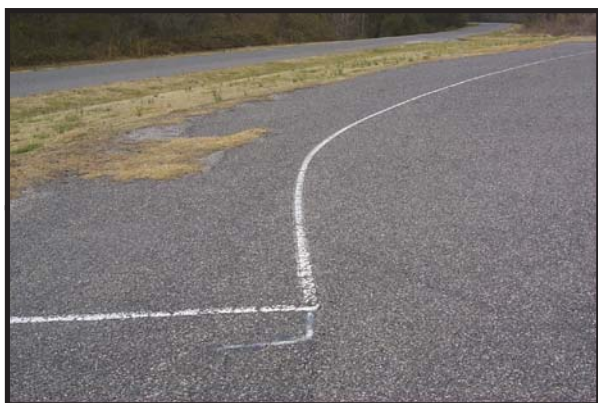
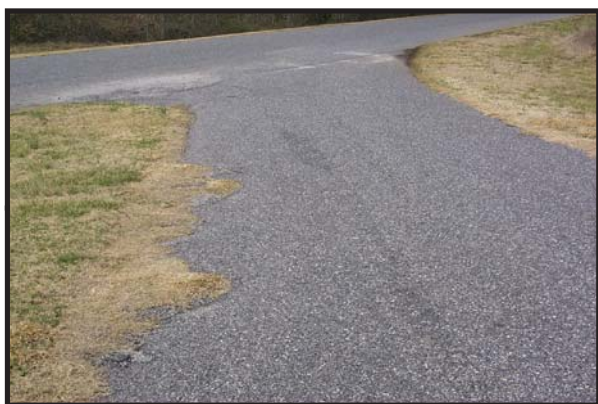
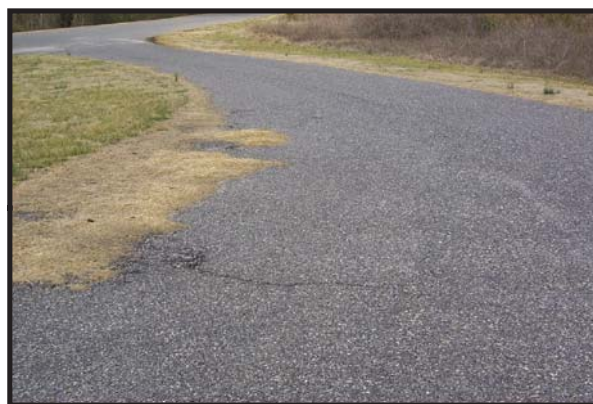
## Route 0903

Route	Public / NonPublic	Date Visited	Area (sq ft)	Lane Miles *	Surface Type	Condition / PCR
0903	Public	3/12/2002	6986	0.12	AS	GOOD / 90

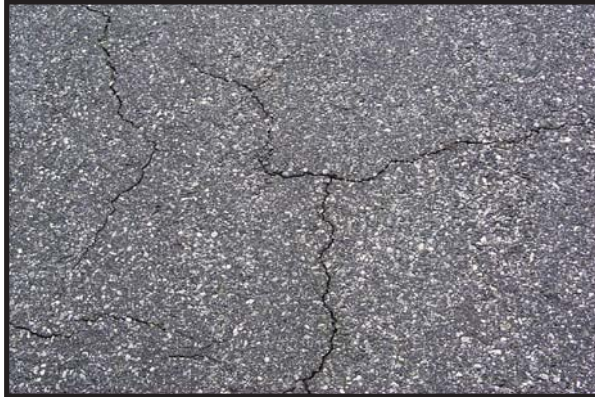
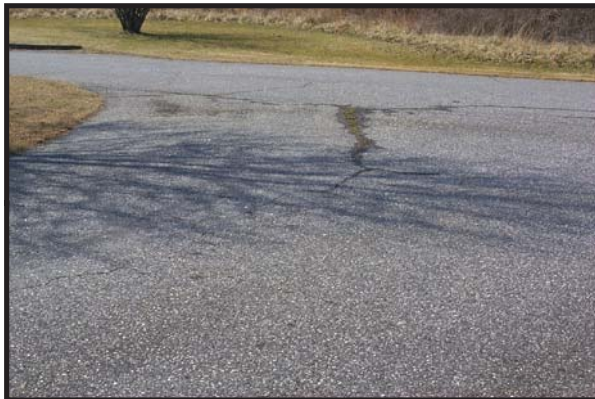
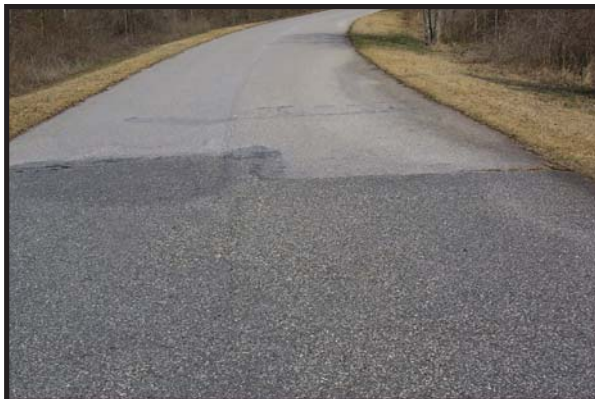
## Route 0904

Route	Public / NonPublic	Date Visited	Area (sq ft)	Lane Miles *	Surface Type	Condition / PCR
0904	Public	3/13/2002	18988	0.33	AS	FAIR / 73

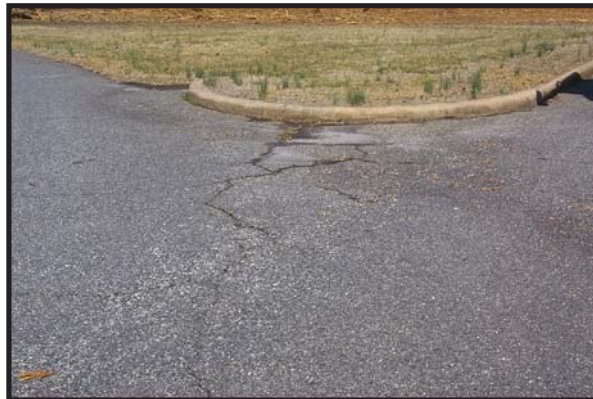
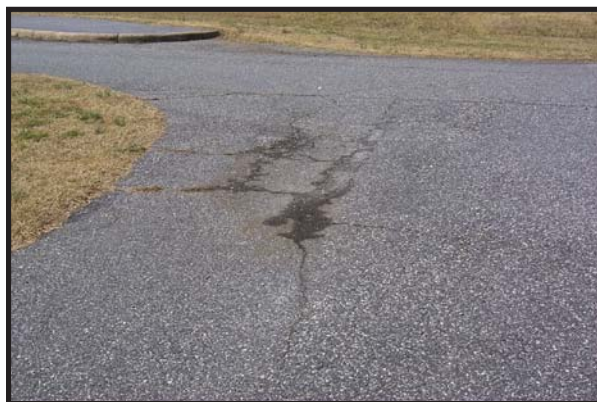
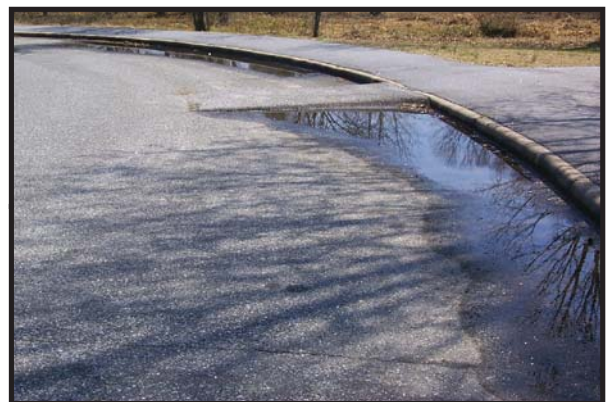
## Route 0905

Route	Public / NonPublic	Date Visited	Area (sq ft)	Lane Miles *	Surface Type	Condition / PCR
0905	Public	3/13/2002	21600	0.37	AS	FAIR / 73

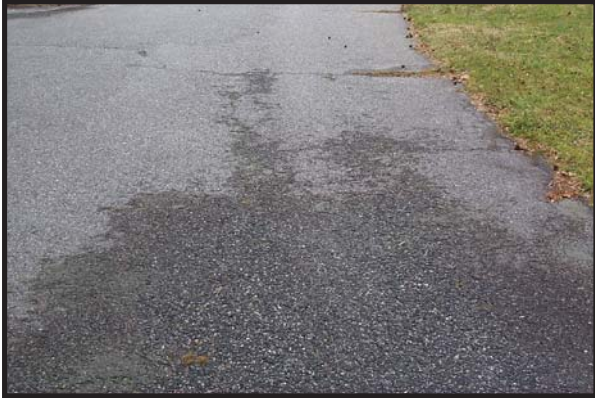
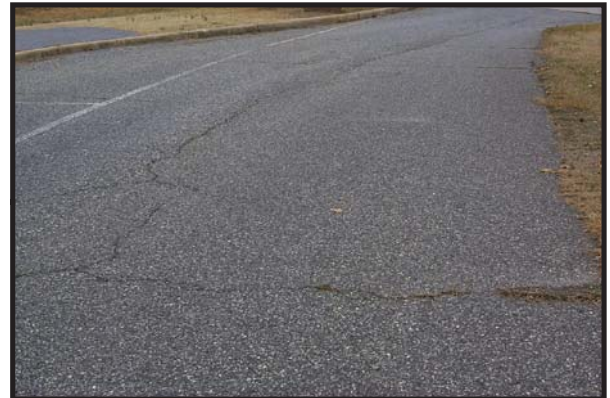
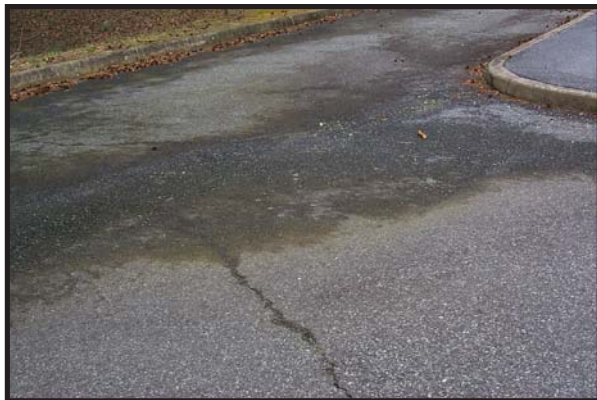
## Route 0906

Route	Public / NonPublic	Date Visited	Area (sq ft)	Lane Miles *	Surface Type	Condition / PCR
0906	Public	3/13/2002	6050	0.10	AS	GOOD / 90

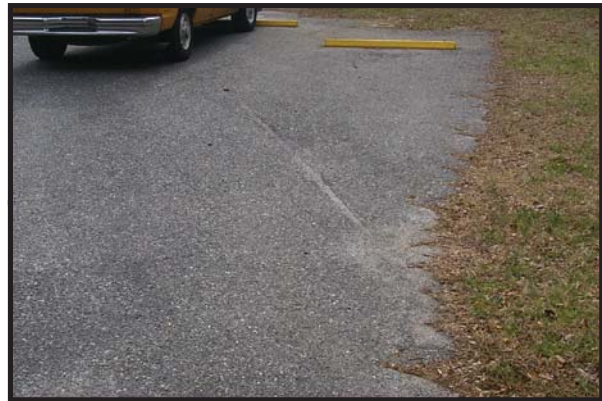
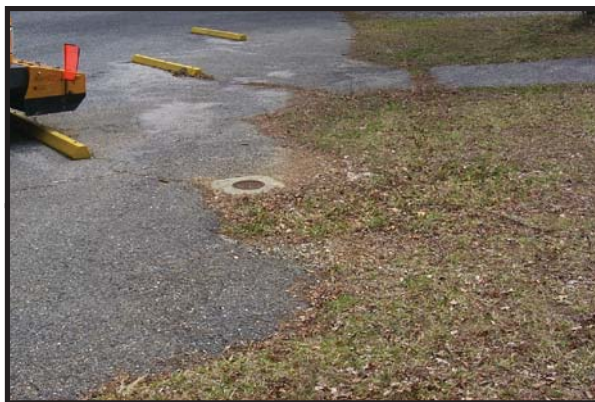
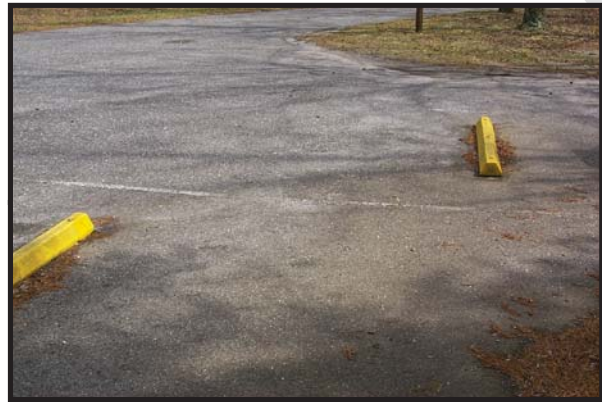
## Route 0907

Route	Public / NonPublic	Date Visited	Area (sq ft)	Lane Miles *	Surface Type	Condition / PCR
0907	Public	3/13/2002	3201	0.06	AS	GOOD / 90

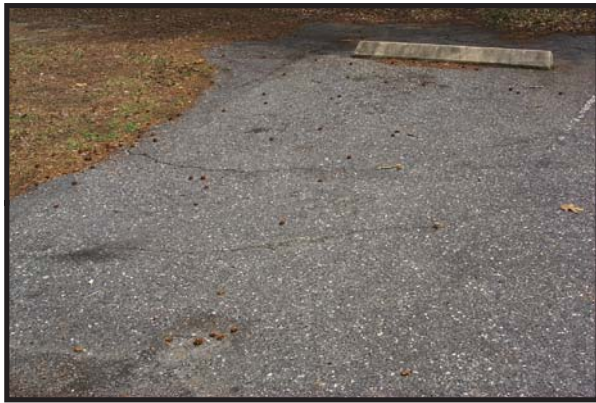
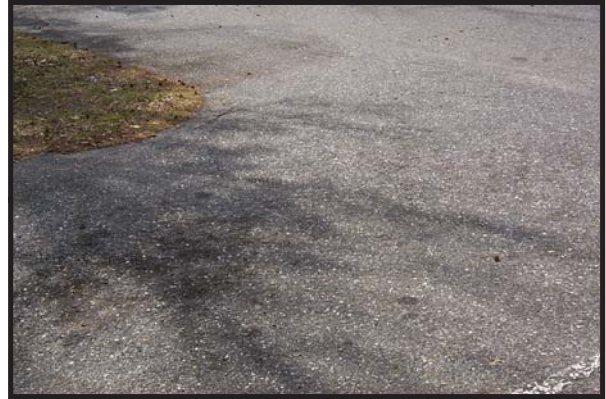
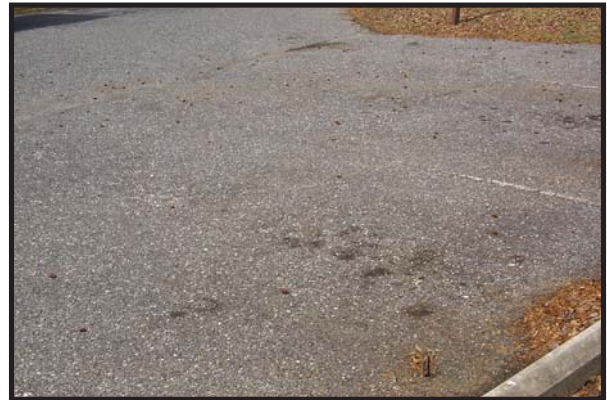
## Route 0908

Route	Public / NonPublic	Date Visited	Area (sq ft)	Lane Miles *	Surface Type	Condition / PCR
0908	Public	3/13/2002	1393	0.02	AS	GOOD / 90

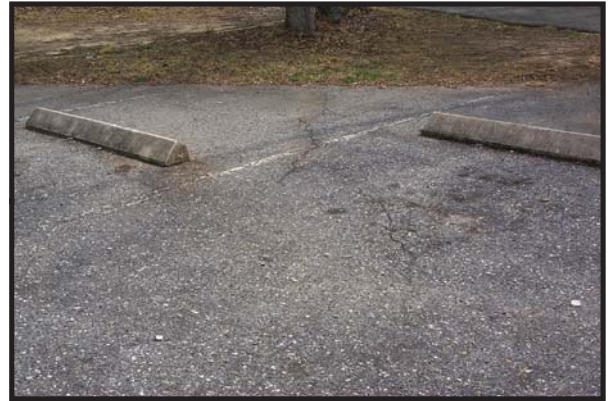
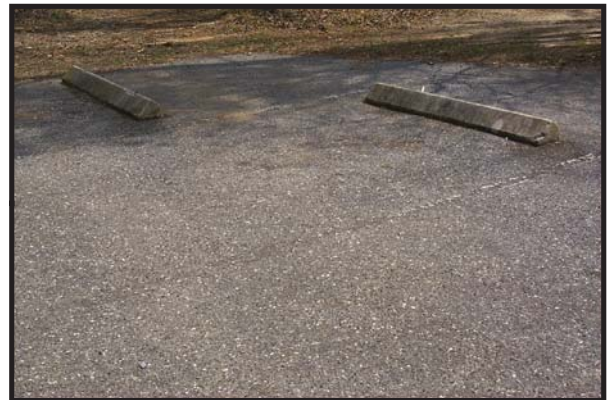
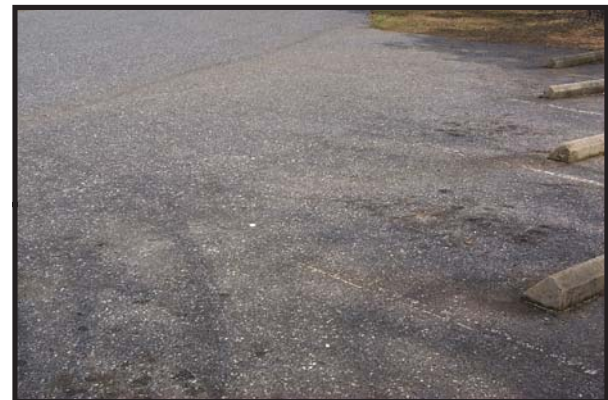
## Route 0909

Route	Public / NonPublic	Date Visited	Area (sq ft)	Lane Miles *	Surface Type	Condition / PCR
0909	Public	3/13/2002	1408	0.02	AS	GOOD / 90

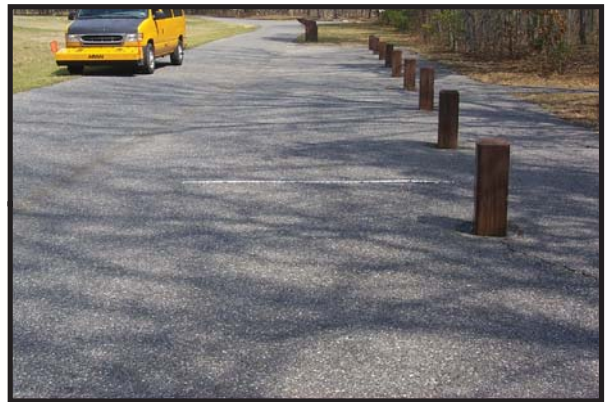
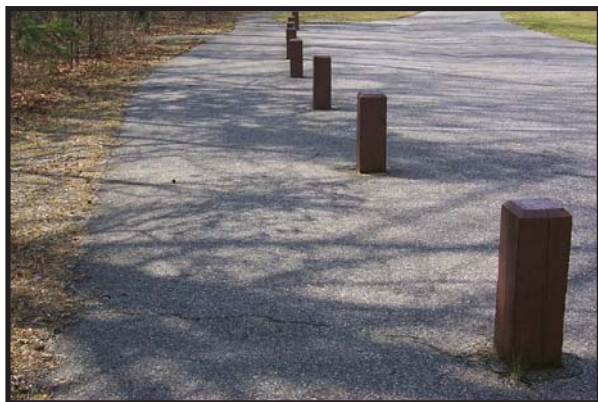
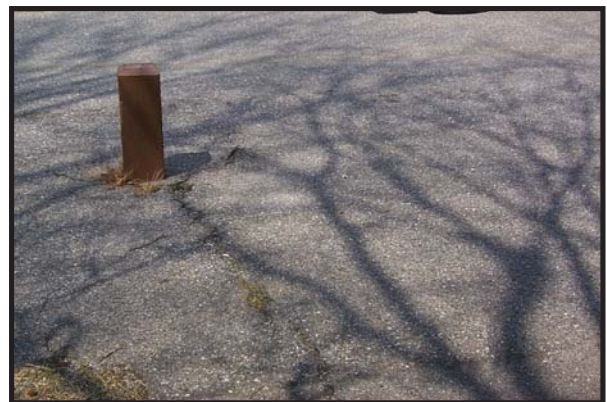
## Route 0910

Route	Public / NonPublic	Date Visited	Area (sq ft)	Lane Miles *	Surface Type	Condition / PCR
0910	Public	3/13/2002	3067	0.05	AS	GOOD / 90

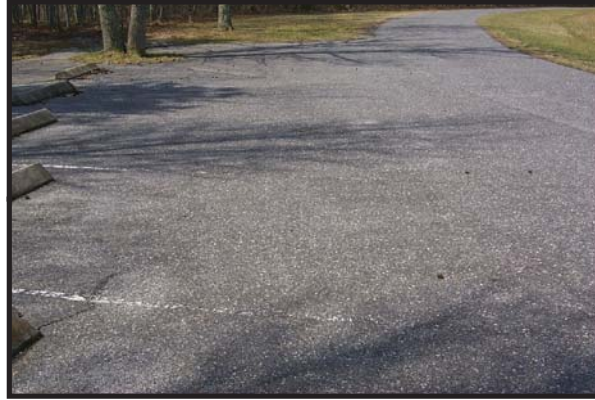
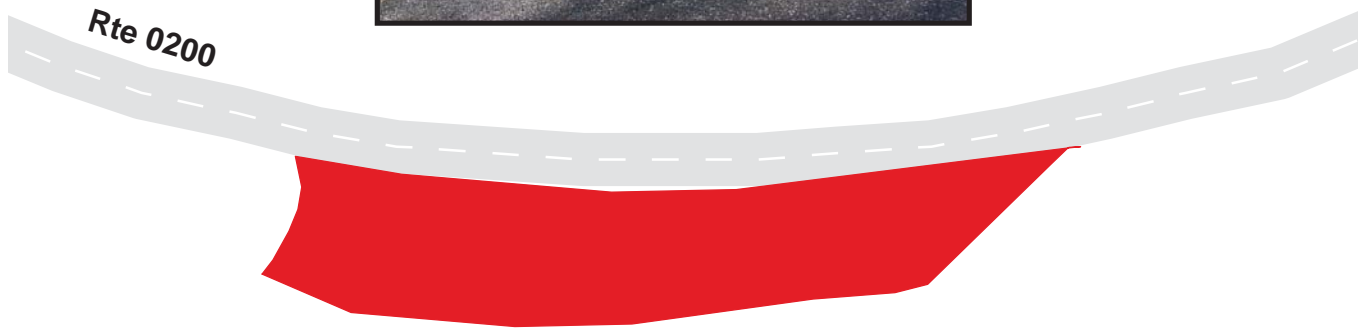
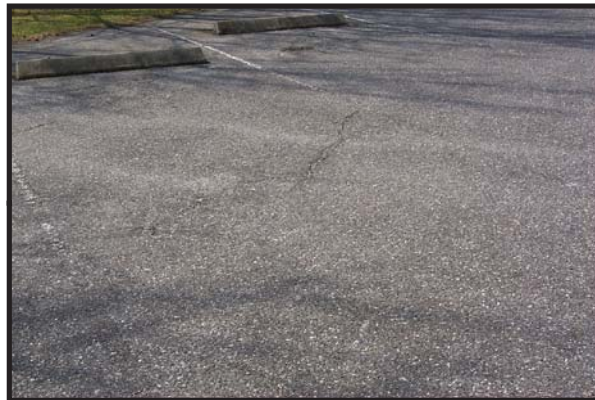
## Route 0911

Route	Public / NonPublic	Date Visited	Area (sq ft)	Lane Miles *	Surface Type	Condition / PCR
0911	Public	3/13/2002	3273	0.06	AS	GOOD / 90

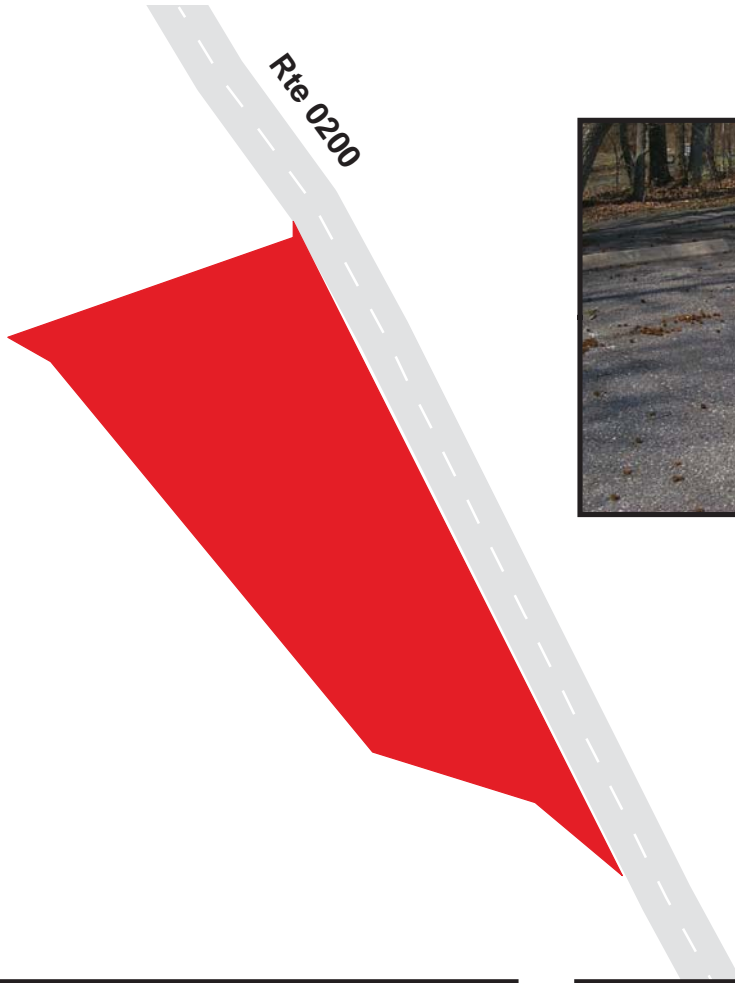
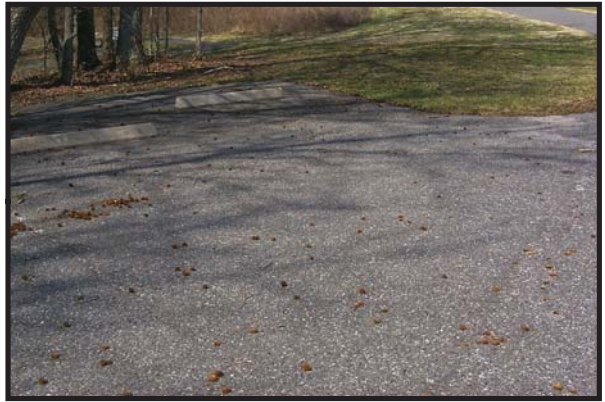
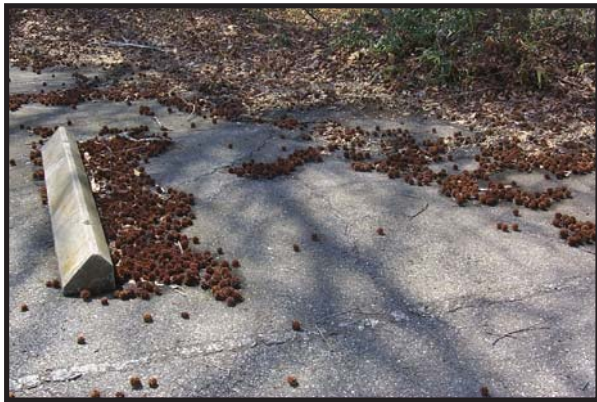
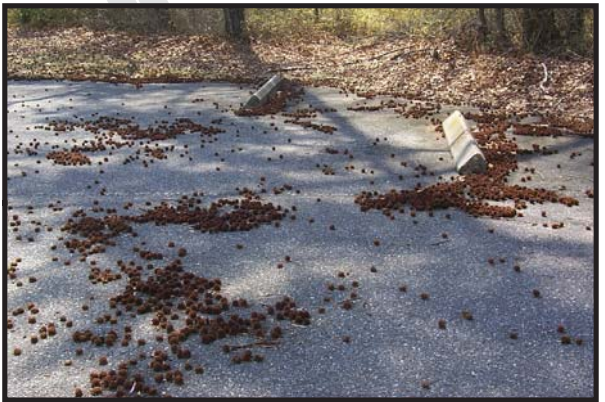
## Route 0912

Route	Public / NonPublic	Date Visited	Area (sq ft)	Lane Miles *	Surface Type	Condition / PCR
0912	Public	3/13/2002	1504	0.03	AS	GOOD / 90

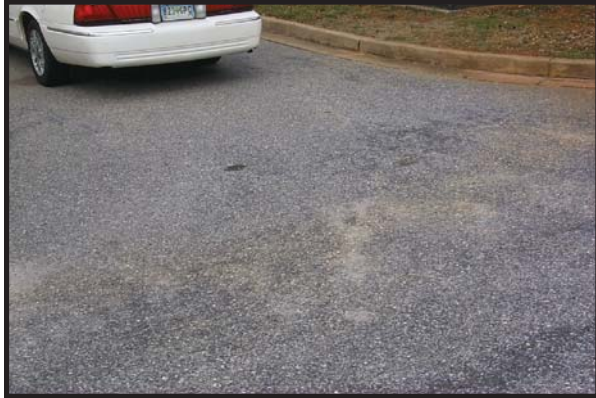
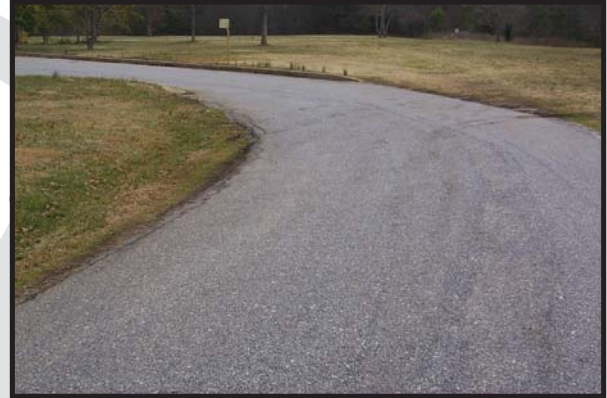
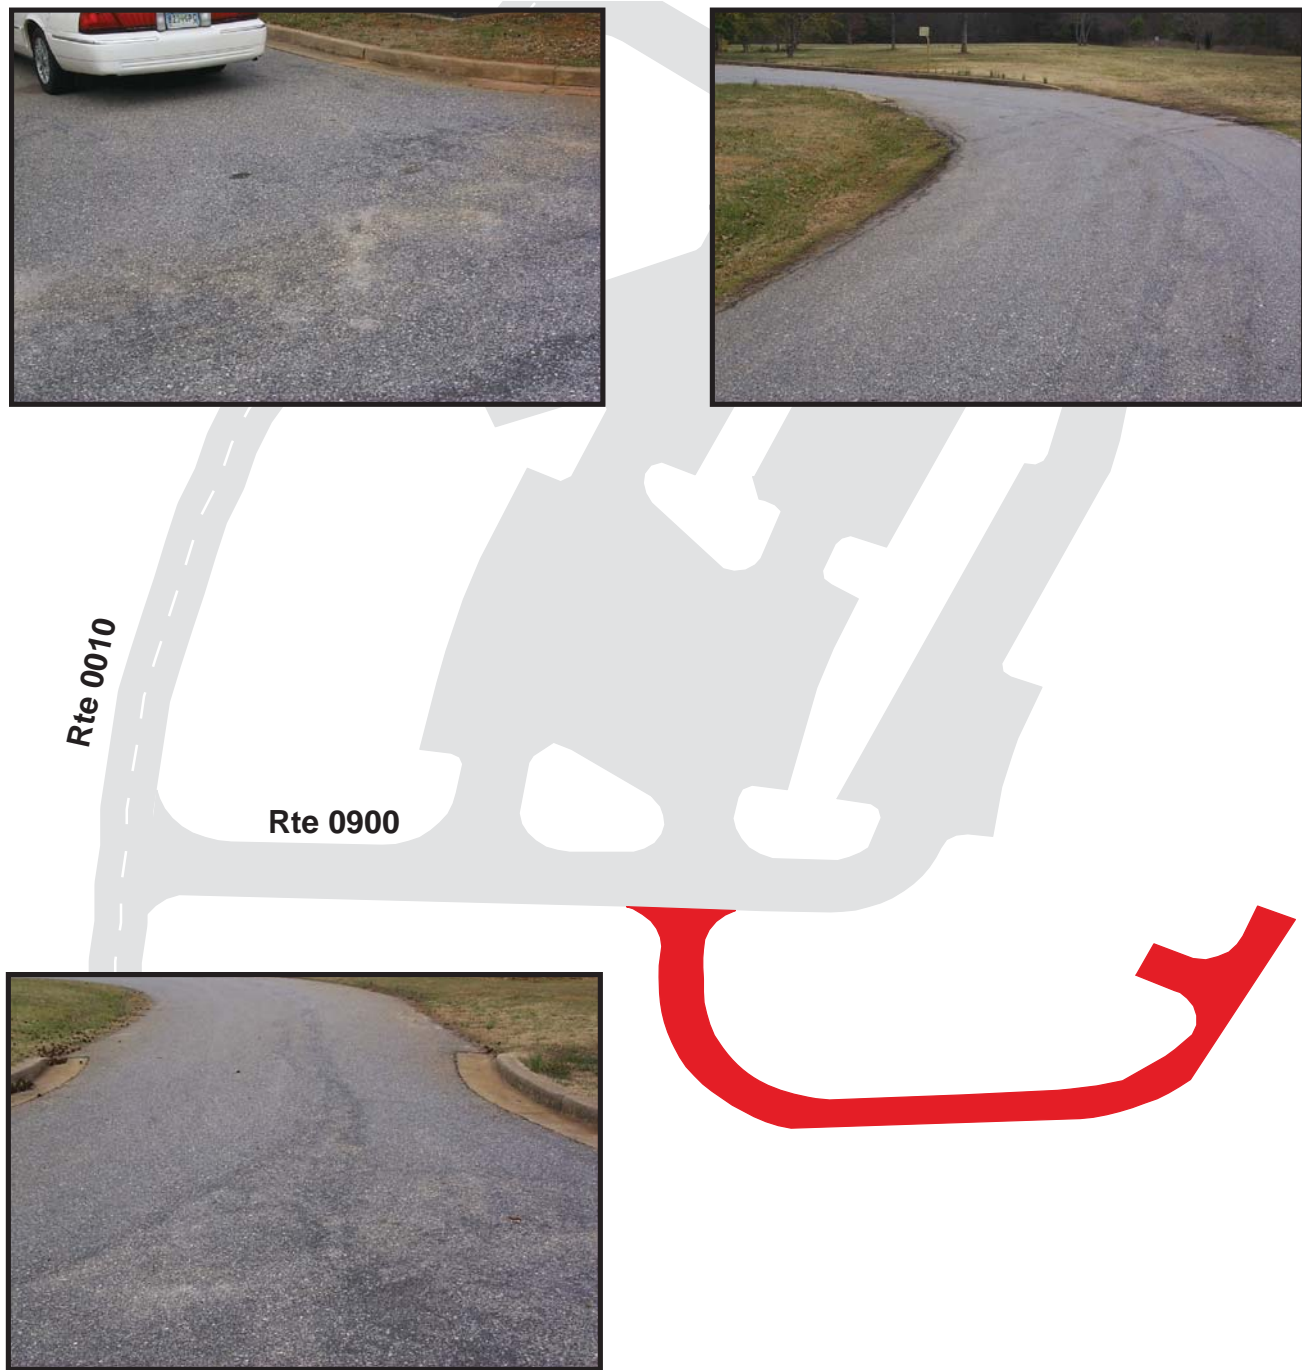
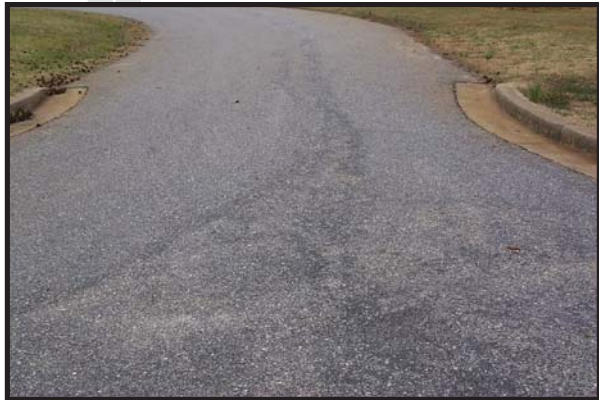
## Route 0913

Route	Public / NonPublic	Date Visited	Area (sq ft)	Lane Miles *	Surface Type	Condition / PCR
0913	NonPublic	3/12/2002	5856	0.10	AS	GOOD / 90
