The Road Inventory of Crater Lake National Park CRLA - 9320

Road Inventory Program

Prepared By:
Federal Highway Administration
Eastern Federal Lands Highway Division
Cycle 3

Crater Lake National Park in Oregon

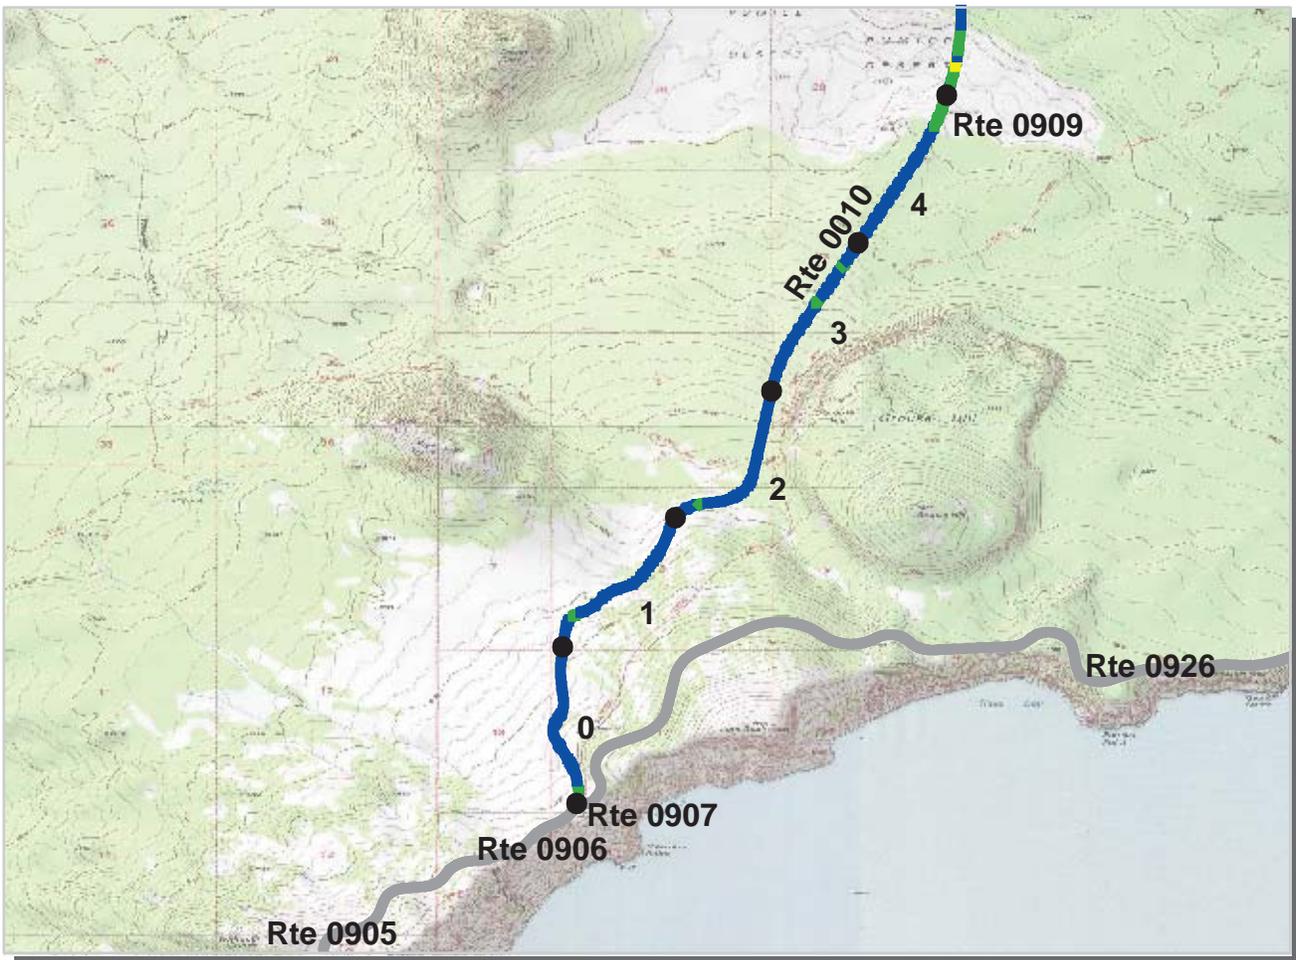
Section Number	0	1	2	3	4
Section Length (mi)	1.00	1.00	1.00	1.00	1.00
AADT	**				
SADT	**				
ADT Date	**				
Cross Section Information					
Number of Lanes	2	2	2	2	2
Paved Width (ft)	22	22	22	22	22
Lane Width (ft)	11	11	11	11	10
Shoulder Width (ft)	5	4	5	4	5
Roadway Condition Information					
PCR (Pavement Condition Rating)	97	98	97	96	96
RCI (Roughness Condition Index)	98	99	99	99	100
SCR (Surface Condition Rating)	96	98	96	94	94
Alligator Cracking Index	100	100	100	100	100
Rutting Index	96	98	96	94	94
Patching Index	99	100	100	99	100
Transverse Cracking Index	99	100	100	99	100
Longitudinal Cracking Index	99	100	99	99	99
Shoulder Condition Rating	GOOD	GOOD	GOOD	GOOD	GOOD
Drainage Condition Rating	GOOD	GOOD	GOOD	GOOD	GOOD

Section Number	5	6	7	8	9
Section Length (mi)	1.00	1.00	1.00	1.00	0.12
AADT	**				
SADT	**				
ADT Date	**				
Cross Section Information					
Number of Lanes	2	2	2	2	2
Paved Width (ft)	21	23	23	22	23
Lane Width (ft)	10	11	12	10	12
Shoulder Width (ft)	6	4	3	4	4
Roadway Condition Information					
PCR (Pavement Condition Rating)	93	98	93	87	47
RCI (Roughness Condition Index)	99	99	97	100	83
SCR (Surface Condition Rating)	89	97	90	79	24
Alligator Cracking Index	99	100	100	100	100
Rutting Index	90	97	91	79	84
Patching Index	100	100	99	99	100
Transverse Cracking Index	99	100	100	99	34
Longitudinal Cracking Index	100	99	99	99	95
Shoulder Condition Rating	GOOD	GOOD	GOOD	GOOD	GOOD
Drainage Condition Rating	GOOD	GOOD	GOOD	GOOD	GOOD

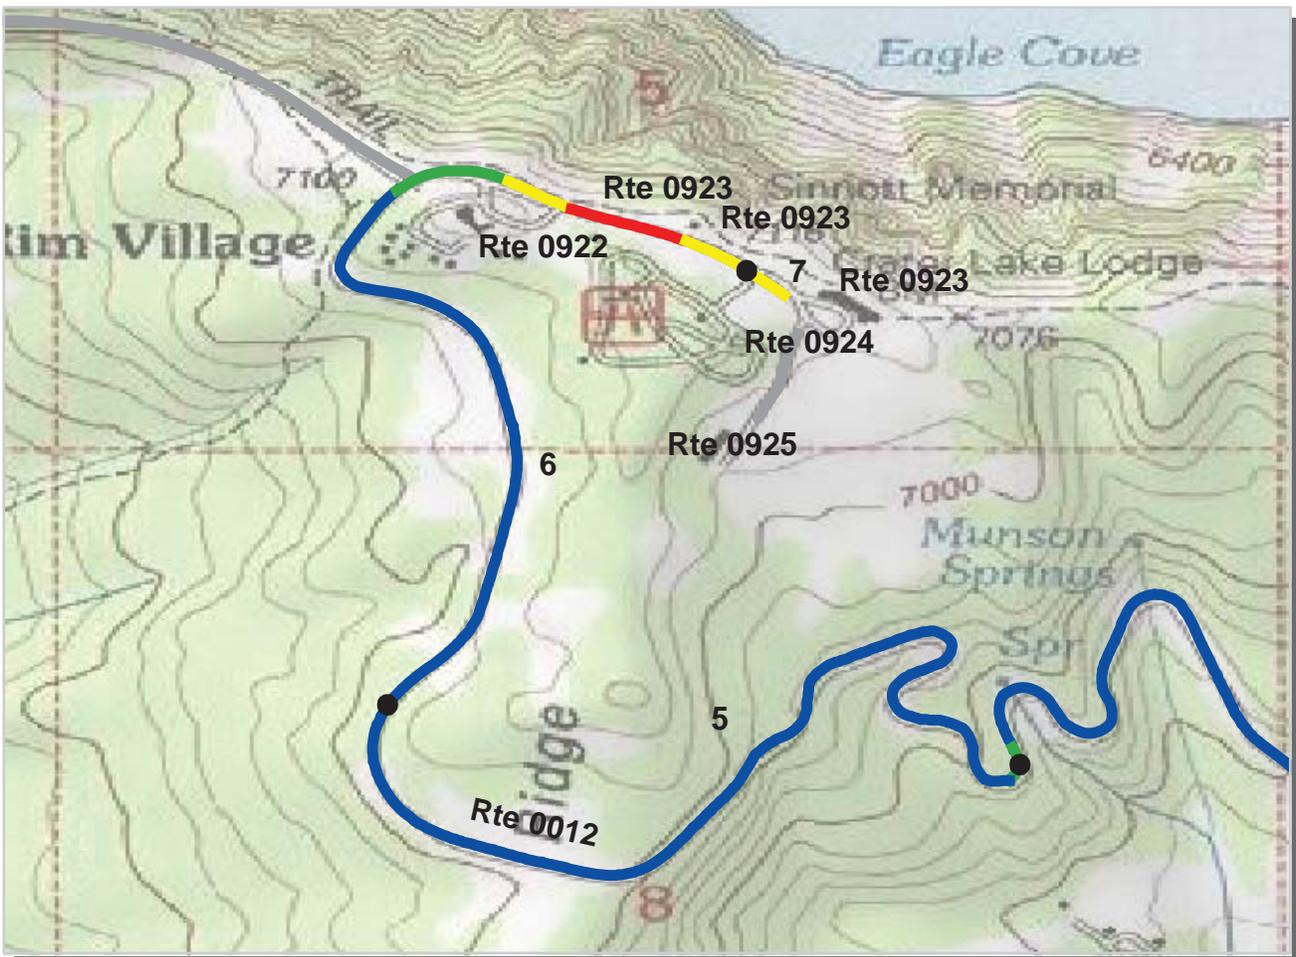
ROUTE: 0012 Munson Valley Road

Section Number	5	6	7		
Section Length (mi)	1.00	1.00	0.06		
AADT	**				
SADT	**				
ADT Date	**				
Cross Section Information					
Number of Lanes	2	2	2		
Paved Width (ft)	22	20	28		
Lane Width (ft)	11	10	14		
Shoulder Width (ft)	4	6	0		
Roadway Condition Information					
PCR (Pavement Condition Rating)	97	84	15		
RCI (Roughness Condition Index)	97	96	0		
SCR (Surface Condition Rating)	97	83	15		
Alligator Cracking Index	100	97	29		
Rutting Index	97	89	87		
Patching Index	100	97	99		
Transverse Cracking Index	100	99	93		
Longitudinal Cracking Index	100	99	79		
Shoulder Condition Rating	GOOD	GOOD	N/A		
Drainage Condition Rating	GOOD	GOOD	GOOD

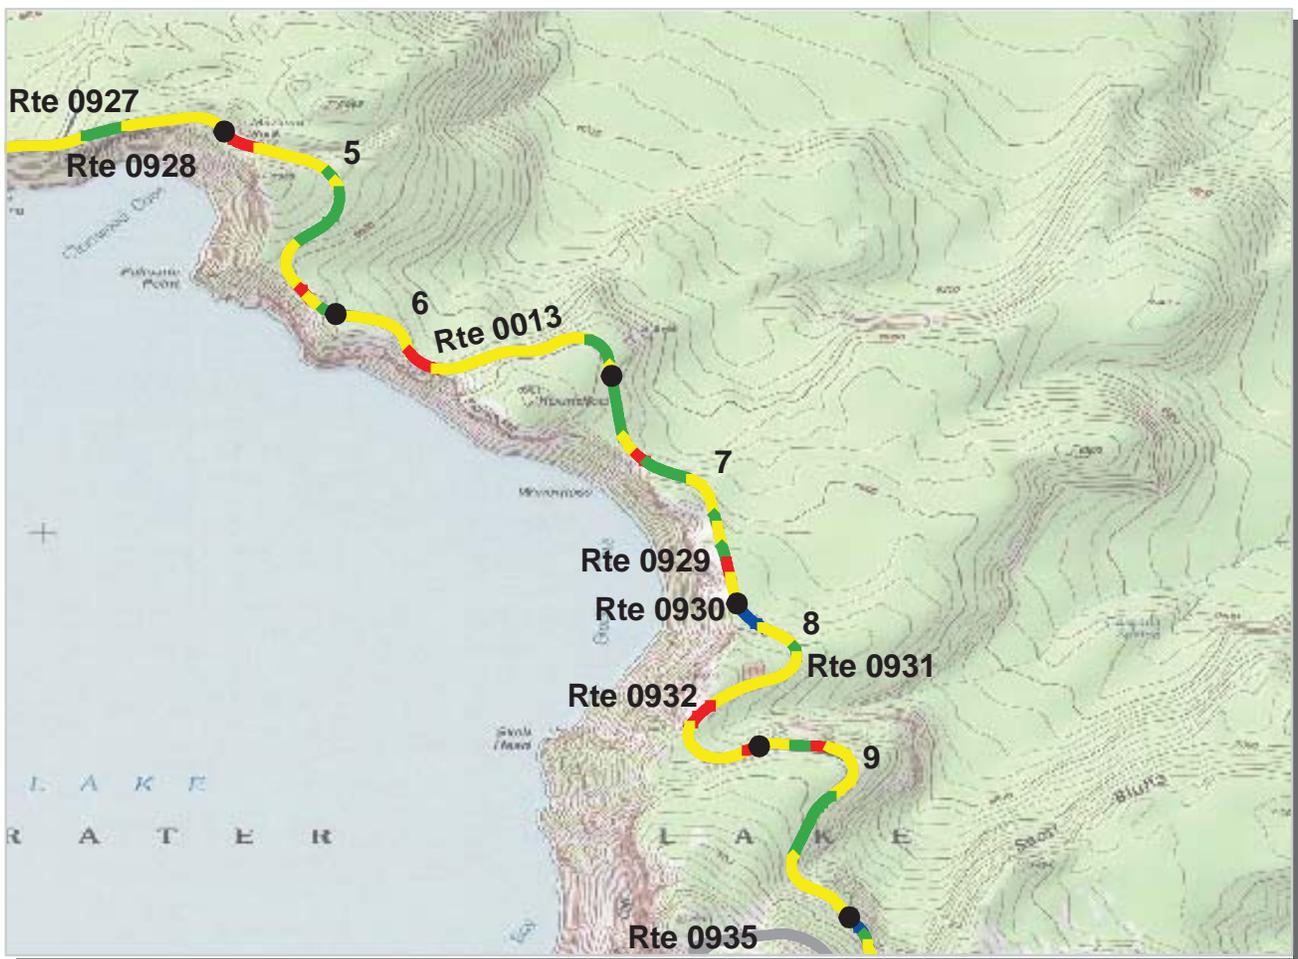
ROUTE: 0013 East Rim Drive

Section Number	5	6	7	8	9
Section Length (mi)	1.00	1.00	1.00	1.00	1.00
AADT	**				
SADT	**				
ADT Date	**				
Cross Section Information					
Number of Lanes	2	2	2	2	2
Paved Width (ft)	18	19	20	19	20
Lane Width (ft)	9	10	10	10	9
Shoulder Width (ft)	6	0	3	3	0
Roadway Condition Information					
PCR (Pavement Condition Rating)	74	73	77	74	79
RCI (Roughness Condition Index)	85	81	85	80	88
SCR (Surface Condition Rating)	67	67	73	70	73
Alligator Cracking Index	100	99	100	99	99
Rutting Index	69	70	77	73	74
Patching Index	98	99	99	99	99
Transverse Cracking Index	98	98	97	98	100
Longitudinal Cracking Index	99	99	98	99	99
Shoulder Condition Rating	GOOD	N/A	GOOD	GOOD	N/A
Drainage Condition Rating	GOOD	GOOD	GOOD	GOOD	GOOD

Section Number	10	11	12	13	14
Section Length (mi)	1.00	1.00	1.00	1.00	1.00
ADT	**				
SADT	**				
ADT Date	**				
Cross Section Information					
Number of Lanes	2	2	2	2	2
Paved Width (ft)	18	18	18	20	17
Lane Width (ft)	10	10	8	10	9
Shoulder Width (ft)	3	0	0	0	0
Roadway Condition Information					
PCR (Pavement Condition Rating)	83	51	72	68	64
RCI (Roughness Condition Index)	93	68	82	76	60
SCR (Surface Condition Rating)	77	40	66	62	67
Alligator Cracking Index	100	62	96	94	97
Rutting Index	77	66	73	66	73
Patching Index	99	99	99	99	98
Transverse Cracking Index	99	97	98	99	99
Longitudinal Cracking Index	99	97	98	99	98
Shoulder Condition Rating	GOOD	N/A	N/A	N/A	N/A
Drainage Condition Rating	GOOD	GOOD	GOOD	GOOD	GOOD

Section Number	15	16	17	18	19
Section Length (mi)	1.00	1.00	1.00	1.00	1.00
AADT	**				
SADT	**				
ADT Date	**				
Cross Section Information					
Number of Lanes	2	2	2	2	2
Paved Width (ft)	20	18	19	21	19
Lane Width (ft)	10	9	9	10	10
Shoulder Width (ft)	0	0	0	0	0
Roadway Condition Information					
PCR (Pavement Condition Rating)	81	82	87	78	85
RCI (Roughness Condition Index)	76	87	88	82	87
SCR (Surface Condition Rating)	84	79	86	76	84
Alligator Cracking Index	99	99	100	100	99
Rutting Index	86	79	88	78	85
Patching Index	98	99	99	98	99
Transverse Cracking Index	99	99	99	99	99
Longitudinal Cracking Index	99	99	99	99	99
Shoulder Condition Rating	N/A	N/A	N/A	N/A	N/A
Drainage Condition Rating	GOOD	GOOD	GOOD	GOOD	GOOD

Section Number	20	21	22	23	
Section Length (mi)	1.00	1.00	1.00	0.13	
AADT	**				
SADT	**				
ADT Date	**				
Cross Section Information					
Number of Lanes	2	2	2	2	
Paved Width (ft)	17	19	18	19	
Lane Width (ft)	8	8	9	8	
Shoulder Width (ft)	0	3	3	2	
Roadway Condition Information					
PCR (Pavement Condition Rating)	78	79	79	87	
RCI (Roughness Condition Index)	86	86	76	96	
SCR (Surface Condition Rating)	73	74	81	84	
Alligator Cracking Index	98	99	99	99	
Rutting Index	78	76	82	89	
Patching Index	99	99	99	99	
Transverse Cracking Index	98	99	99	97	
Longitudinal Cracking Index	97	98	99	98	
Shoulder Condition Rating	N/A	GOOD	GOOD	GOOD	
Drainage Condition Rating	GOOD	GOOD	GOOD	GOOD

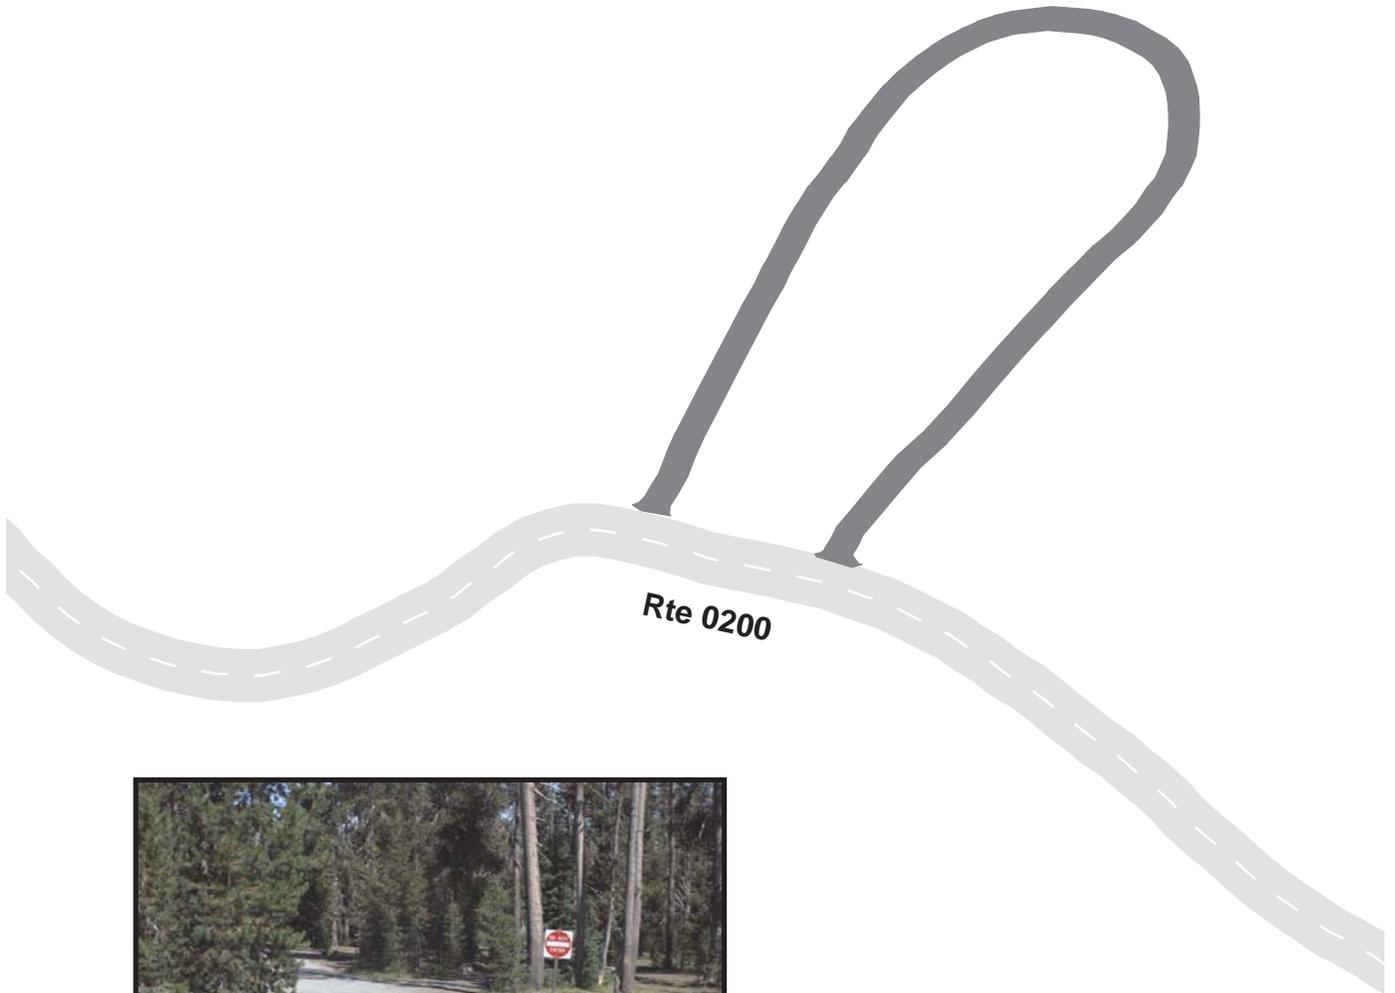
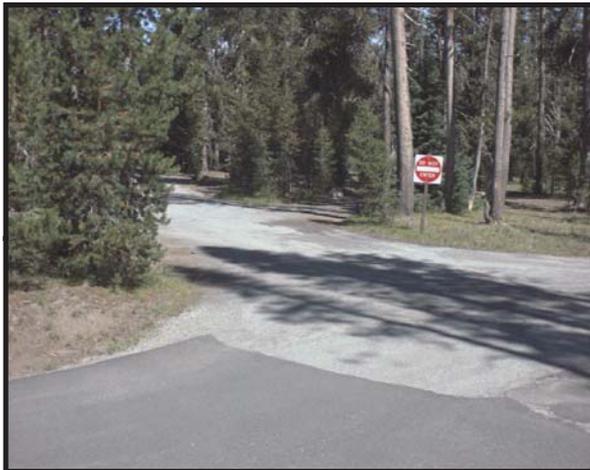
Crater Lake National Park
Route 0203C
Mazama Campground Loop C
From Route 0200 at MP 0.37 on Left

Route	Length (mi)	Width (ft)	Area (sq ft)	Lane Miles *	Condition / PCR	Surface Type
0203C	0.26	0.00	24140	0.42	GOOD / 90	AS

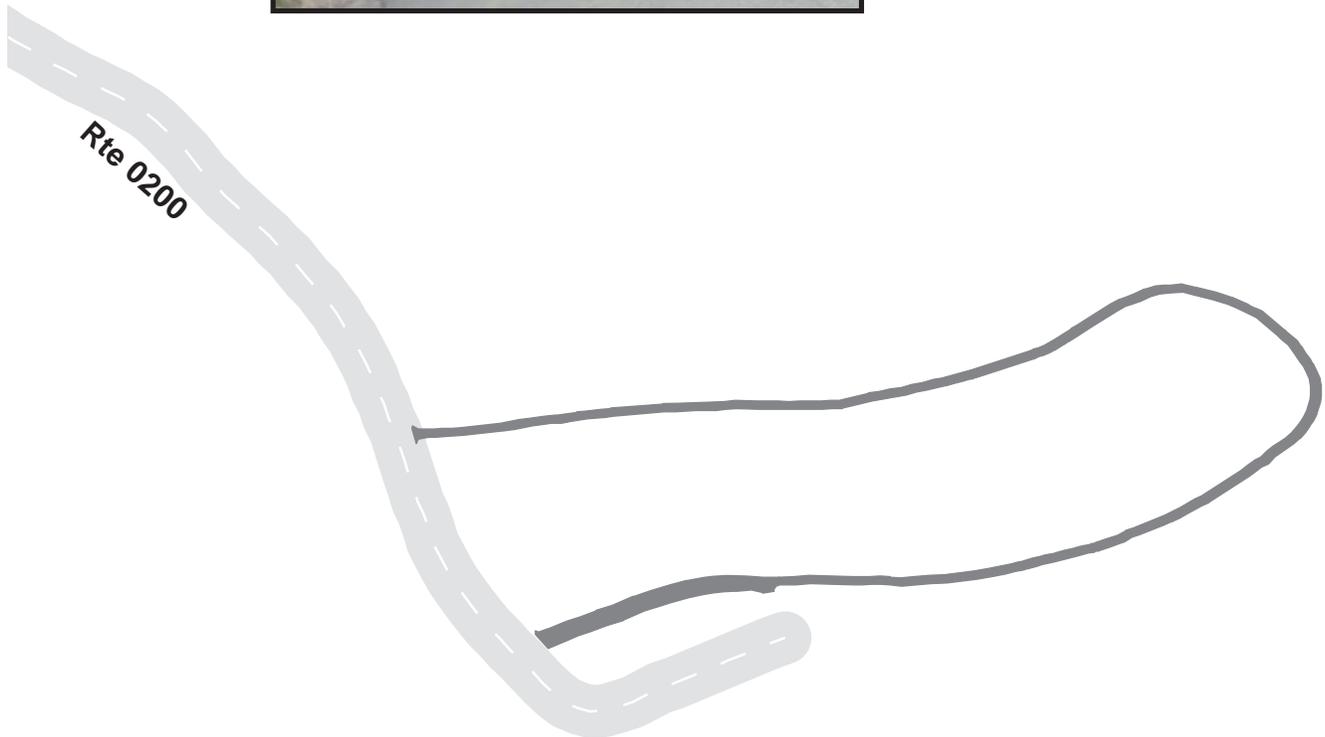
Crater Lake National Park
Route 0203G
 Mazama Campground Loop G
 From Route 0200 at MP 0.63 on Right

Route	Length (mi)	Width (ft)	Area (sq ft)	Lane Miles *	Condition / PCR	Surface Type
0203G	0.38	0.00	21424	0.37	GOOD / 90	AS

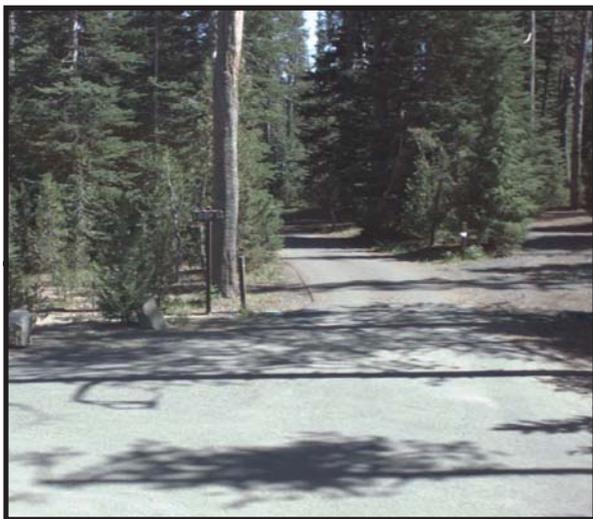
Crater Lake National Park
Route 0207
 Picnic Hill
 From Route 0012 at MP 7.01 on Right

Route	Length (mi)	Width (ft)	Area (sq ft)	Lane Miles *	Condition / PCR	Surface Type
0207	0.52	0.00	55384	0.95	FAIR / 73	AS

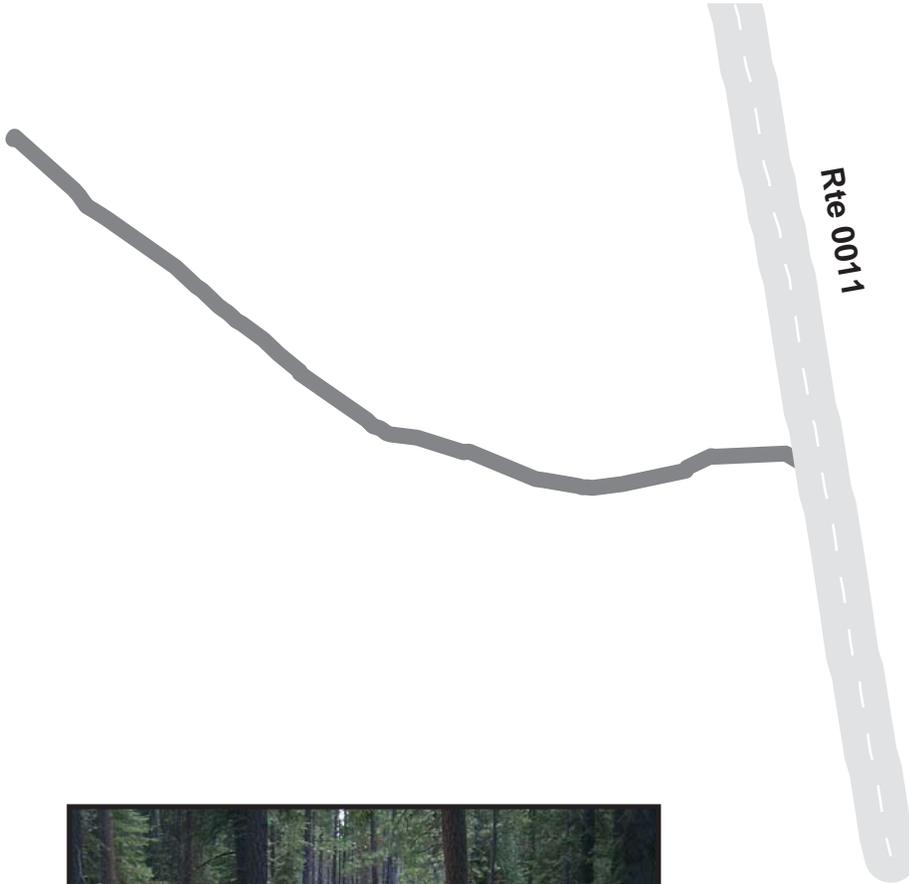
Route 0405

Route	Length (mi)	Width (ft)	Area (sq ft)	Lane Miles *	Condition / PCR	Surface Type
0405	0.16	0.00	0	0.00	POOR / 45	AS

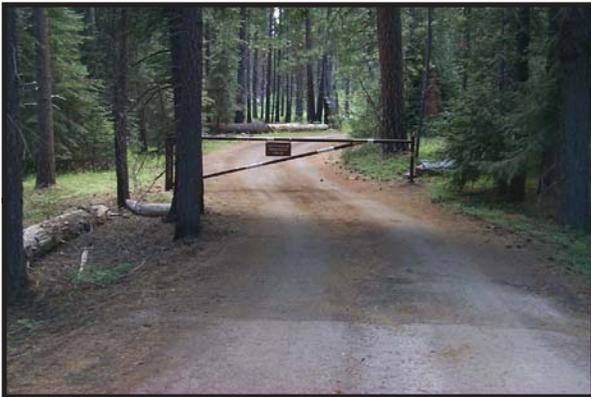
Crater Lake National Park
Route 0900
 Discovery Point
 Adjacent to Route 0014 at MP 1.1 on Right

Route	Public / NonPublic	Date Visited	Area (sq ft)	Lane Miles *	Surface Type	Condition / PCR
0900	Public	7/23/2002	32527	0.56	AS	FAIR / 73

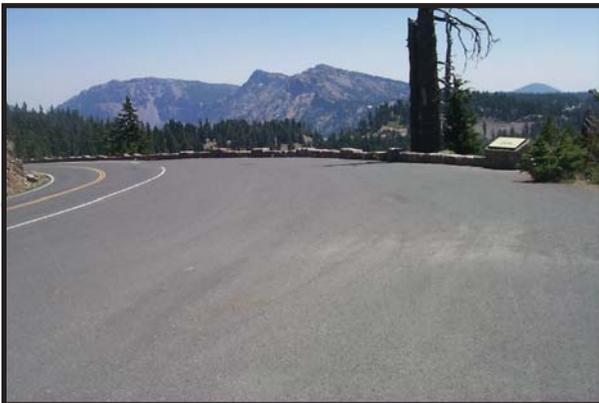
Crater Lake National Park
Route 0904
The Corrals
From Route 0014 at MP 3.74 on Right

Route	Public / NonPublic	Date Visited	Area (sq ft)	Lane Miles *	Surface Type	Condition / PCR
0904	Public	7/23/2002	13572	0.23	AS	FAIR / 73

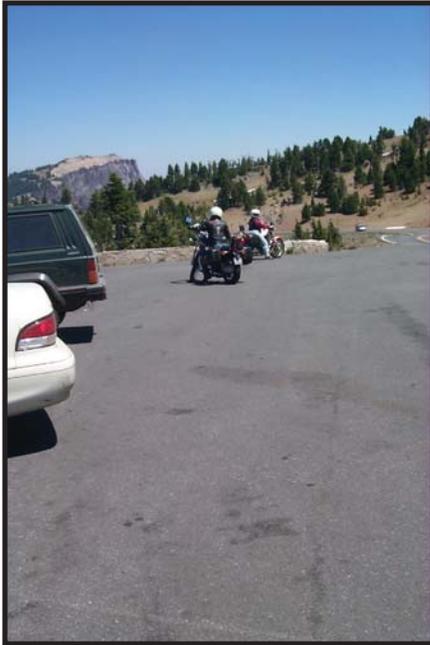
Crater Lake National Park
Route 0906
Glacial Valleys
Adjacent to Route 0014 at MP 5.7 on Right

Route	Public / NonPublic	Date Visited	Area (sq ft)	Lane Miles *	Surface Type	Condition / PCR
0906	Public	7/23/2002	20582	0.35	AS	GOOD / 90

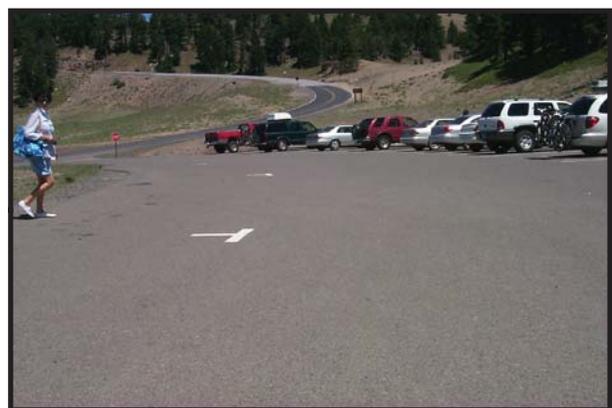
Crater Lake National Park
Route 0909
Pumice Desert
From Route 0010 at MP 4.86 on Left

Route	Public / NonPublic	Date Visited	Area (sq ft)	Lane Miles *	Surface Type	Condition / PCR
0909	Public	7/23/2002	11966	0.21	AS	GOOD / 90

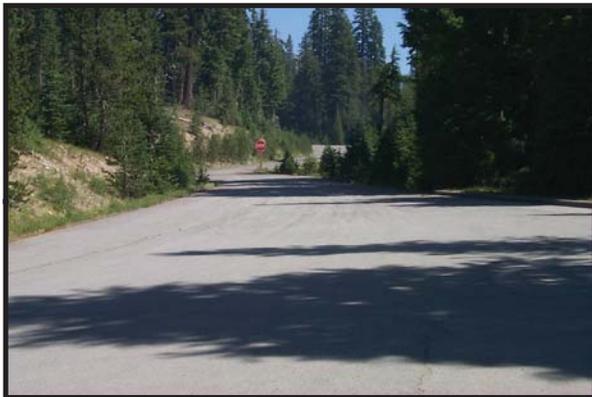
Route 0921

Route	Public / NonPublic	Date Visited	Area (sq ft)	Lane Miles *	Surface Type	Condition / PCR
0921	Public	7/23/2002	34845	0.60	AS	GOOD / 90

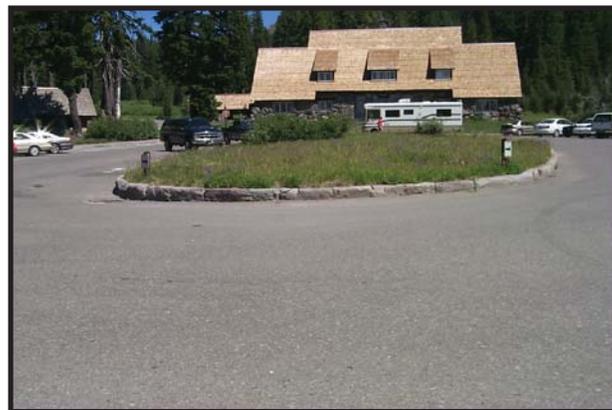
Route 0922

Route	Public / NonPublic	Date Visited	Area (sq ft)	Lane Miles *	Surface Type	Condition / PCR
0922	Public	7/23/2002	94998	1.64	AS	FAIR / 73

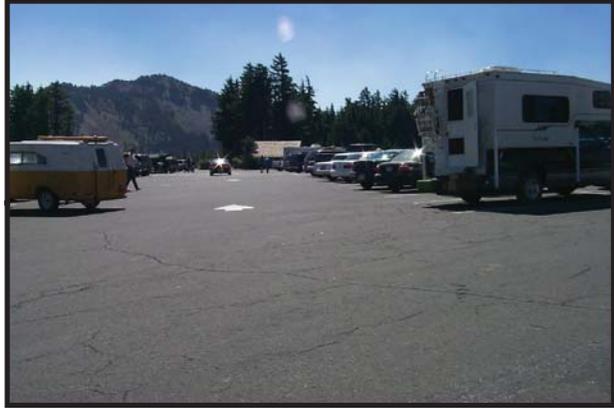
Route 0923

Route	Public / NonPublic	Date Visited	Area (sq ft)	Lane Miles *	Surface Type	Condition / PCR
0923	Public	7/23/2002	38596	0.66	AS	GOOD / 90

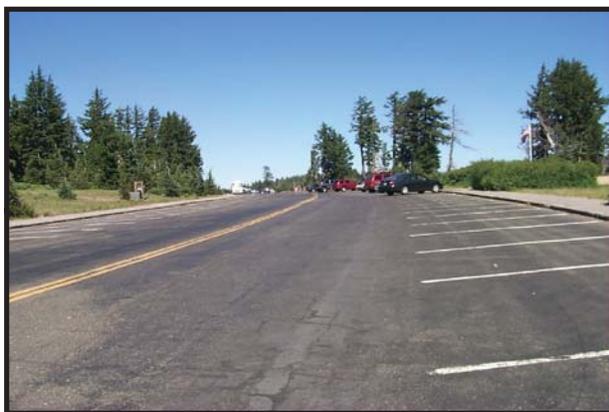
Route 0924

Route	Public / NonPublic	Date Visited	Area (sq ft)	Lane Miles *	Surface Type	Condition / PCR
0924	Public	7/23/2002	31336	0.54	AS	GOOD / 90

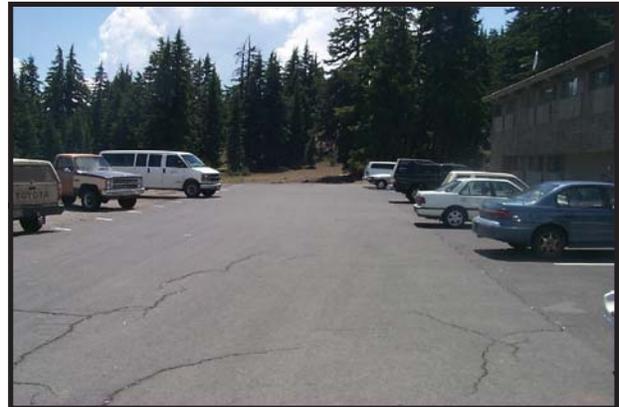
Route 0926

Route	Public / NonPublic	Date Visited	Area (sq ft)	Lane Miles *	Surface Type	Condition / PCR
0926	Public	7/22/2002	6178	0.11	AS	POOR / 45

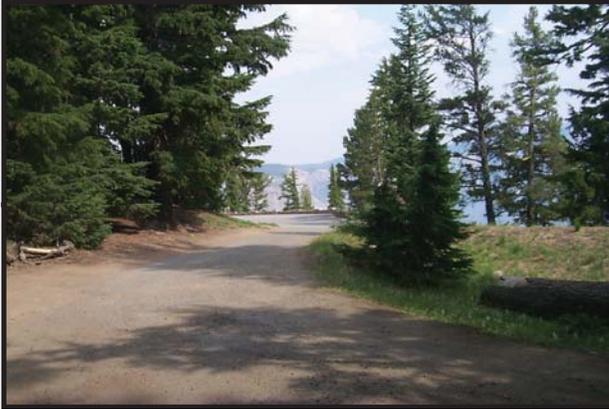
Route 0927

Route	Public / NonPublic	Date Visited	Area (sq ft)	Lane Miles *	Surface Type	Condition / PCR
0927	Public	7/23/2002	40781	0.70	AS	POOR / 45

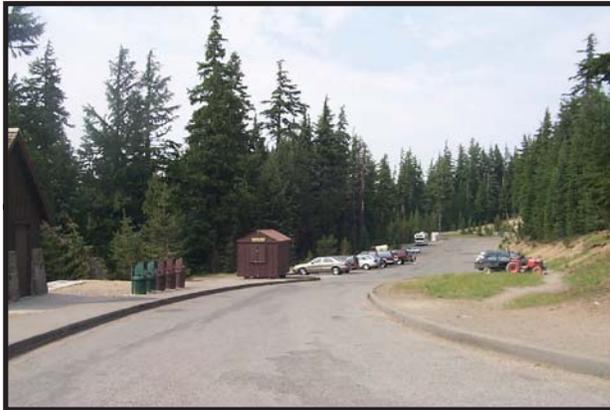
Route 0928

Route	Public / NonPublic	Date Visited	Area (sq ft)	Lane Miles *	Surface Type	Condition / PCR
0928	Public	7/23/2002	4210	0.07	AS	FAIR / 73

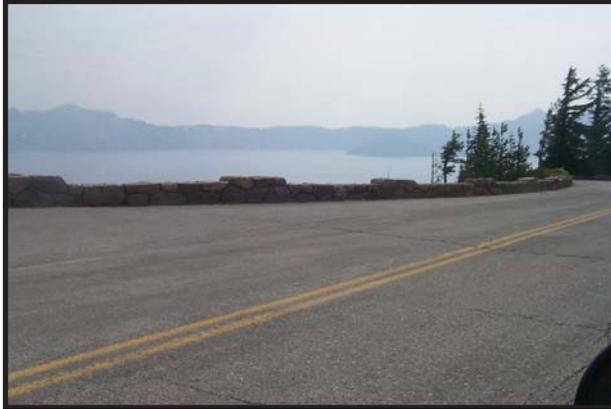
Route 0929

Route	Public / NonPublic	Date Visited	Area (sq ft)	Lane Miles *	Surface Type	Condition / PCR
0929	Public	7/23/2002	14228	0.24	AS	FAIR / 73

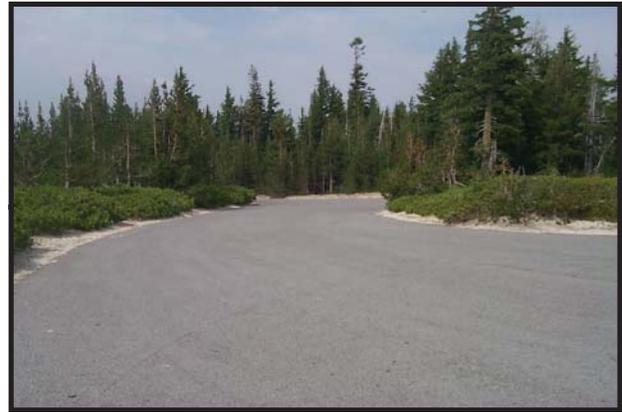
Route 0930

Route	Public / NonPublic	Date Visited	Area (sq ft)	Lane Miles *	Surface Type	Condition / PCR
0930	Public	7/23/2002	5856	0.10	AS	FAIR / 73

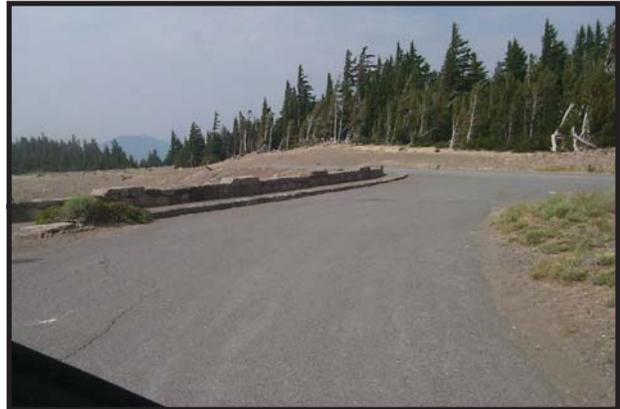
Route 0931

Route	Public / NonPublic	Date Visited	Area (sq ft)	Lane Miles *	Surface Type	Condition / PCR
0931	Public	7/23/2002	3481	0.06	AS	POOR / 45

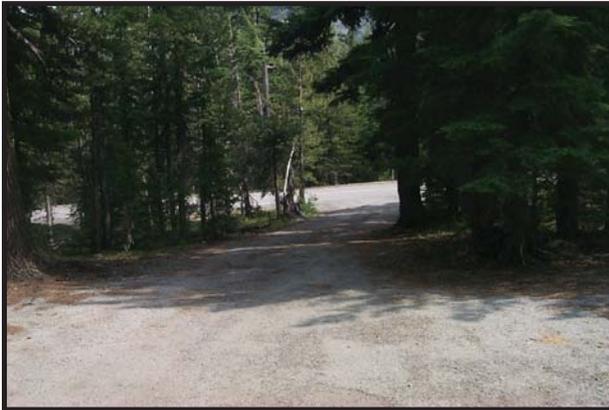
Route 0932

Route	Public / NonPublic	Date Visited	Area (sq ft)	Lane Miles *	Surface Type	Condition / PCR
0932	Public	7/23/2002	28812	0.50	AS	FAIR / 73

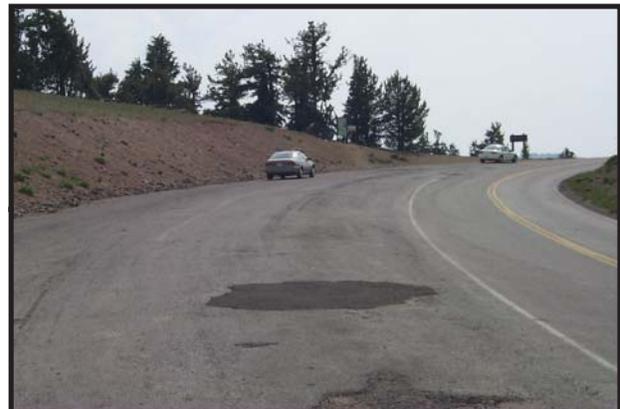
Crater Lake National Park
Route 0935
 Cloudcap Overlook
 Adjacent to Route 0201 at end loop

Route	Public / NonPublic	Date Visited	Area (sq ft)	Lane Miles *	Surface Type	Condition / PCR
0935	Public	7/23/2002	4531	0.08	AS	FAIR / 73

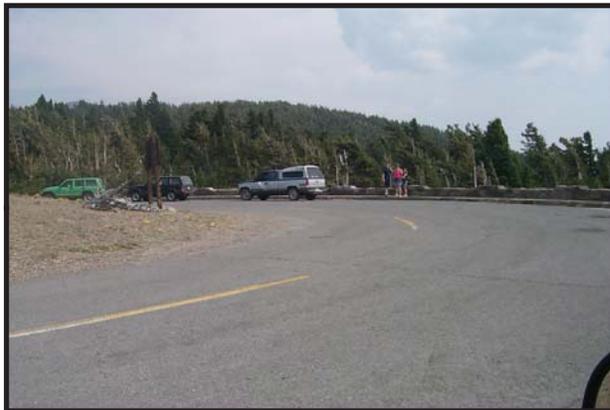
Route 0936

Route	Public / NonPublic	Date Visited	Area (sq ft)	Lane Miles *	Surface Type	Condition / PCR
0936	Public	7/23/2002	15842	0.27	AS	GOOD / 90

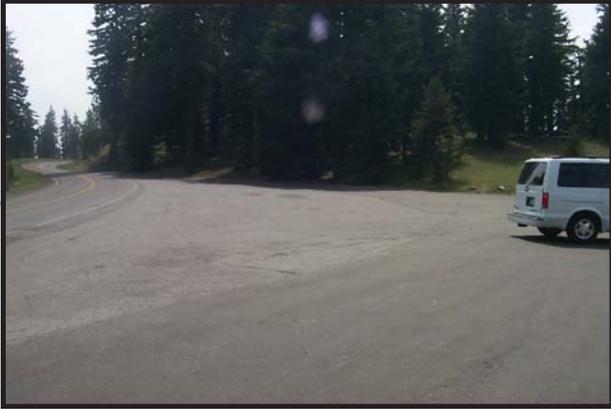
Route 0937

Route	Public / NonPublic	Date Visited	Area (sq ft)	Lane Miles *	Surface Type	Condition / PCR
0937	Public	7/23/2002	11572	0.20	NC	FAIR / 73

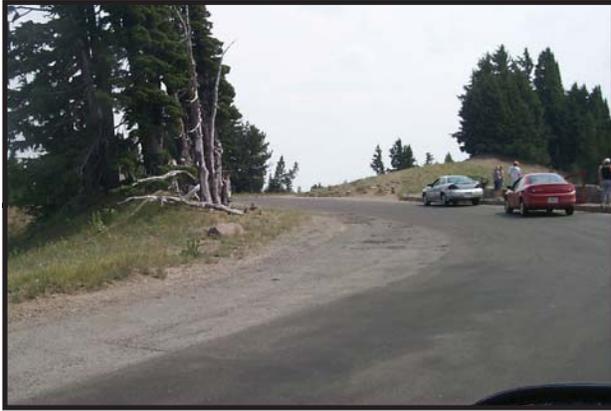
Route 0938

Route	Public / NonPublic	Date Visited	Area (sq ft)	Lane Miles *	Surface Type	Condition / PCR
0938	Public	7/23/2002	9517	0.16	NC	POOR / 45

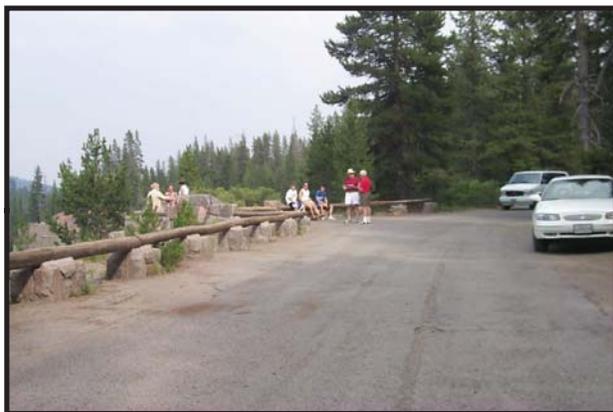
Route 0940

Route	Public / NonPublic	Date Visited	Area (sq ft)	Lane Miles *	Surface Type	Condition / PCR
0940	Public	7/23/2002	13669	0.24	AS	POOR / 45

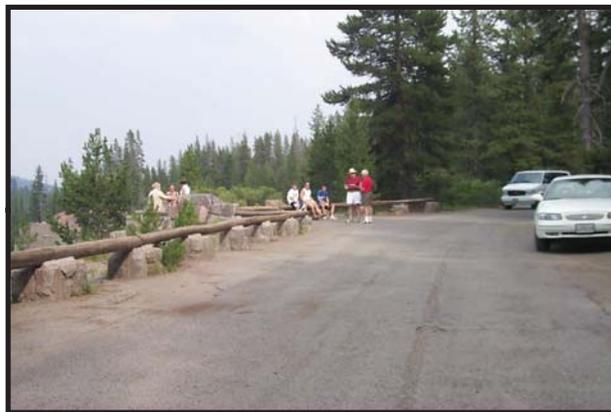
Route 0941

Route	Public / NonPublic	Date Visited	Area (sq ft)	Lane Miles *	Surface Type	Condition / PCR
0941	Public	7/23/2002	11125	0.19	AS	FAIR / 73

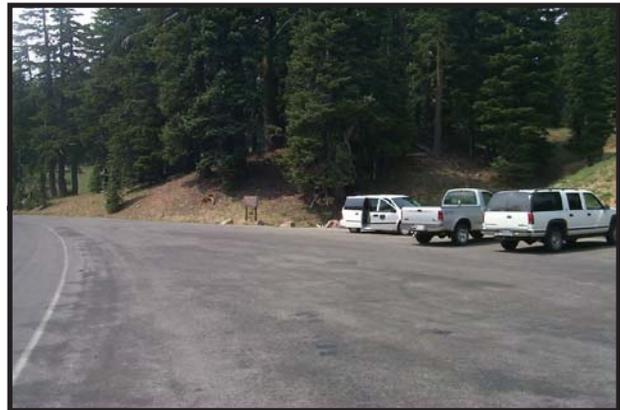
Route 0942

Route	Public / NonPublic	Date Visited	Area (sq ft)	Lane Miles *	Surface Type	Condition / PCR
0942	Public	7/23/2002	3096	0.05	AS	FAIR / 73

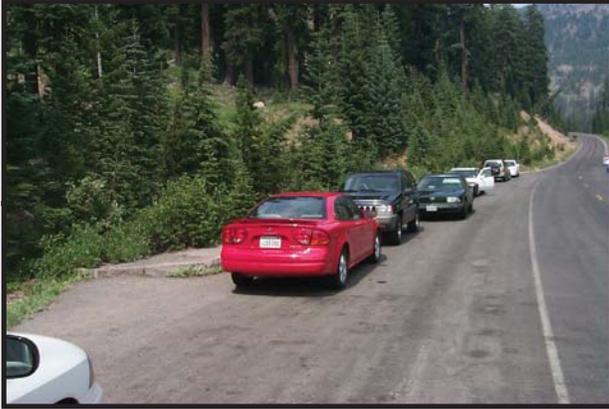
Route 0944

Route	Public / NonPublic	Date Visited	Area (sq ft)	Lane Miles *	Surface Type	Condition / PCR
0944	Public	7/22/2002	1338	0.02	AS	POOR / 45

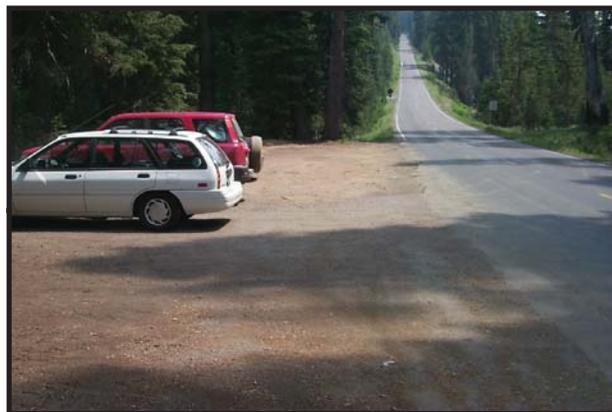
Route 0945

Route	Public / NonPublic	Date Visited	Area (sq ft)	Lane Miles *	Surface Type	Condition / PCR
0945	Public	7/23/2002	7360	0.13	AS	GOOD / 90

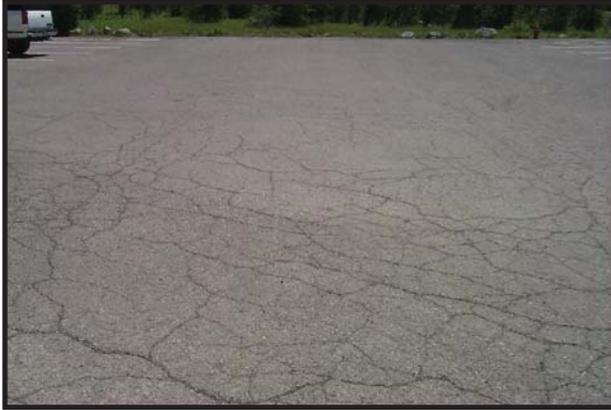
Route 0947

Route	Public / NonPublic	Date Visited	Area (sq ft)	Lane Miles *	Surface Type	Condition / PCR
0947	Public	7/23/2002	41998	0.72	AS	GOOD / 90

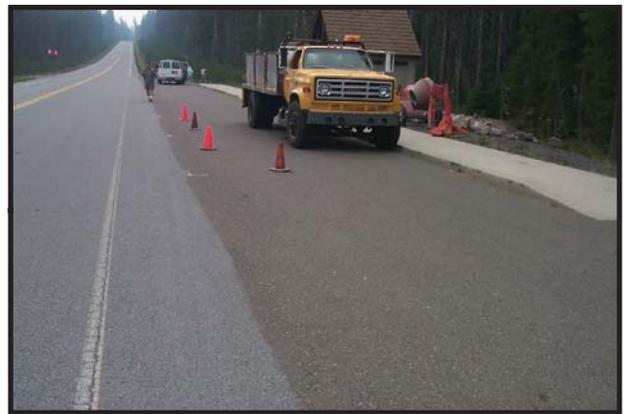
Route 0950

Route	Public / NonPublic	Date Visited	Area (sq ft)	Lane Miles *	Surface Type	Condition / PCR
0950	Public	7/22/2002	3375	0.06	AS	GOOD / 90

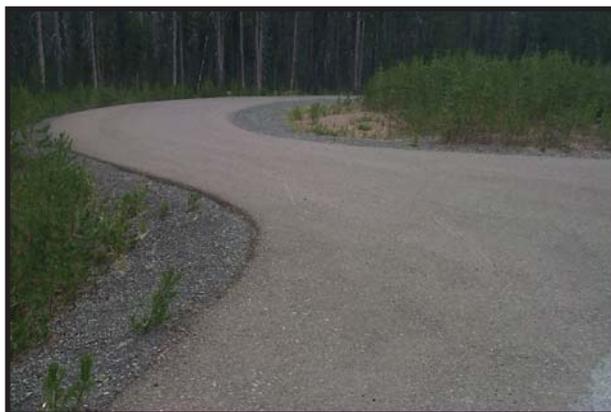
Route 0951

Route	Public / NonPublic	Date Visited	Area (sq ft)	Lane Miles *	Surface Type	Condition / PCR
0951	Public	7/23/2002	5069	0.09	AS	POOR / 45
