**The Road Inventory
of
Craters of the Moon National Monument
CRMO - 9280**

Prepared By:
Federal Highway Administration
Eastern Federal Lands Highway Division
Cycle 3

Craters of the Moon National Monument in Idaho

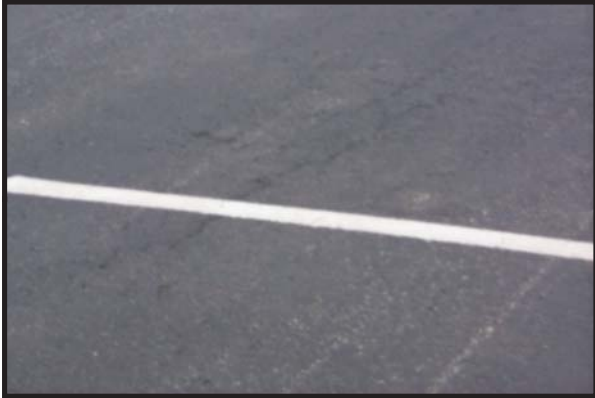
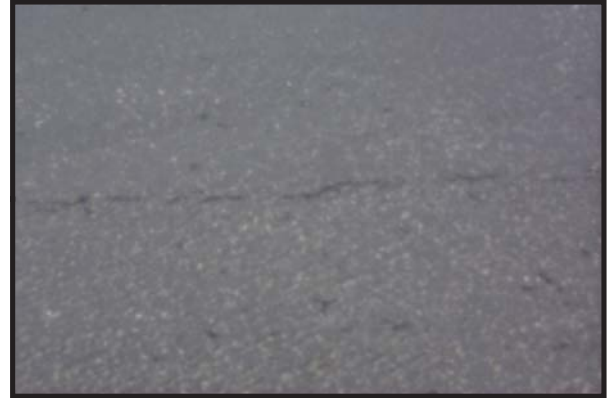
Route	Public / NonPublic	Date Visited	Area (sq ft)	Lane Miles *	Surface Type	Condition / PCR
0900	Public	5/4/2003	13282	0.23	AS	GOOD / 90

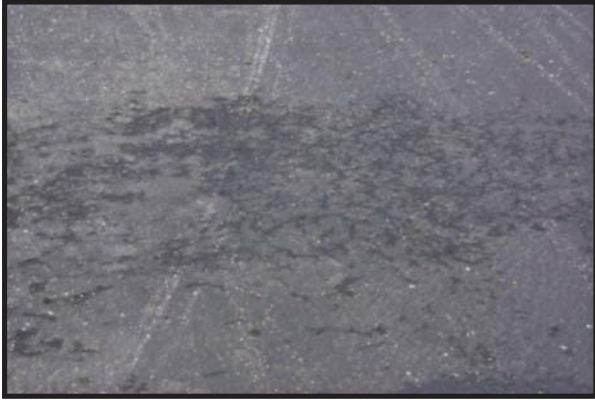
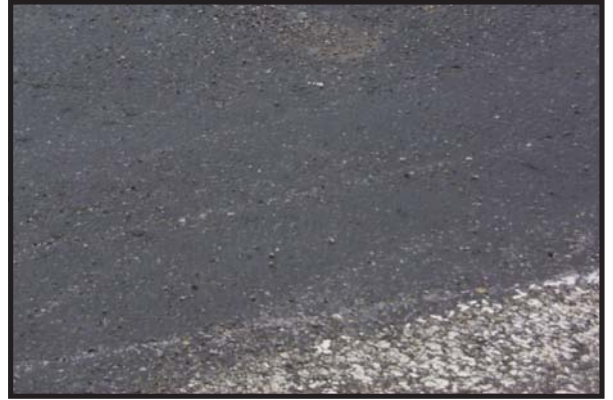
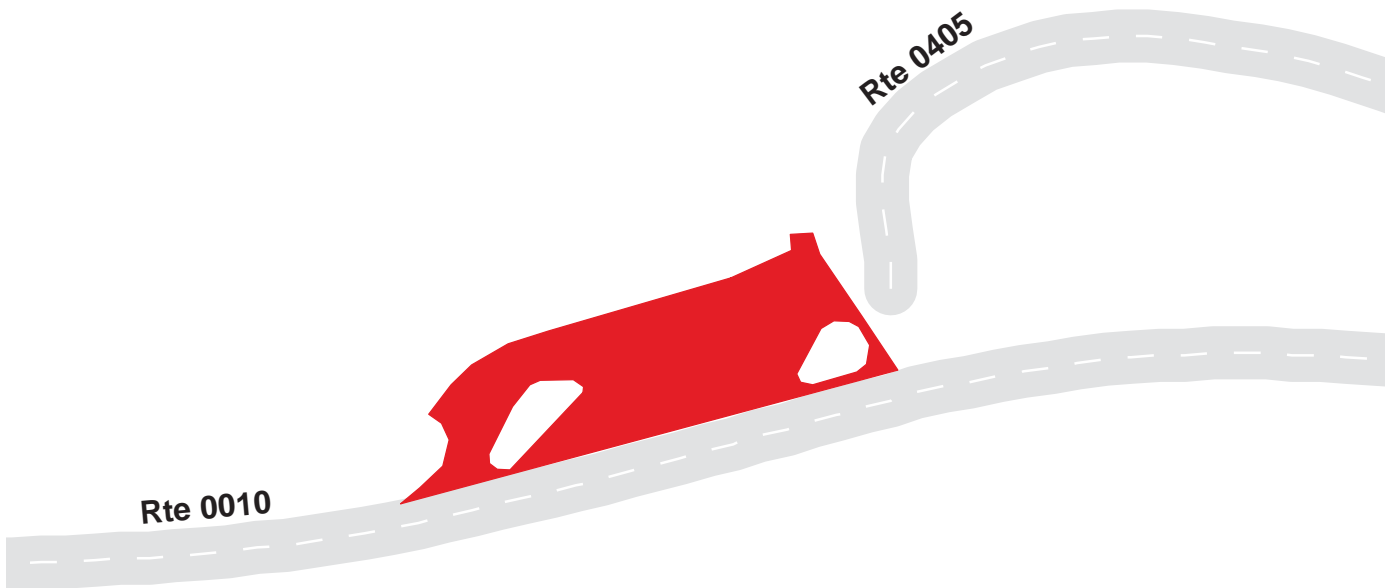
Route 0901

Route	Public / NonPublic	Date Visited	Area (sq ft)	Lane Miles *	Surface Type	Condition / PCR
0901	Public	5/4/2003	16306	0.28	AS	GOOD / 90

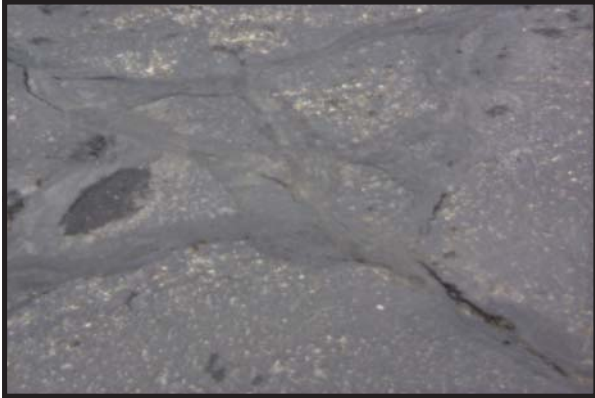
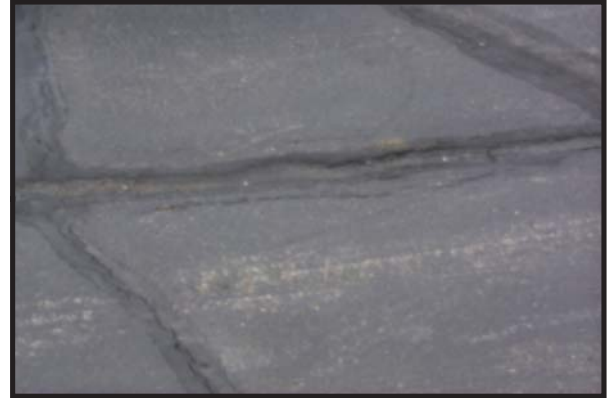
Route 0902

Route	Public / NonPublic	Date Visited	Area (sq ft)	Lane Miles *	Surface Type	Condition / PCR
0902	NonPublic	5/4/2003	15862	0.27	AS	FAIR / 73

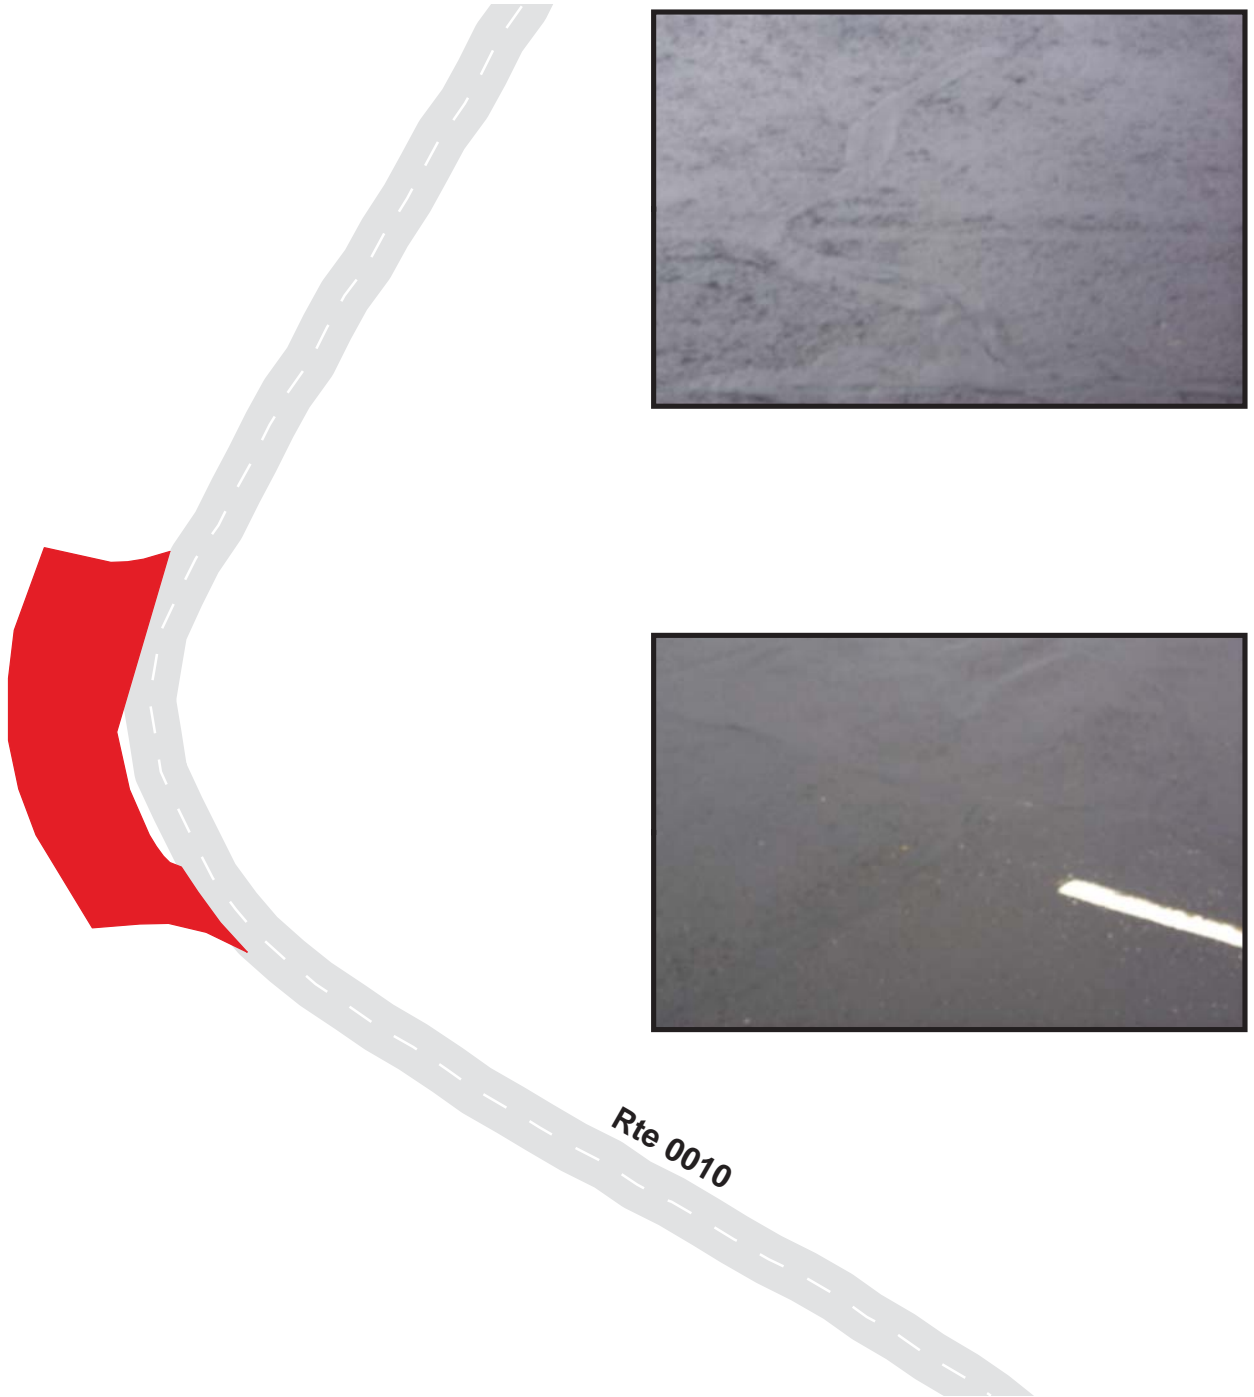
Route 0904

Route	Public / NonPublic	Date Visited	Area (sq ft)	Lane Miles *	Surface Type	Condition / PCR
0904	Public	5/4/2003	7694	0.13	AS	FAIR / 73

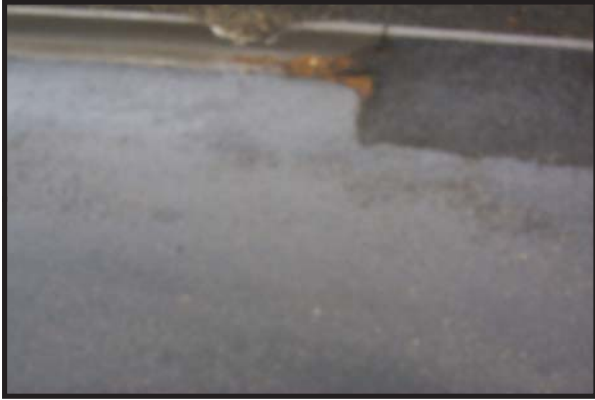
Route 0905

Route	Public / NonPublic	Date Visited	Area (sq ft)	Lane Miles *	Surface Type	Condition / PCR
0905	Public	5/4/2003	4891	0.08	AS	GOOD / 90

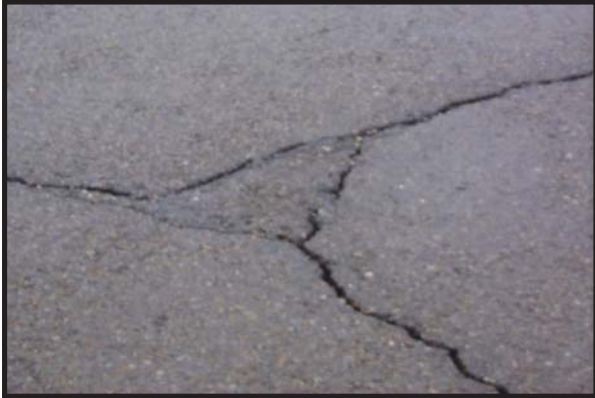
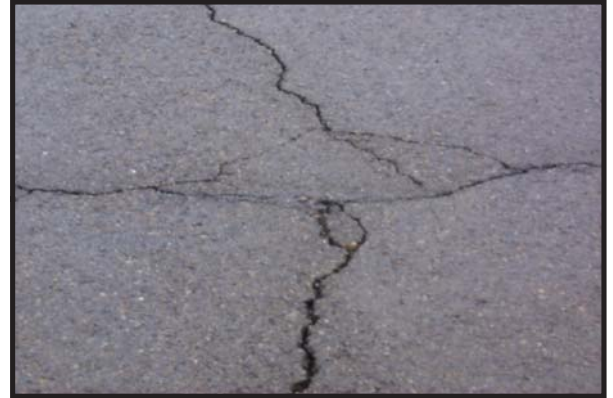
Route 0906

Route	Public / NonPublic	Date Visited	Area (sq ft)	Lane Miles *	Surface Type	Condition / PCR
0906	Public	5/4/2003	15320	0.26	AS	POOR / 45

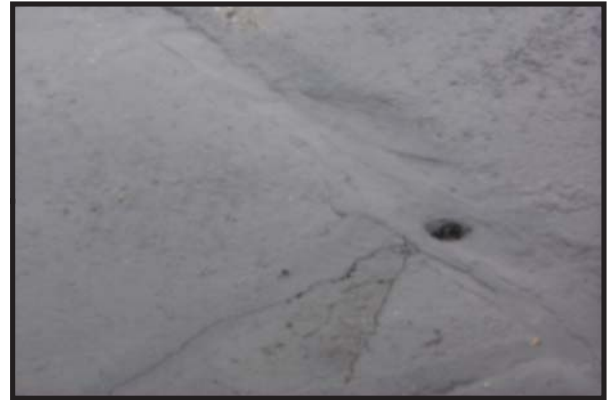
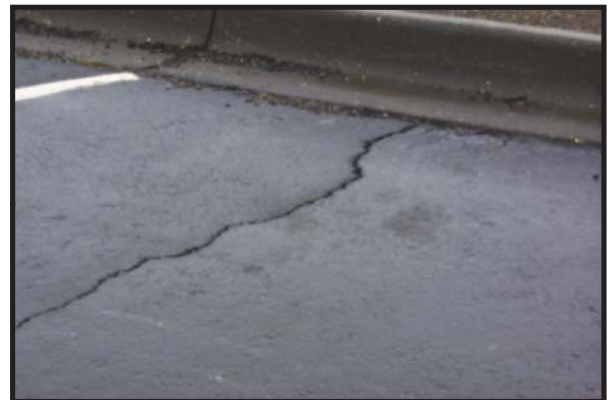
Route 0907

Route	Public / NonPublic	Date Visited	Area (sq ft)	Lane Miles *	Surface Type	Condition / PCR
0907	Public	5/4/2003	10222	0.18	AS	FAIR / 73

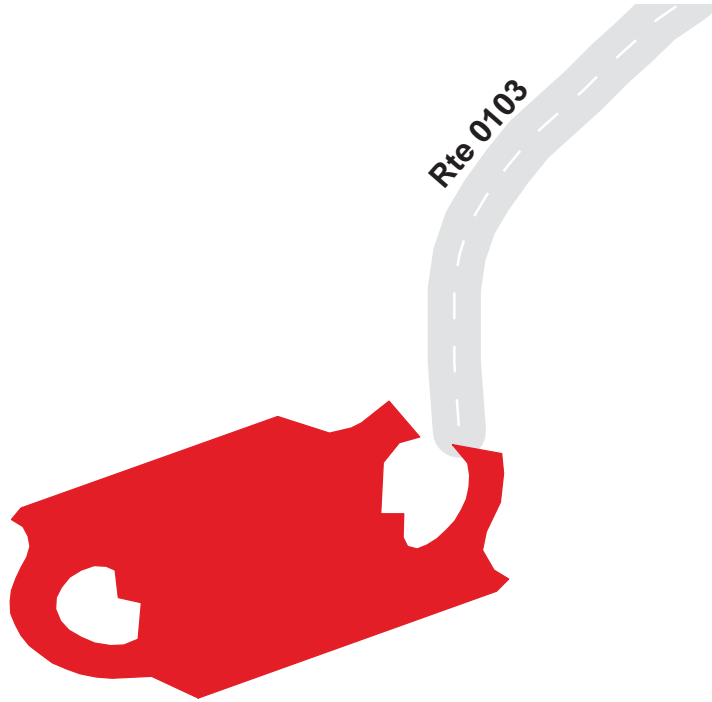
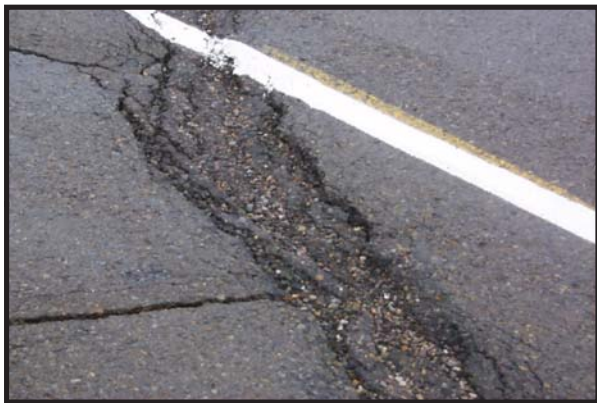
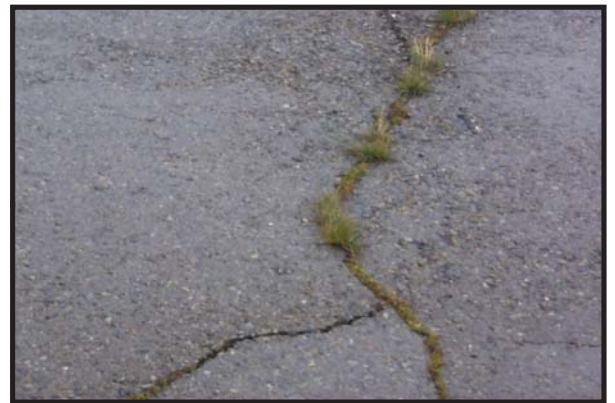
Route 0908

Route	Public / NonPublic	Date Visited	Area (sq ft)	Lane Miles *	Surface Type	Condition / PCR
0908	Public	5/4/2003	17134	0.30	AS	POOR / 45

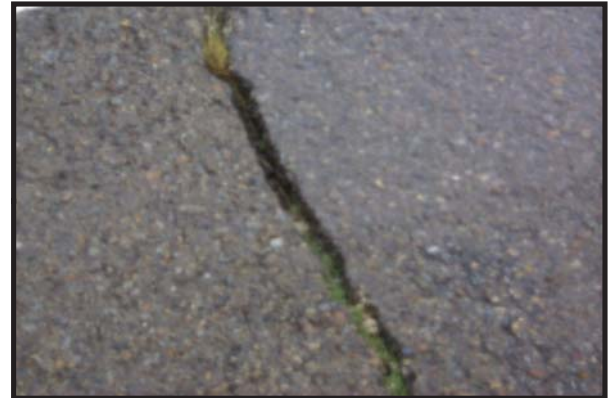
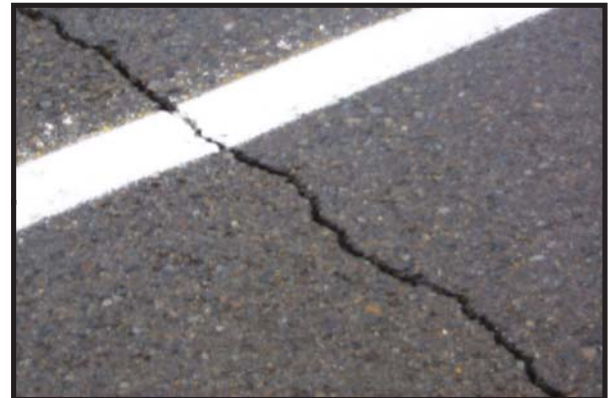
Route 0909

Route	Public / NonPublic	Date Visited	Area (sq ft)	Lane Miles *	Surface Type	Condition / PCR
0909	Public	5/4/2003	2182	0.04	AS	FAIR / 73

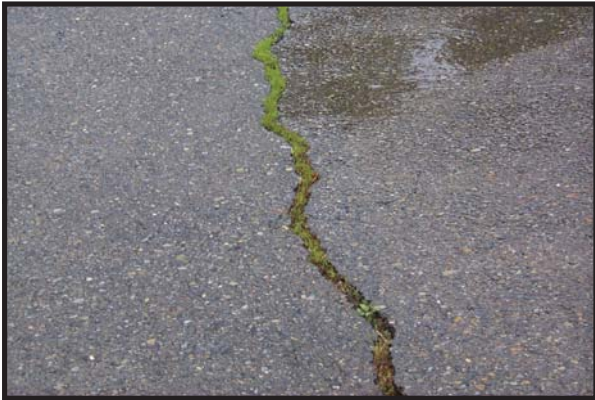
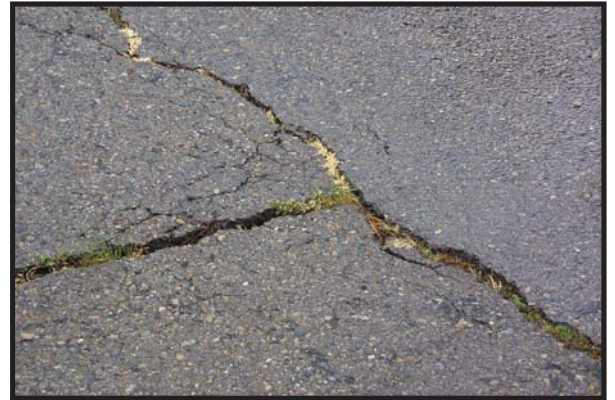
Route 0910

Route	Public / NonPublic	Date Visited	Area (sq ft)	Lane Miles *	Surface Type	Condition / PCR
0910	Public	5/4/2003	4670	0.08	AS	POOR / 45

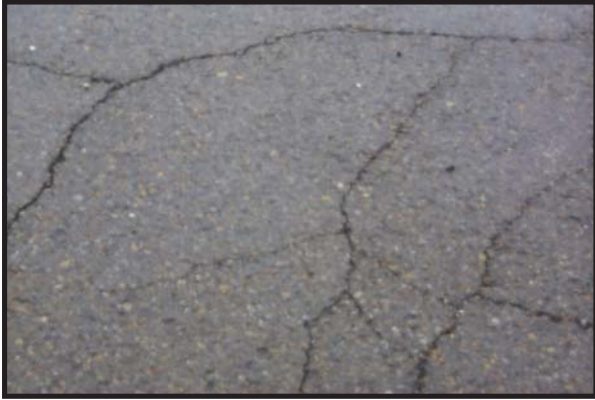
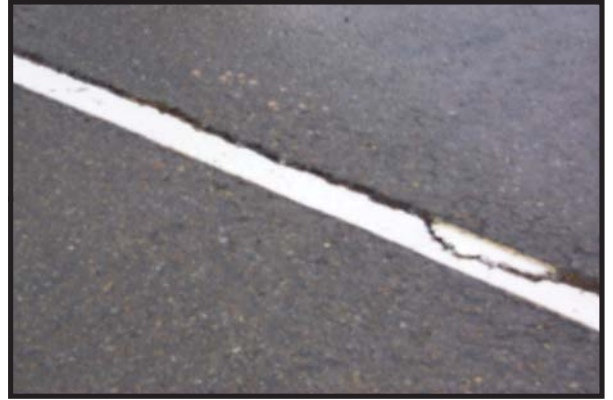
Route 0911

Route	Public / NonPublic	Date Visited	Area (sq ft)	Lane Miles *	Surface Type	Condition / PCR
0911	Public	5/4/2003	18674	0.32	AS	POOR / 45

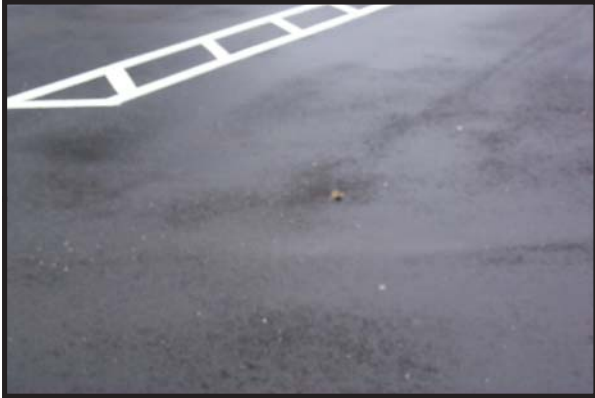
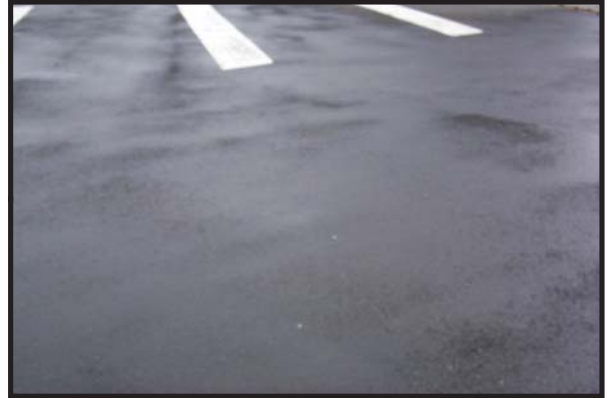
Route 0912

Route	Public / NonPublic	Date Visited	Area (sq ft)	Lane Miles *	Surface Type	Condition / PCR
0912	Public	5/4/2003	39092	0.67	AS	GOOD / 90

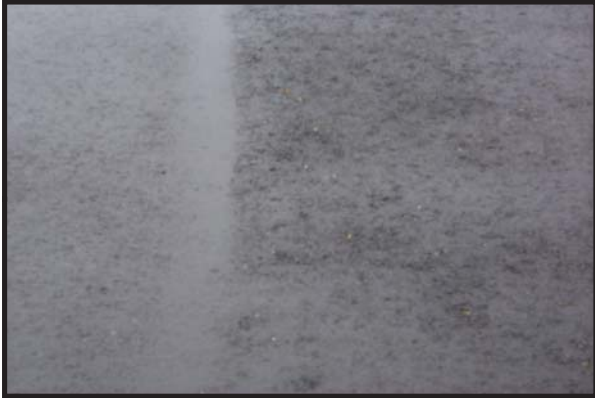
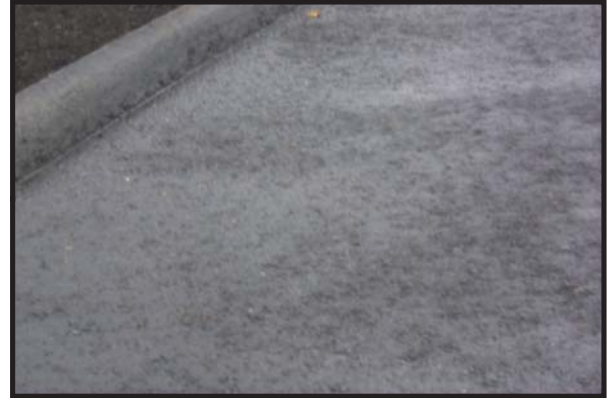
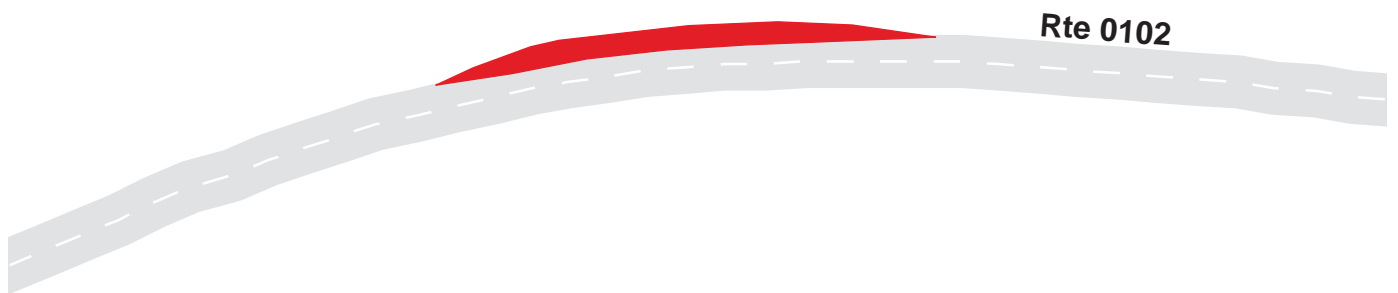
Route 0913

Route	Public / NonPublic	Date Visited	Area (sq ft)	Lane Miles *	Surface Type	Condition / PCR
0913	Public	5/4/2003	1396	0.02	AS	GOOD / 90

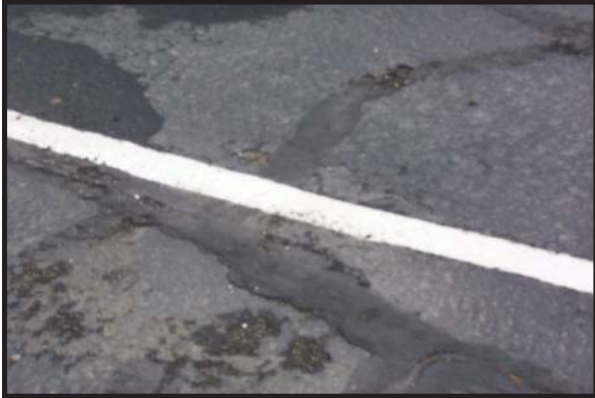
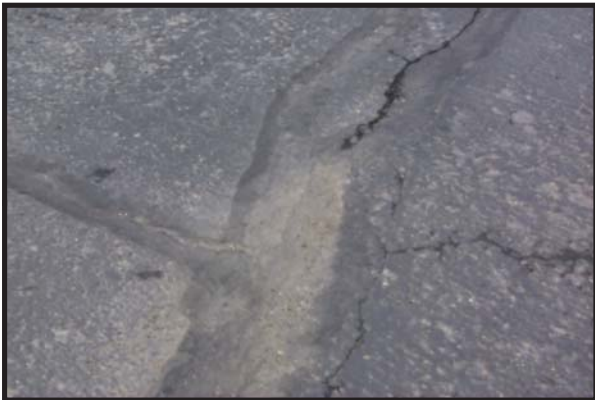
Route 0914

Route	Public / NonPublic	Date Visited	Area (sq ft)	Lane Miles *	Surface Type	Condition / PCR
0914	NonPublic	5/4/2003	1303	0.02	AS	POOR / 45

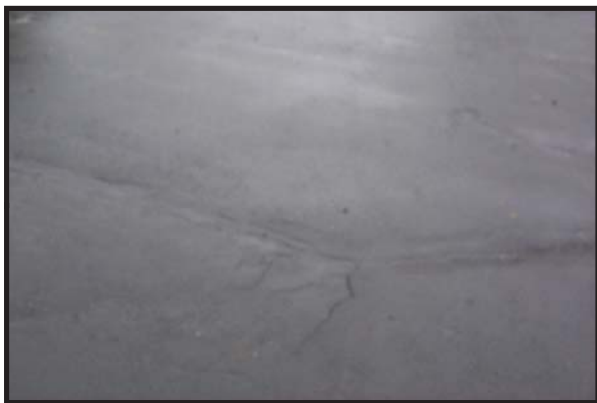
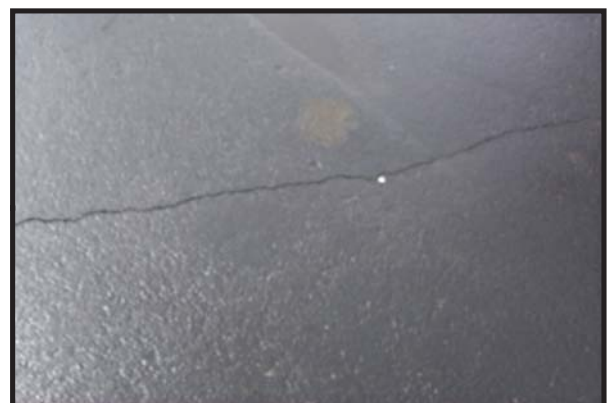
Route 0915

Route	Public / NonPublic	Date Visited	Area (sq ft)	Lane Miles *	Surface Type	Condition / PCR
0915	Public	5/4/2003	2688	0.05	AS	FAIR / 73
