The Road Inventory of Cumberland Gap National Historical Park CUGA – 5230

Road Inventory Program

Prepared By:
Federal Highway Administration
Eastern Federal Lands Highway Division
Cycle 3

Cumberland Gap National Historical Park in Kentucky

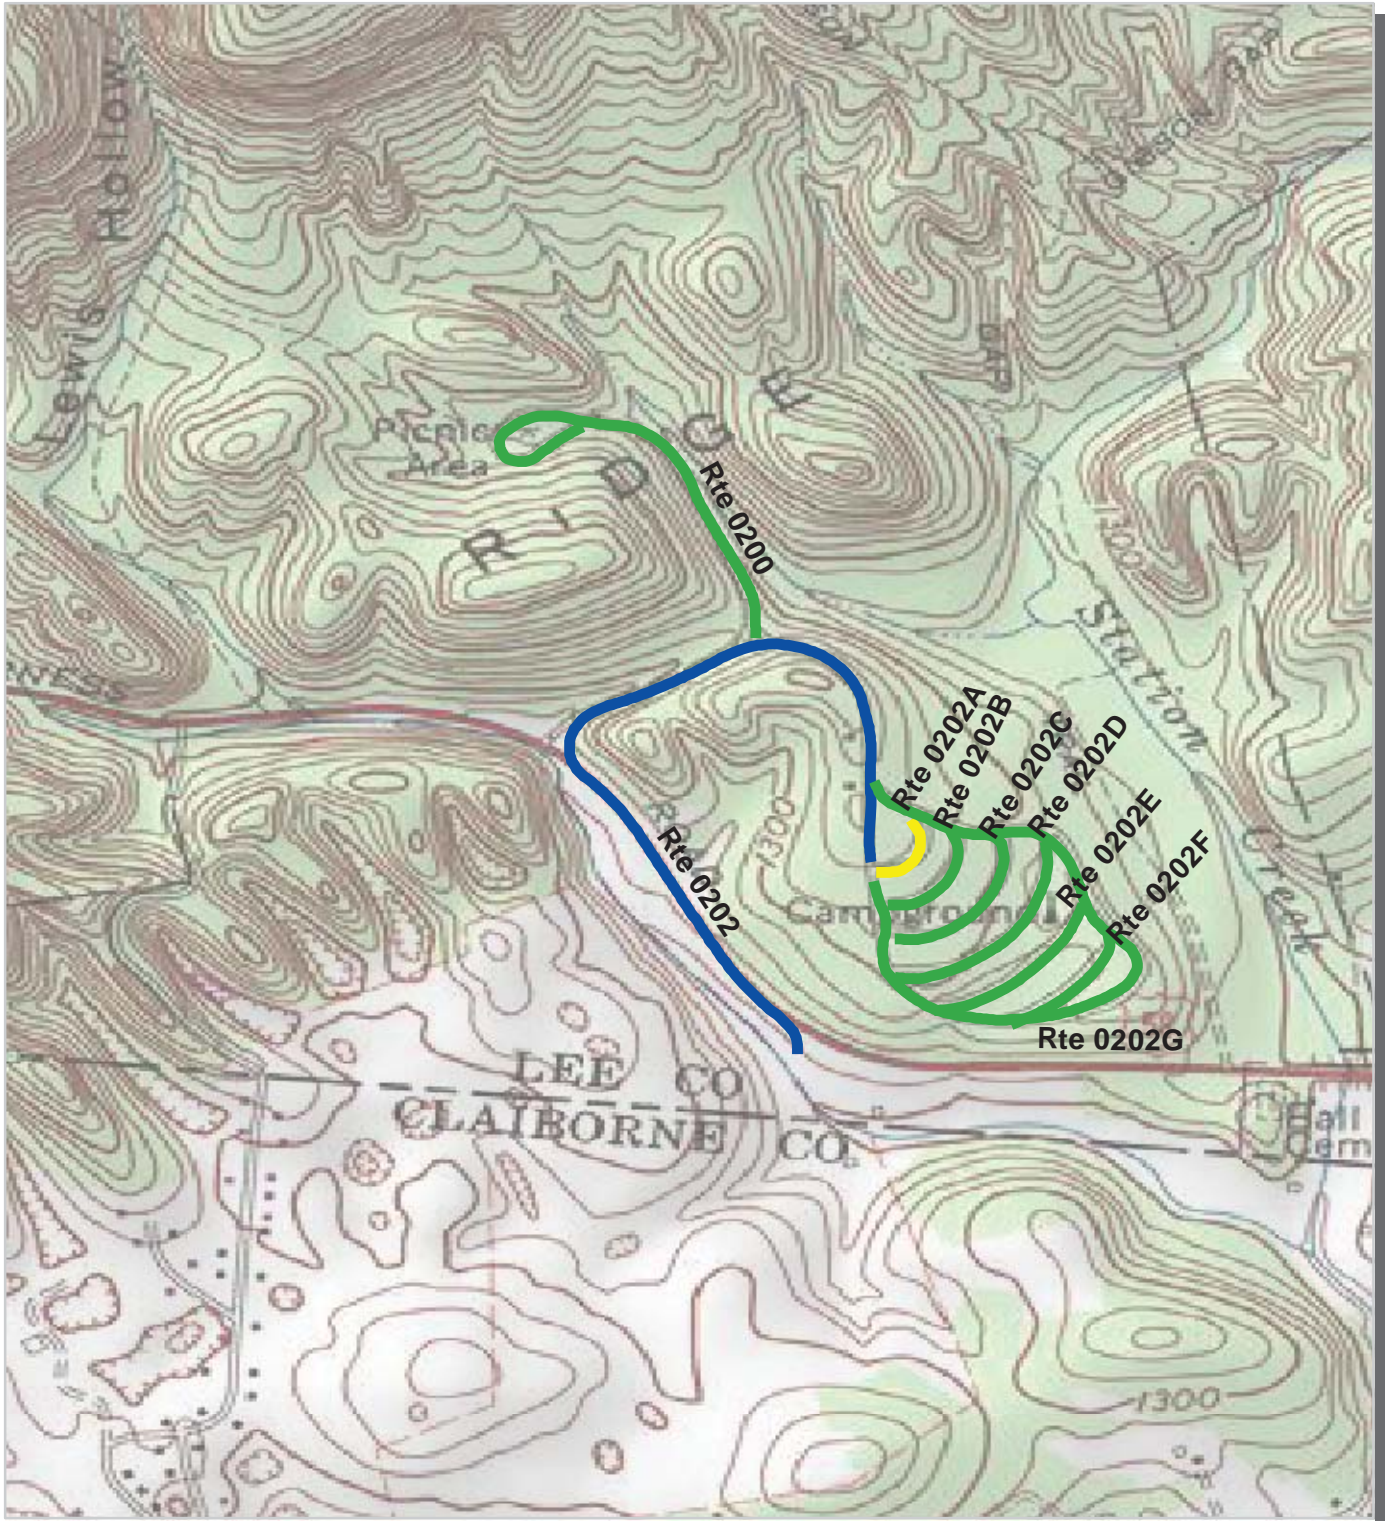
Route Condition Area Map 3

PCR - Mile by Mile

PCR	Poor		Fair		Good		Excellent	
	(≤ 60)		(61 - 84)		(85 - 94)		(95 - 100)

* If the PCR rating is not available for a section, the SCR rating will be displayed. See appendix for definitions and formulas.

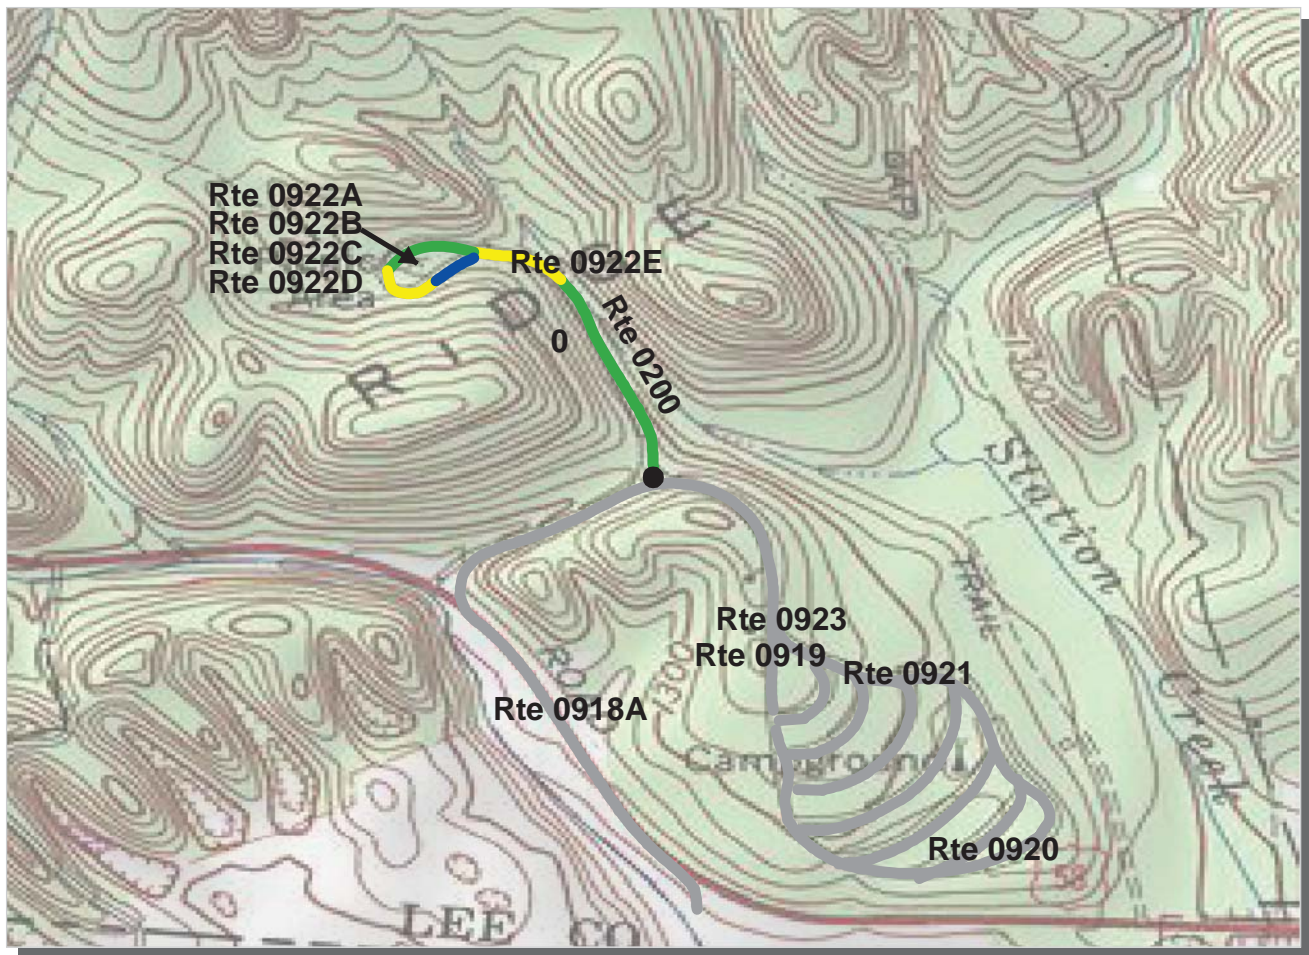
ROUTE: 0200 Wilderness Picnic Area Road **TOTAL LENGTH: 0.50 Miles**

Section Number	0				
Section Length (mi)	0.50				
AADT	**				
SADT	**				
ADT Date	**				
Cross Section Information					
Number of Lanes	2				
Paved Width (ft)	13				
Lane Width (ft)	7				
Shoulder Width (ft)	2				
Roadway Condition Information					
PCR (Pavement Condition Rating)	87				
RCI (Roughness Condition Index)	87				
SCR (Surface Condition Rating)	86				
Alligator Cracking Index	100				
Rutting Index	86				
Patching Index	100				
Transverse Cracking Index	100				
Longitudinal Cracking Index	100				
Shoulder Condition Rating	GOOD				
Drainage Condition Rating	GOOD

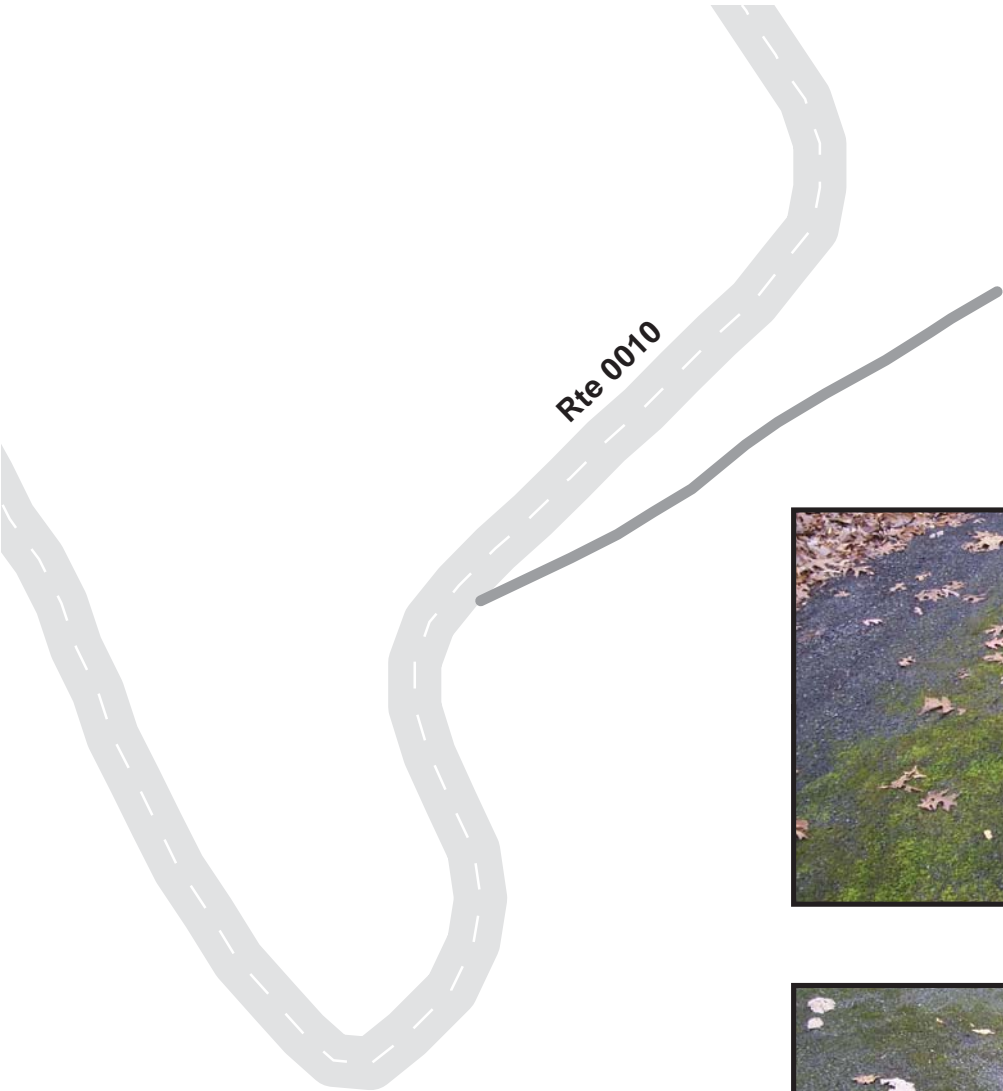
Route 0403

Route	Length (mi)	Width (ft)	Area (sq ft)	Lane Miles *	Condition / PCR	Surface Type
0403	0.04	9.00	1901	0.03	FAIR / 73	AS

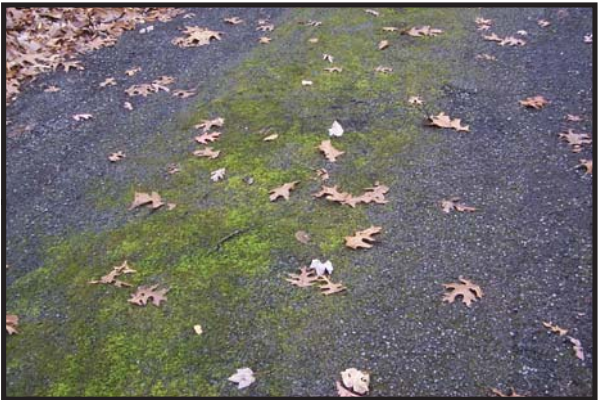
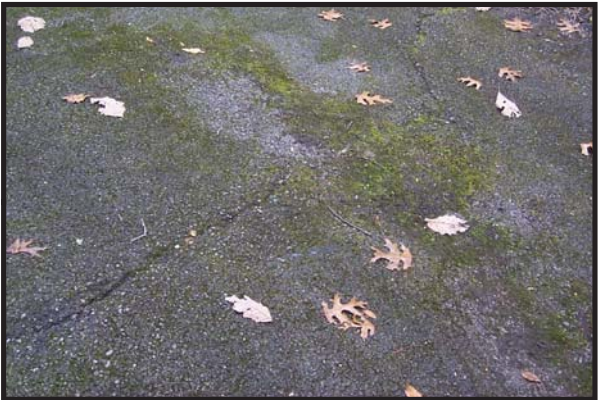
Route 0900

Route	Public / NonPublic	Date Visited	Area (sq ft)	Lane Miles *	Surface Type	Condition / PCR
0900	Public	11/16/2002	86189	1.48	AS	GOOD / 90

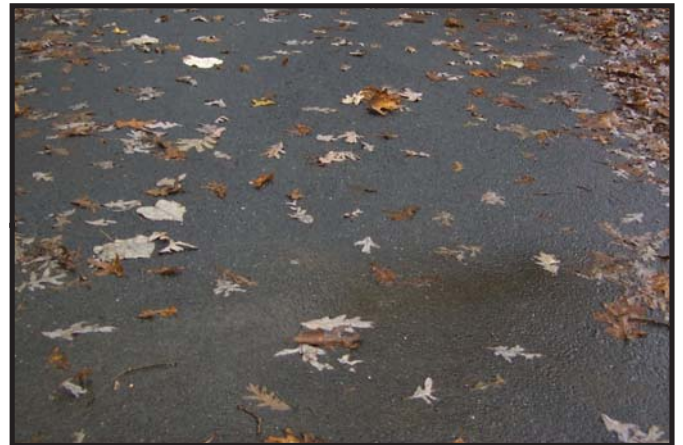
Route 0904

Route	Public / NonPublic	Date Visited	Area (sq ft)	Lane Miles *	Surface Type	Condition / PCR
0904	NonPublic	11/17/2002	10548	0.18	AS	GOOD / 90

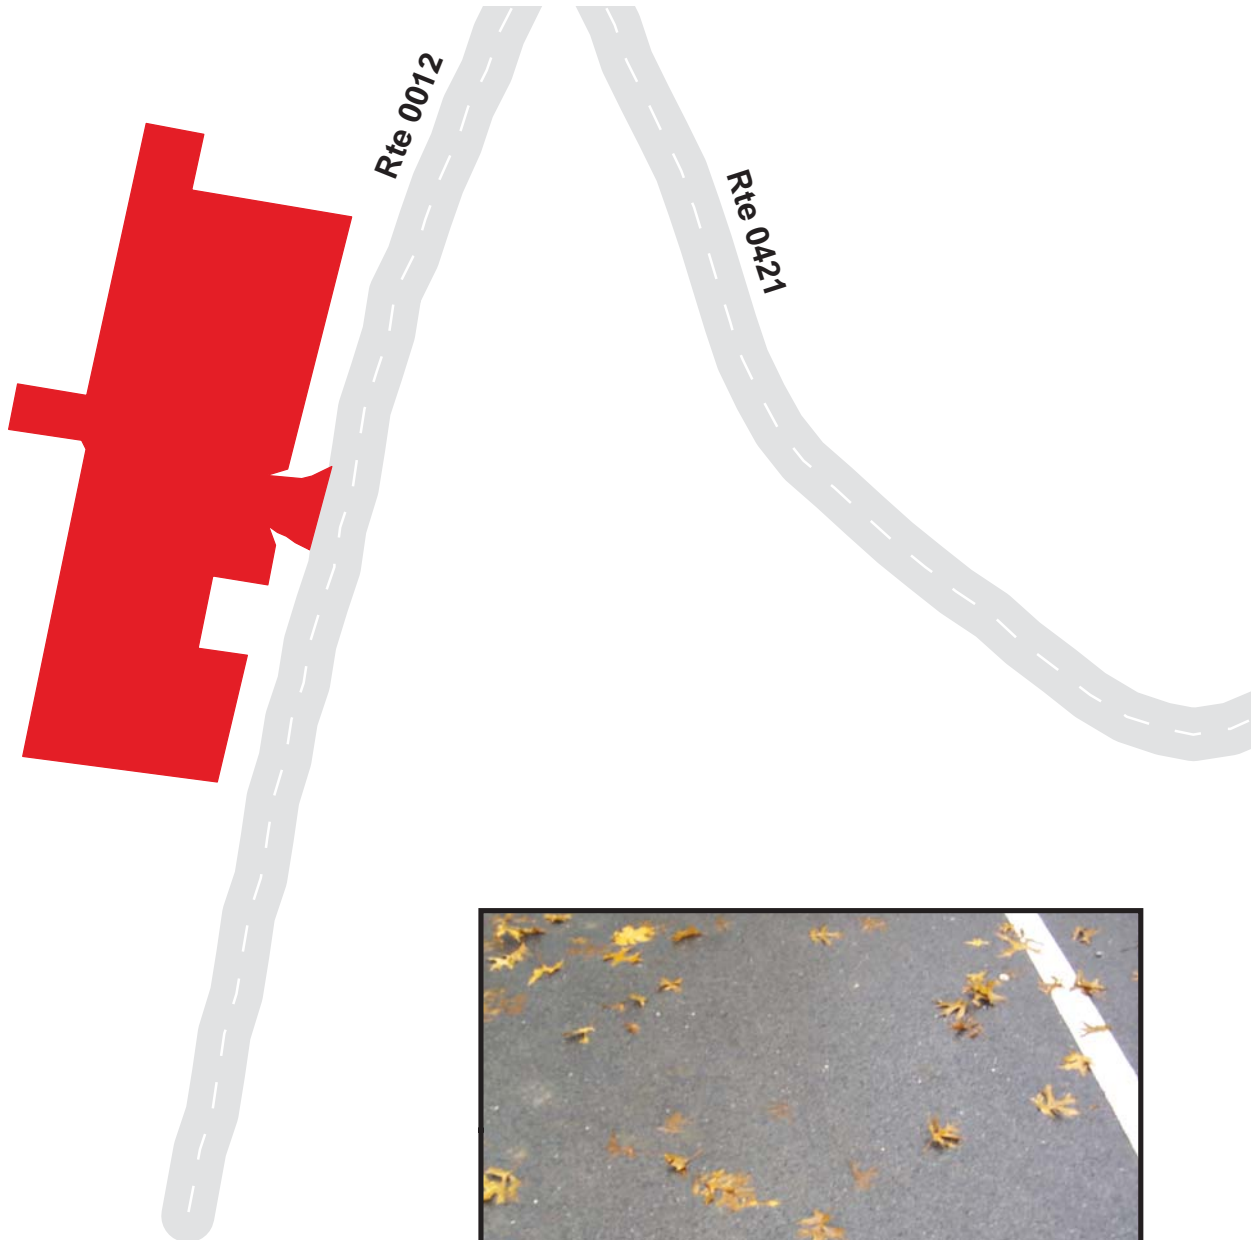
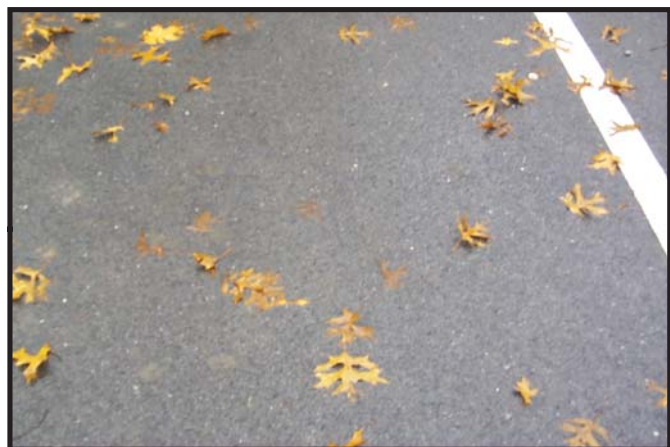
Route 0907A

Route	Public / NonPublic	Date Visited	Area (sq ft)	Lane Miles *	Surface Type	Condition / PCR
0907A	NonPublic	11/17/2002	21181	0.36	AS	FAIR / 73

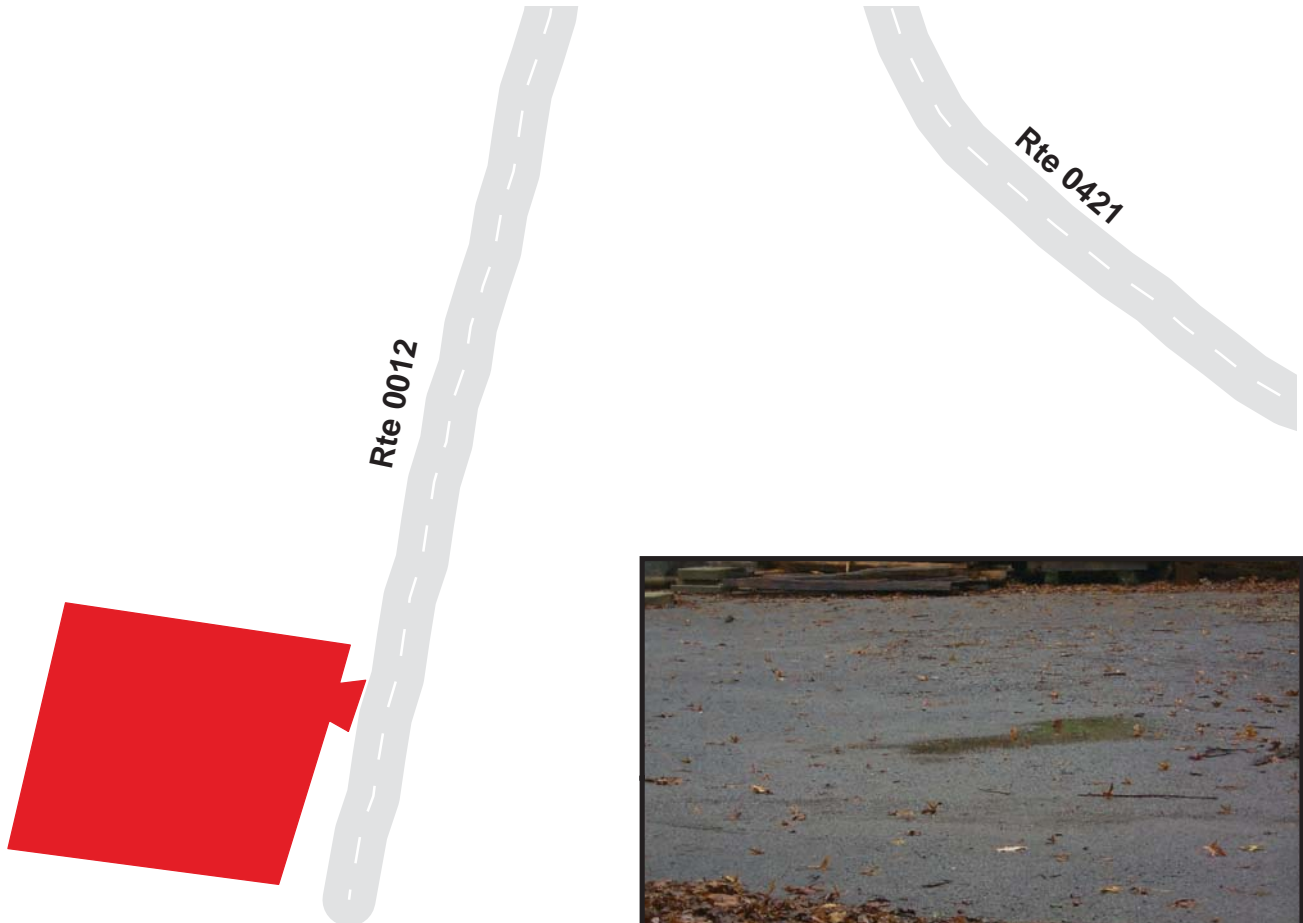
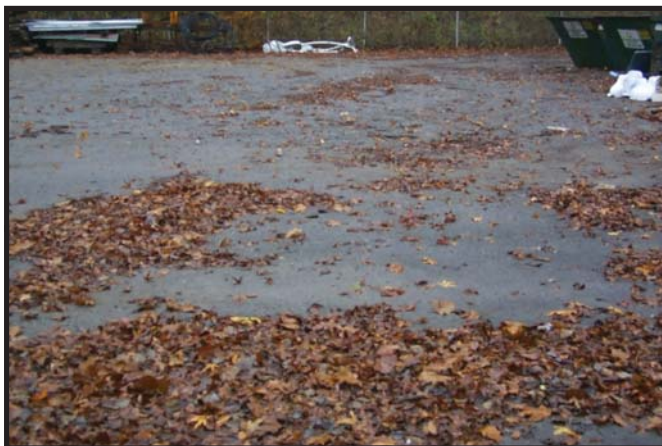
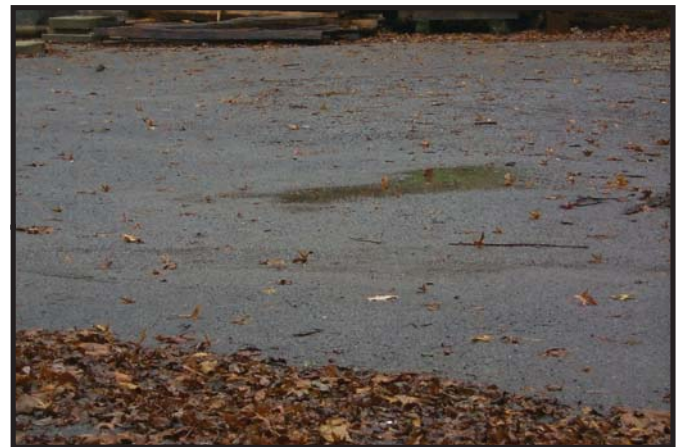
Route	Public / NonPublic	Date Visited	Area (sq ft)	Lane Miles *	Surface Type	Condition / PCR
0907B	NonPublic	11/17/2002	11925	0.21	AS	POOR / 45

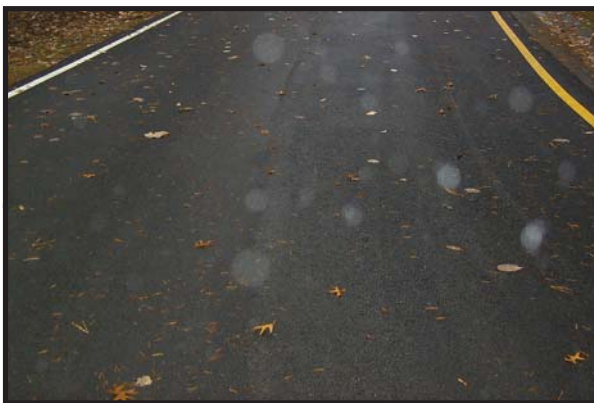
Route 0920

Route	Public / NonPublic	Date Visited	Area (sq ft)	Lane Miles *	Surface Type	Condition / PCR
0920	Public	11/16/2002	4957	0.09	AS	EXCELLENT / 97

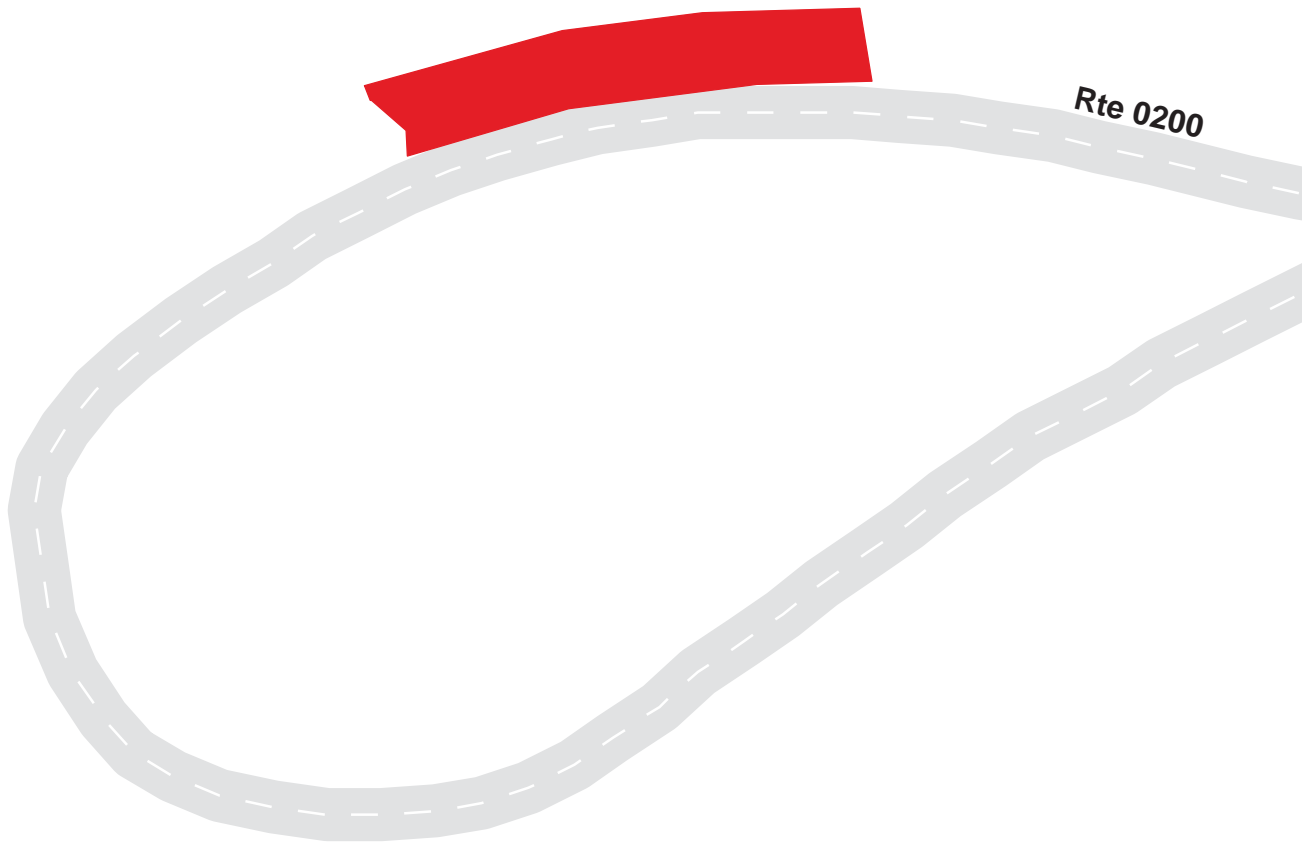
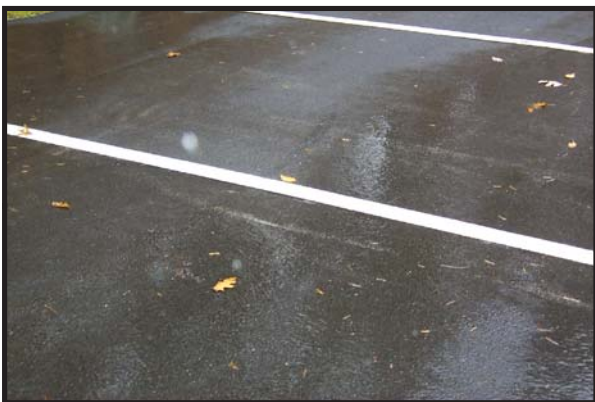
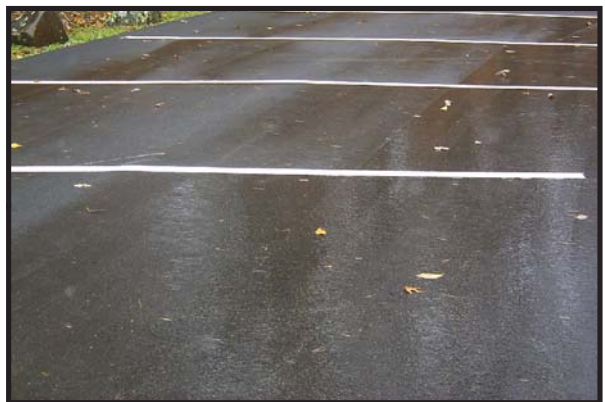
Route	Public / NonPublic	Date Visited	Area (sq ft)	Lane Miles *	Surface Type	Condition / PCR
0922A	Public	11/16/2002	3871	0.07	AS	EXCELLENT / 97

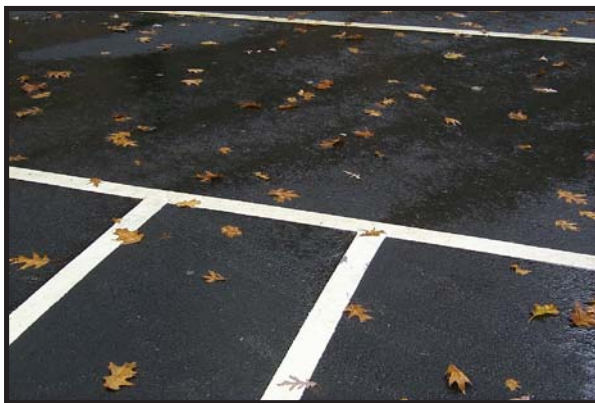
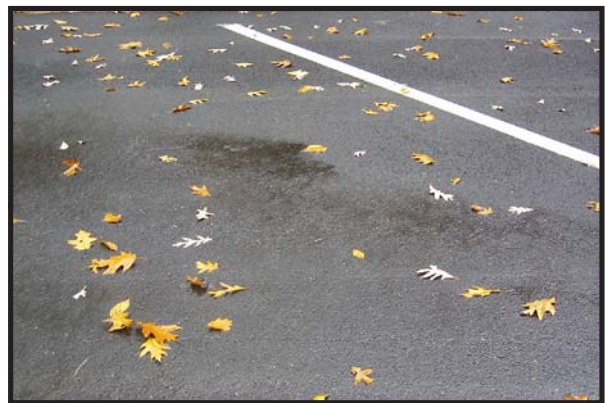
Route	Public / NonPublic	Date Visited	Area (sq ft)	Lane Miles *	Surface Type	Condition / PCR
0922B	Public	11/16/2002	2116	0.04	AS	EXCELLENT / 97

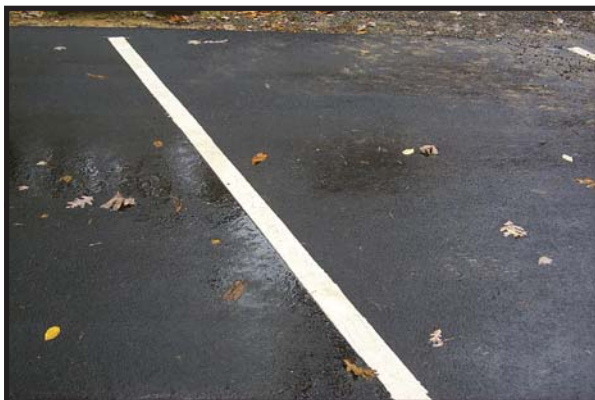
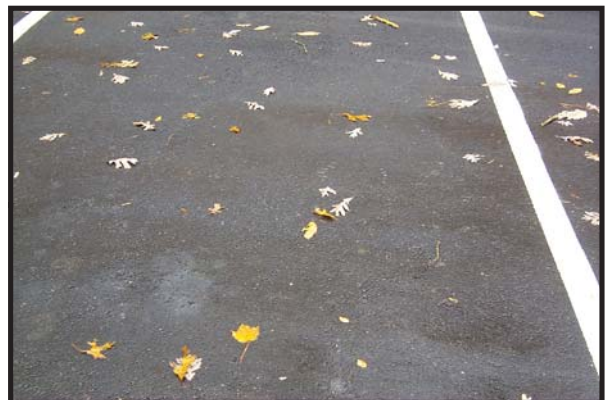
Route	Public / NonPublic	Date Visited	Area (sq ft)	Lane Miles *	Surface Type	Condition / PCR
0922C	Public	11/16/2002	1806	0.03	AS	EXCELLENT / 97

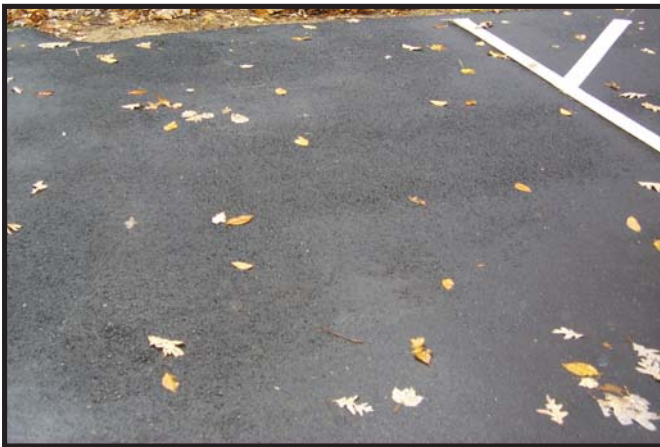
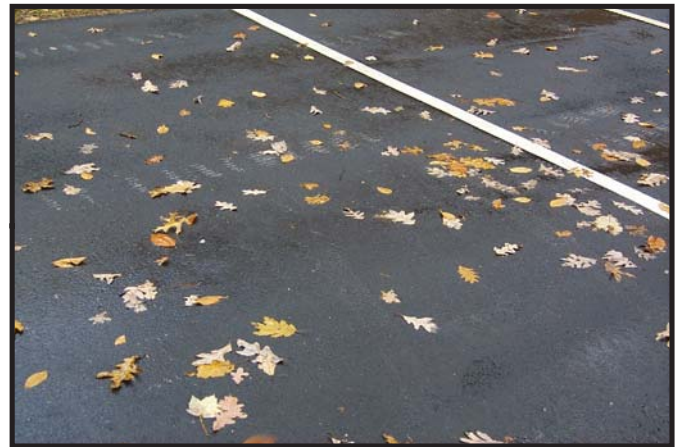
Route	Public / NonPublic	Date Visited	Area (sq ft)	Lane Miles *	Surface Type	Condition / PCR
0922D	Public	11/16/2002	2587	0.04	AS	EXCELLENT / 97

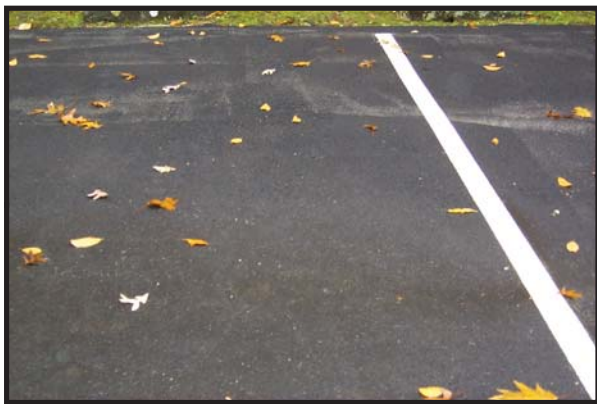
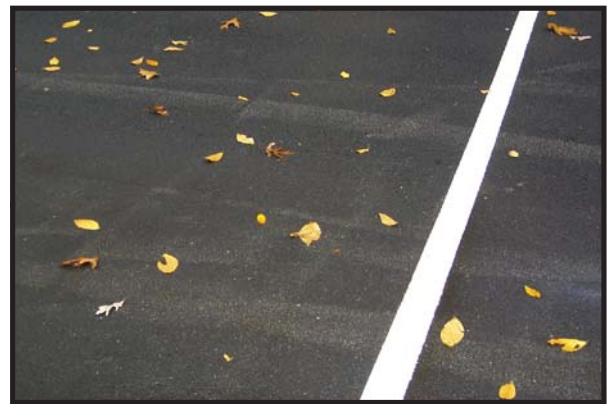
Route	Public / NonPublic	Date Visited	Area (sq ft)	Lane Miles *	Surface Type	Condition / PCR
0922E	Public	11/16/2002	2079	0.04	AS	EXCELLENT / 97

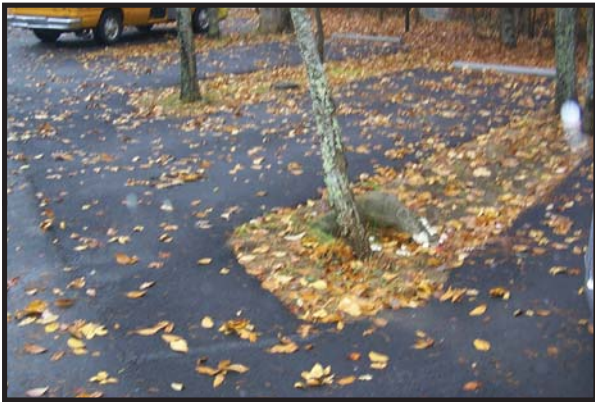
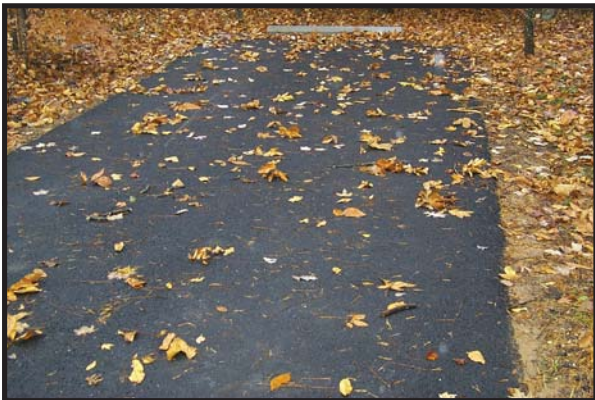
Route	Public / NonPublic	Date Visited	Area (sq ft)	Lane Miles *	Surface Type	Condition / PCR
0923	Public	11/16/2002	2082	0.04	AS	EXCELLENT / 97

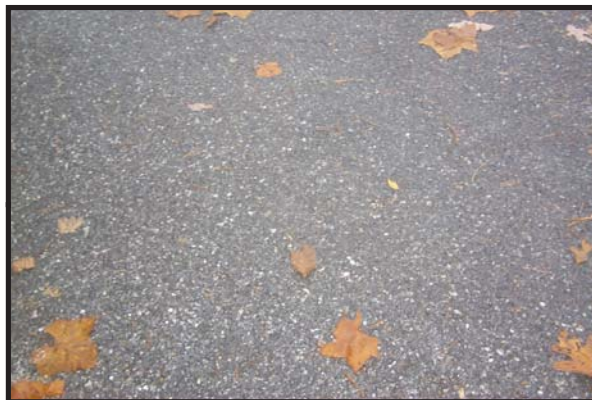
Route 0924

Route	Public / NonPublic	Date Visited	Area (sq ft)	Lane Miles *	Surface Type	Condition / PCR
0924	Public	11/16/2002	722	0.01	AS	GOOD / 90
