The Road Inventory of Curecanti National Recreation Area CURE - 1379

Road Inventory Program

Prepared By:
Federal Highway Administration
Eastern Federal Lands Highway Division
Cycle 3

Curecanti National Recreation Area in Colorado

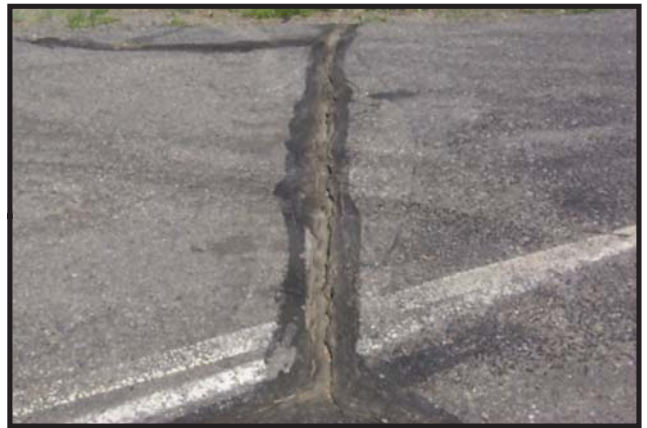
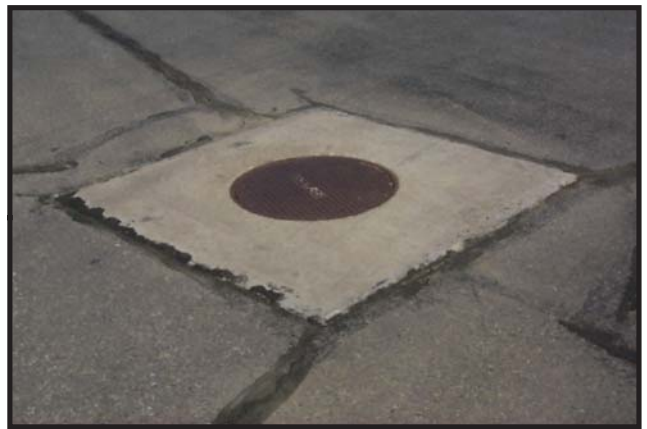
Route	Public / NonPublic	Date Visited	Area (sq ft)	Lane Miles *	Surface Type	Condition / PCR
0900	NonPublic	6/15/2003	39845	0.69	AS	FAIR / 73

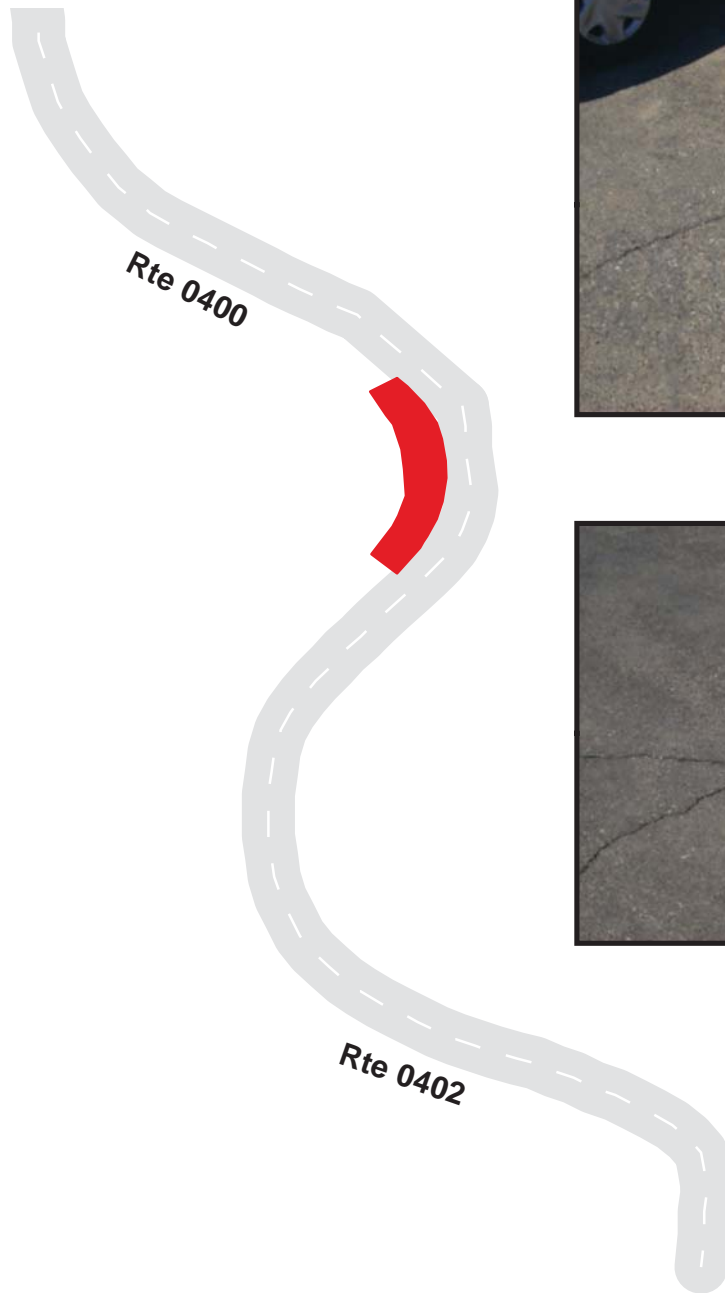
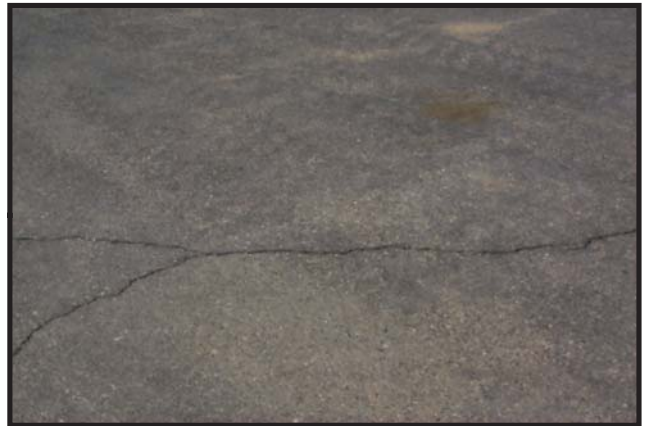
Route 0901

Route	Public / NonPublic	Date Visited	Area (sq ft)	Lane Miles *	Surface Type	Condition / PCR
0901	NonPublic	6/15/2003	4496	0.08	AS	FAIR / 73

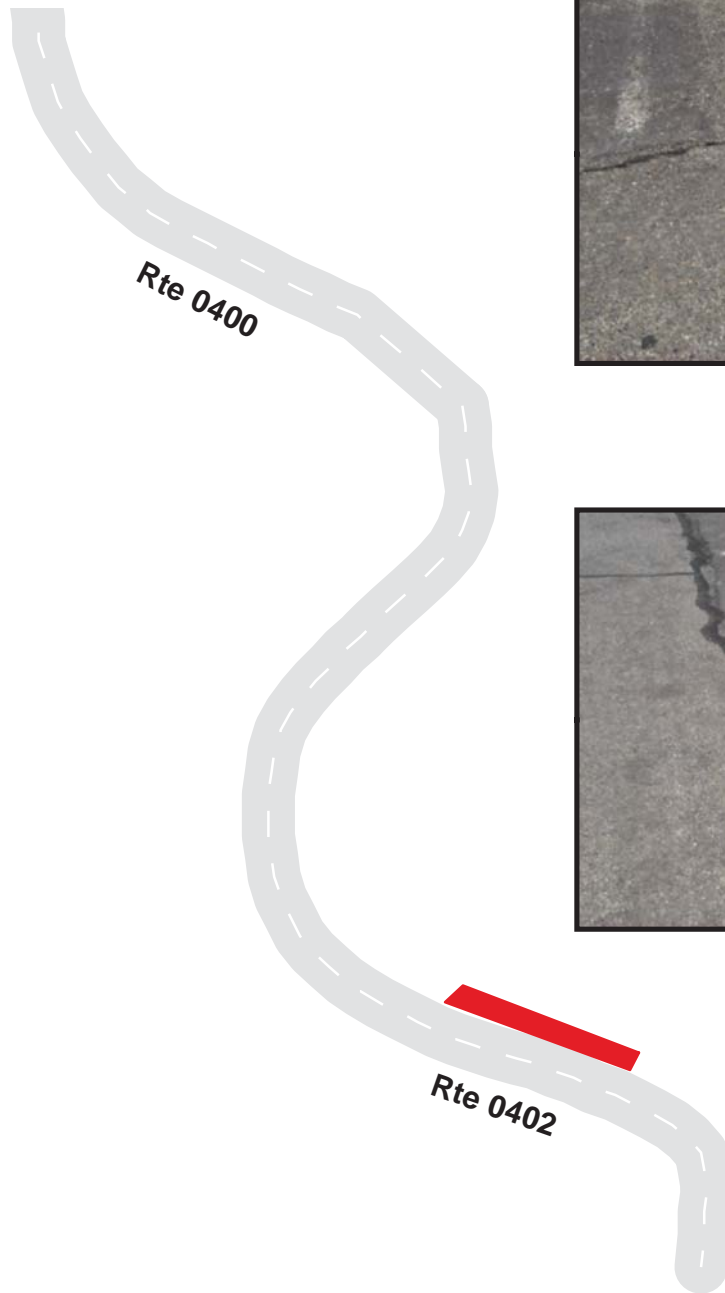
Route 0902A

Route	Public / NonPublic	Date Visited	Area (sq ft)	Lane Miles *	Surface Type	Condition / PCR
0902A	NonPublic	6/15/2003	2415	0.04	AS	FAIR / 73

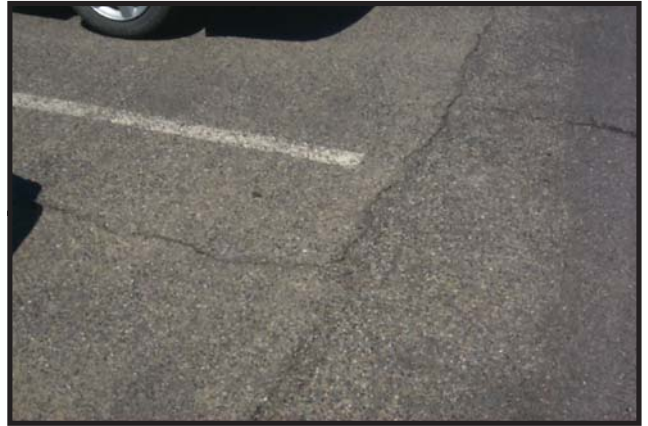
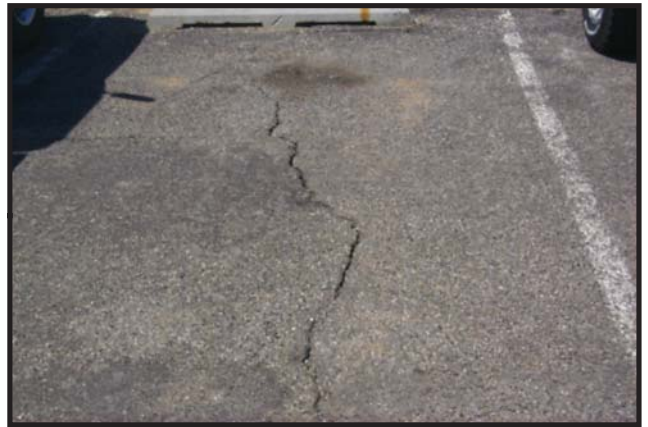
Route 0902B

Route	Public / NonPublic	Date Visited	Area (sq ft)	Lane Miles *	Surface Type	Condition / PCR
0902B	NonPublic	6/15/2003	1772	0.03	AS	FAIR / 73

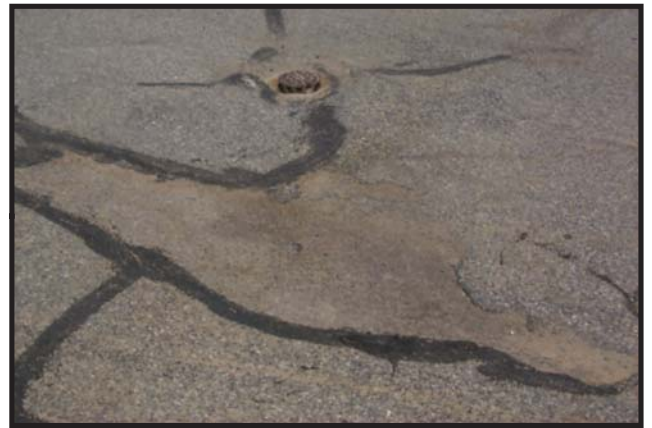
Route 0903

Route	Public / NonPublic	Date Visited	Area (sq ft)	Lane Miles *	Surface Type	Condition / PCR
0903	Public	6/15/2003	73356	1.26	AS	FAIR / 73

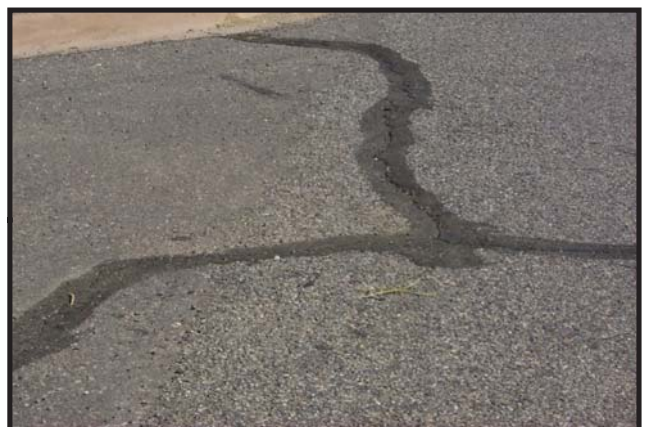
Route 0912

Route	Public / NonPublic	Date Visited	Area (sq ft)	Lane Miles *	Surface Type	Condition / PCR
0912	Public	6/15/2003	67591	1.16	AS	POOR / 45

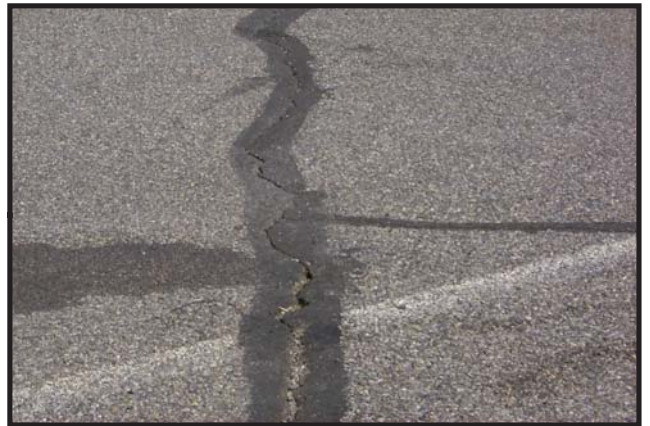
Route 0914A

Route	Public / NonPublic	Date Visited	Area (sq ft)	Lane Miles *	Surface Type	Condition / PCR
0914A	Public	6/15/2003	62328	1.07	AS	POOR / 45

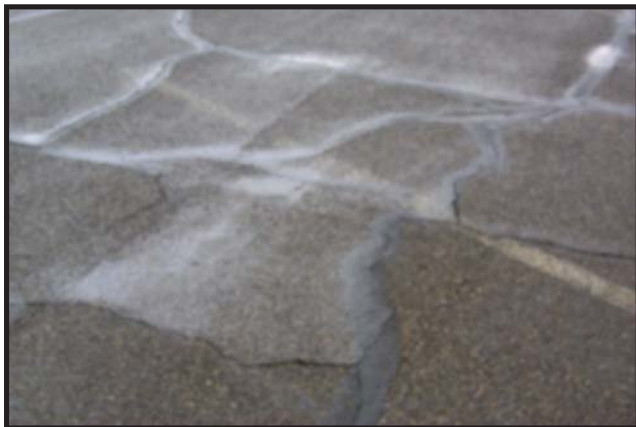
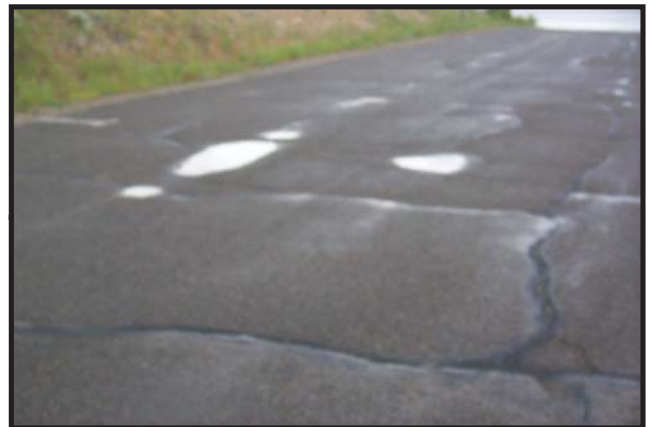
Route	Public / NonPublic	Date Visited	Area (sq ft)	Lane Miles *	Surface Type	Condition / PCR
0917	Public	6/15/2003	59881	1.03	AS	FAIR / 73

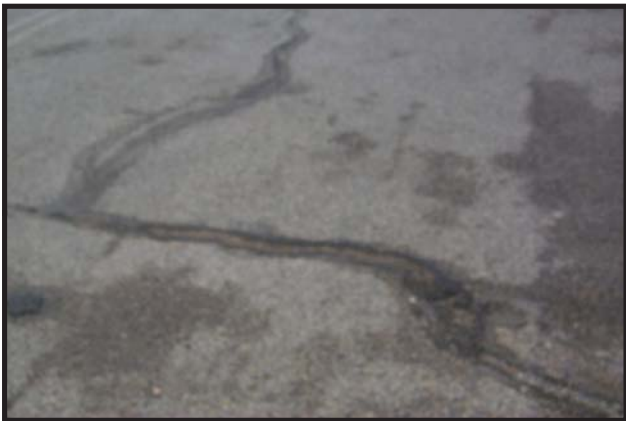
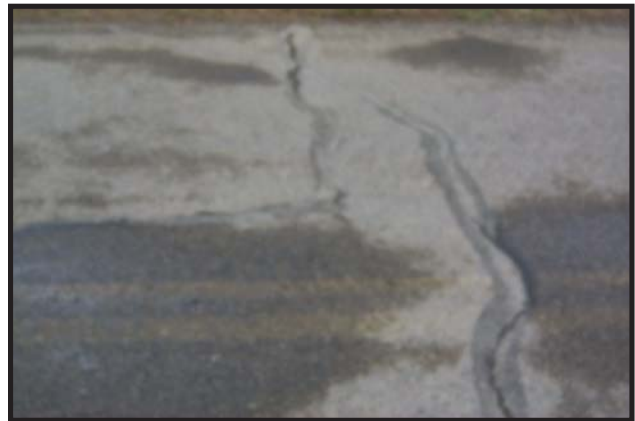
Route 0918

Route	Public / NonPublic	Date Visited	Area (sq ft)	Lane Miles *	Surface Type	Condition / PCR
0918	Public	6/15/2003	8689	0.15	AS	FAIR / 73

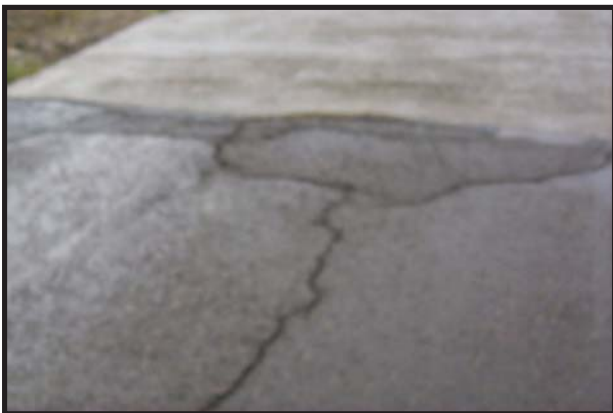
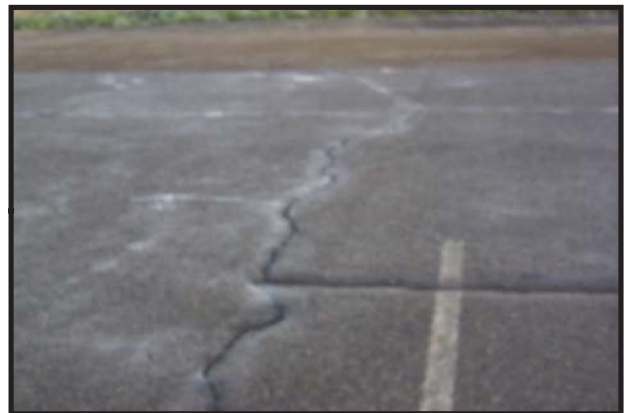
Route	Public / NonPublic	Date Visited	Area (sq ft)	Lane Miles *	Surface Type	Condition / PCR
0920	Public	6/15/2003	28962	0.50	AS	FAIR / 73

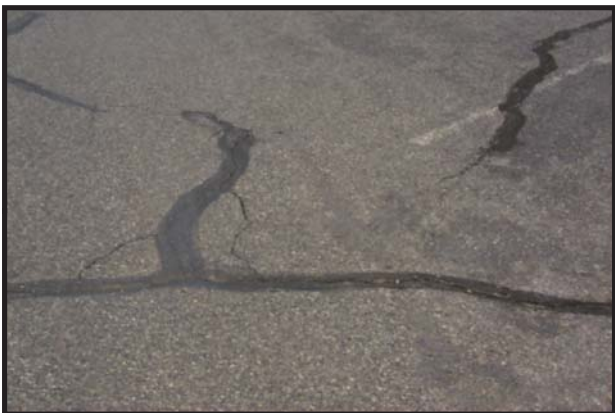
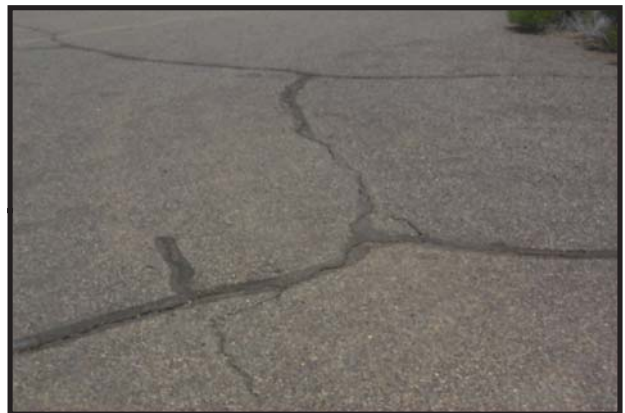
Route 0922

Route	Public / NonPublic	Date Visited	Area (sq ft)	Lane Miles *	Surface Type	Condition / PCR
0922	Public	6/15/2003	47257	0.81	AS	FAIR / 73

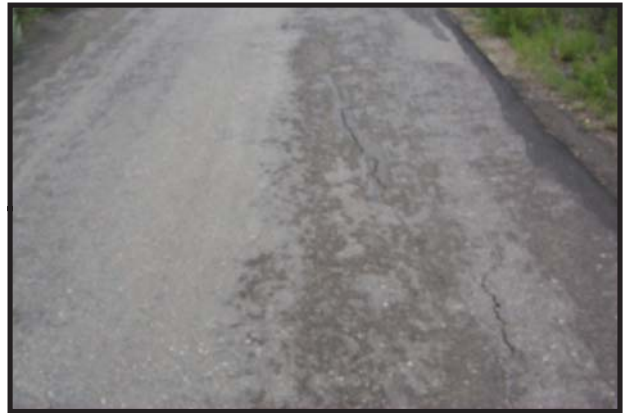
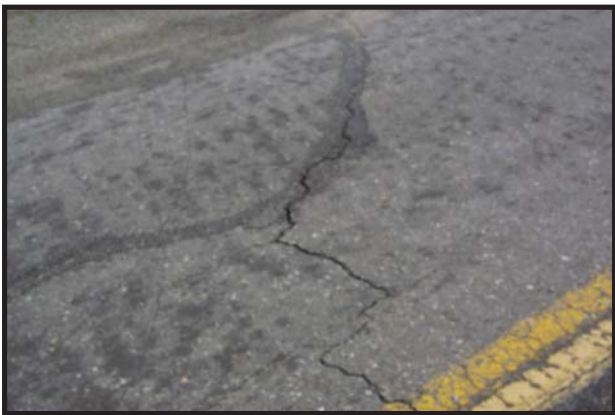
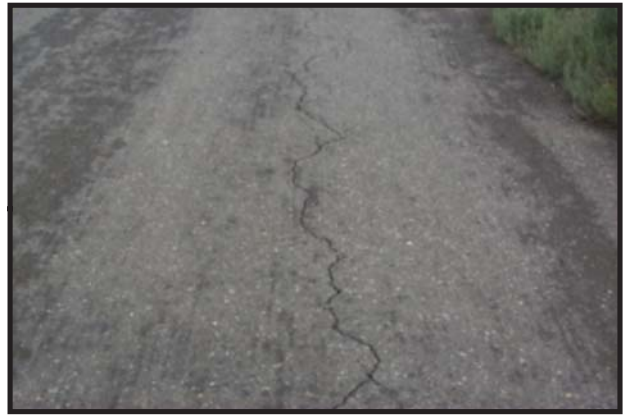
Route	Public / NonPublic	Date Visited	Area (sq ft)	Lane Miles *	Surface Type	Condition / PCR
0924	Public	6/15/2003	20640	0.36	AS	POOR / 45

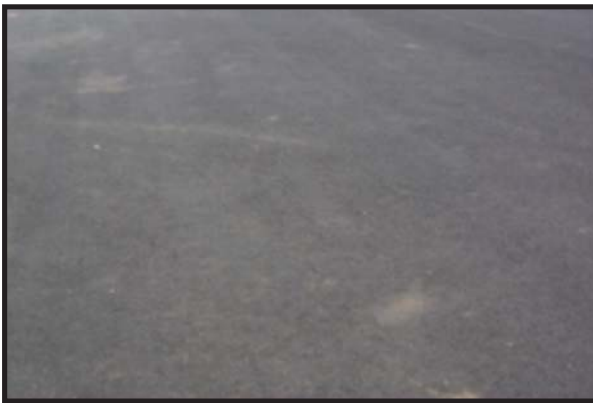
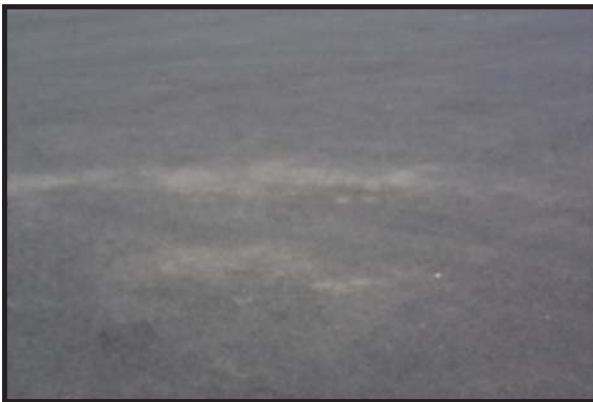
Route	Public / NonPublic	Date Visited	Area (sq ft)	Lane Miles *	Surface Type	Condition / PCR
0926	Public	6/15/2003	13357	0.23	AS	GOOD / 90

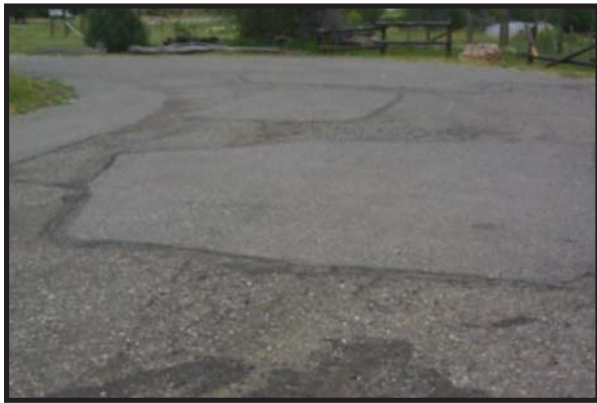
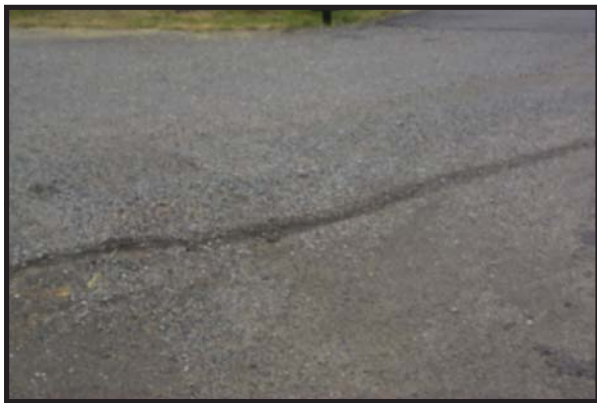
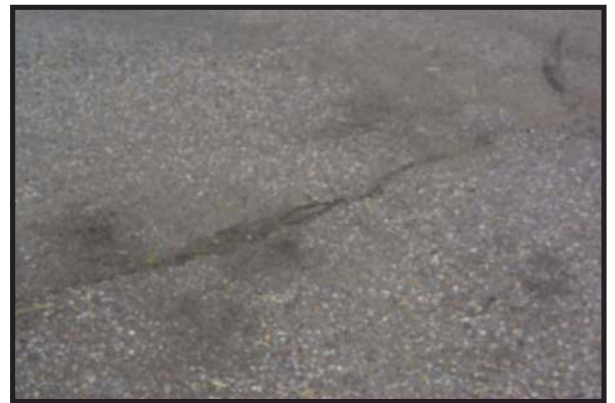
Route 0927

Route	Public / NonPublic	Date Visited	Area (sq ft)	Lane Miles *	Surface Type	Condition / PCR
0927	Public	6/17/2003	8476	0.15	AS	POOR / 45

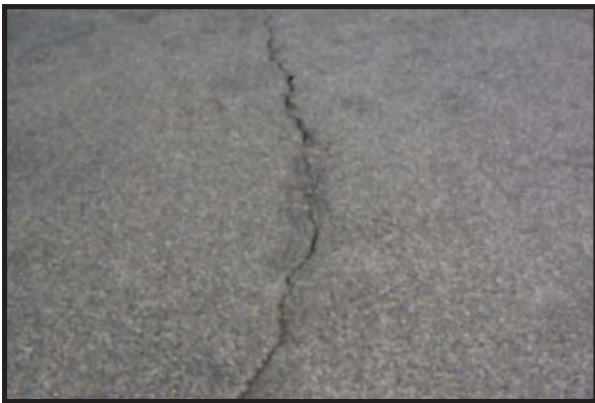
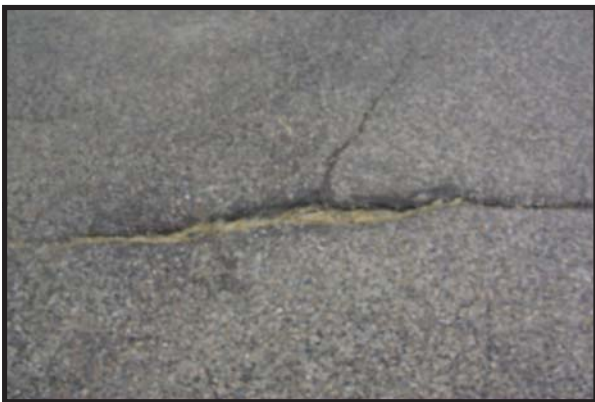
Route	Public / NonPublic	Date Visited	Area (sq ft)	Lane Miles *	Surface Type	Condition / PCR
0930B	Public	6/17/2003	1817	0.03	AS	GOOD / 90

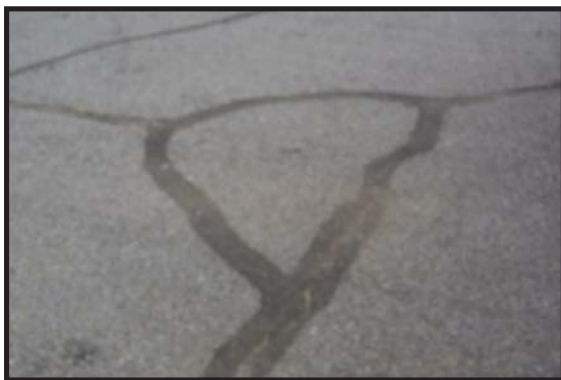
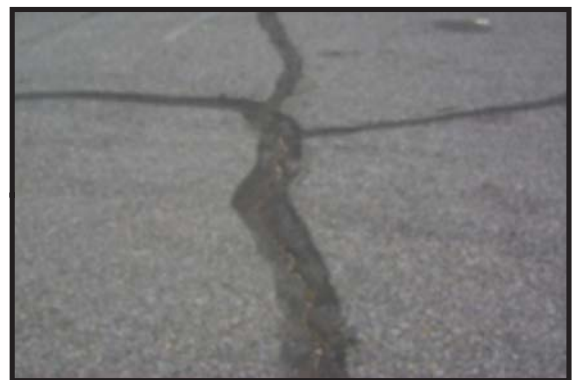
Route 0932

Route	Public / NonPublic	Date Visited	Area (sq ft)	Lane Miles *	Surface Type	Condition / PCR
0932	Public	6/17/2003	14620	0.25	AS	FAIR / 73

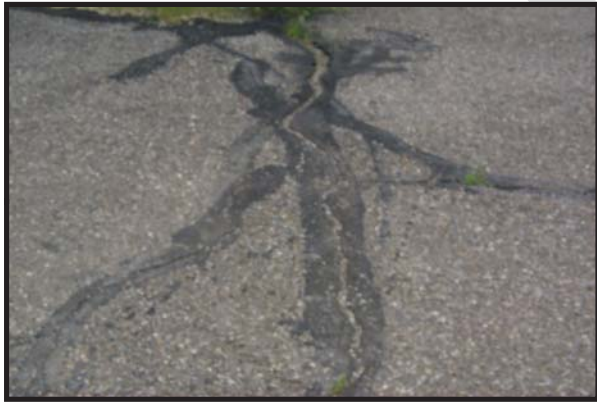
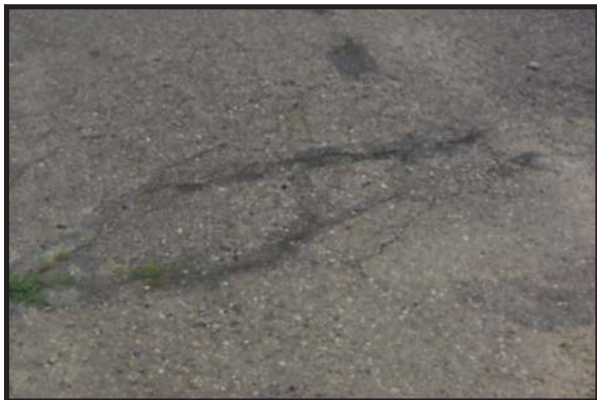
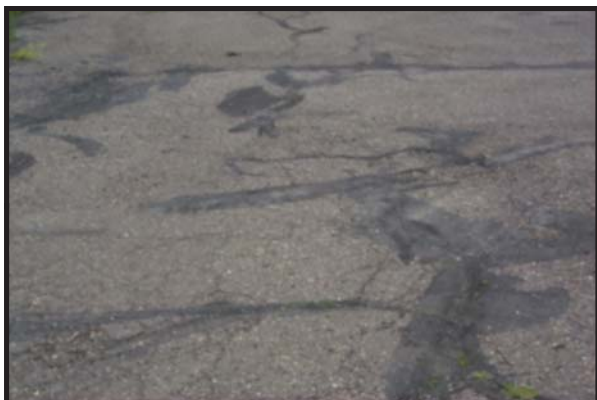
Route 0938

Route	Public / NonPublic	Date Visited	Area (sq ft)	Lane Miles *	Surface Type	Condition / PCR
0938	NonPublic	6/17/2003	22446	0.39	AS	POOR / 45

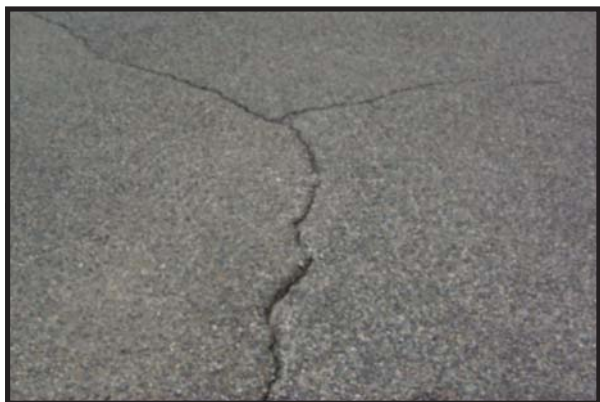
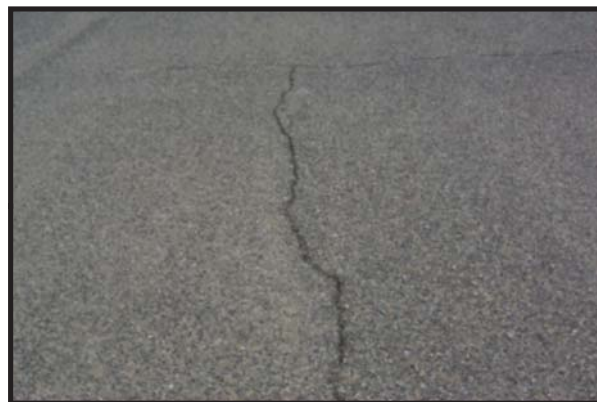
Route	Public / NonPublic	Date Visited	Area (sq ft)	Lane Miles *	Surface Type	Condition / PCR
0939	Public	6/17/2003	31328	0.54	AS	FAIR / 73
