# The Road Inventory of Denali National Park and Preserve DENA - 9830

## Road Inventory Program

Prepared By:  
Federal Highway Administration  
Eastern Federal Lands Highway Division  
Cycle 3

# Denali National Park and Preserve in Alaska

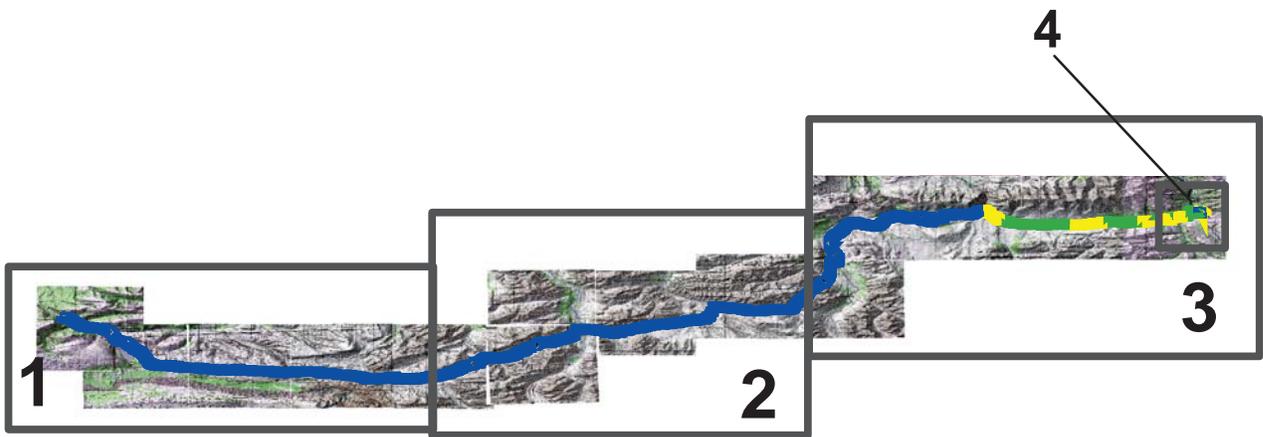
# Denali National Park and Preserve Route Condition Key Map PCR - Mile by Mile

PCR	Poor		Fair		Good		Excellent	
	(<=60)		(61 - 84)		(85 - 94)		(95 - 100)

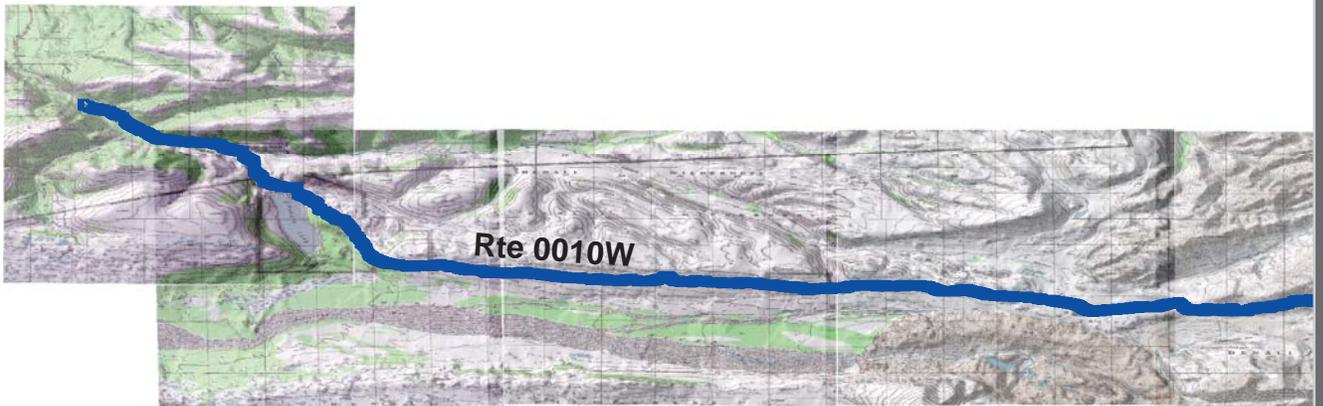
# Denali National Park and Preserve Route Condition Area Map 1 PCR - Mile by Mile

PCR    Poor

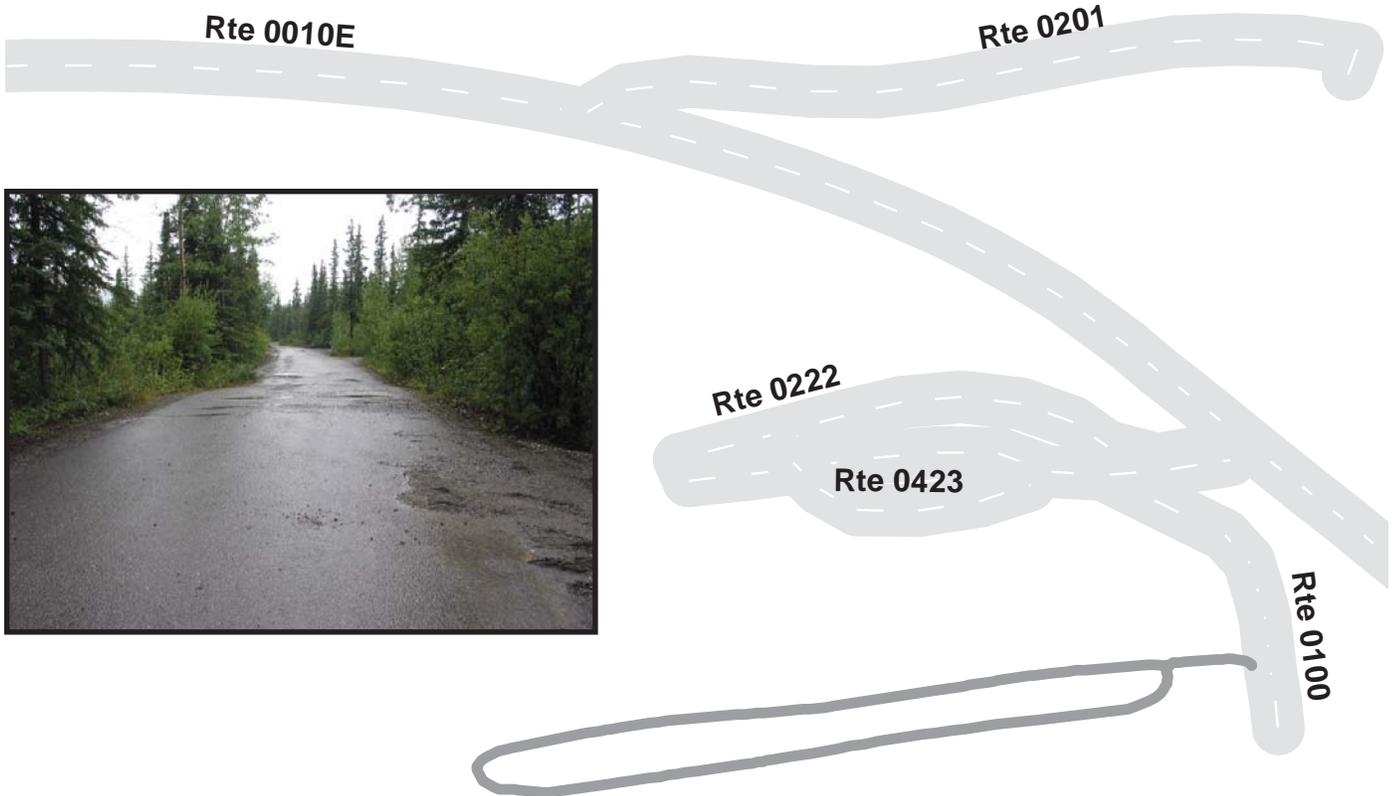
## Route 0200B

Route	Length (mi)	Width (ft)	Area (sq ft)	Lane Miles *	Condition / PCR	Surface Type
0200B	0.52	12.00	33137	0.57	FAIR / 73	AS

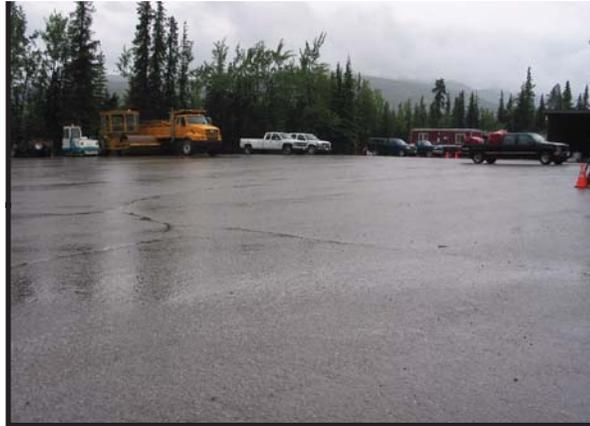
Route	Public / NonPublic	Date Visited	Area (sq ft)	Lane Miles *	Surface Type	Condition / PCR
0933	NonPublic	8/16/2002	38180	0.66	AS	N/A

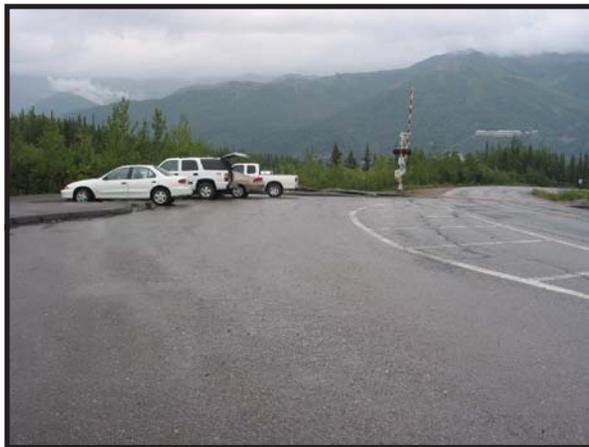
## Route 0957

Route	Public / NonPublic	Date Visited	Area (sq ft)	Lane Miles *	Surface Type	Condition / PCR
0957	Public	8/16/2002	5927	0.10	AS	N/A

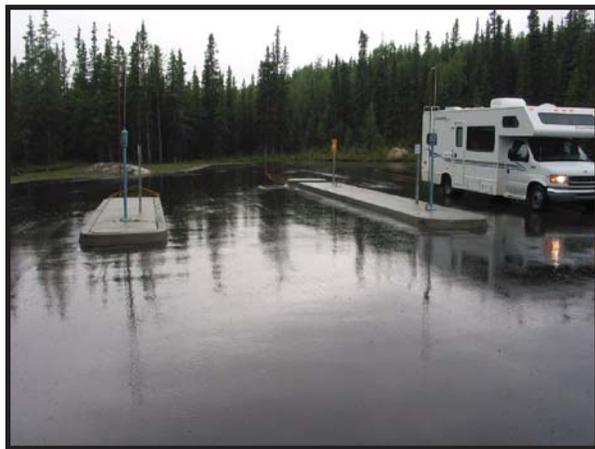
## Route 0971

Route	Public / NonPublic	Date Visited	Area (sq ft)	Lane Miles *	Surface Type	Condition / PCR
0971	Public	8/16/2002	10968	0.19	AS	N/A

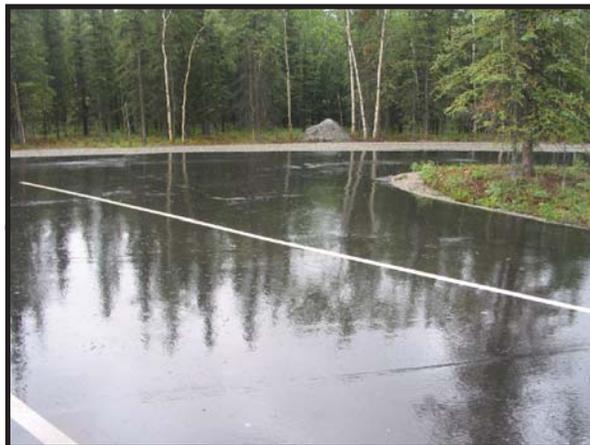
## Route 0972

Route	Public / NonPublic	Date Visited	Area (sq ft)	Lane Miles *	Surface Type	Condition / PCR
0972	Public	8/16/2002	22245	0.38	AS	N/A
