The Road Inventory of De Soto National Memorial DESO - 5300

Road Inventory Program

Prepared By:
Federal Highway Administration
Eastern Federal Lands Highway Division
Cycle 3

De Soto National Memorial in Florida

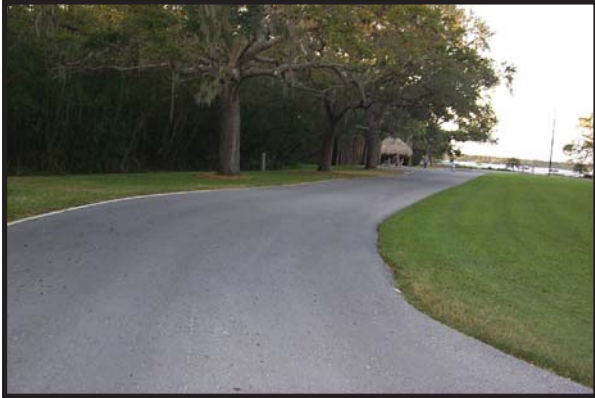
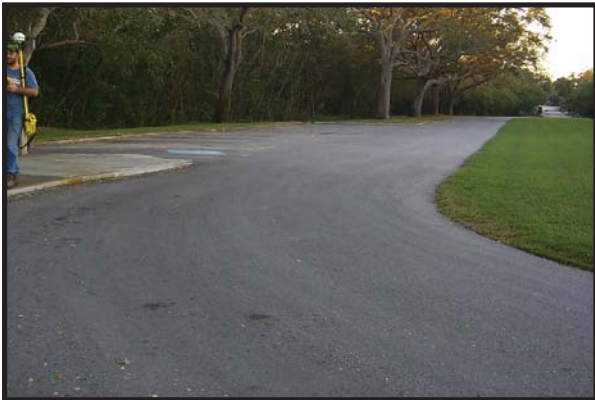
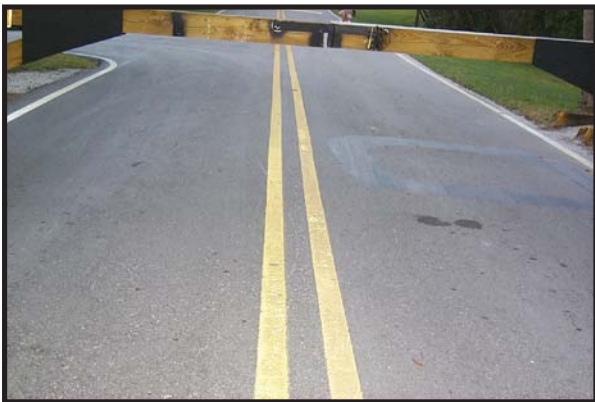
De Soto National Memorial
Route 0900
 VISITOR CENTER PARKING
 From 75TH Street NW at Park Boundary

Route	Public / NonPublic	Date Visited	Area (sq ft)	Lane Miles *	Surface Type	Condition / PCR
0900	Public	2/1/2002	29136	0.50	AS	GOOD / 90
