# The Road Inventory of Devils Tower National Monument DETO - 1390

## Road Inventory Program

Prepared By:  
Federal Highway Administration  
Eastern Federal Lands Highway Division  
Cycle 3

# Devils Tower National Monument in Wyoming

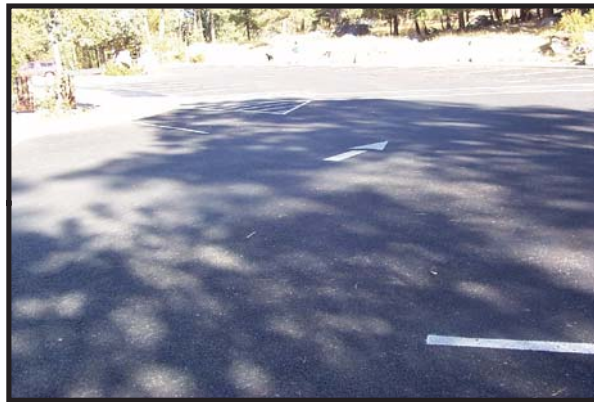
## Route 0902

Route	Public / NonPublic	Date Visited	Area (sq ft)	Lane Miles *	Surface Type	Condition / PCR
0902	Public	10/15/2001	42098	0.72	AS	EXCELLENT / 97

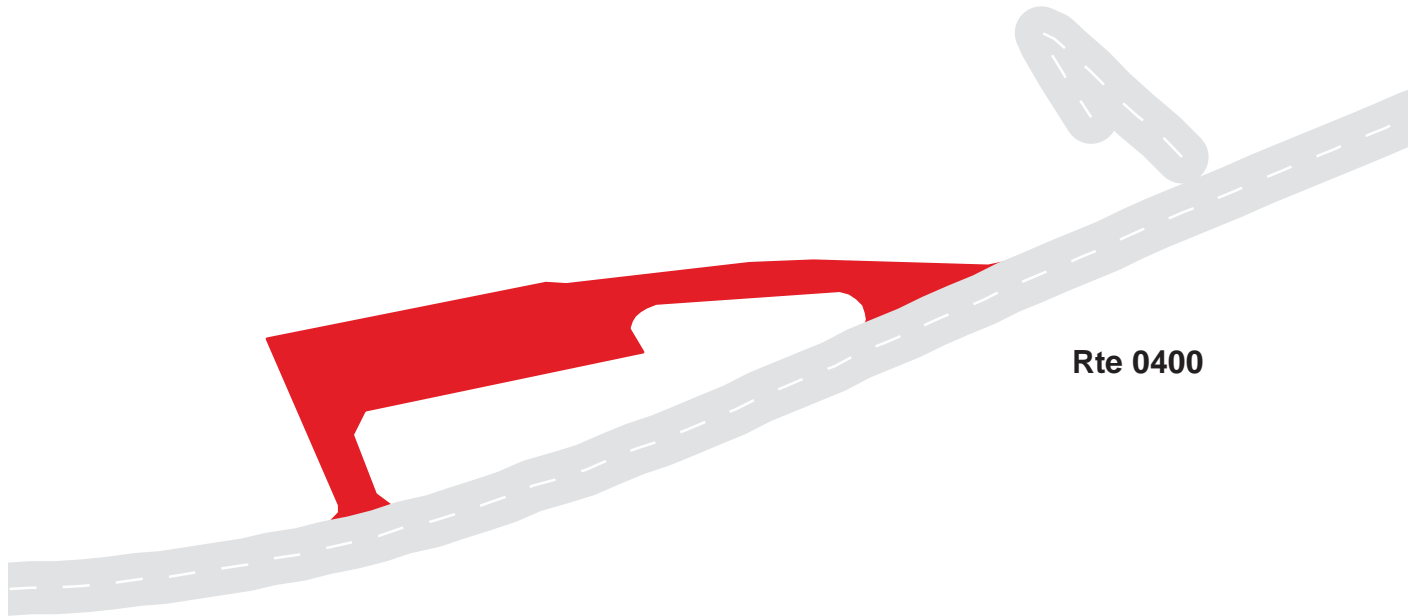
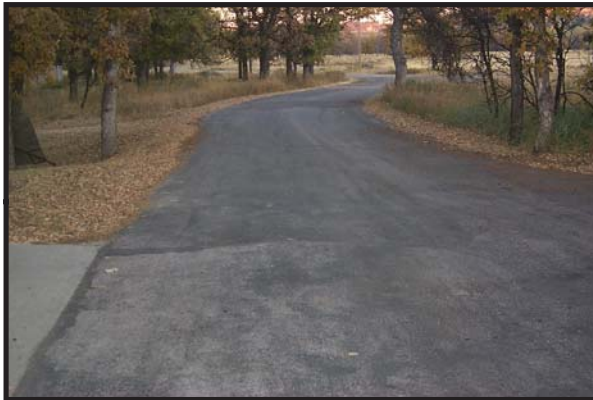
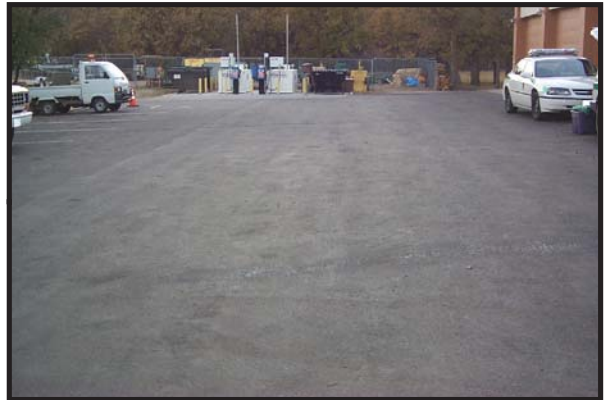
## Route 0905

Route	Public / NonPublic	Date Visited	Area (sq ft)	Lane Miles *	Surface Type	Condition / PCR
0905	NonPublic	10/15/2001	16166	0.28	AS	GOOD / 90

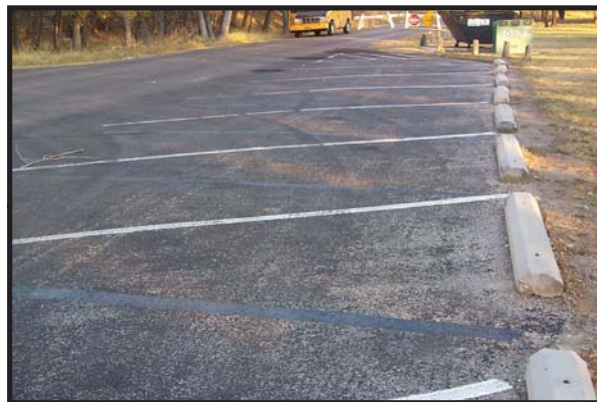
## Route 0907A

Route	Public / NonPublic	Date Visited	Area (sq ft)	Lane Miles *	Surface Type	Condition / PCR
0907A	Public	10/15/2001	3519	0.06	AS	FAIR / 73

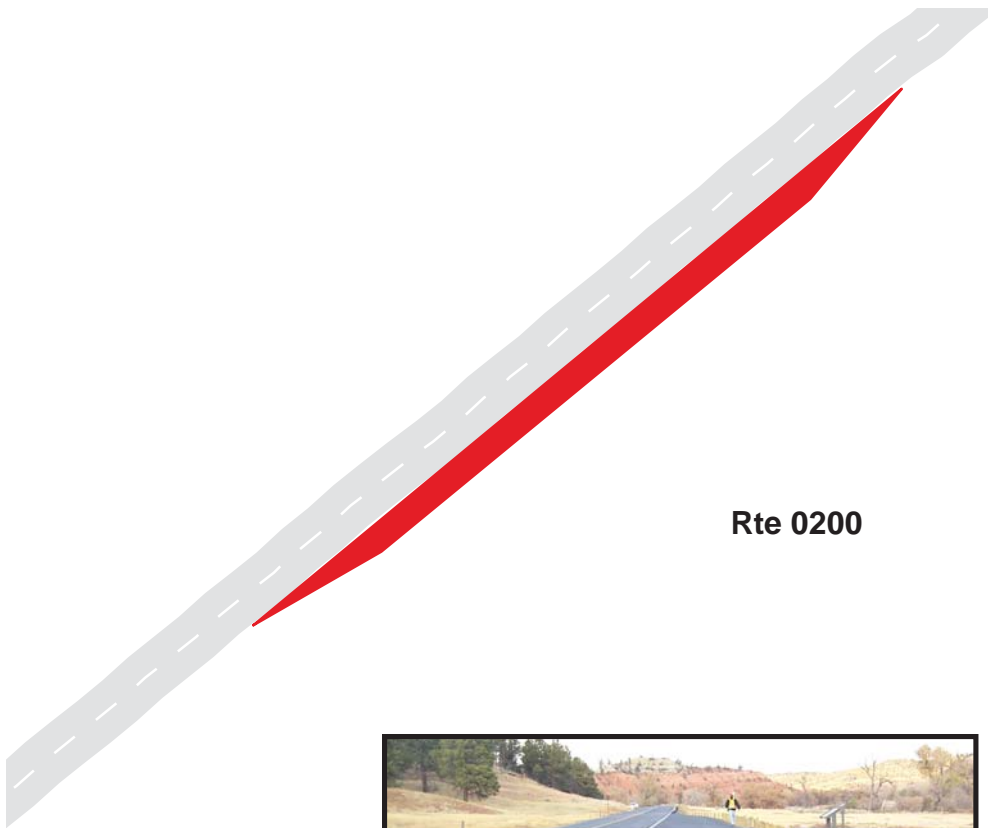
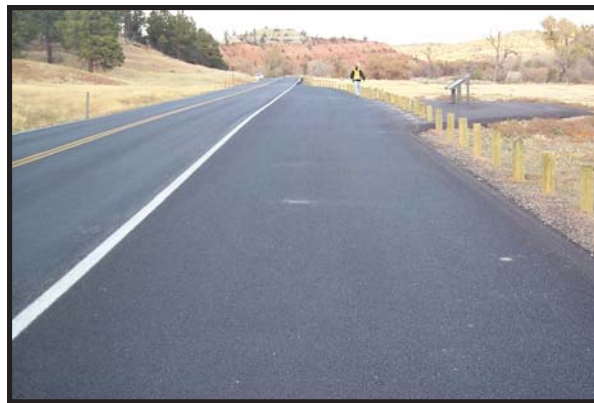
## Route 0908A

Route	Public / NonPublic	Date Visited	Area (sq ft)	Lane Miles *	Surface Type	Condition / PCR
0908A	Public	10/18/2001	3741	0.06	AS	EXCELLENT / 97

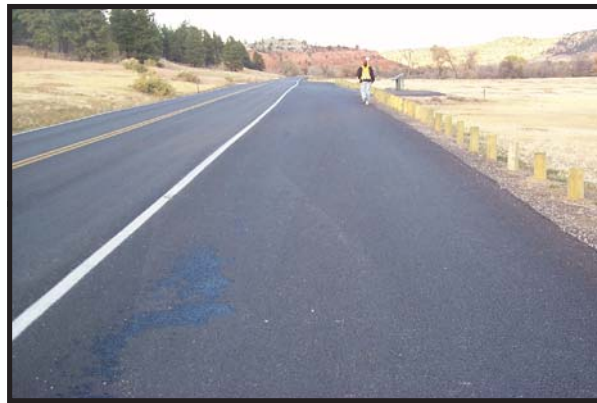
## Route 0908B

Route	Public / NonPublic	Date Visited	Area (sq ft)	Lane Miles *	Surface Type	Condition / PCR
0908B	Public	10/18/2001	5073	0.09	AS	EXCELLENT / 97

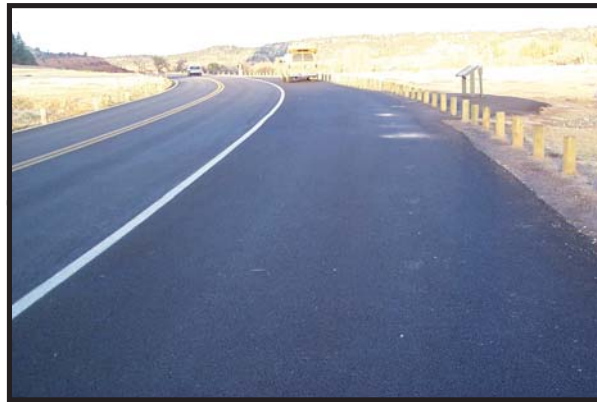
## Route 0908C

Route	Public / NonPublic	Date Visited	Area (sq ft)	Lane Miles *	Surface Type	Condition / PCR
0908C	Public	10/18/2001	4796	0.08	AS	EXCELLENT / 97

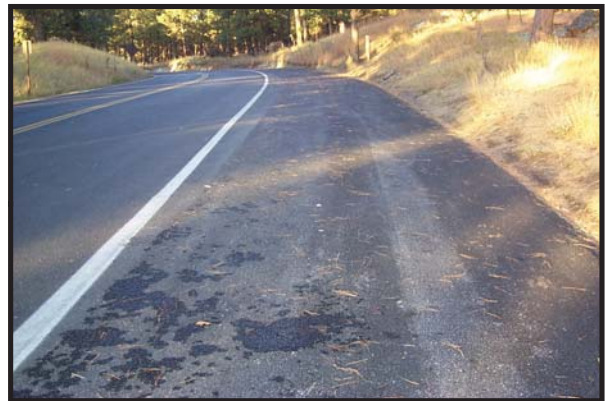
## Route 0909

Route	Public / NonPublic	Date Visited	Area (sq ft)	Lane Miles *	Surface Type	Condition / PCR
0909	Public	10/18/2001	7088	0.12	AS	EXCELLENT / 97
