# The Road Inventory of Death Valley National Park DEVA - 8130

## Road Inventory Program

Prepared By:  
Federal Highway Administration  
Eastern Federal Lands Highway Division  
Cycle 3

# Death Valley National Park in California

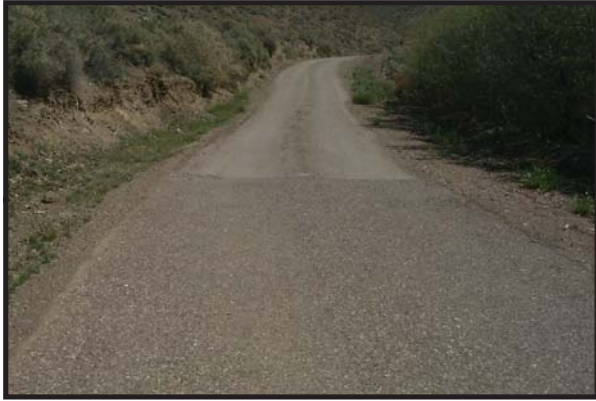
Route	Length (mi)	Width (ft)	Area (sq ft)	Lane Miles *	Condition / PCR	Surface Type
0116	0.09	0.00	5554	0.10	FAIR / 73	AS

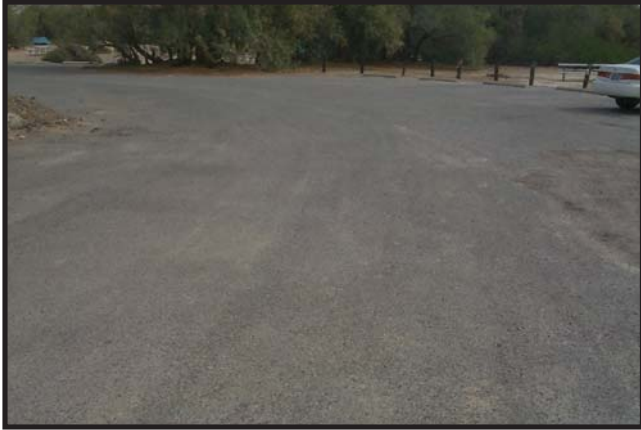
## Route 0201

Route	Length (mi)	Width (ft)	Area (sq ft)	Lane Miles *	Condition / PCR	Surface Type
0201	0.64	0.00	153707	2.65	FAIR / 73	AS

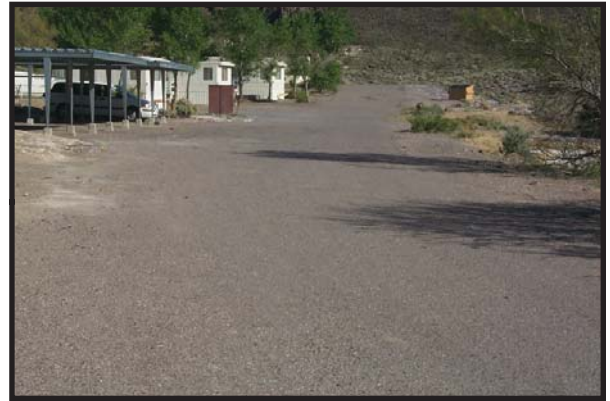
## Route 0409

Route	Length (mi)	Width (ft)	Area (sq ft)	Lane Miles *	Condition / PCR	Surface Type
0409	0.11	0.00	12453	0.21	GOOD / 90	AS

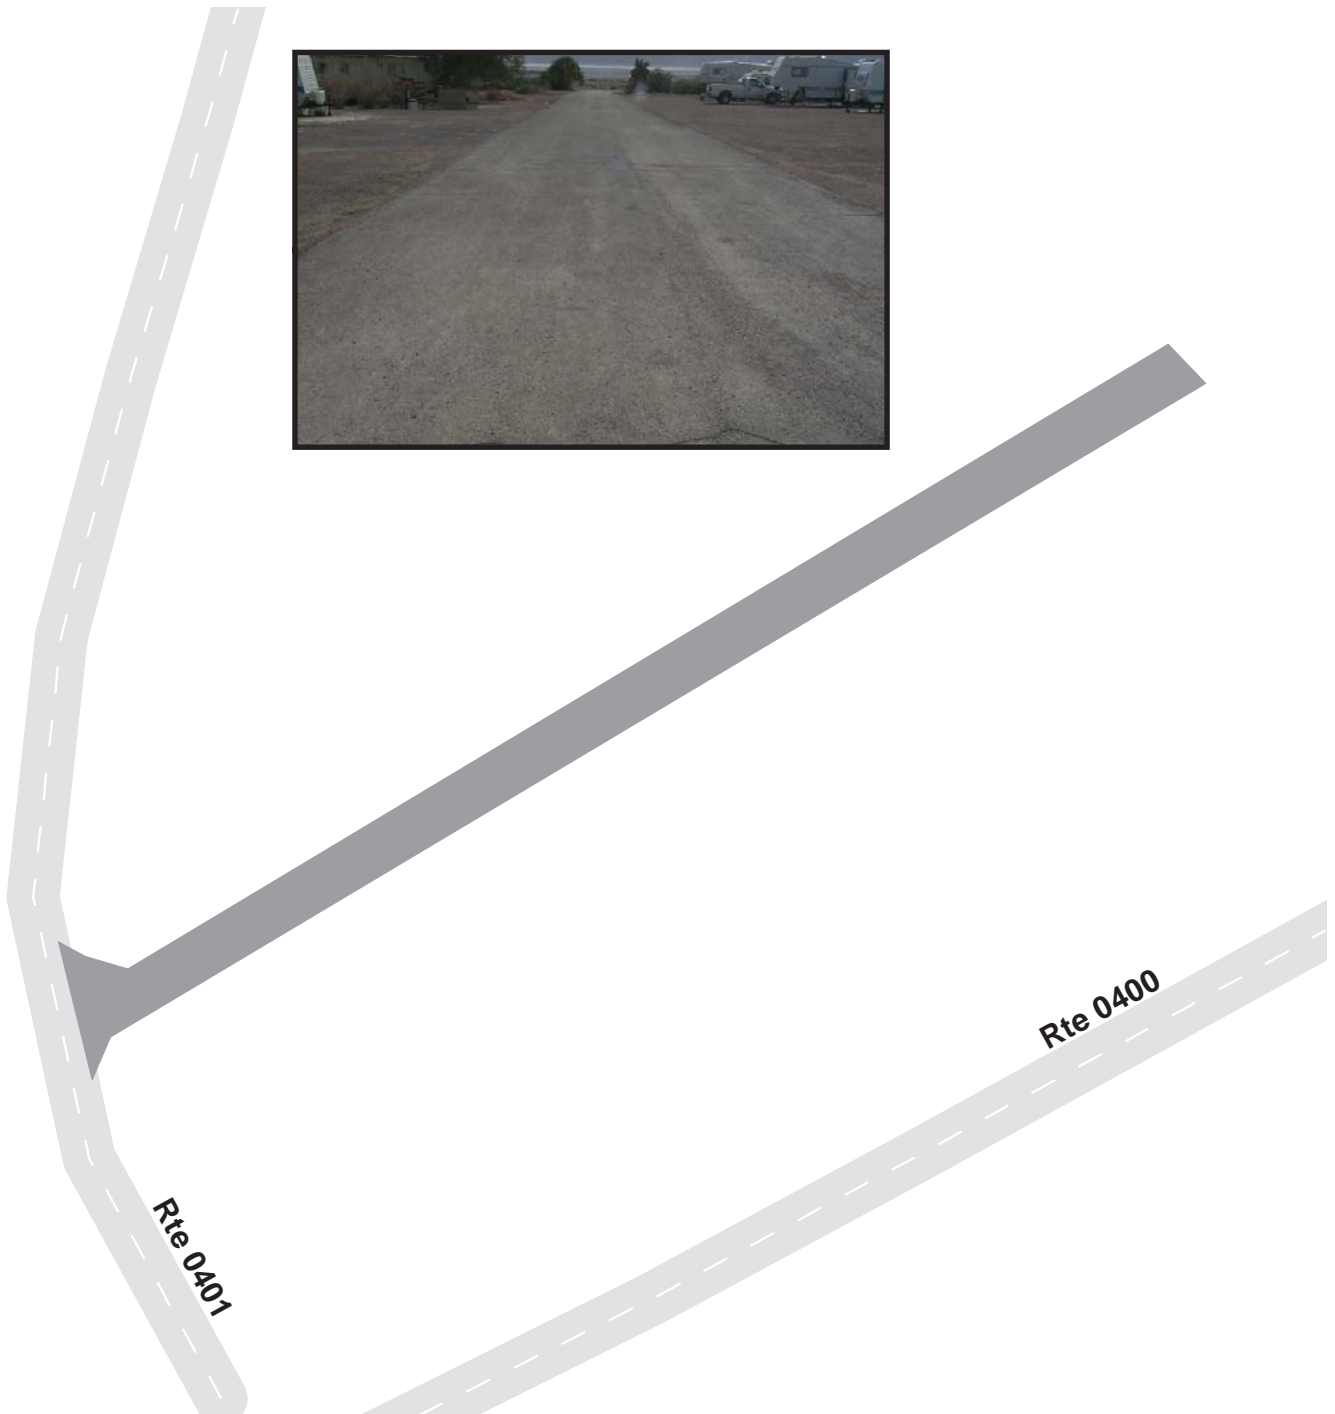
**Death Valley National Park**  
**Route 0415**  
 Sims Circle Rv Park  
 From Route 0401 MP 0.04 on the Right

Route	Length (mi)	Width (ft)	Area (sq ft)	Lane Miles *	Condition / PCR	Surface Type
0415	0.09	0.00	8763	0.15	FAIR / 73	AS

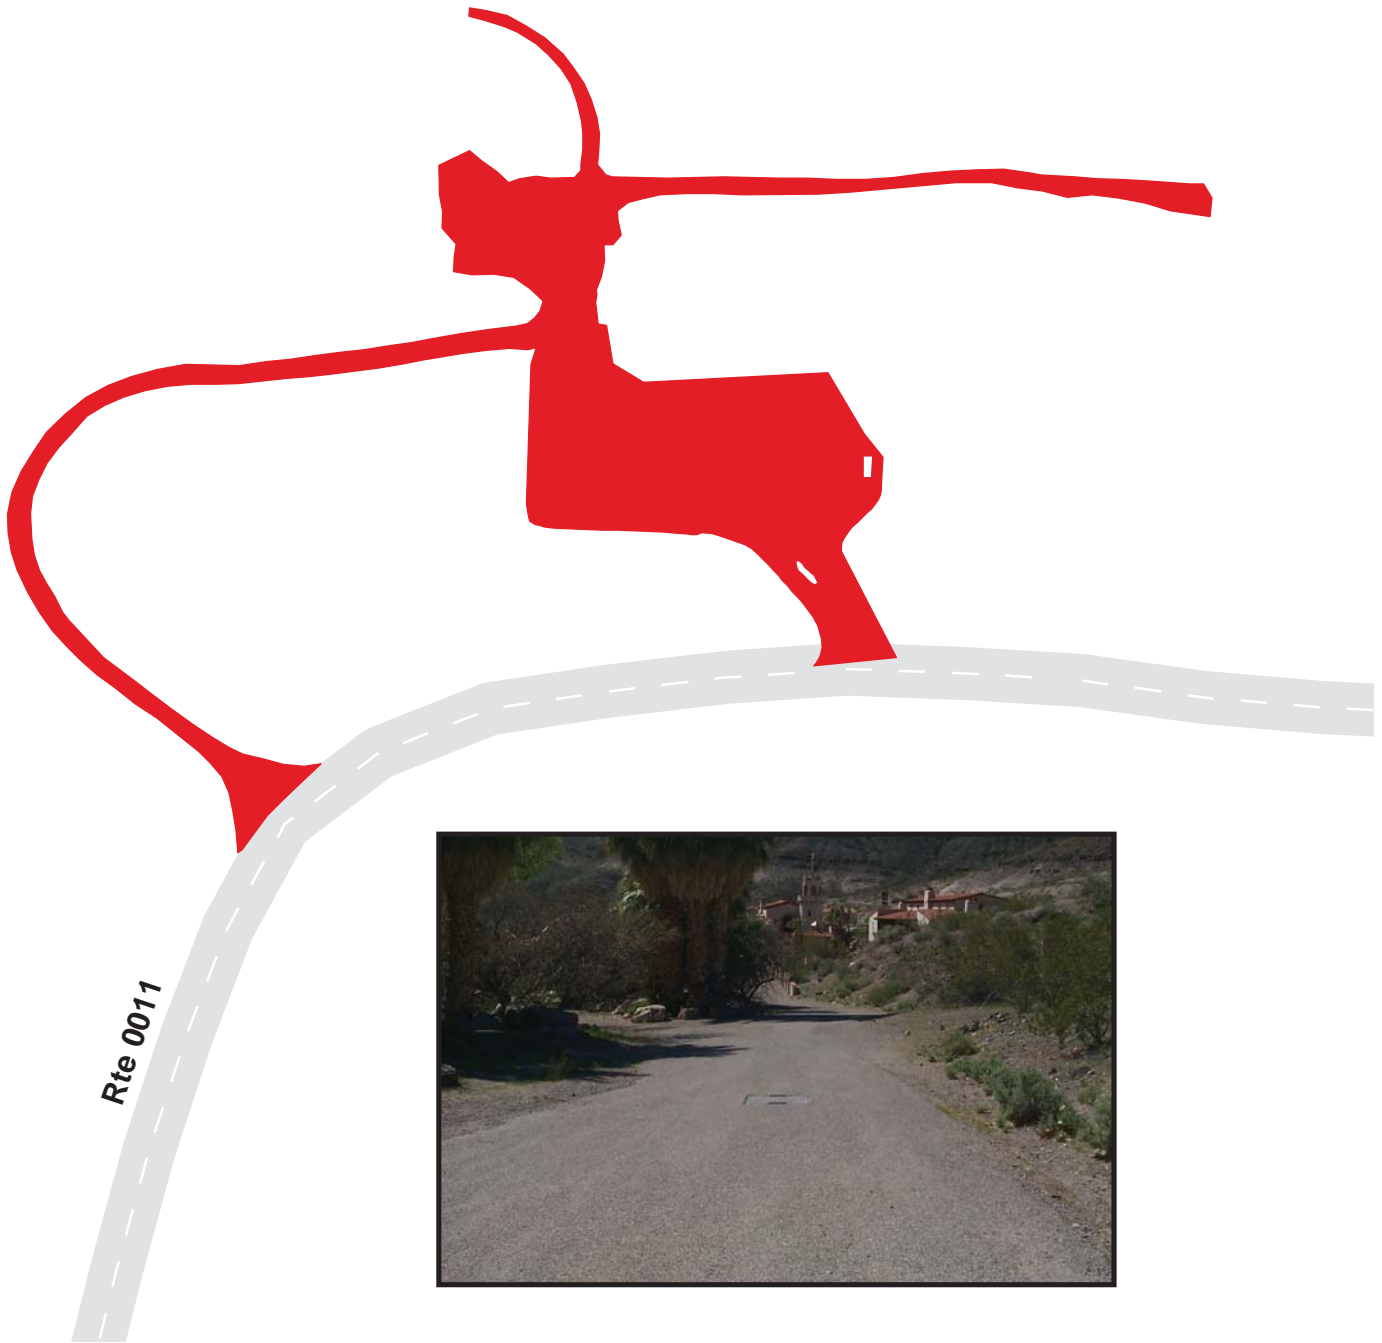
## Route 0900

Route	Public / NonPublic	Date Visited	Area (sq ft)	Lane Miles *	Surface Type	Condition / PCR
0900	PUBLIC	4/3/2001	93064	1.60	AS	GOOD / 90

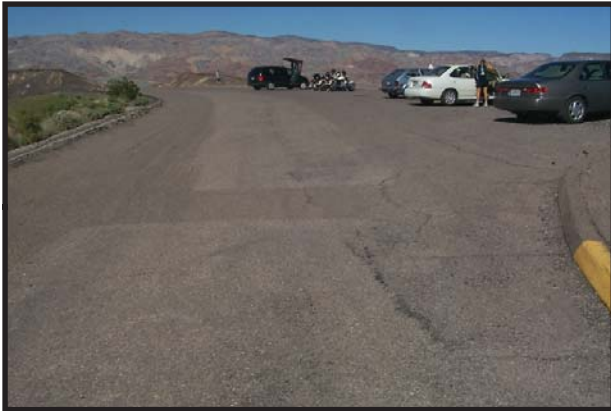
## Route 0901

Route	Public / NonPublic	Date Visited	Area (sq ft)	Lane Miles *	Surface Type	Condition / PCR
0901	Public	4/3/2001	8713	0.15	OC	FAIR / 73

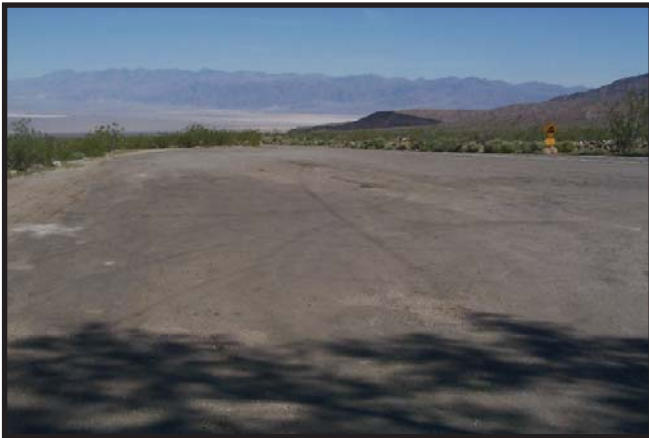
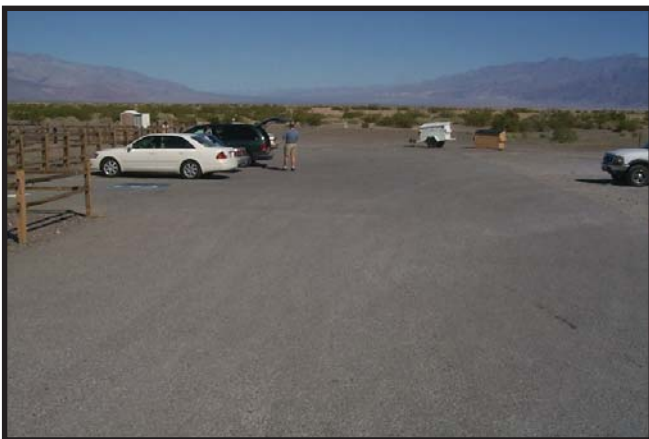
## Route 0903

Route	Public / NonPublic	Date Visited	Area (sq ft)	Lane Miles *	Surface Type	Condition / PCR
0903	Public	4/3/2001	23678	0.41	AS	FAIR / 73

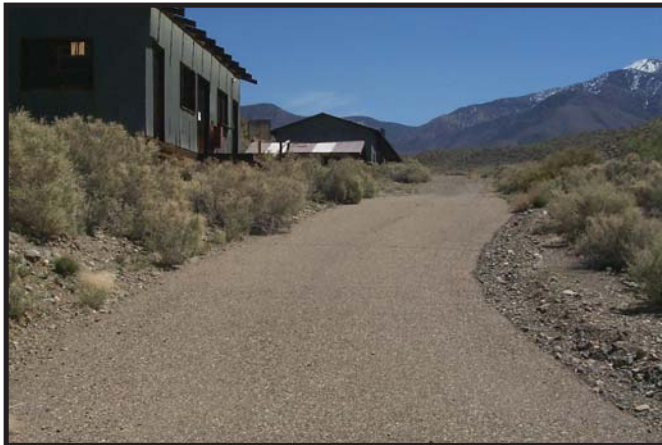
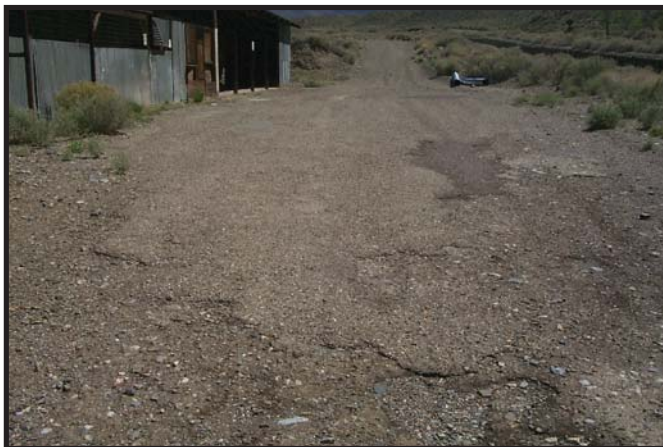
## Route 0906

Route	Public / NonPublic	Date Visited	Area (sq ft)	Lane Miles *	Surface Type	Condition / PCR
0906	NonPublic	4/3/2001	7945	0.14	AS	POOR / 45

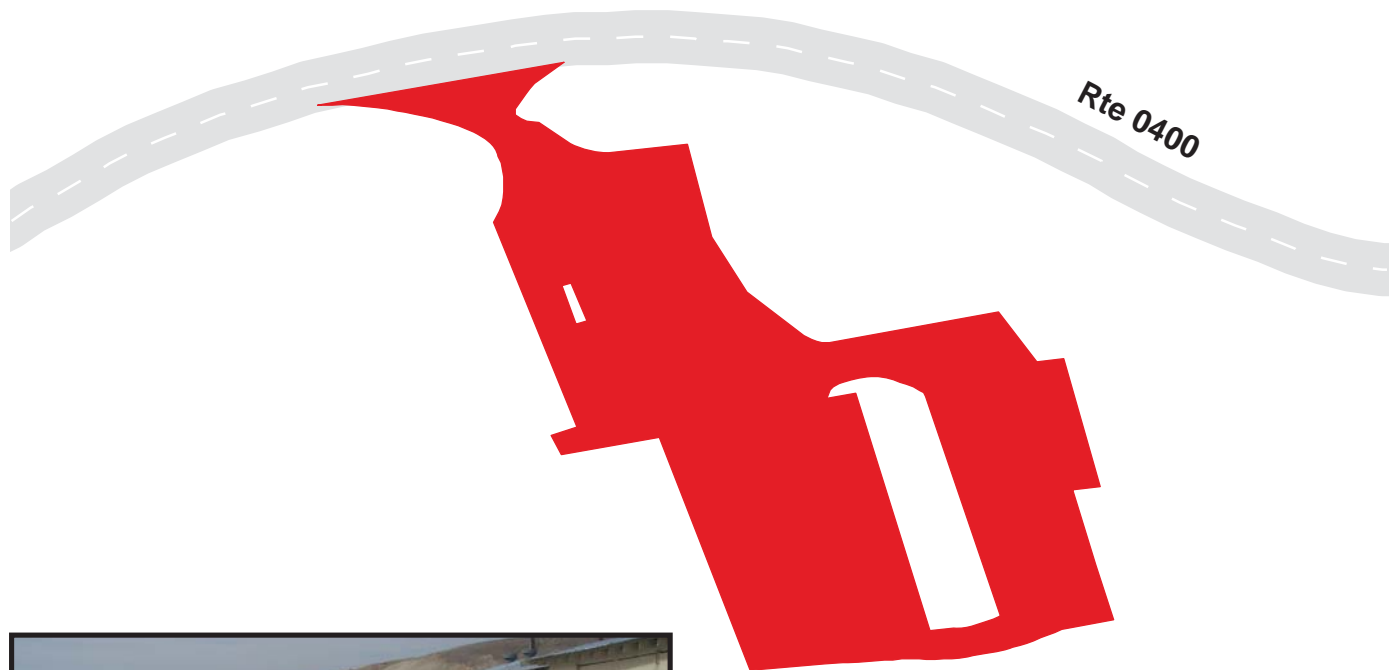
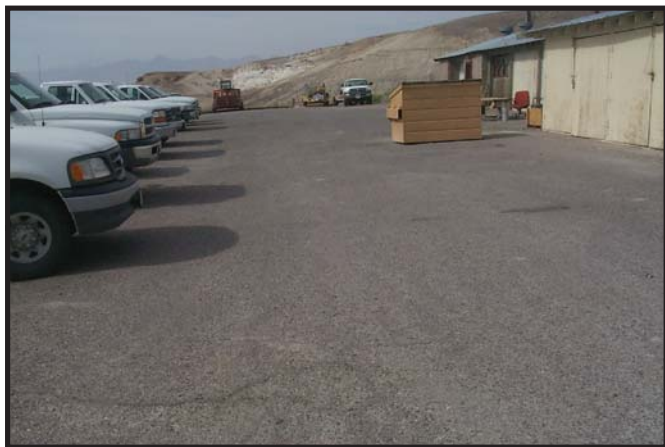
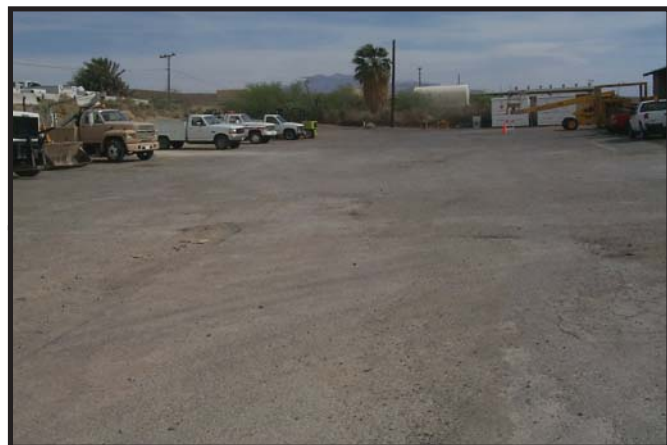
## Route 0910

Route	Public / NonPublic	Date Visited	Area (sq ft)	Lane Miles *	Surface Type	Condition / PCR
0910	NonPublic	4/3/2001	49800	0.86	AS	FAIR / 73

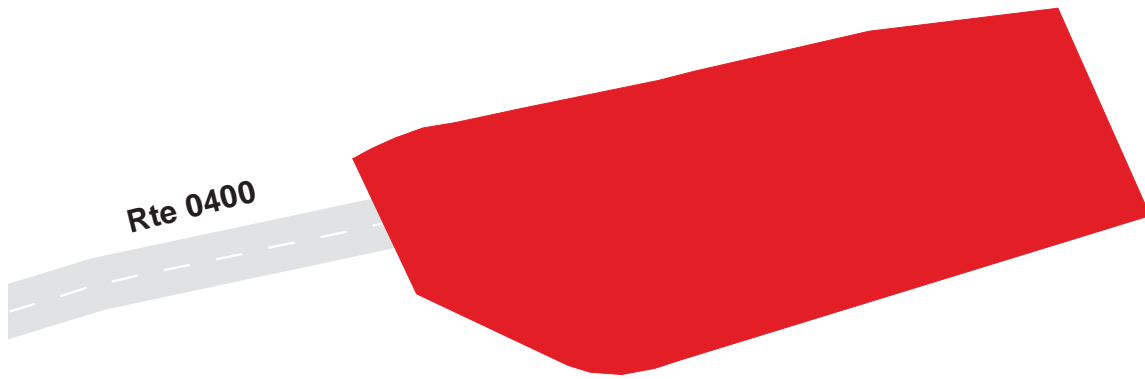
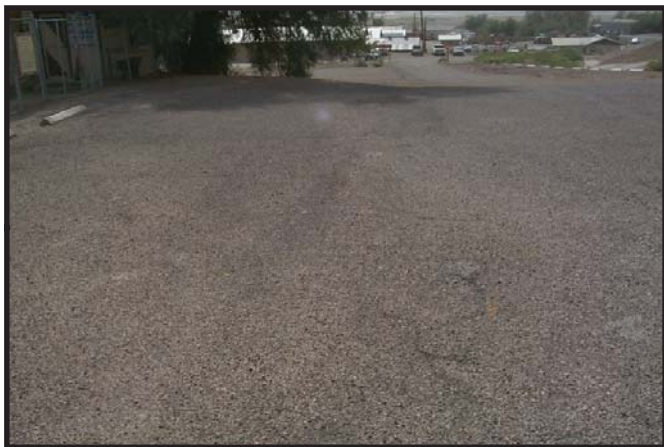
## Route 0911

Route	Public / NonPublic	Date Visited	Area (sq ft)	Lane Miles *	Surface Type	Condition / PCR
0911	NonPublic	3/31/2001	3026	0.05	AS	GOOD / 90

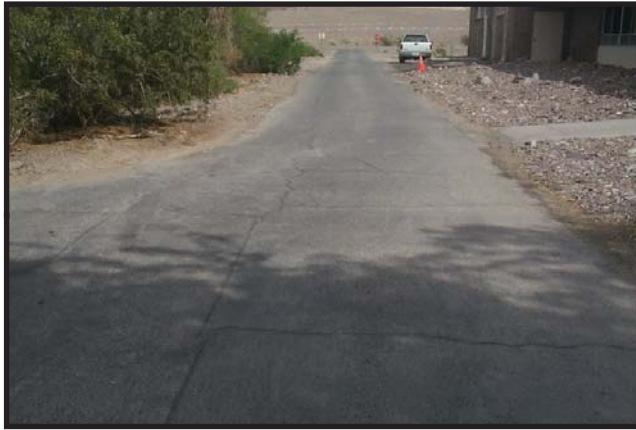
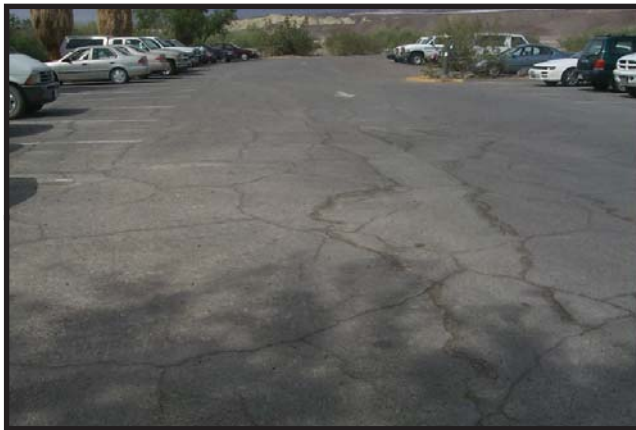
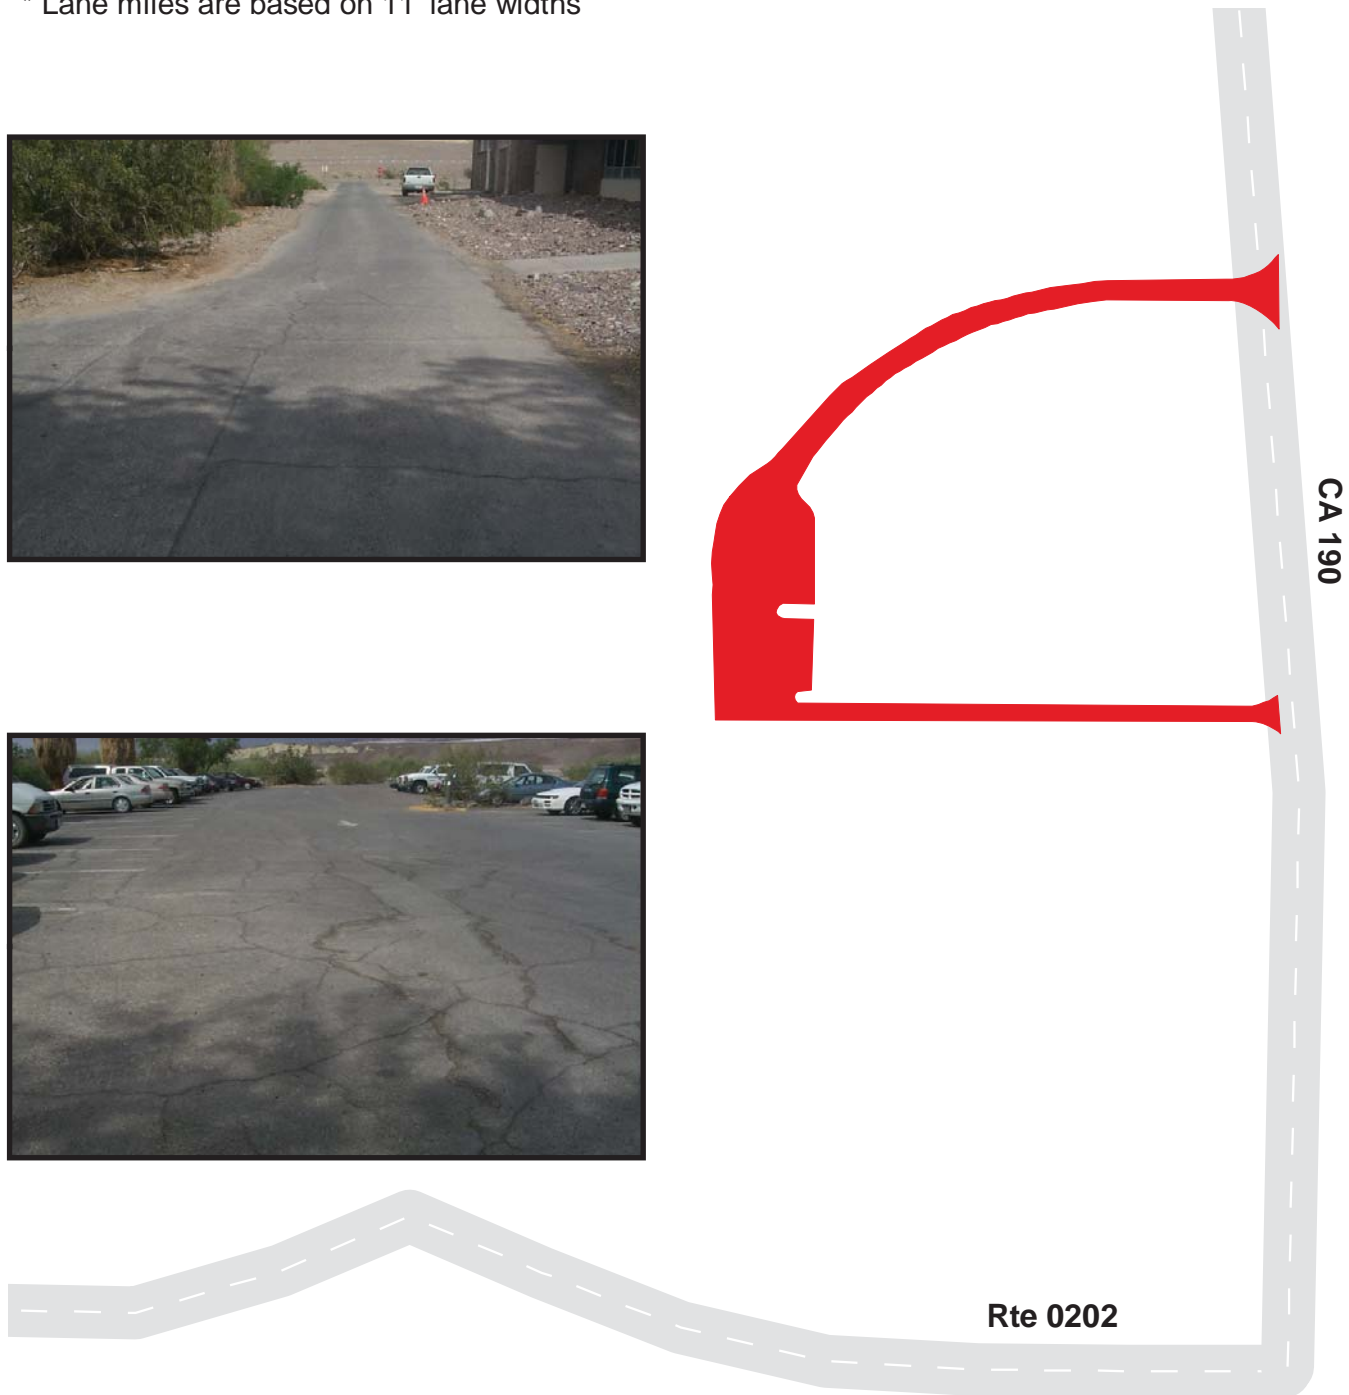
## Route 0912

Route	Public / NonPublic	Date Visited	Area (sq ft)	Lane Miles *	Surface Type	Condition / PCR
0912	NonPublic	4/3/2001	26464	0.46	AS	FAIR / 73

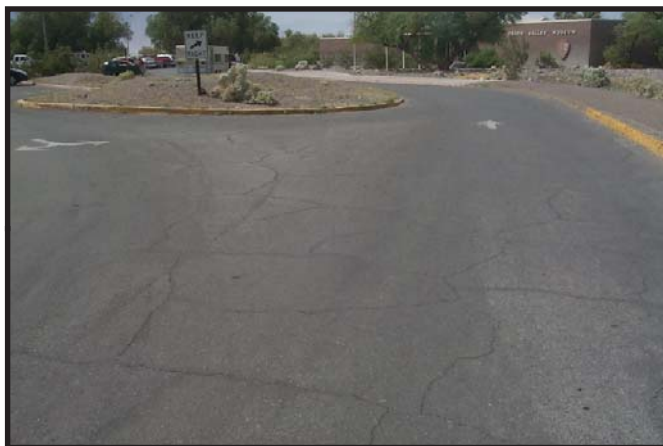
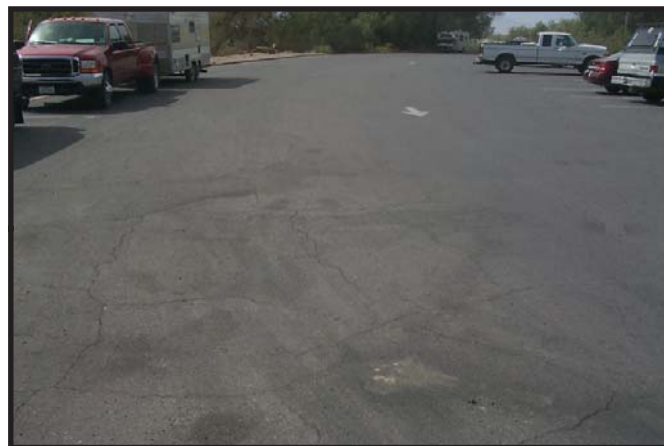
## Route 0913

Route	Public / NonPublic	Date Visited	Area (sq ft)	Lane Miles *	Surface Type	Condition / PCR
0913	Public	3/31/2001	51204	0.88	AS	FAIR / 73

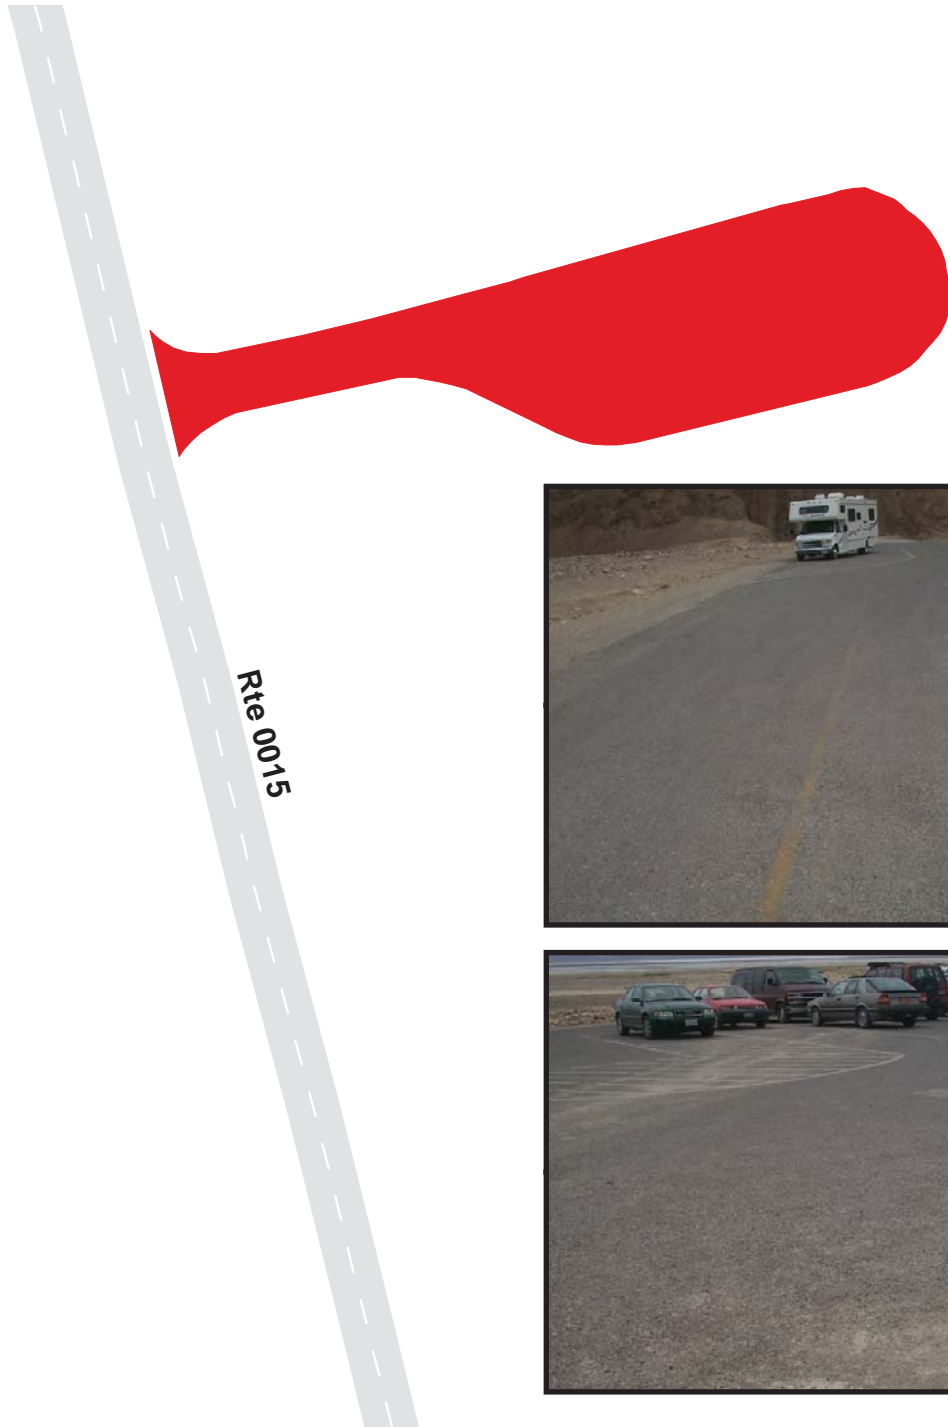
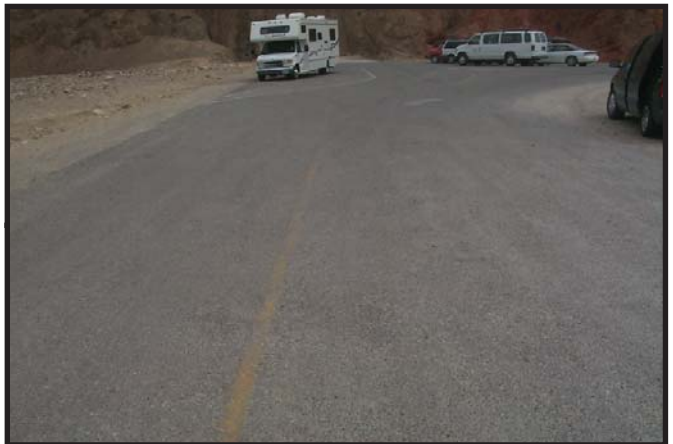
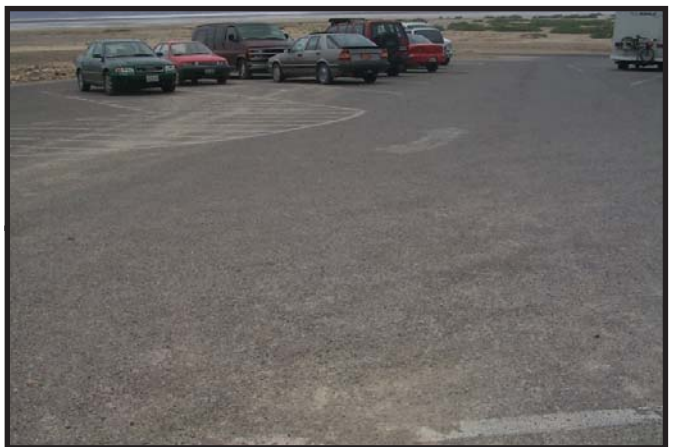
## Route 0915

Route	Public / NonPublic	Date Visited	Area (sq ft)	Lane Miles *	Surface Type	Condition / PCR
0915	Public	3/31/2001	19706	0.34	OC	GOOD / 90

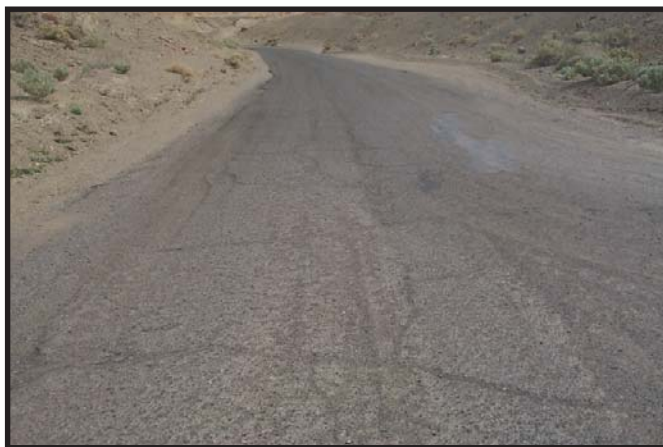
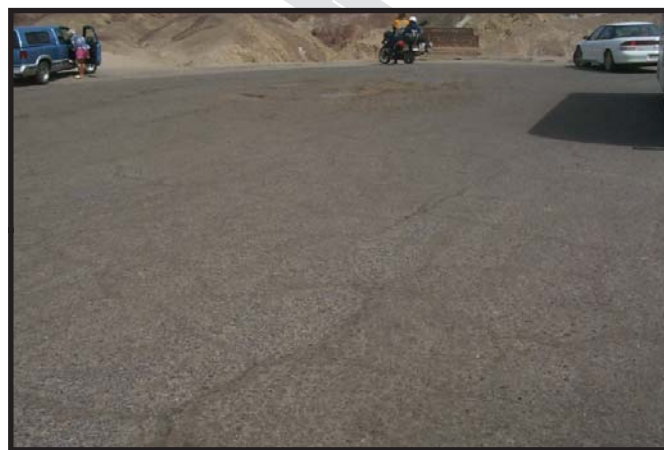
## Route 0927

Route	Public / NonPublic	Date Visited	Area (sq ft)	Lane Miles *	Surface Type	Condition / PCR
0927	Public	3/30/2001	22636	0.39	AS	POOR / 45
