**The Road Inventory
of
Delaware Water Gap National Recreation Area
DEWA - 4320**

Prepared By:
Federal Highway Administration
Eastern Federal Lands Highway Division
Cycle 3

Delaware Water Gap National Recreation Area in Pennsylvania

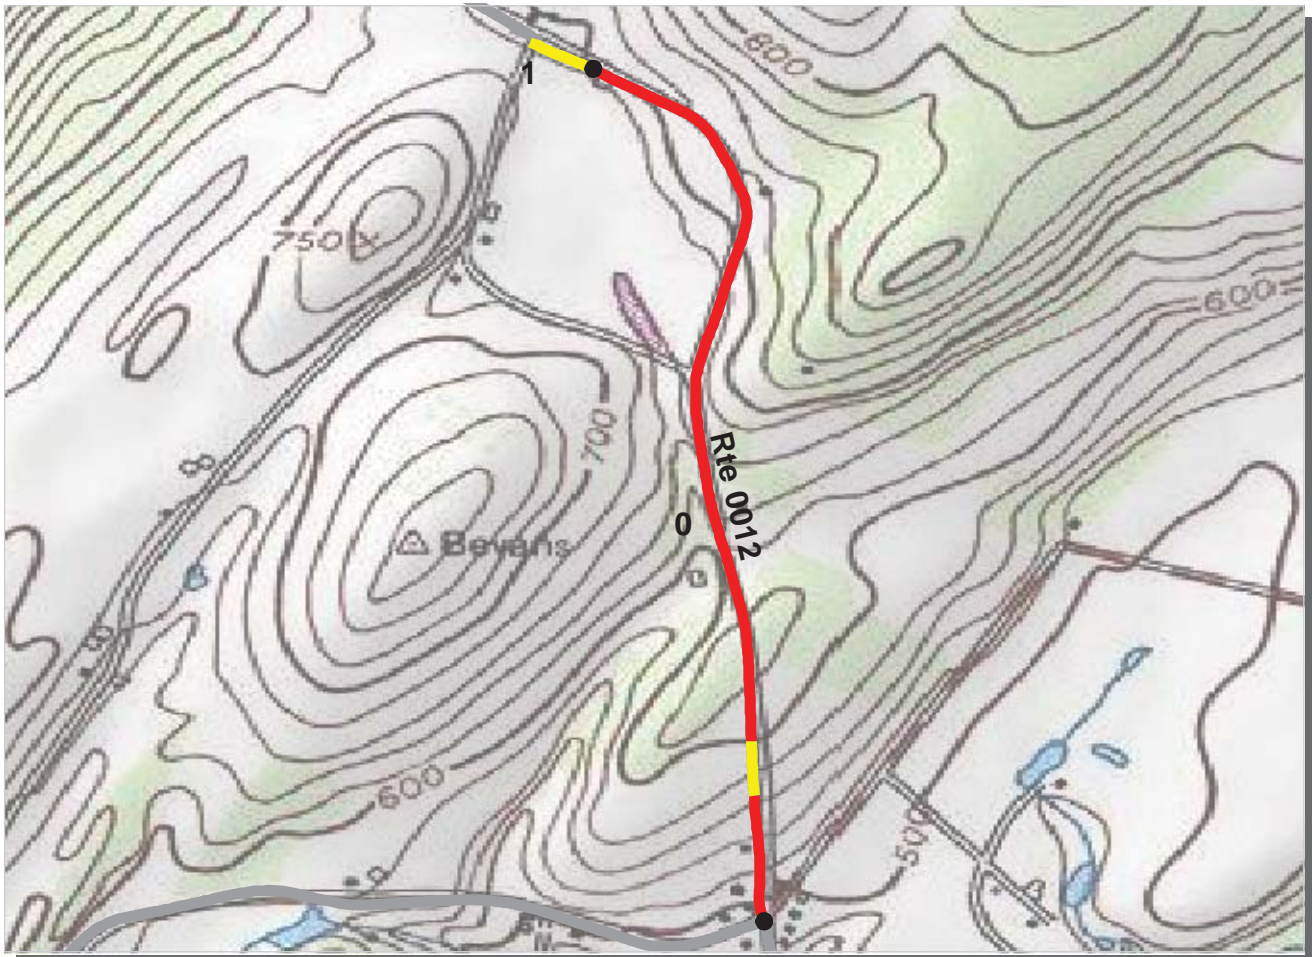
ROUTE: 0011 KUHN ROAD

Section Number	0				
Section Length (mi)	0.78				
AADT	**				
SADT	**				
ADT Date	**				
Cross Section Information					
Number of Lanes	2				
Paved Width (ft)	19				
Lane Width (ft)	10				
Shoulder Width (ft)	0				
Roadway Condition Information					
PCR (Pavement Condition Rating)	80				
RCI (Roughness Condition Index)	87				
SCR (Surface Condition Rating)	77				
Alligator Cracking Index	100				
Rutting Index	77				
Patching Index	100				
Transverse Cracking Index	99				
Longitudinal Cracking Index	99				
Shoulder Condition Rating	N/A				
Drainage Condition Rating	N/C

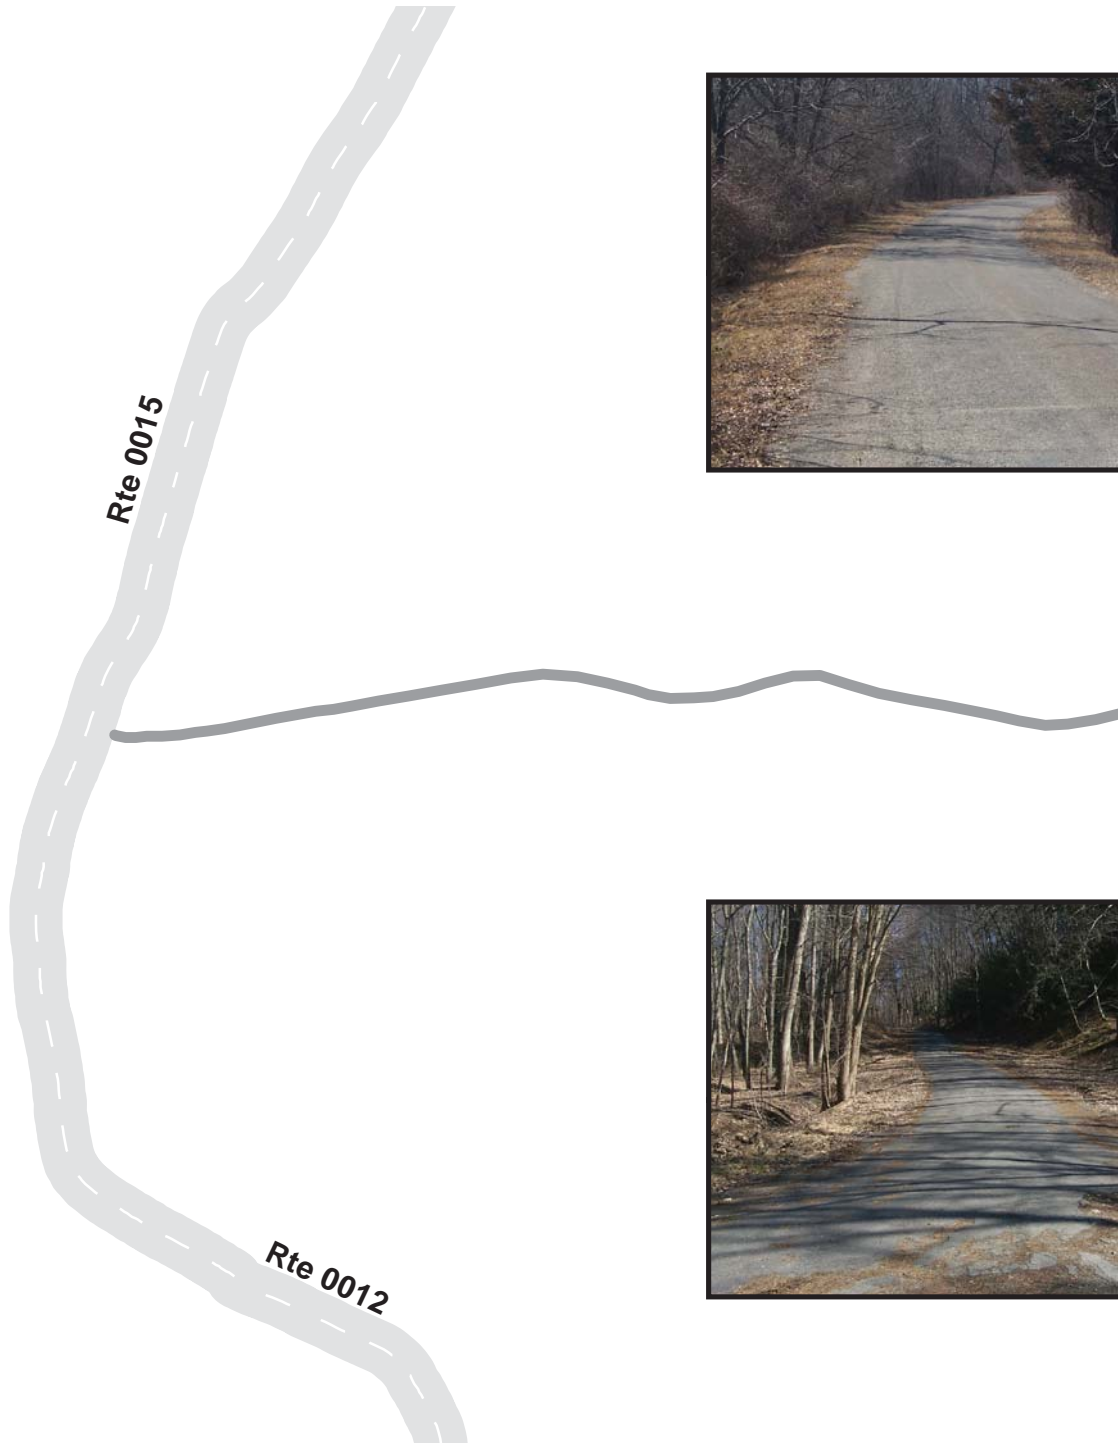
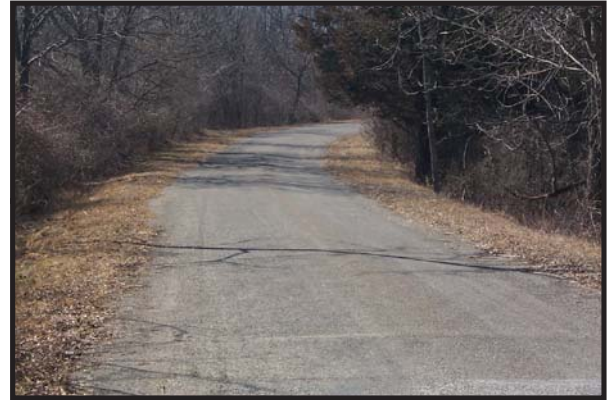
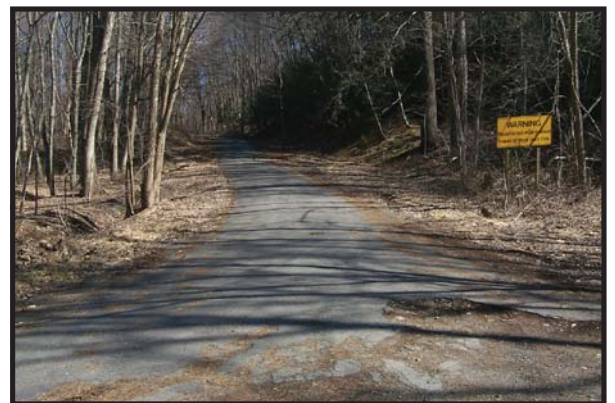
Route	Length (mi)	Width (ft)	Area (sq ft)	Lane Miles *	Condition / PCR	Surface Type
0103	0.87	15.00	68825	1.19	POOR / 45	AS

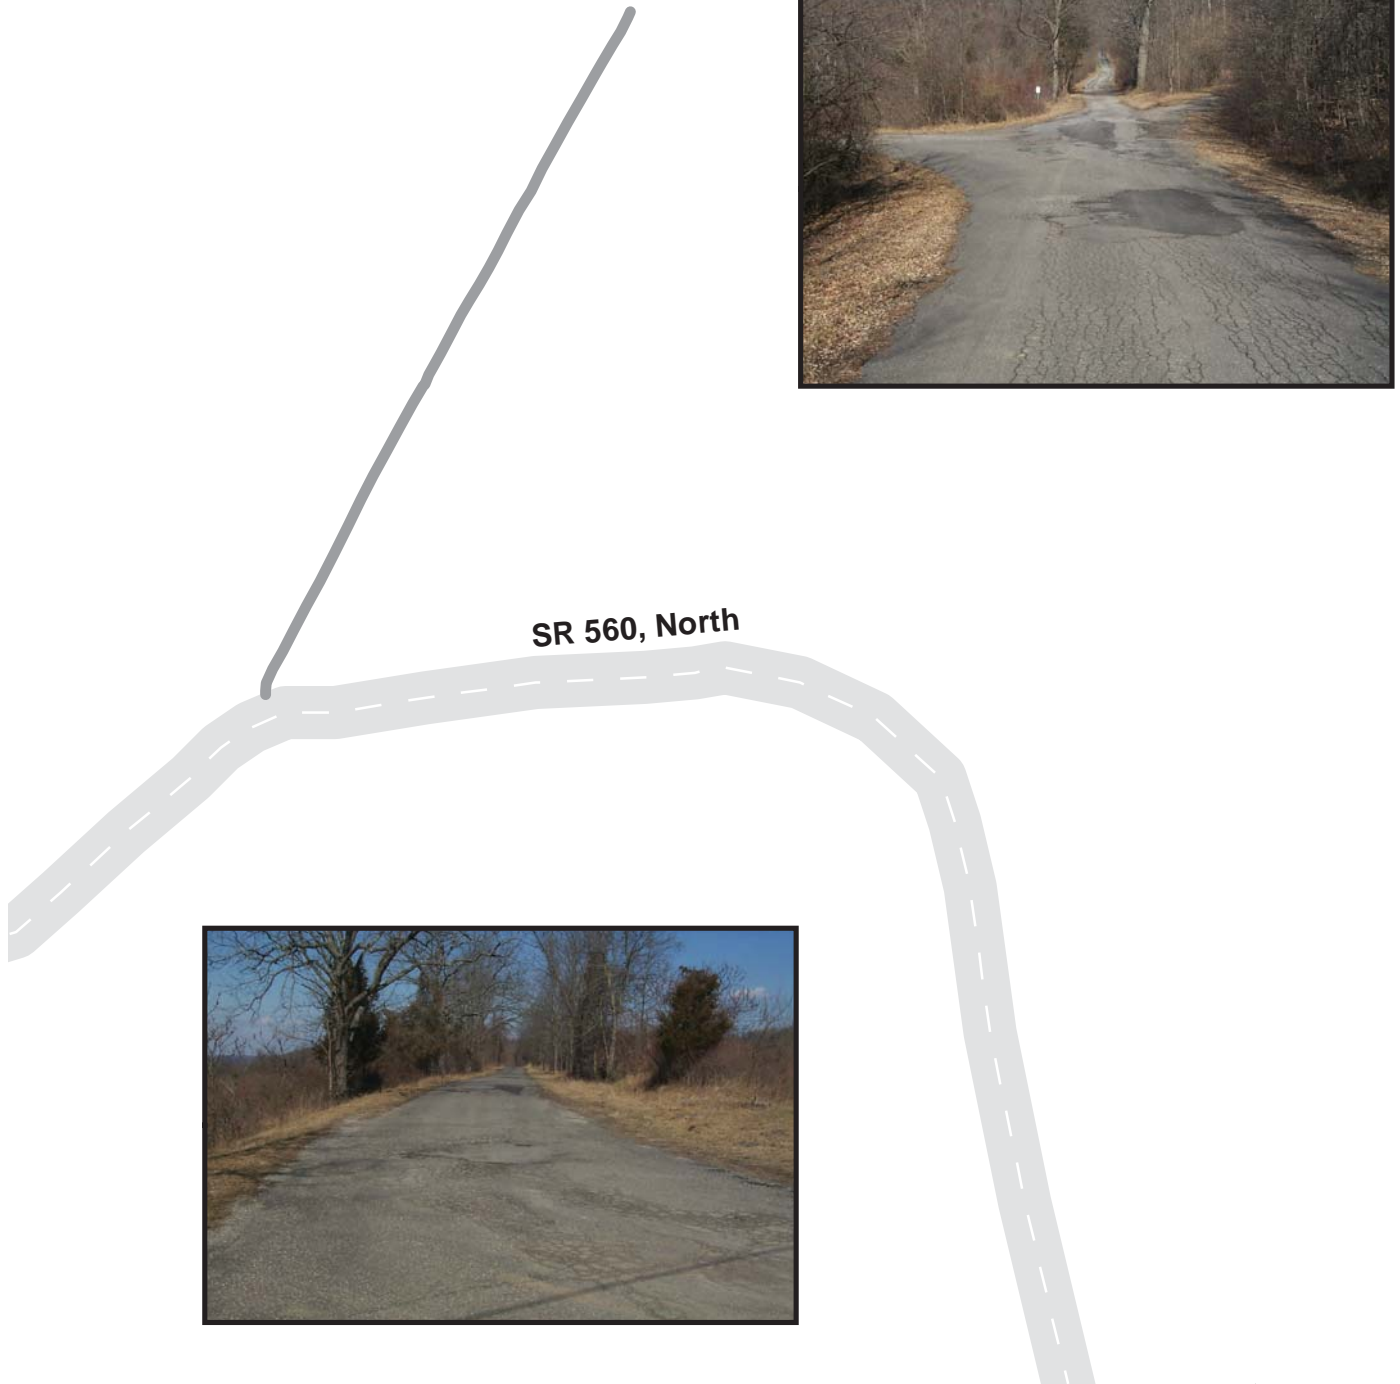
Route 0104

Route	Length (mi)	Width (ft)	Area (sq ft)	Lane Miles *	Condition / PCR	Surface Type
0104	0.72	18.00	68239	1.17	POOR / 45	AS

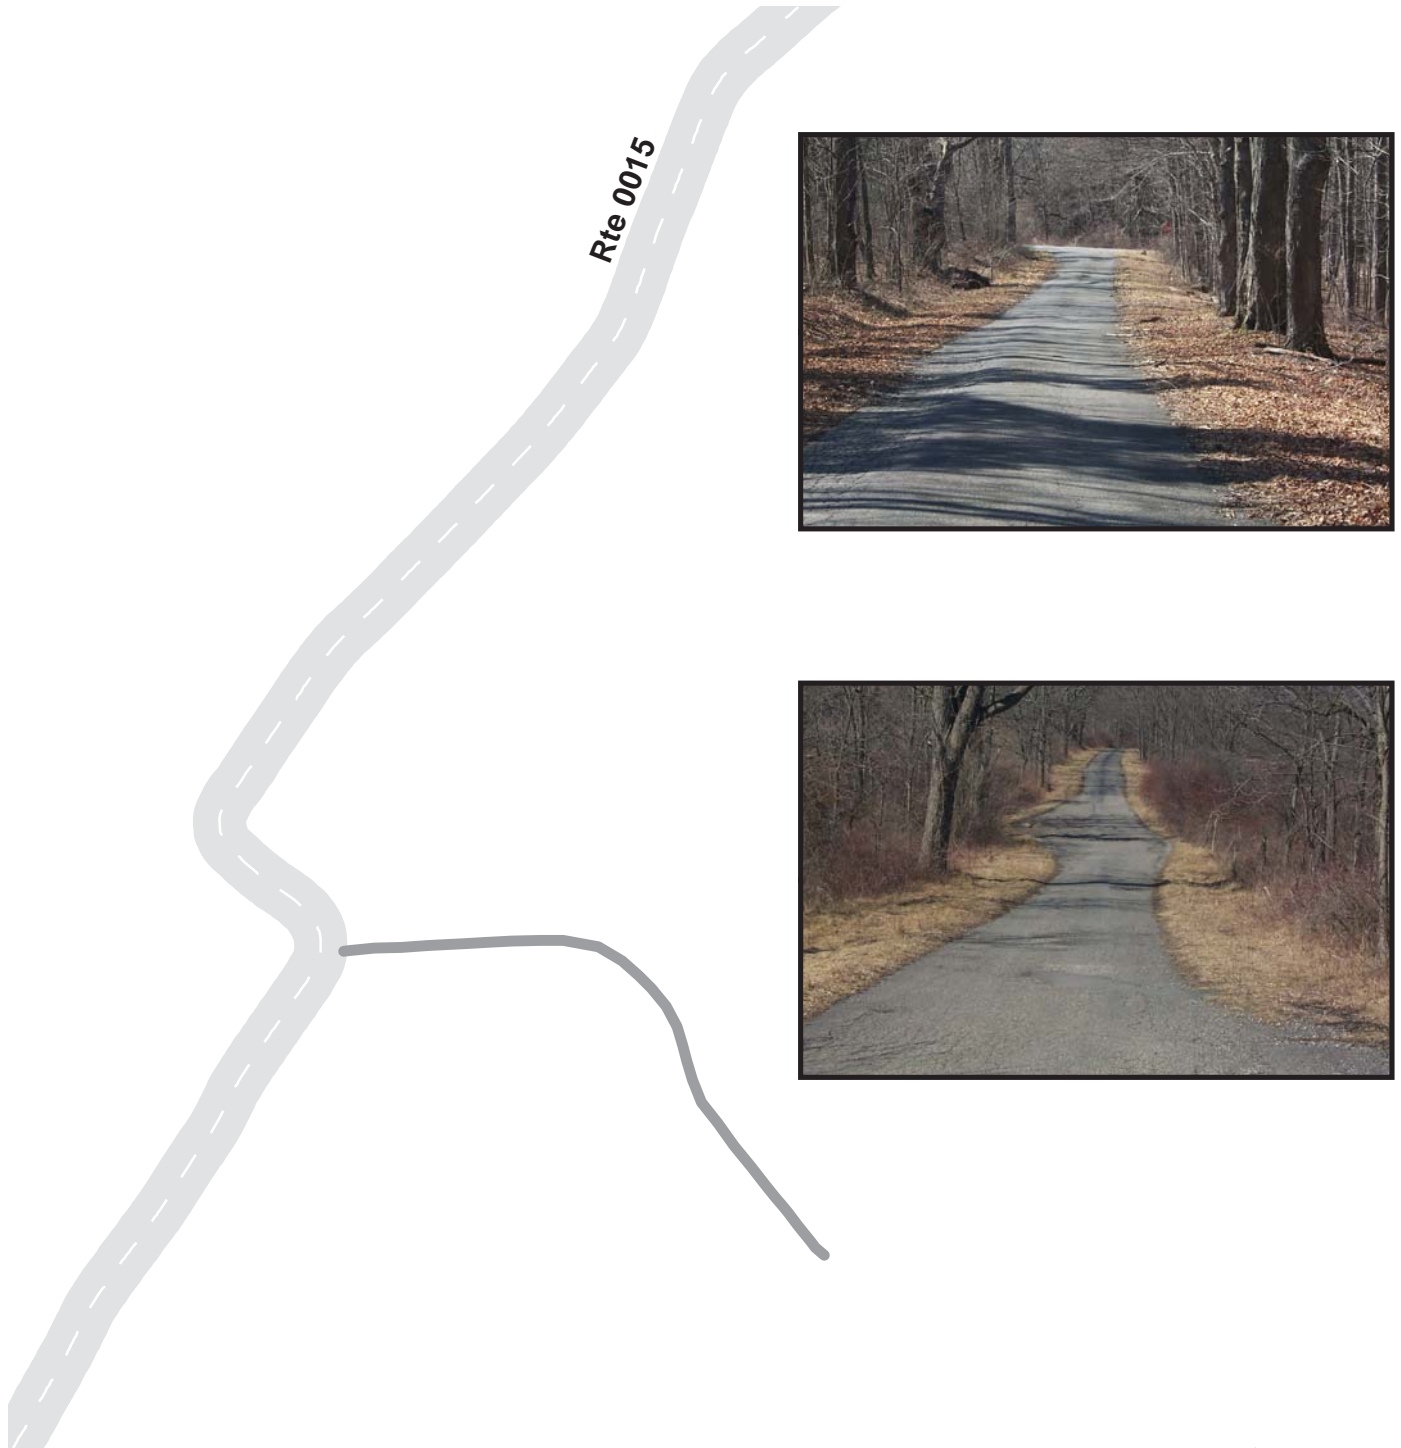
Route 0107

Route	Length (mi)	Width (ft)	Area (sq ft)	Lane Miles *	Condition / PCR	Surface Type
0107	0.54	12.00	34024	0.59	POOR / 45	AS

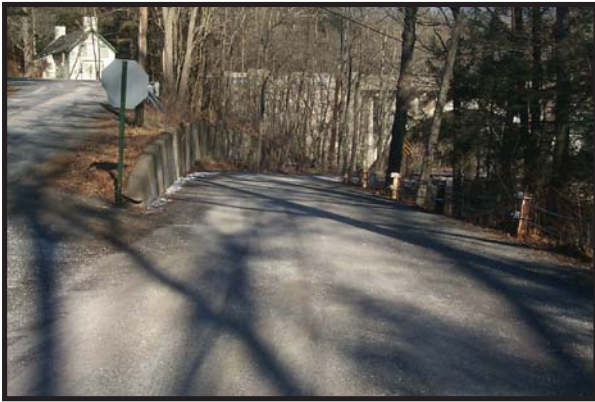
Route 0116

Route	Length (mi)	Width (ft)	Area (sq ft)	Lane Miles *	Condition / PCR	Surface Type
0116	0.12	11.00	7202	0.12	POOR / 45	AS

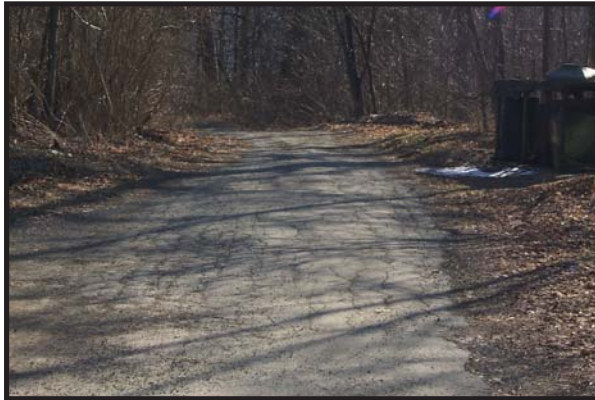
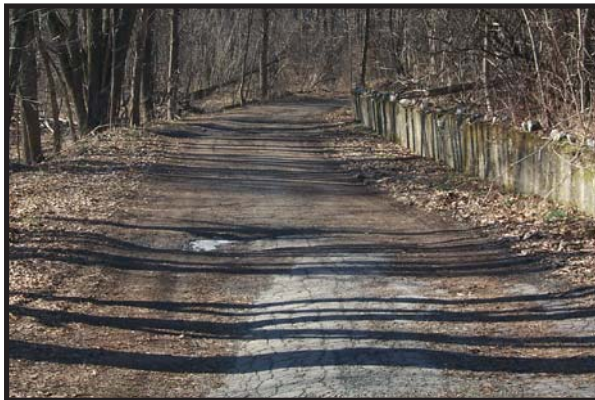
Route 0117

Route	Length (mi)	Width (ft)	Area (sq ft)	Lane Miles *	Condition / PCR	Surface Type
0117	0.06	9.00	2756	0.05	POOR / 45	AS

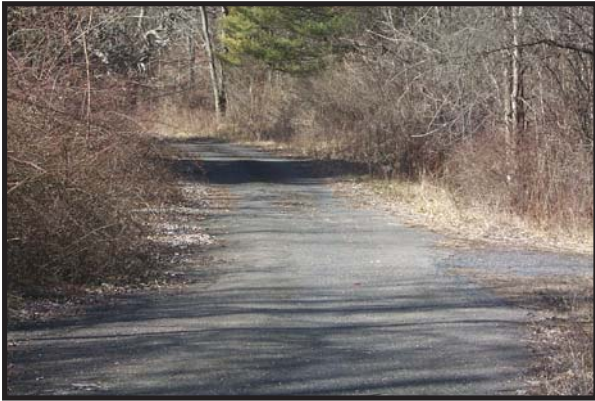
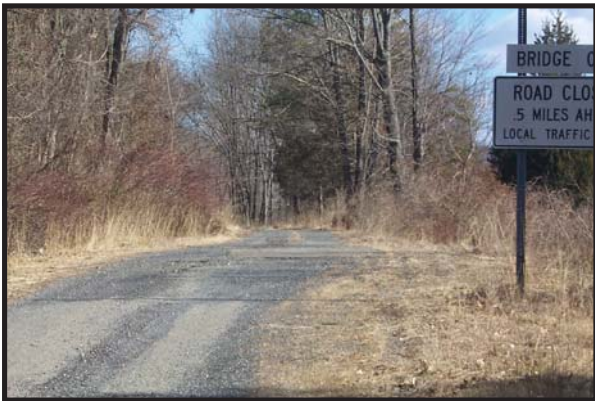
Route 0232

Route	Length (mi)	Width (ft)	Area (sq ft)	Lane Miles *	Condition / PCR	Surface Type
0232	0.31	0.00	0	0.00	POOR / 45	AS

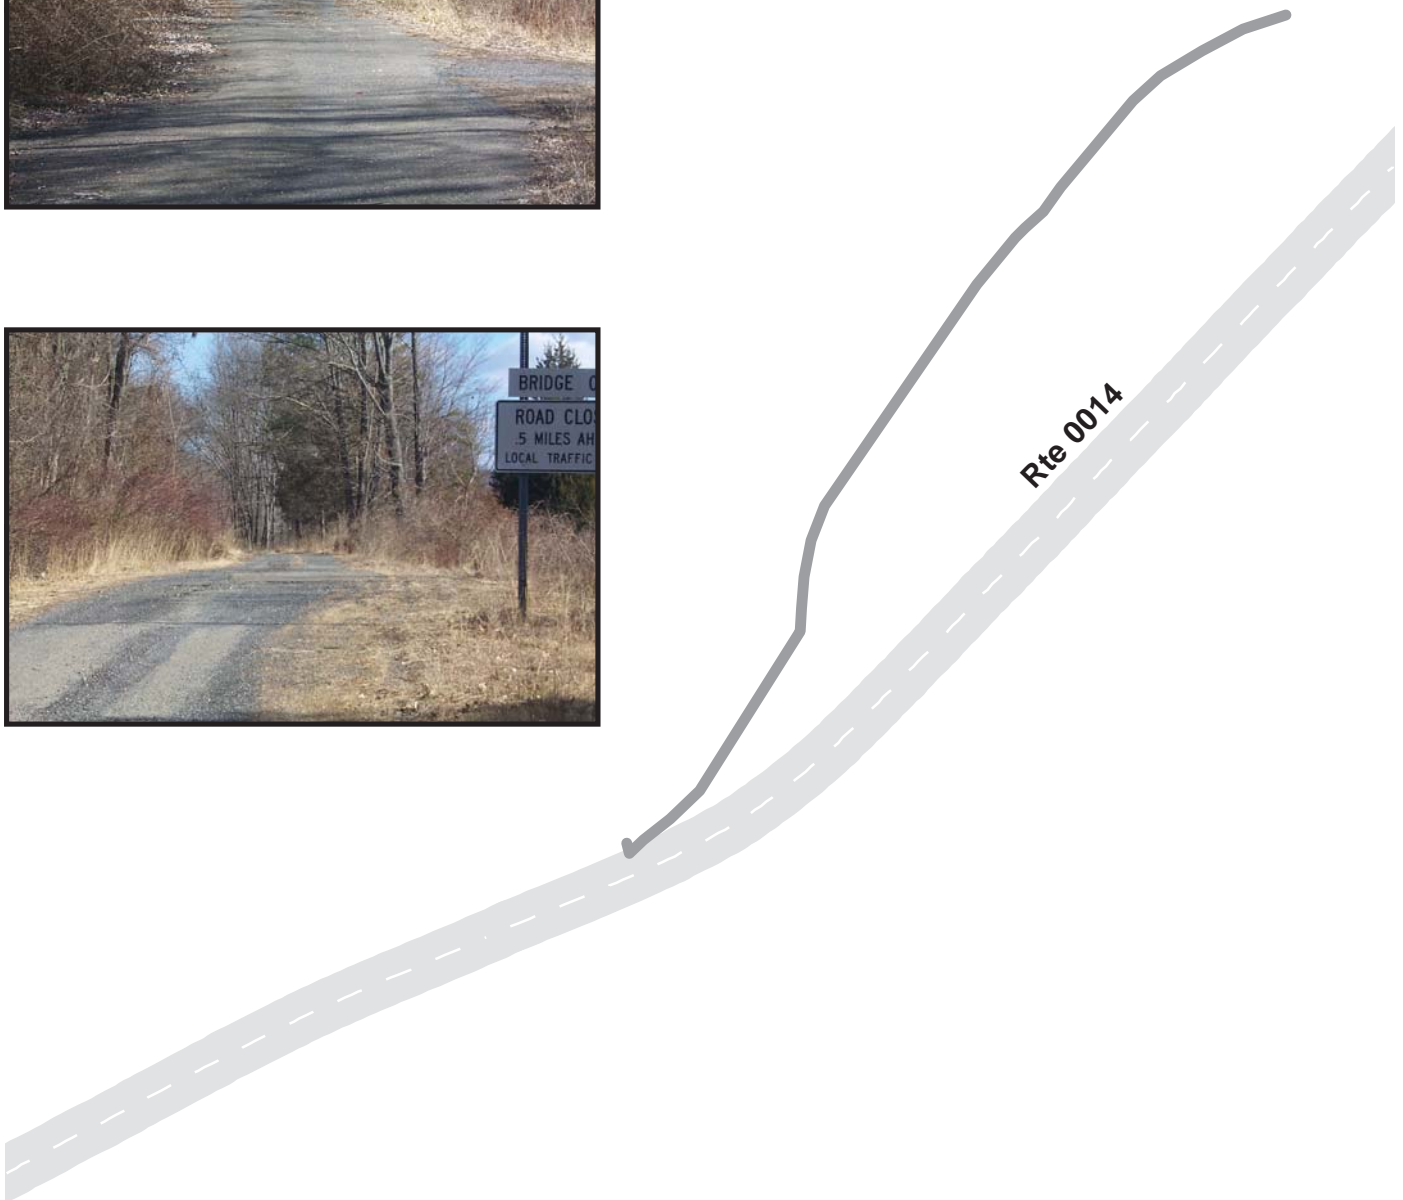
Route 0211

Route	Length (mi)	Width (ft)	Area (sq ft)	Lane Miles *	Condition / PCR	Surface Type
0211	0.49	10.00	25819	0.44	POOR / 45	AS

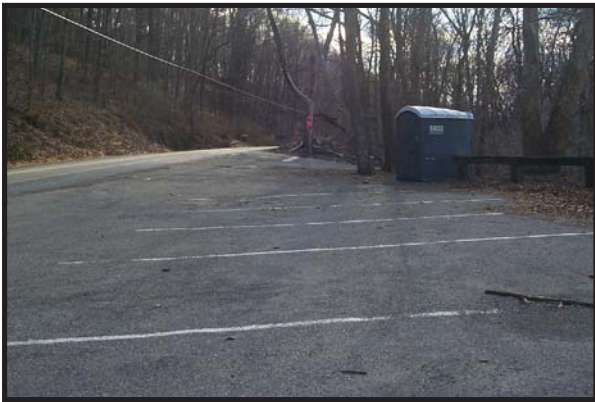
Route 0902

Route	Public / NonPublic	Date Visited	Area (sq ft)	Lane Miles *	Surface Type	Condition / PCR
0902	PUBLIC	10/8/2003	13032	0.22	AS	GOOD / 90

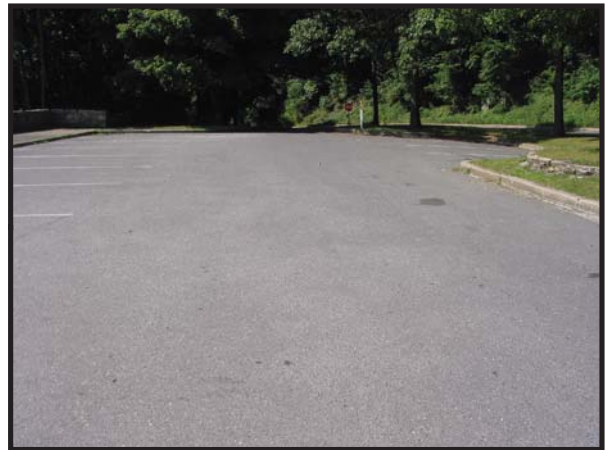
Route 0903 POINT OF GAP FROM SR 611

Route	Public / NonPublic	Date Visited	Area (sq ft)	Lane Miles *	Surface Type	Condition / PCR
0903	PUBLIC	10/8/2003	42242	0.73	AS	FAIR / 73

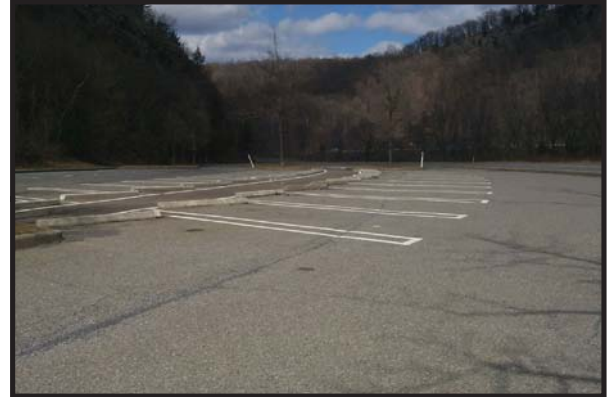
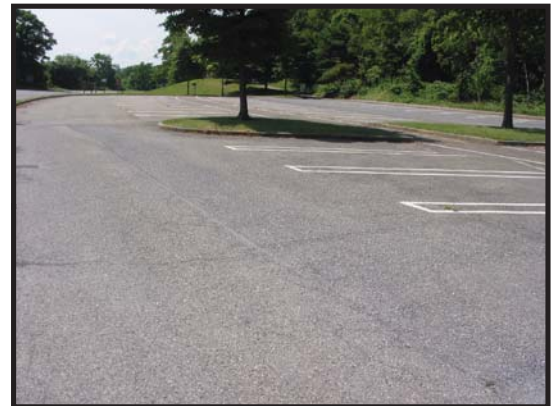
Route 0904A

Route	Public / NonPublic	Date Visited	Area (sq ft)	Lane Miles *	Surface Type	Condition / PCR
0904A	PUBLIC	10/8/2003	11872	0.20	AS	FAIR / 73

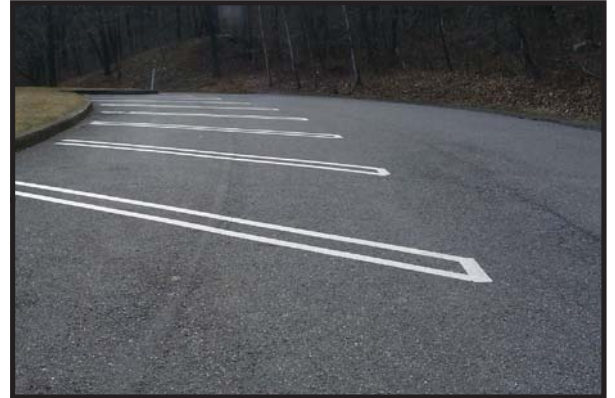
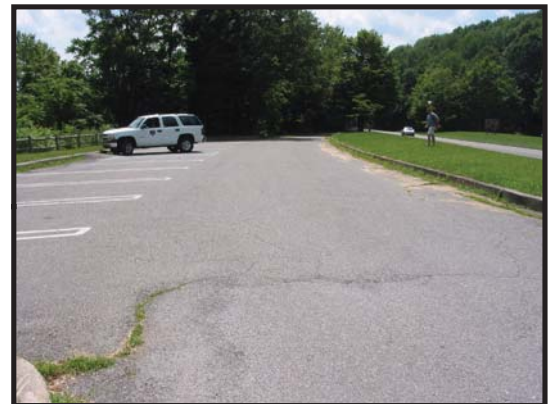
Route 0904B

Route	Public / NonPublic	Date Visited	Area (sq ft)	Lane Miles *	Surface Type	Condition / PCR
0904B	PUBLIC	10/8/2003	13568	0.23	AS	FAIR / 73

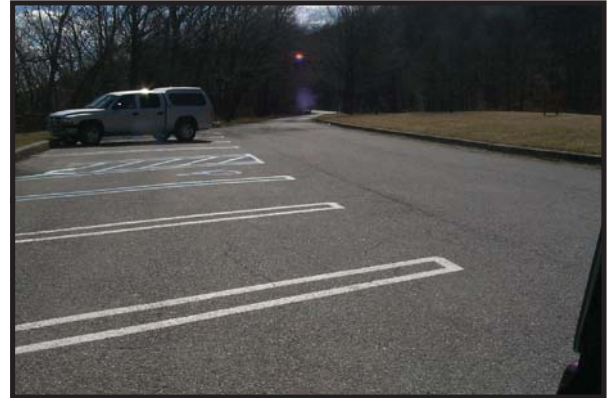
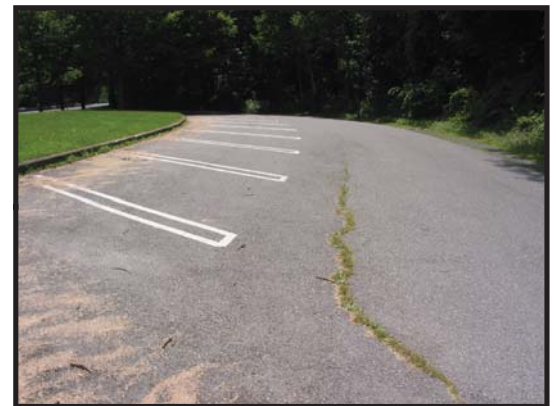
Route 0905

Route	Public / NonPublic	Date Visited	Area (sq ft)	Lane Miles *	Surface Type	Condition / PCR
0905	NONPUBLIC	10/8/2003	28222	0.49	AS	FAIR / 73

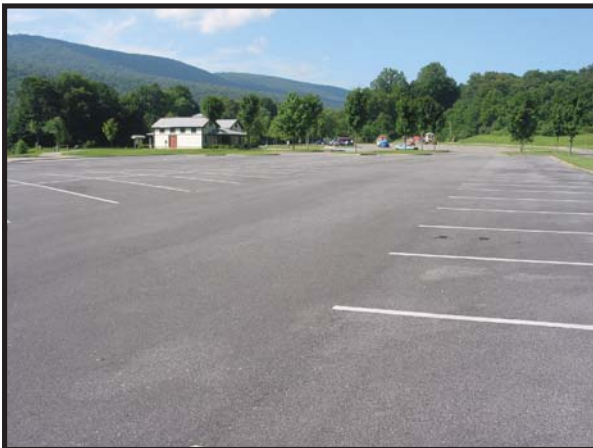
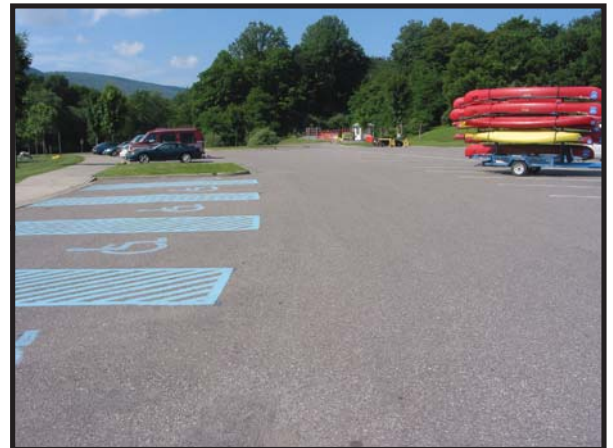
Route 0906B

Route	Public / NonPublic	Date Visited	Area (sq ft)	Lane Miles *	Surface Type	Condition / PCR
0906B	PUBLIC	10/8/2003	65790	1.13	AS	FAIR / 73

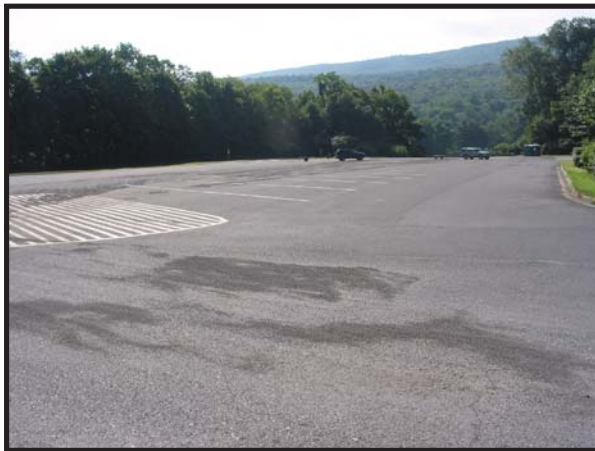
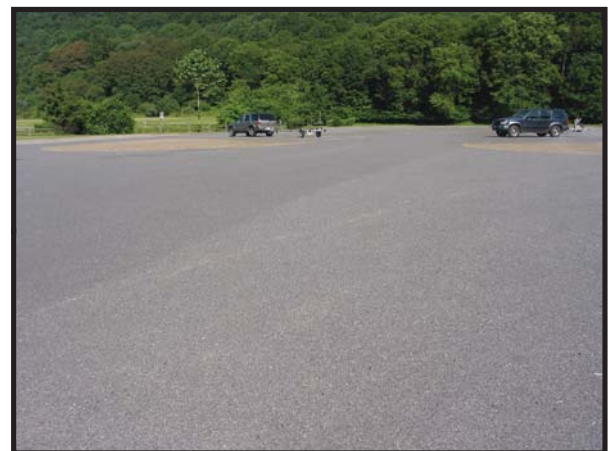
Route 0907

Route	Public / NonPublic	Date Visited	Area (sq ft)	Lane Miles *	Surface Type	Condition / PCR
0907	PUBLIC	10/8/2003	16121	0.28	AS	GOOD / 90

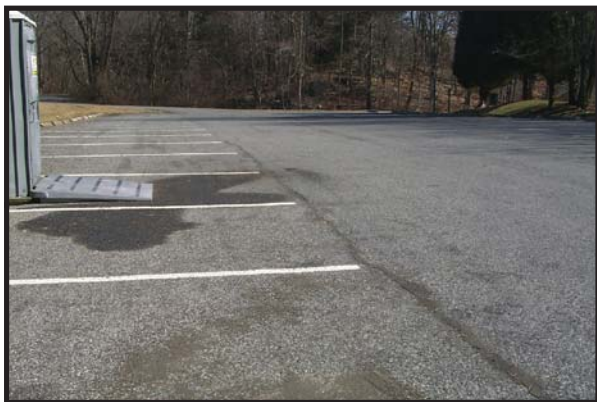
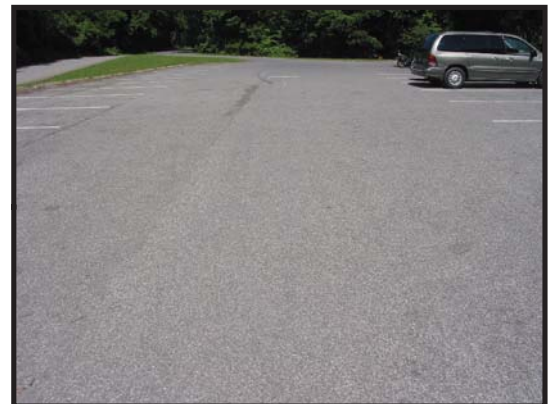
Route 0908

Route	Public / NonPublic	Date Visited	Area (sq ft)	Lane Miles *	Surface Type	Condition / PCR
0908	PUBLIC	10/8/2003	110893	1.91	AS	GOOD / 90

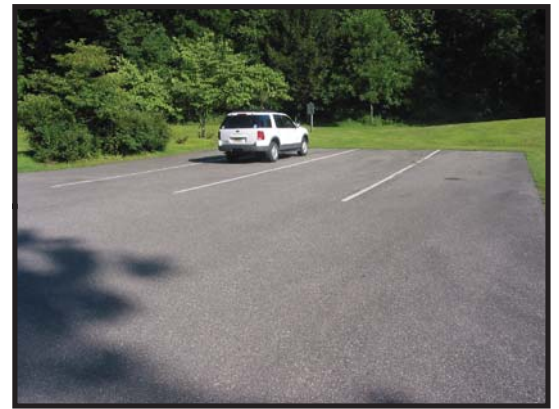
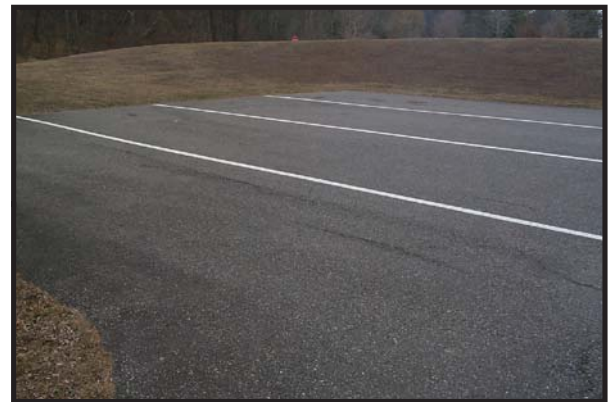
Route	Public / NonPublic	Date Visited	Area (sq ft)	Lane Miles *	Surface Type	Condition / PCR
0909A	PUBLIC	10/8/2003	2343	0.04	AS	FAIR / 73

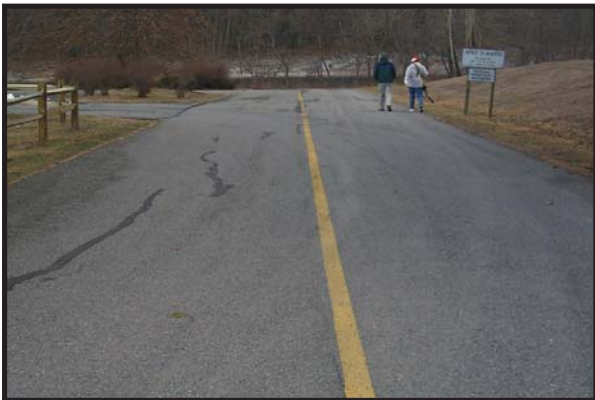
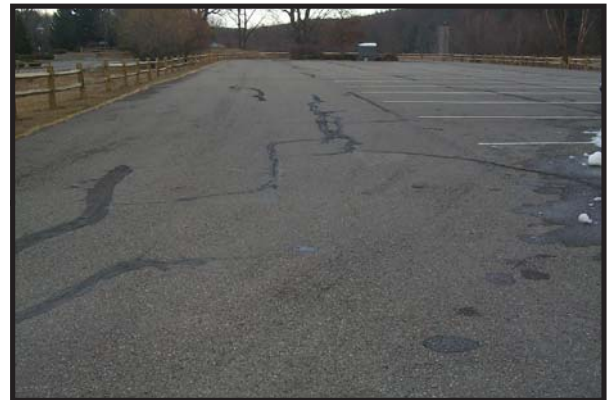
Route 0909B

Route	Public / NonPublic	Date Visited	Area (sq ft)	Lane Miles *	Surface Type	Condition / PCR
0909B	PUBLIC	10/8/2003	42230	0.73	AS	FAIR / 73

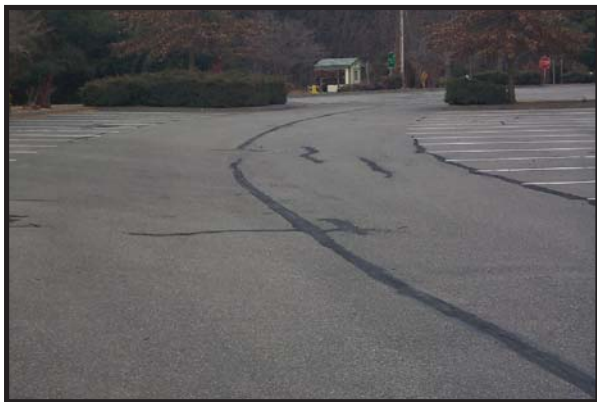
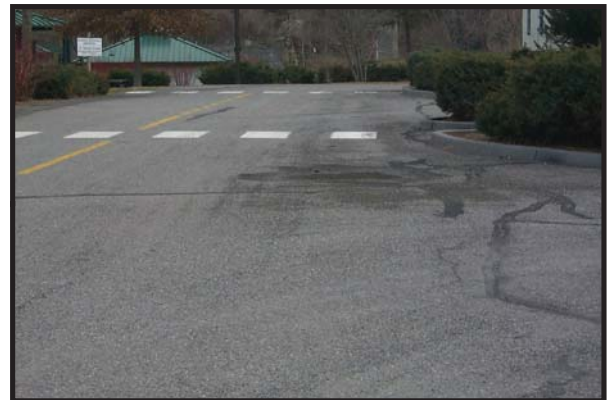
Route 0909C

Route	Public / NonPublic	Date Visited	Area (sq ft)	Lane Miles *	Surface Type	Condition / PCR
0909C	PUBLIC	10/8/2003	83141	1.43	AS	FAIR / 73

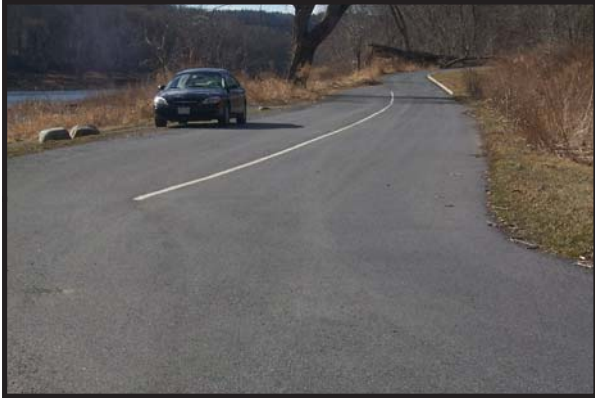
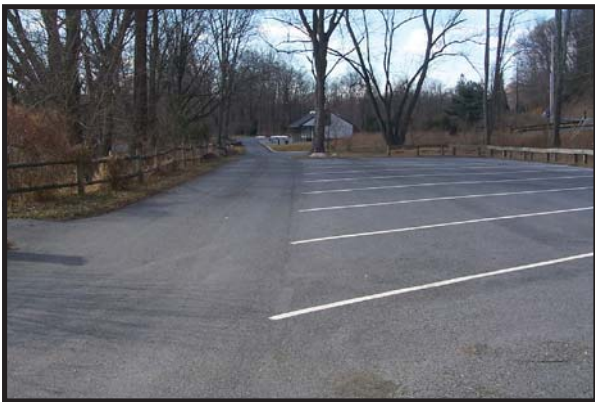
Route 0910

Route	Public / NonPublic	Date Visited	Area (sq ft)	Lane Miles *	Surface Type	Condition / PCR
0910	PUBLIC	10/8/2003	69710	1.20	AS	GOOD / 90

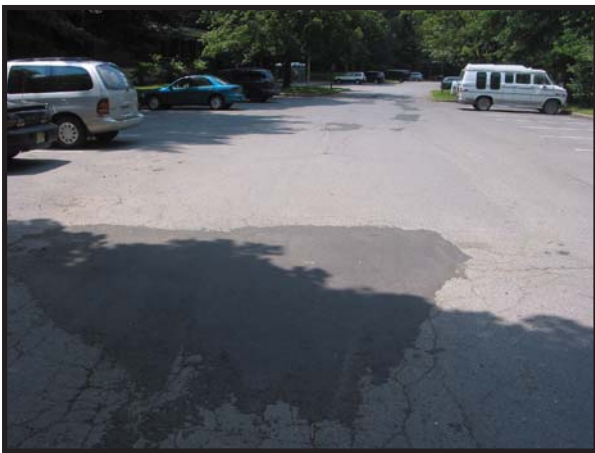
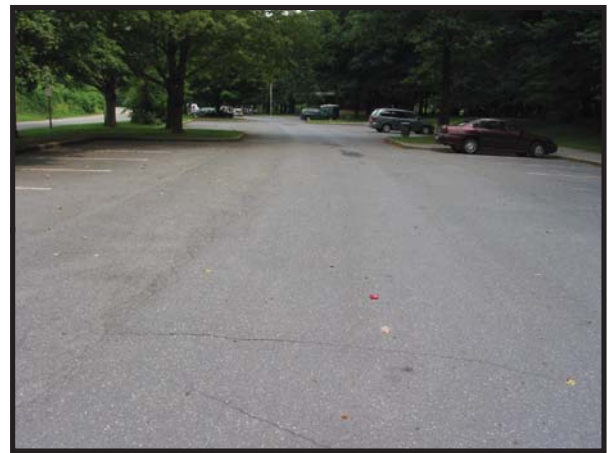
Route 0911

Route	Public / NonPublic	Date Visited	Area (sq ft)	Lane Miles *	Surface Type	Condition / PCR
0911	PUBLIC	10/8/2003	45261	0.78	AS	FAIR / 73

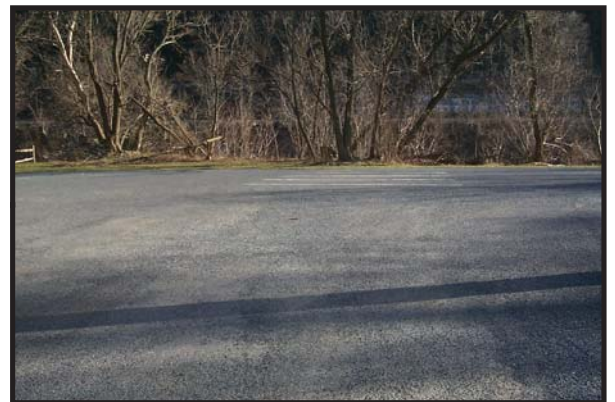
Route 0913

Route	Public / NonPublic	Date Visited	Area (sq ft)	Lane Miles *	Surface Type	Condition / PCR
0913	PUBLIC	10/8/2003	8857	0.15	NC	GOOD / 90

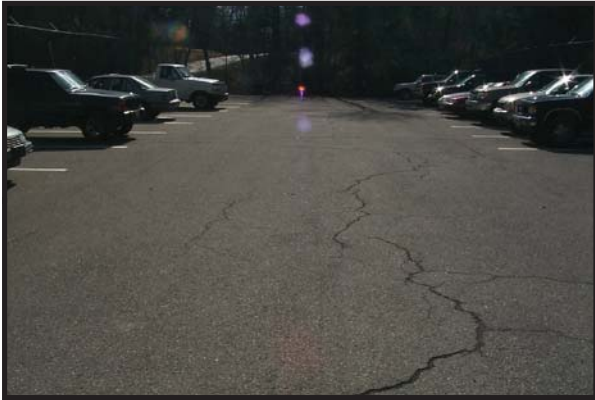
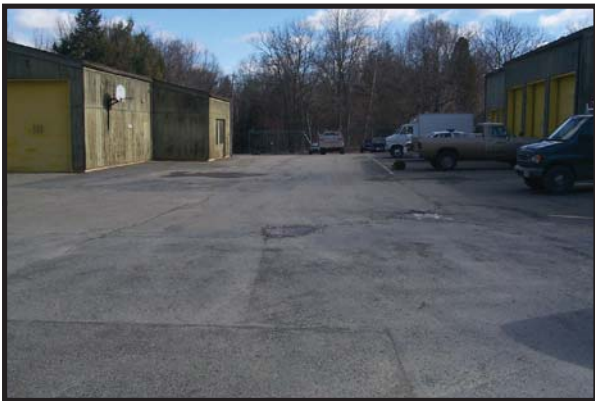
Route 0915

Route	Public / NonPublic	Date Visited	Area (sq ft)	Lane Miles *	Surface Type	Condition / PCR
0915	NONPUBLIC	10/8/2003	25547	0.44	AS	POOR / 45

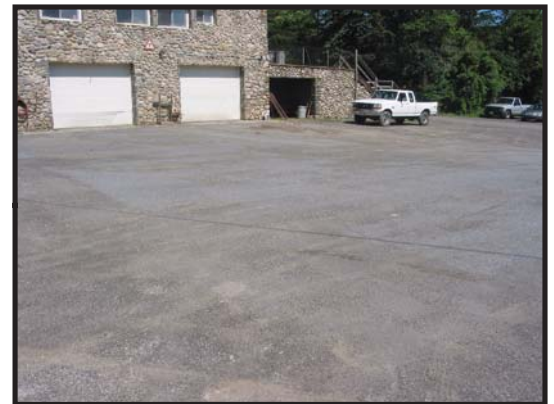
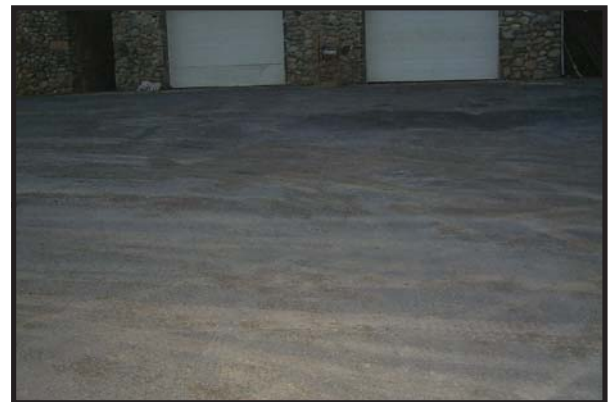
Route 0916

Route	Public / NonPublic	Date Visited	Area (sq ft)	Lane Miles *	Surface Type	Condition / PCR
0916	NONPUBLIC	10/8/2003	3461	0.06	AS	POOR / 45

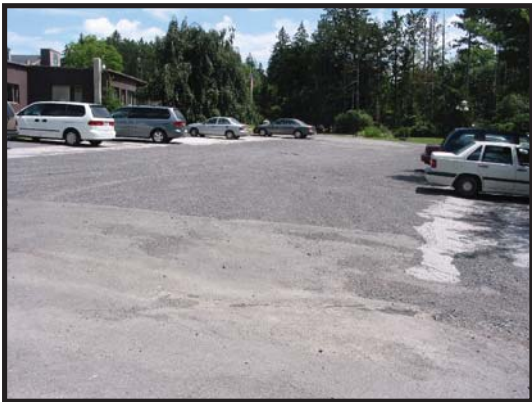
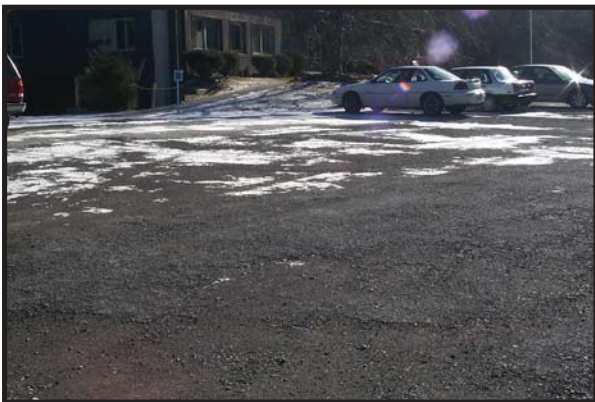
Route 0931A

Route	Public / NonPublic	Date Visited	Area (sq ft)	Lane Miles *	Surface Type	Condition / PCR
0931A	PUBLIC	10/8/2003	17099	0.29	AS	POOR / 45

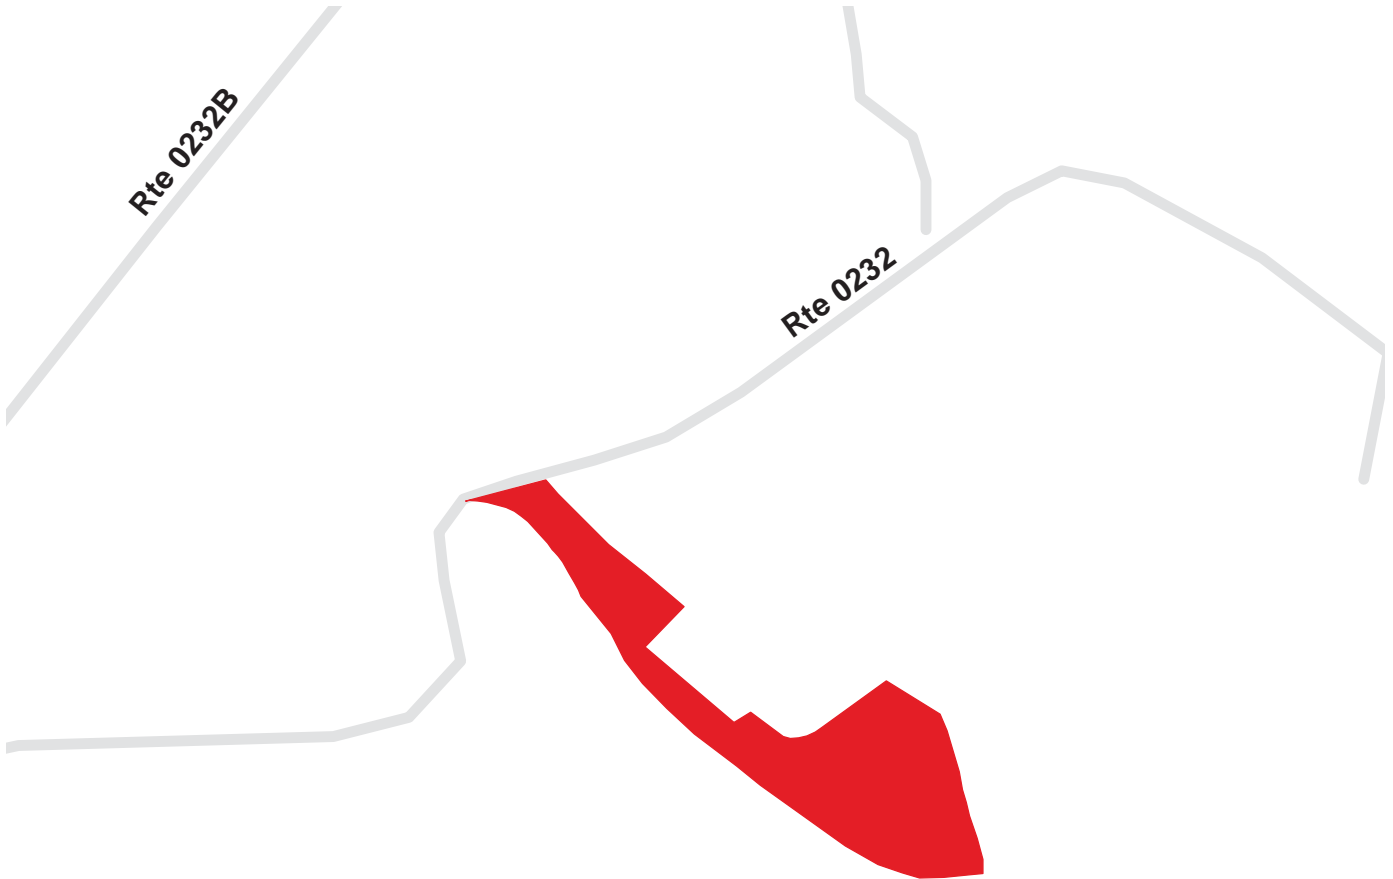
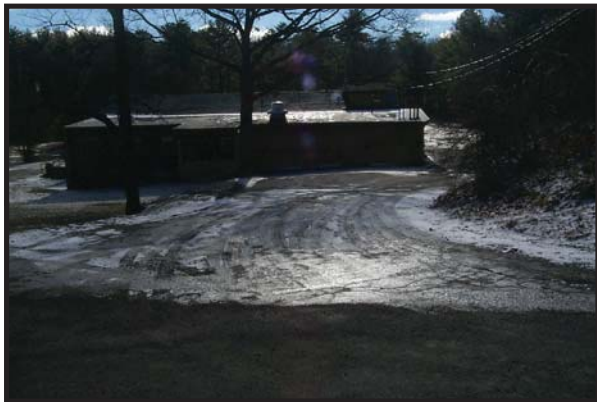
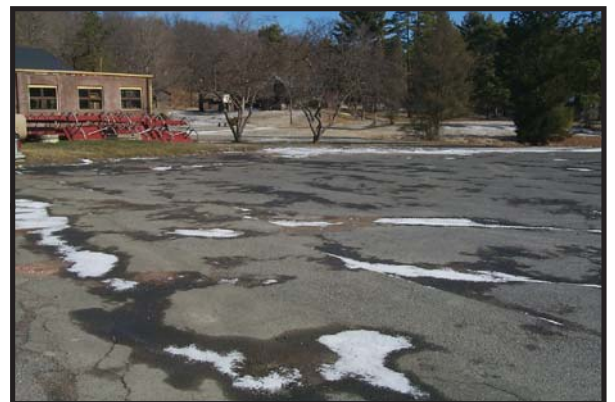
Route 0931B

Route	Public / NonPublic	Date Visited	Area (sq ft)	Lane Miles *	Surface Type	Condition / PCR
0931B	PUBLIC	10/8/2003	12438	0.21	AS	POOR / 45

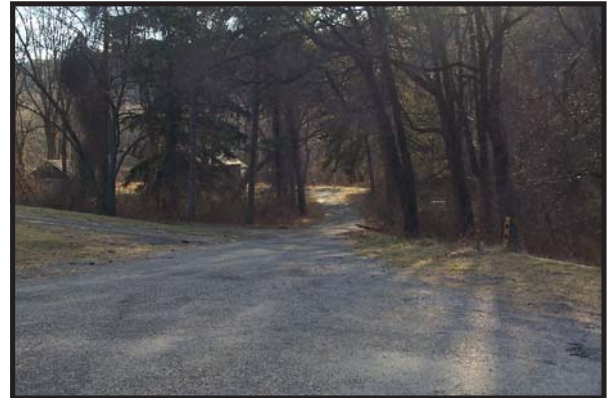
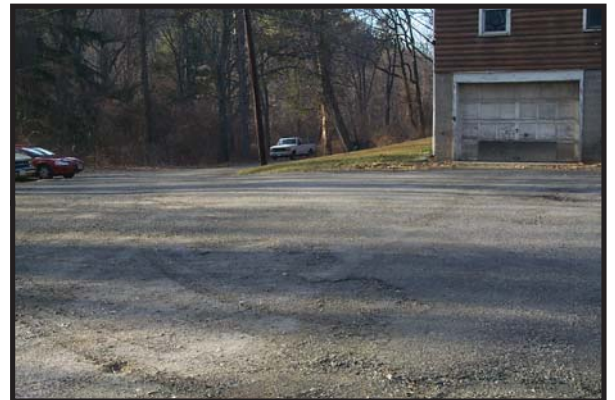
Route 0932

Route	Public / NonPublic	Date Visited	Area (sq ft)	Lane Miles *	Surface Type	Condition / PCR
0932	NONPUBLIC	10/8/2003	25158	0.43	AS	POOR / 45

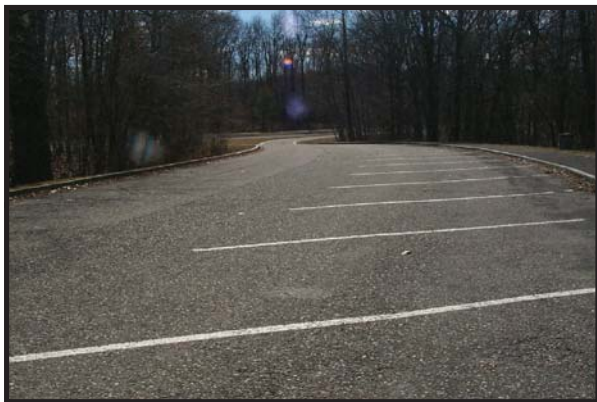
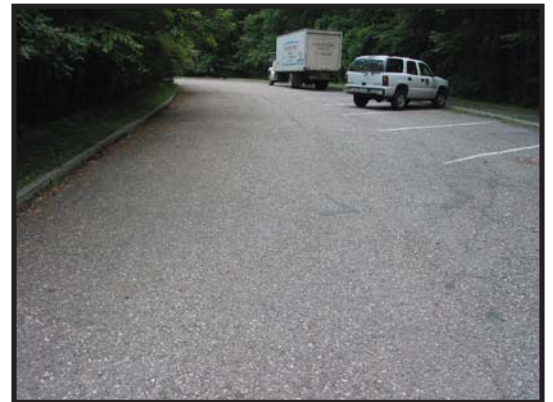
Route 0951

Route	Public / NonPublic	Date Visited	Area (sq ft)	Lane Miles *	Surface Type	Condition / PCR
0951	PUBLIC	10/8/2003	12684	0.22	AS	POOR / 45

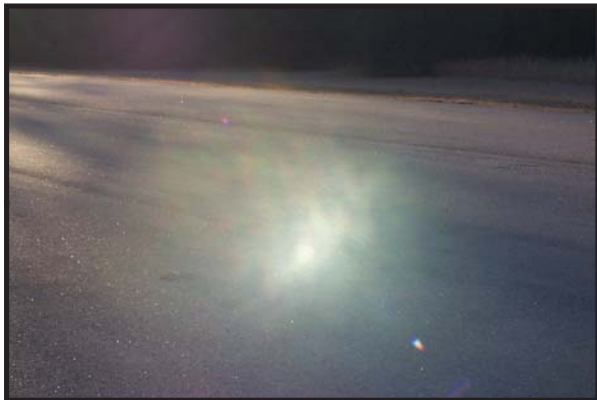
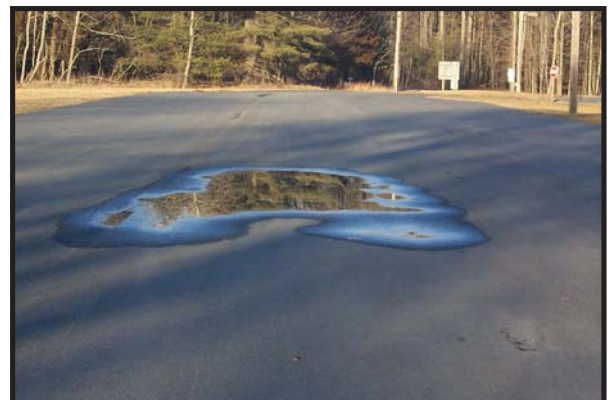
Route 0953

Route	Public / NonPublic	Date Visited	Area (sq ft)	Lane Miles *	Surface Type	Condition / PCR
0953	PUBLIC	10/8/2003	24328	0.42	AS	EXCELLENT / 97

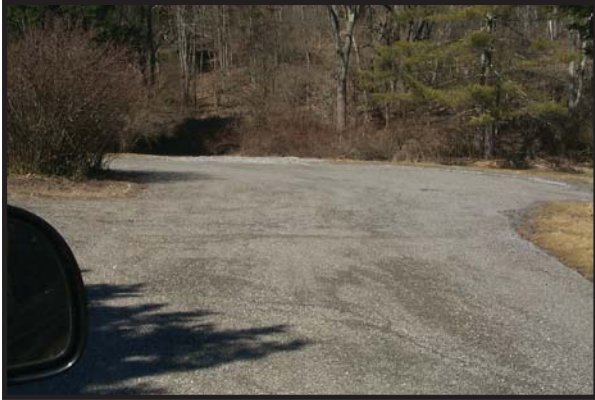
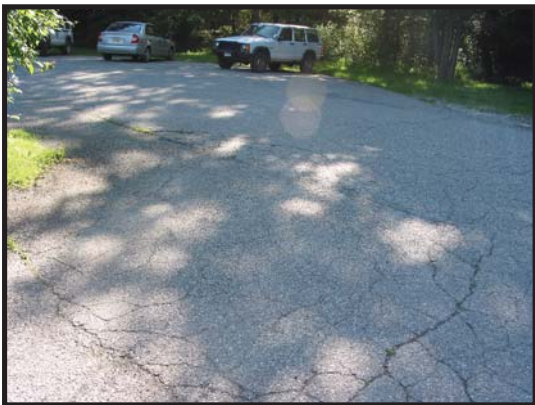
Route 0954

Route	Public / NonPublic	Date Visited	Area (sq ft)	Lane Miles *	Surface Type	Condition / PCR
0954	PUBLIC	10/8/2003	6358	0.11	AS	POOR / 45
