**The Road Inventory
of
Delaware Water Gap National Recreation Area
DEWA - 4320**

Prepared By:
Federal Highway Administration
Eastern Federal Lands Highway Division
Cycle 3

Delaware Water Gap National Recreation Area in Pennsylvania

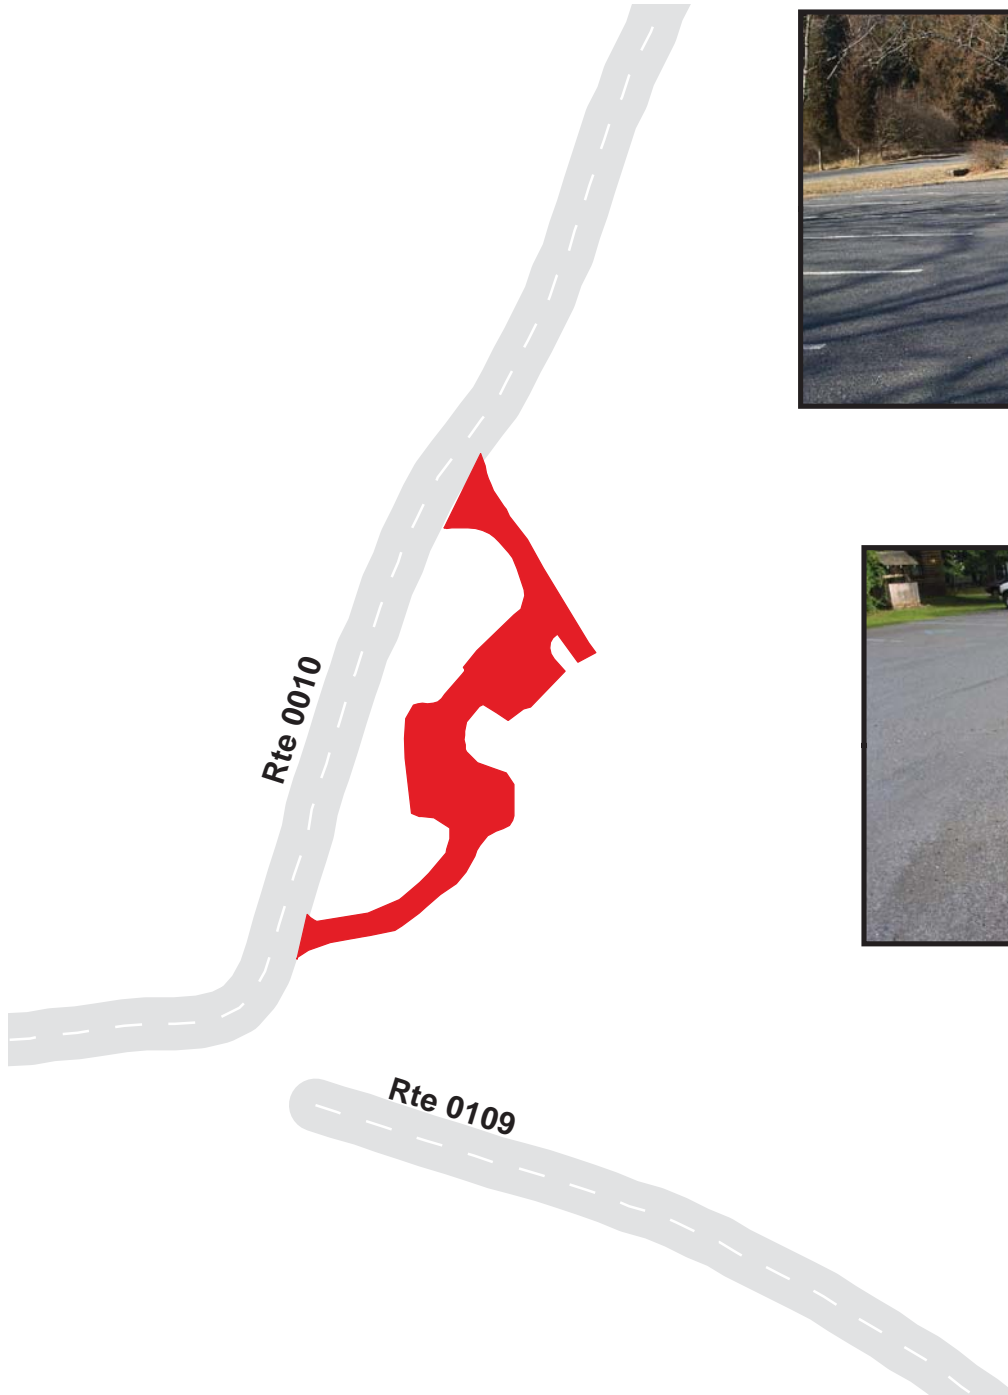
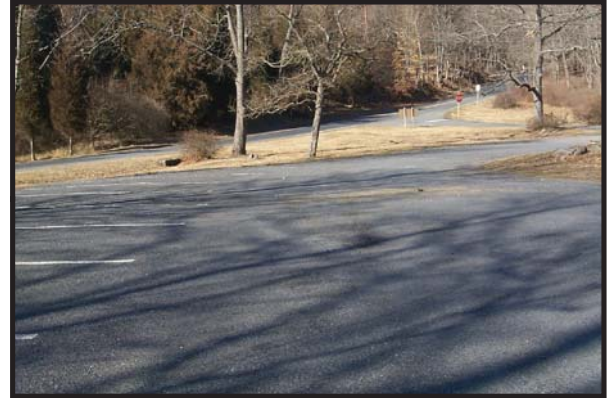
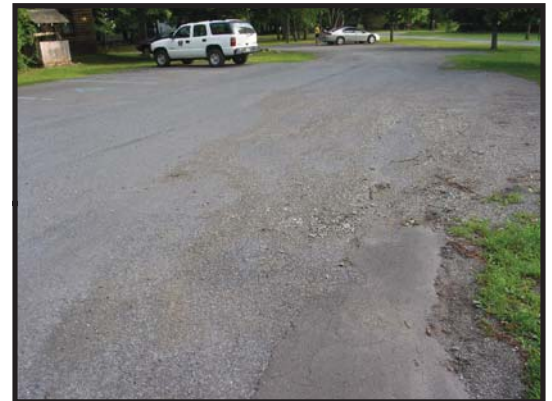
Route 0955

Route	Public / NonPublic	Date Visited	Area (sq ft)	Lane Miles *	Surface Type	Condition / PCR
0955	PUBLIC	10/8/2003	13184	0.23	AS	POOR / 45

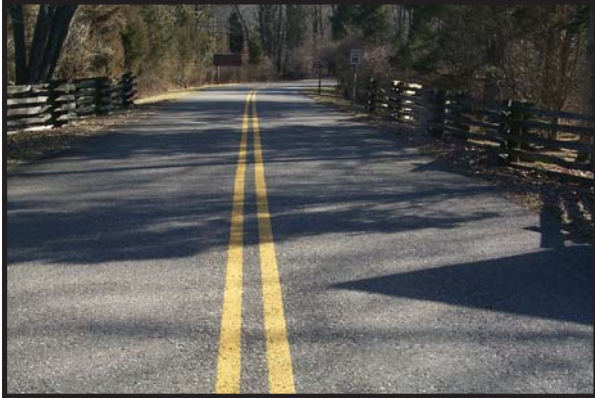
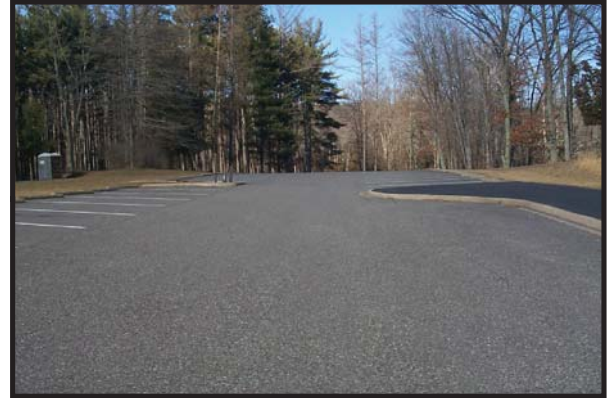
Route 0956

Route	Public / NonPublic	Date Visited	Area (sq ft)	Lane Miles *	Surface Type	Condition / PCR
0956	PUBLIC	10/8/2003	54391	0.94	AS	GOOD / 90

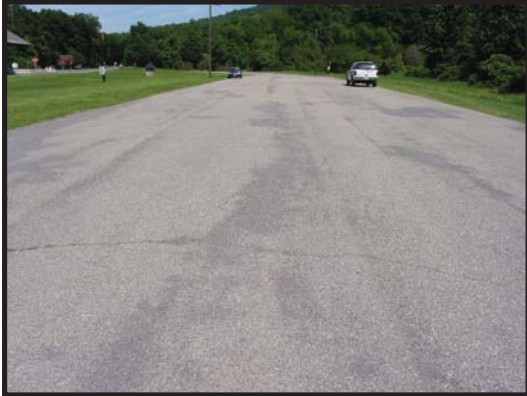
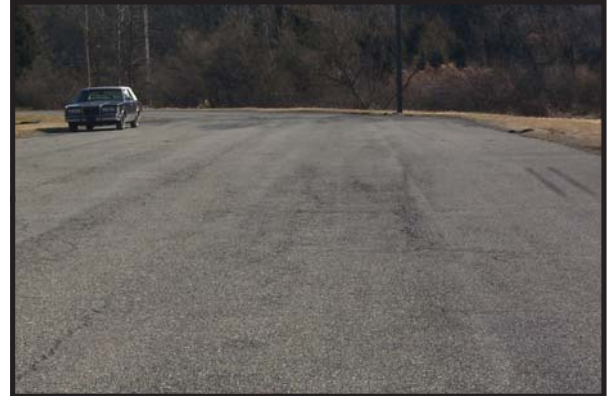
Route 0957

Route	Public / NonPublic	Date Visited	Area (sq ft)	Lane Miles *	Surface Type	Condition / PCR
0957	PUBLIC	10/8/2003	23309	0.40	AS	POOR / 45

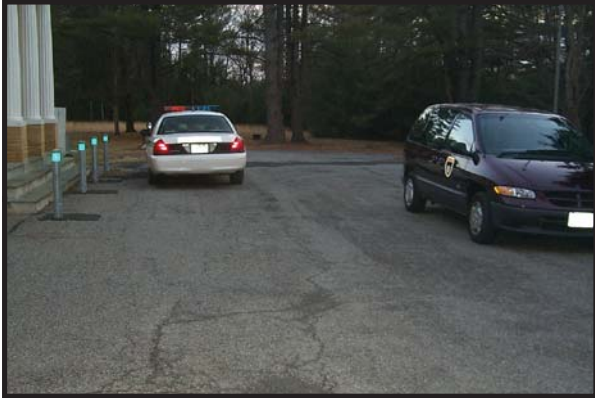
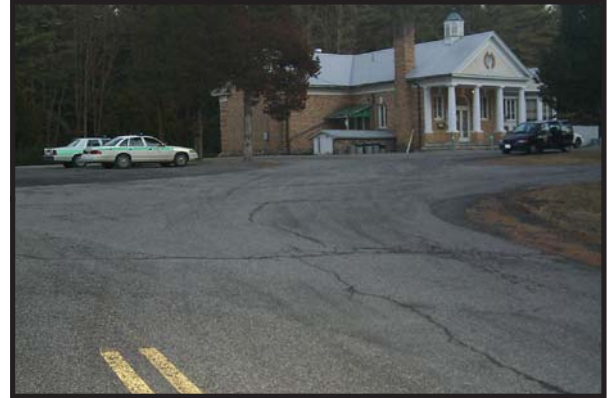
Route 0958

Route	Public / NonPublic	Date Visited	Area (sq ft)	Lane Miles *	Surface Type	Condition / PCR
0958	PUBLIC	10/8/2003	16281	0.28	AS	FAIR / 73

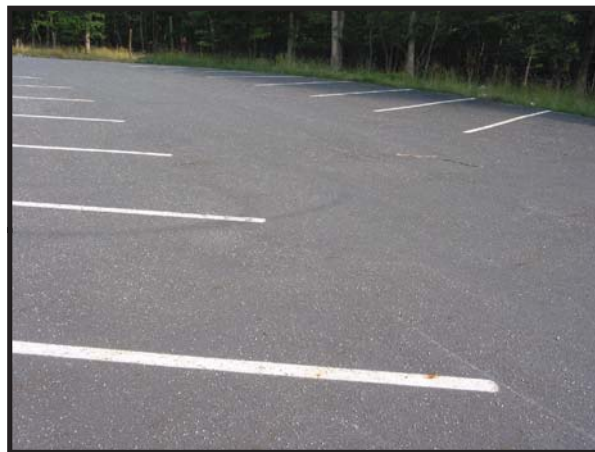
Route 0961

Route	Public / NonPublic	Date Visited	Area (sq ft)	Lane Miles *	Surface Type	Condition / PCR
0961	PUBLIC	10/8/2003	16800	0.29	AS	EXCELLENT / 97
