The Road Inventory Of Dinosaur National Monument DINO - 1400

Road Inventory Program

Prepared By:
Federal Highway Administration
Eastern Federal Lands Highway Division
Cycle 3

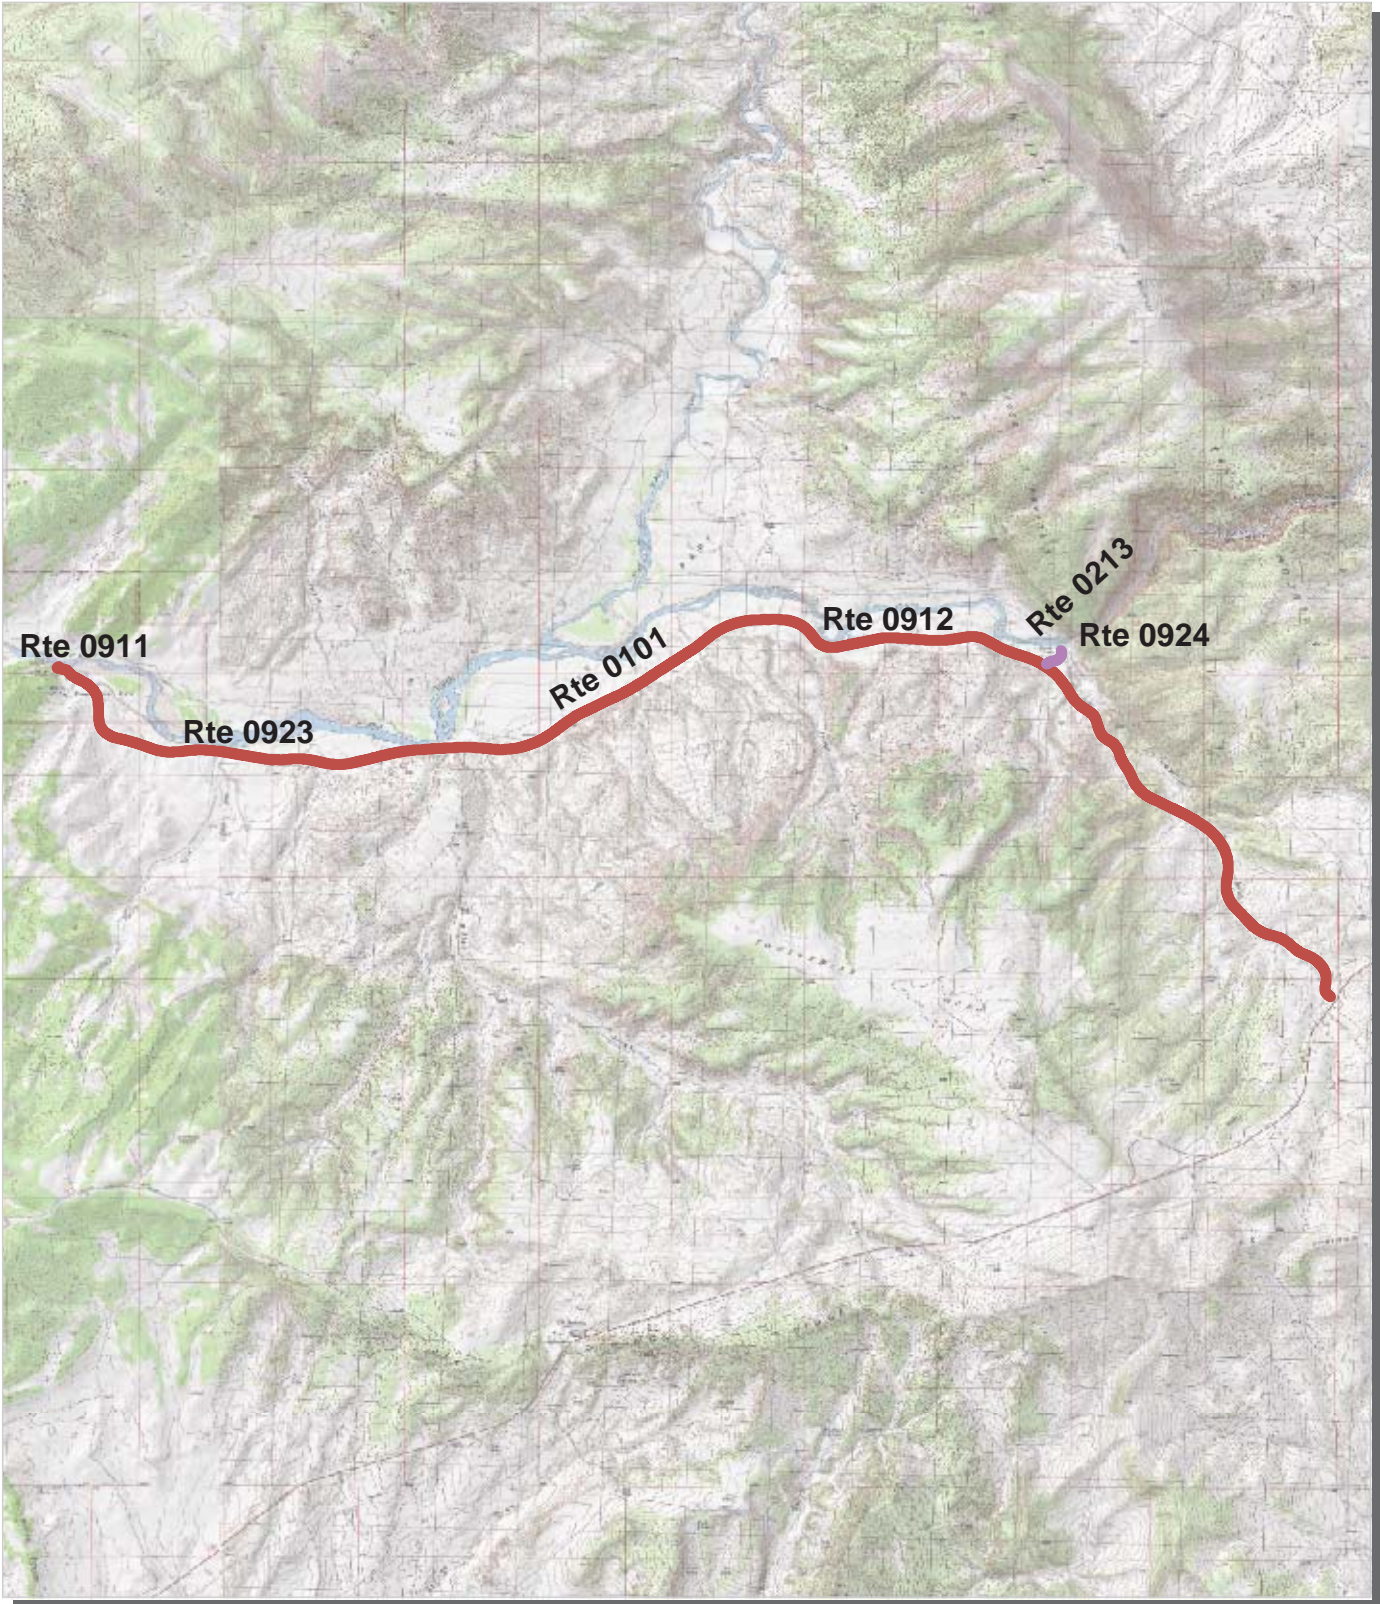
Dinosaur National Monument Route Location Map Area Map 5

Unique colors used to differentiate routes

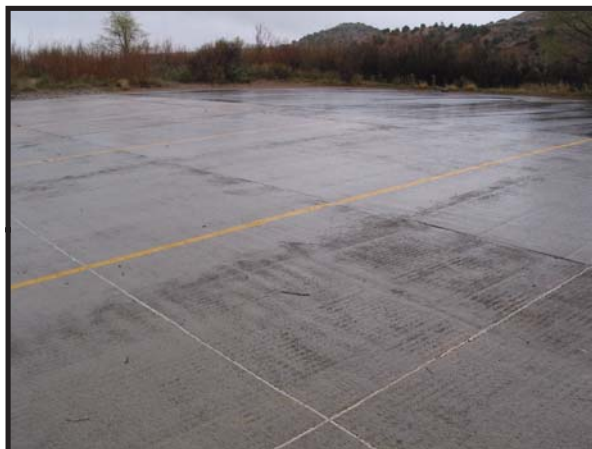
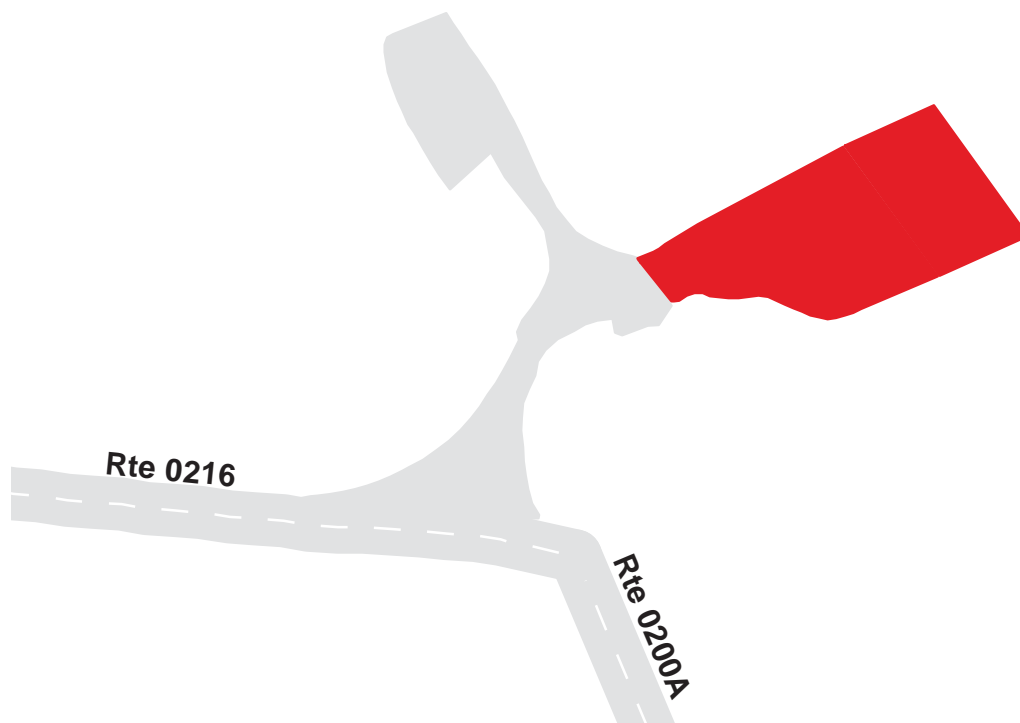
Dinosaur National Monument
Route 0800
 Split Mountain Campground Boat Ramp
 From Route 0903

Route	Public / NonPublic	Date Visited	Area (sq ft)	Lane Miles *	Surface Type	Condition / PCR
0800	Public	4/23/2003	14749	0.25	AS	EXCELLENT / 97

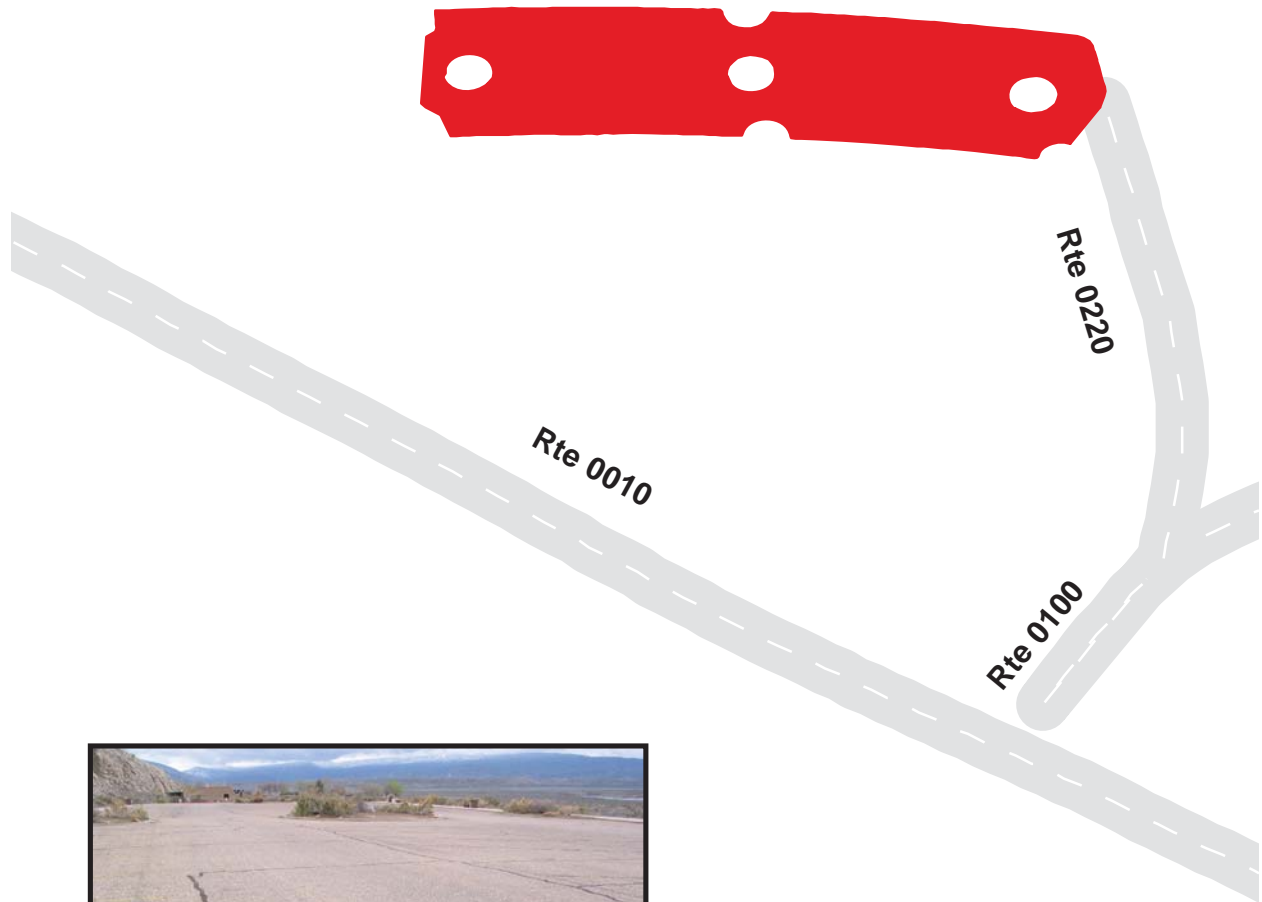
Route 0900

Route	Public / NonPublic	Date Visited	Area (sq ft)	Lane Miles *	Surface Type	Condition / PCR
0900	Public	4/23/2003	74571	1.28	OC	POOR / 45

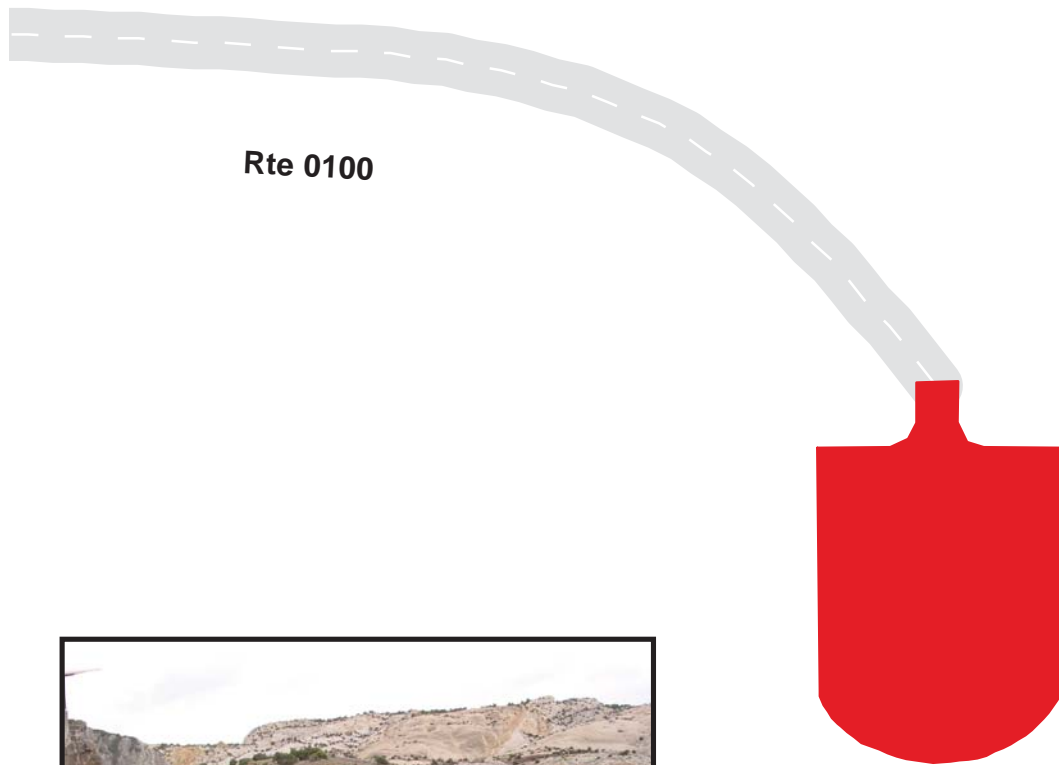
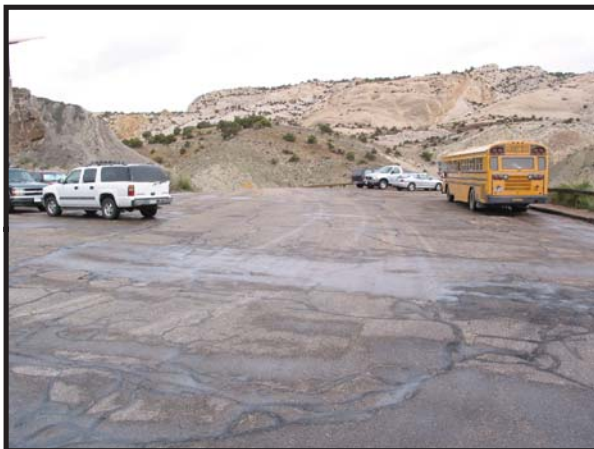
Route 0901

Route	Public / NonPublic	Date Visited	Area (sq ft)	Lane Miles *	Surface Type	Condition / PCR
0901	Public	4/23/2003	24515	0.42	OC	POOR / 45

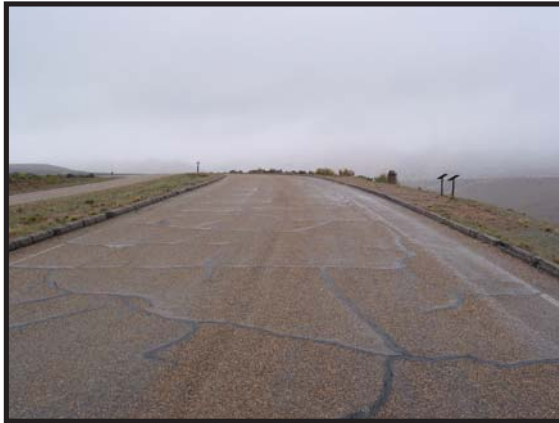
Route 0903

Route	Public / NonPublic	Date Visited	Area (sq ft)	Lane Miles *	Surface Type	Condition / PCR
0903	Public	4/23/2003	13785	0.24	AS	POOR / 45

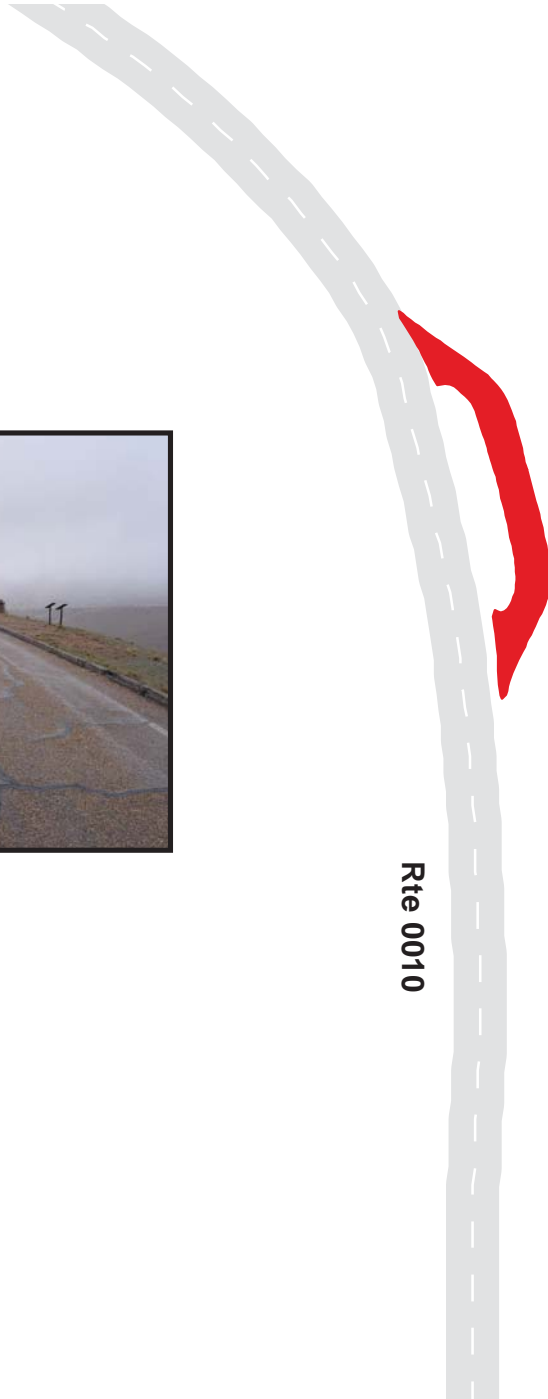
Route 0902

Route	Public / NonPublic	Date Visited	Area (sq ft)	Lane Miles *	Surface Type	Condition / PCR
0902	Public	4/23/2003	11221	0.19	OC	POOR / 45

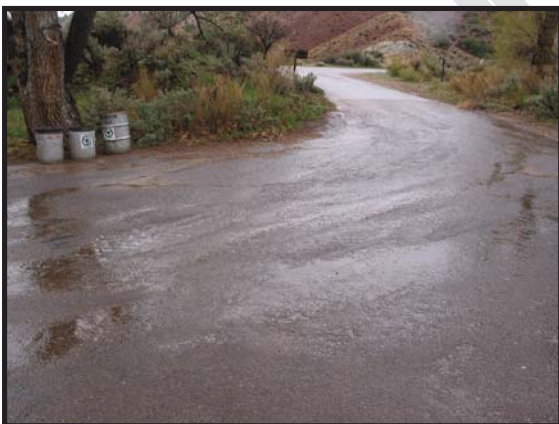
Route 0904

Route	Public / NonPublic	Date Visited	Area (sq ft)	Lane Miles *	Surface Type	Condition / PCR
0904	Public	4/22/2003	20513	0.35	OC	FAIR / 73

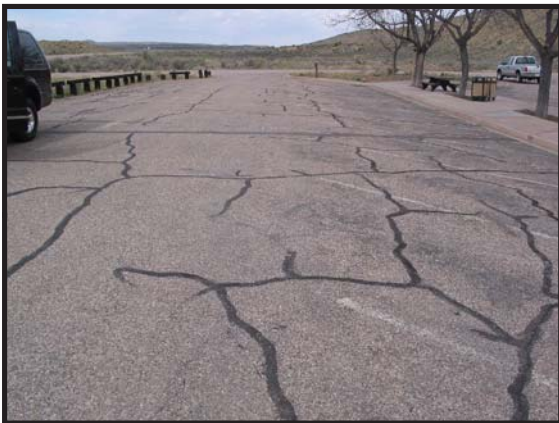
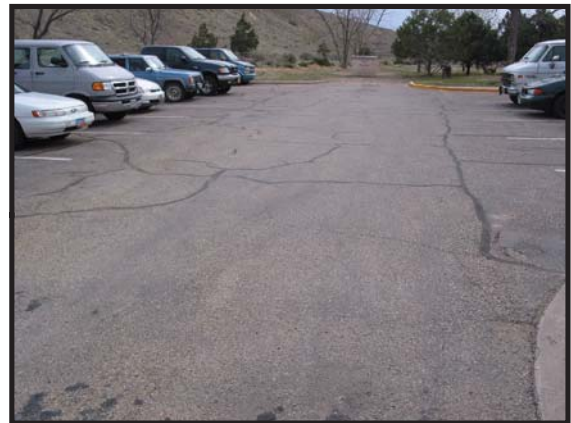
Route 0905

Route	Public / NonPublic	Date Visited	Area (sq ft)	Lane Miles *	Surface Type	Condition / PCR
0905	Public	4/22/2003	7894	0.14	OC	FAIR / 73

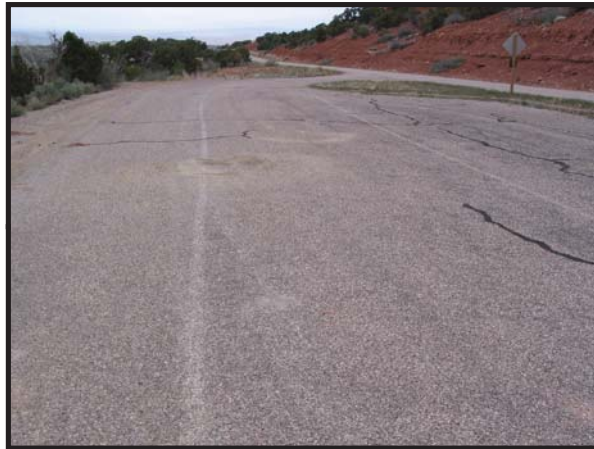
Route 0906

Route	Public / NonPublic	Date Visited	Area (sq ft)	Lane Miles *	Surface Type	Condition / PCR
0906	Public	4/22/2003	6336	0.11	AS	FAIR / 73

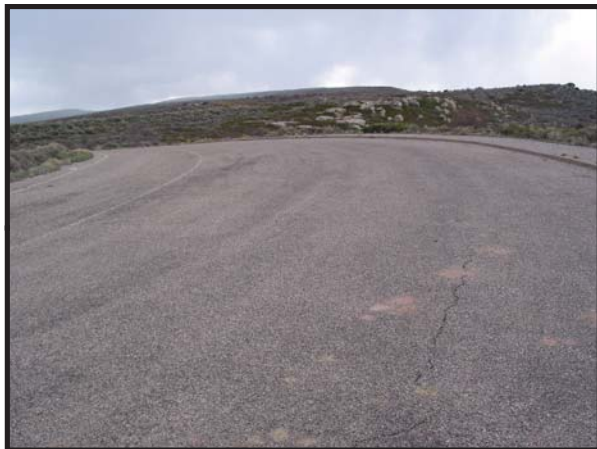
Route 0907

Route	Public / NonPublic	Date Visited	Area (sq ft)	Lane Miles *	Surface Type	Condition / PCR
0907	Public	4/22/2003	11037	0.19	OC	FAIR / 73

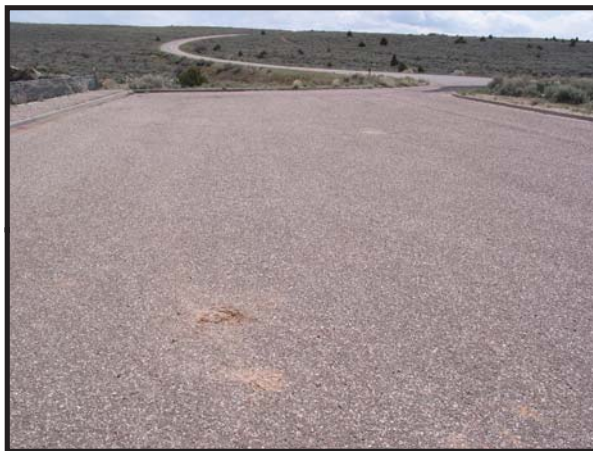
Route 0908

Route	Public / NonPublic	Date Visited	Area (sq ft)	Lane Miles *	Surface Type	Condition / PCR
0908	Public	4/22/2003	6485	0.11	OC	GOOD / 90

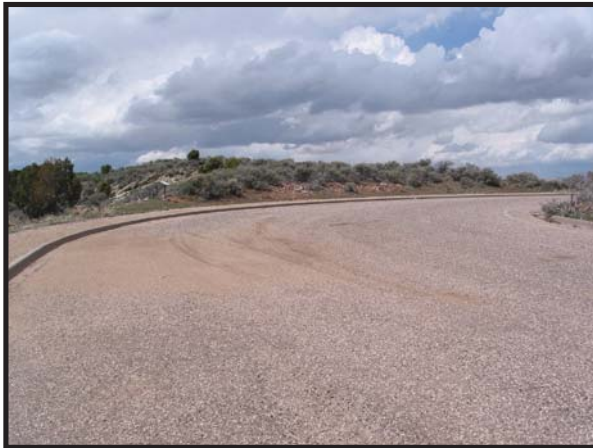
Route 0909A

Route	Public / NonPublic	Date Visited	Area (sq ft)	Lane Miles *	Surface Type	Condition / PCR
0909A	Public	4/22/2003	4422	0.08	OC	FAIR / 73

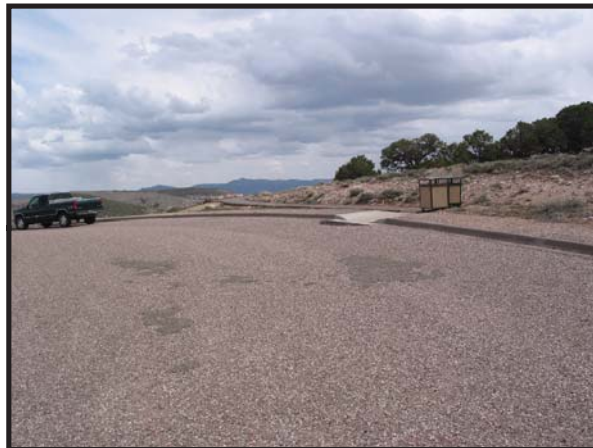
Route 0909B

Route	Public / NonPublic	Date Visited	Area (sq ft)	Lane Miles *	Surface Type	Condition / PCR
0909B	Public	4/22/2003	2827	0.05	OC	FAIR / 73

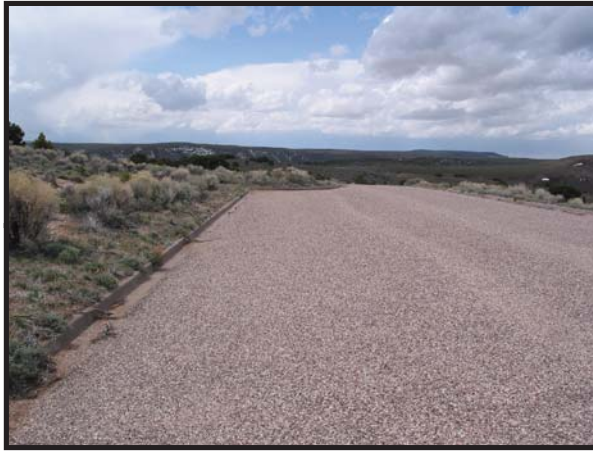
Route 0910

Route	Public / NonPublic	Date Visited	Area (sq ft)	Lane Miles *	Surface Type	Condition / PCR
0910	Public	7/26/1999	12490	0.22	OC	FAIR / 73

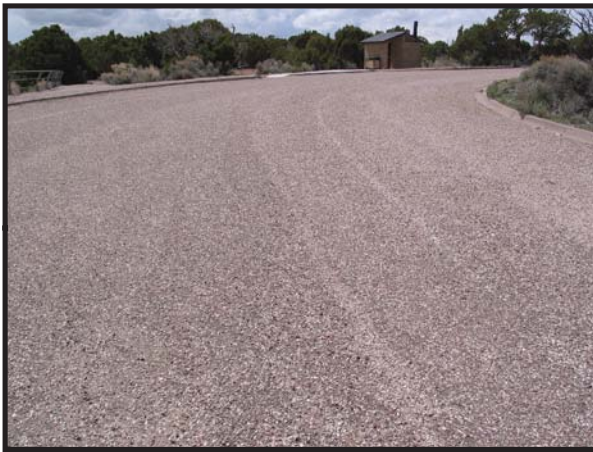
Route 0911A

Route	Public / NonPublic	Date Visited	Area (sq ft)	Lane Miles *	Surface Type	Condition / PCR
0911A	Public	4/22/2003	2626	0.05	OC	FAIR / 73

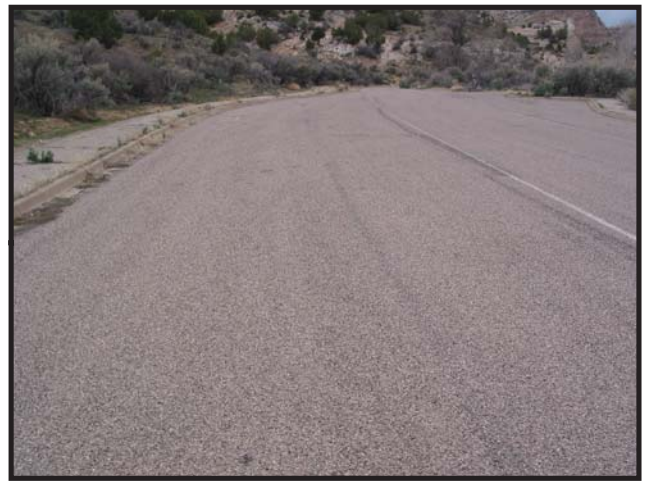
Route 0912

Route	Public / NonPublic	Date Visited	Area (sq ft)	Lane Miles *	Surface Type	Condition / PCR
0912	Public	4/22/2003	21232	0.37	OC	FAIR / 73

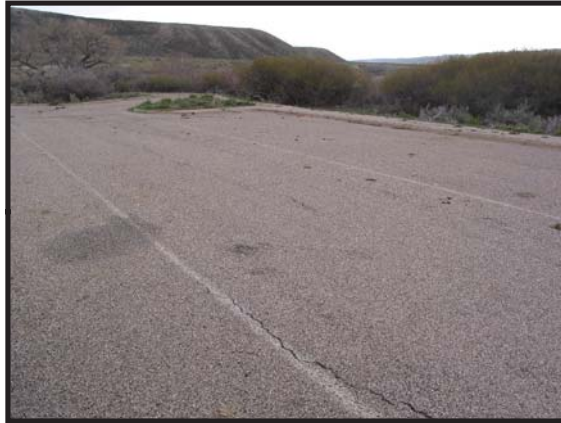
Route 0913

Route	Public / NonPublic	Date Visited	Area (sq ft)	Lane Miles *	Surface Type	Condition / PCR
0913	Public	4/22/2003	9817	0.17	OC	FAIR / 73

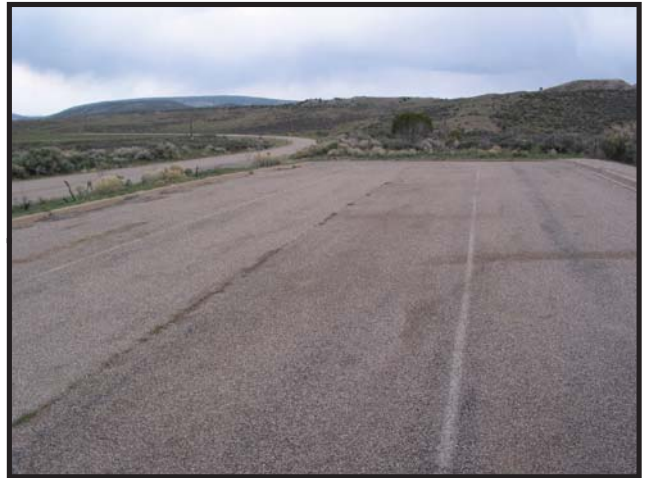
Route 0914

Route	Public / NonPublic	Date Visited	Area (sq ft)	Lane Miles *	Surface Type	Condition / PCR
0914	Public	4/23/2003	15514	0.27	OC	POOR / 45

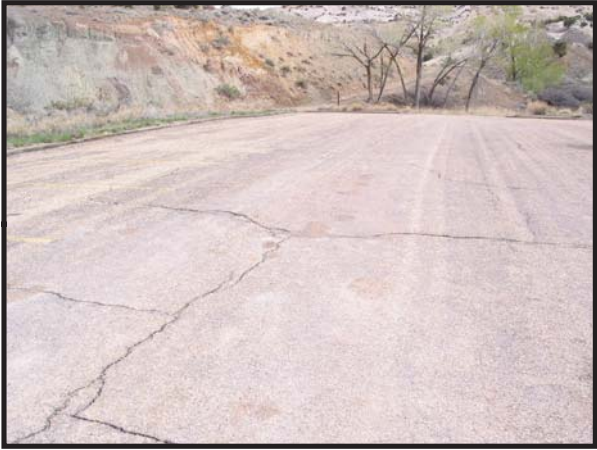
Route 0915

Route	Public / NonPublic	Date Visited	Area (sq ft)	Lane Miles *	Surface Type	Condition / PCR
0915	NonPublic	4/23/2003	6656	0.11	OC	FAIR / 73

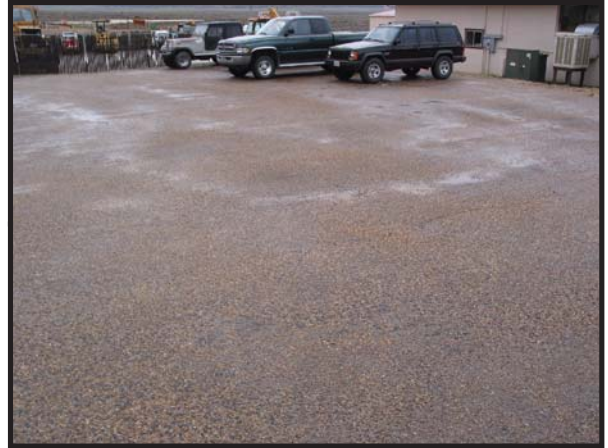
Route 0916A

Route	Public / NonPublic	Date Visited	Area (sq ft)	Lane Miles *	Surface Type	Condition / PCR
0916A	Public	4/22/2003	13271	0.23	OC	FAIR / 73

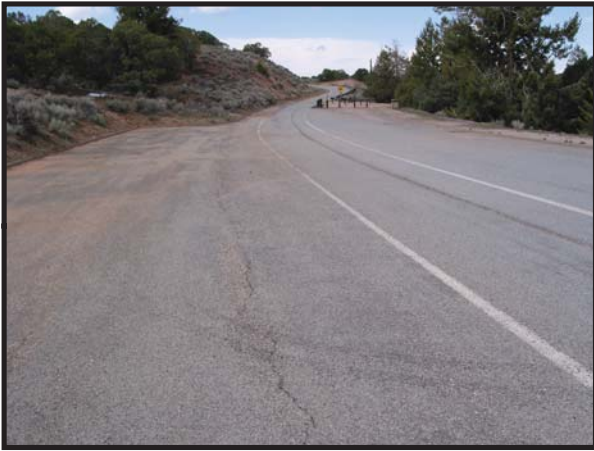
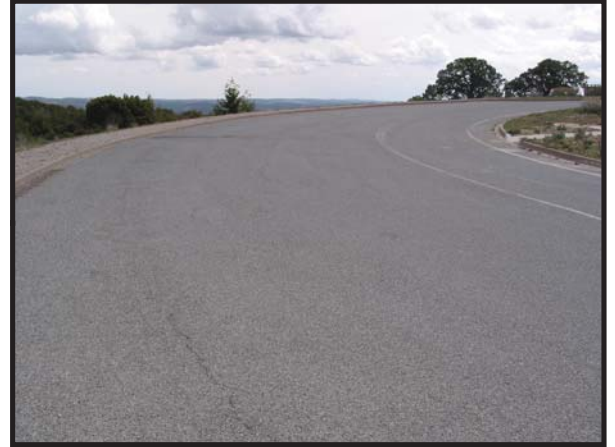
Route 0916B

Route	Public / NonPublic	Date Visited	Area (sq ft)	Lane Miles *	Surface Type	Condition / PCR
0916B	Public	4/22/2003	5884	0.10	OC	FAIR / 73

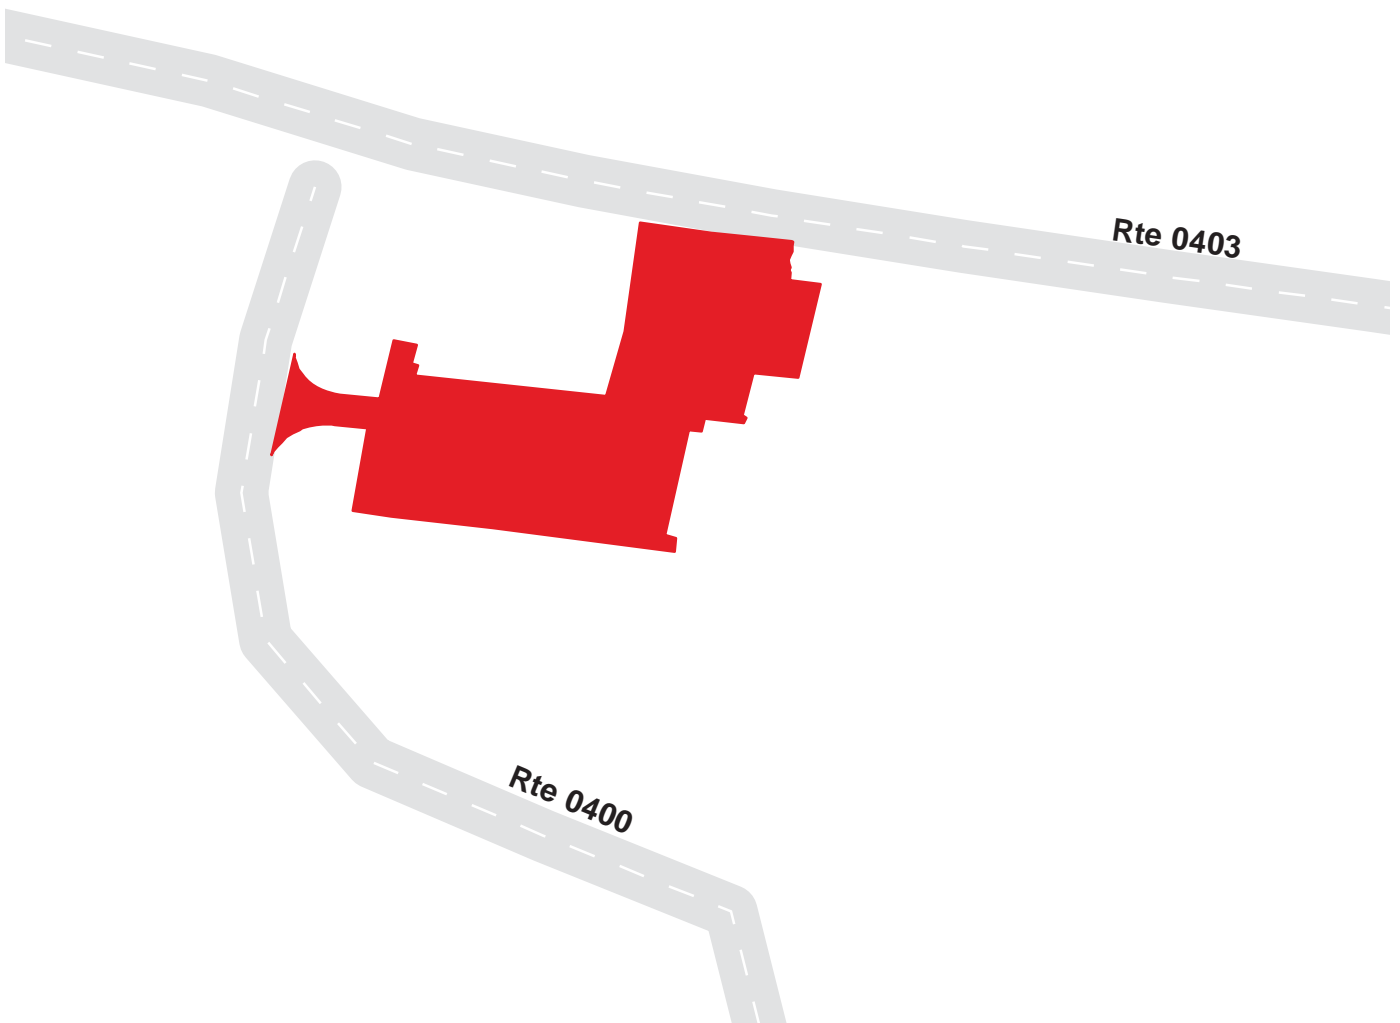
Dinosaur National Monument
Route 0917
Quarry Maintenance Area
Adjacent To Route 0400 and Route 0403

Route	Public / NonPublic	Date Visited	Area (sq ft)	Lane Miles *	Surface Type	Condition / PCR
0917	NonPublic	4/23/2003	28290	0.49	OC	POOR / 45

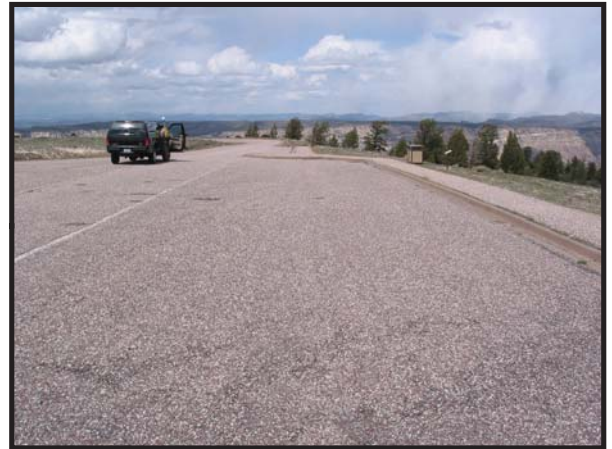
Route 0919B

Route	Public / NonPublic	Date Visited	Area (sq ft)	Lane Miles *	Surface Type	Condition / PCR
0919B	Public	4/22/2003	1186	0.02	AS	FAIR / 73

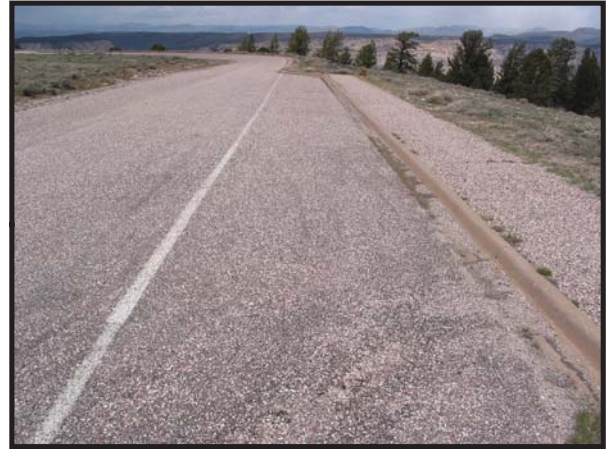
Route 0920

Route	Public / NonPublic	Date Visited	Area (sq ft)	Lane Miles *	Surface Type	Condition / PCR
0920	Public	4/22/2003	4940	0.09	AS	FAIR / 73

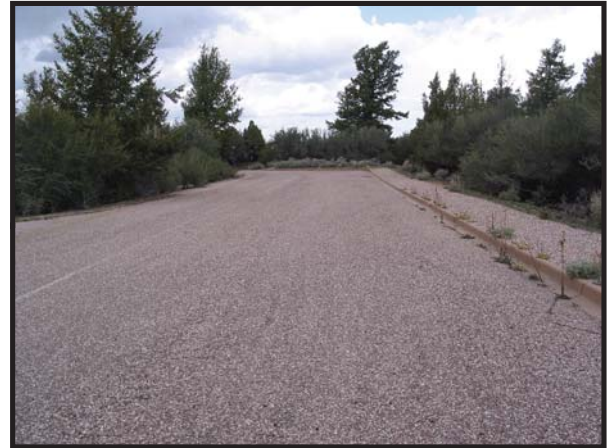
Route 0921

Route	Public / NonPublic	Date Visited	Area (sq ft)	Lane Miles *	Surface Type	Condition / PCR
0921	NonPublic	4/23/2003	4785	0.08	OC	POOR / 45

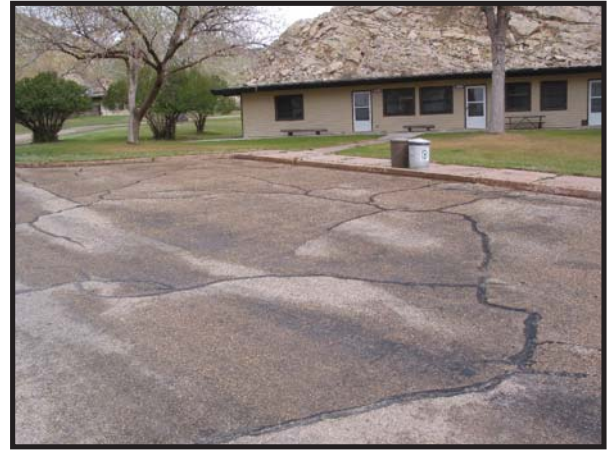
Route 0922A

Route	Public / NonPublic	Date Visited	Area (sq ft)	Lane Miles *	Surface Type	Condition / PCR
0922A	NonPublic	4/22/2003	5805	0.10	OC	FAIR / 73

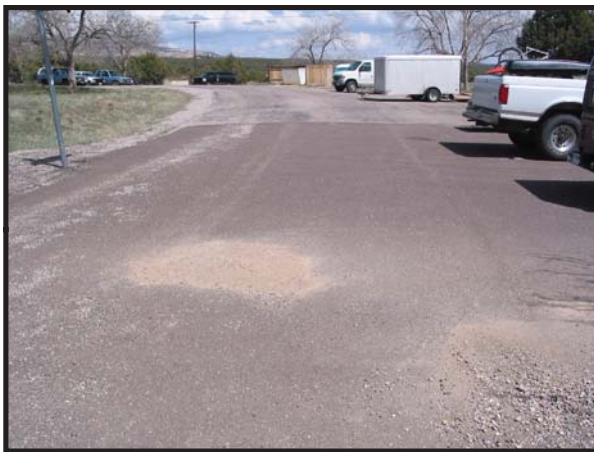
Route 0922B

Route	Public / NonPublic	Date Visited	Area (sq ft)	Lane Miles *	Surface Type	Condition / PCR
0922B	NonPublic	4/22/2003	1121	0.02	AS	GOOD / 90

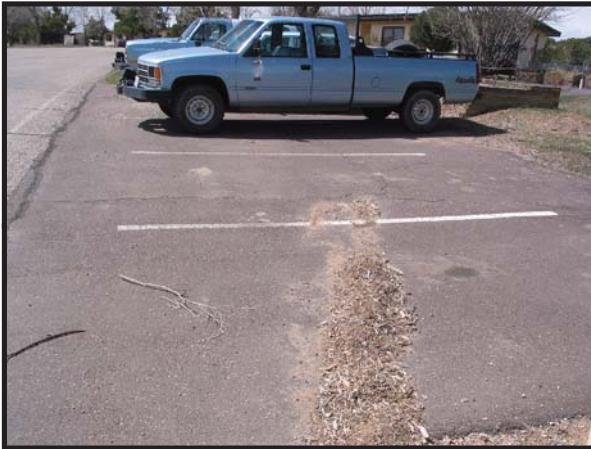
Route 0923

Route	Public / NonPublic	Date Visited	Area (sq ft)	Lane Miles *	Surface Type	Condition / PCR
0923	Public	4/22/2003	14496	0.25	OC	FAIR / 73

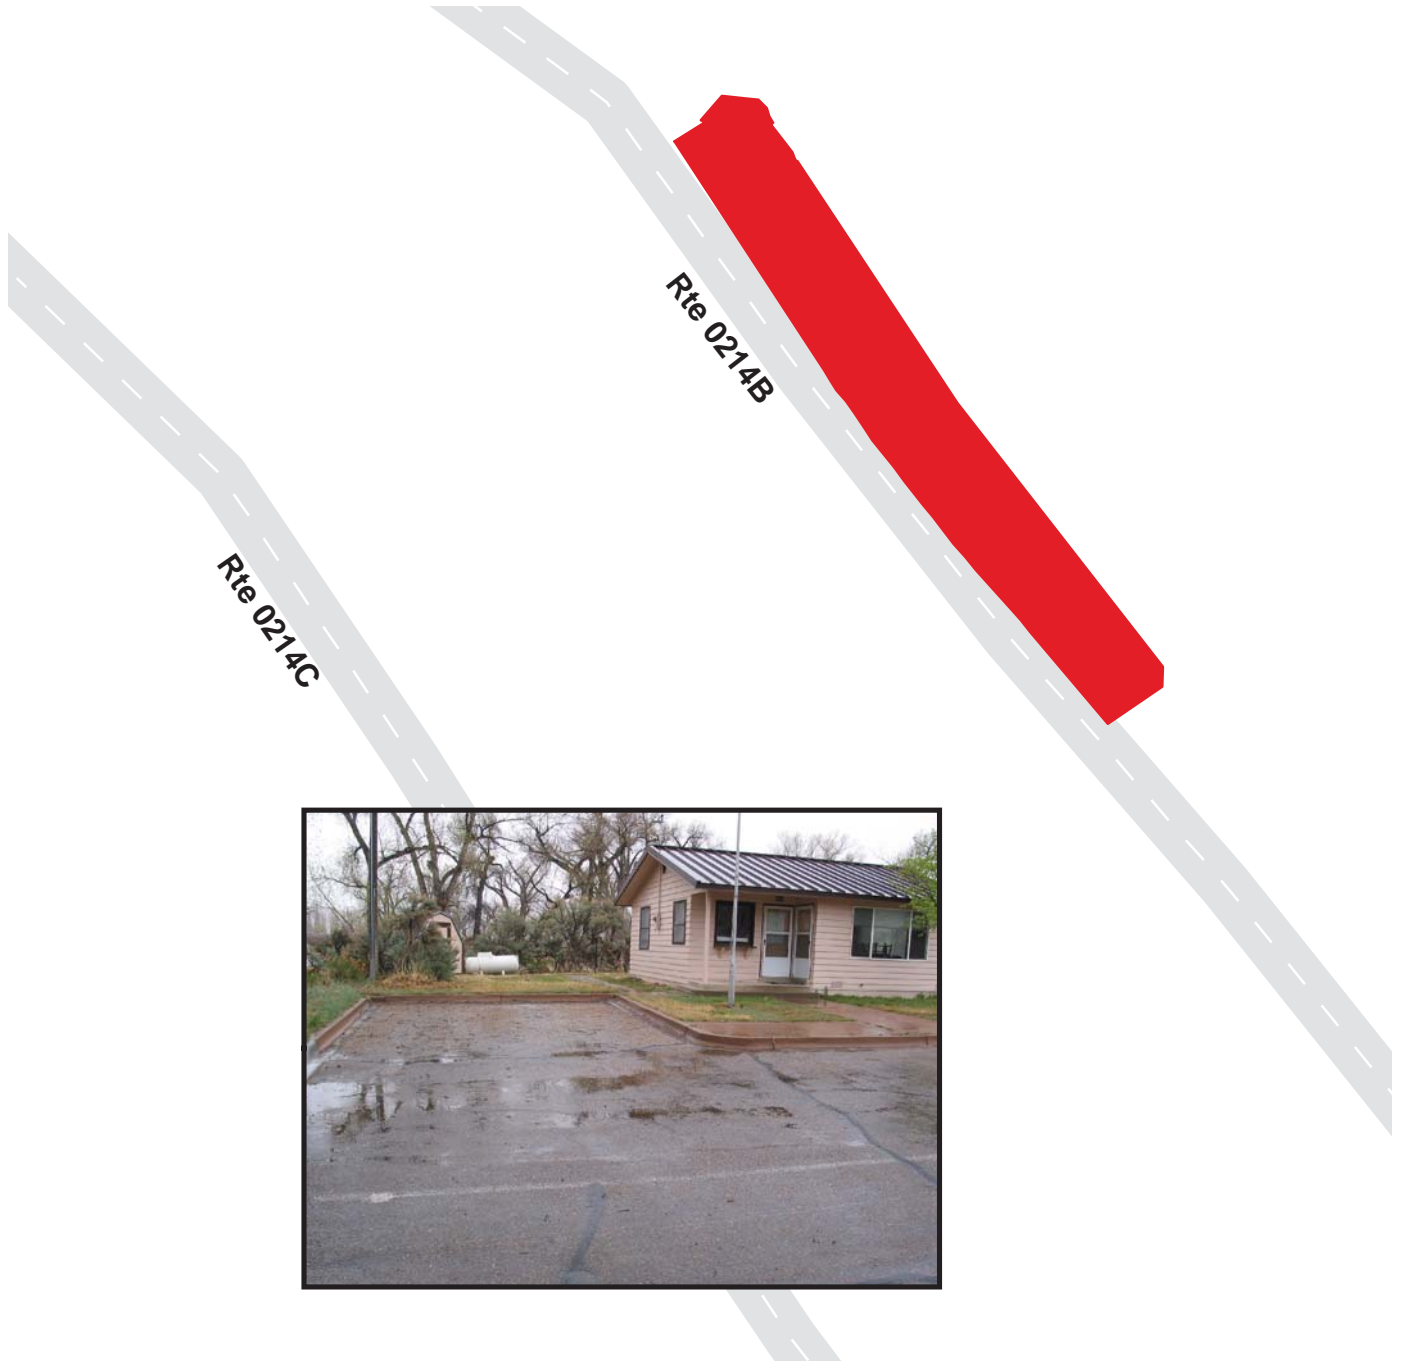
Route 0926

Route	Public / NonPublic	Date Visited	Area (sq ft)	Lane Miles *	Surface Type	Condition / PCR
0926	Public	4/23/2003	19872	0.34	NC	FAIR / 73

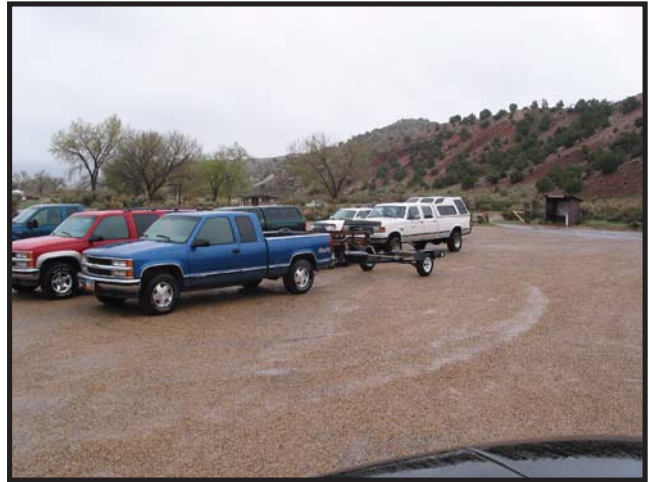
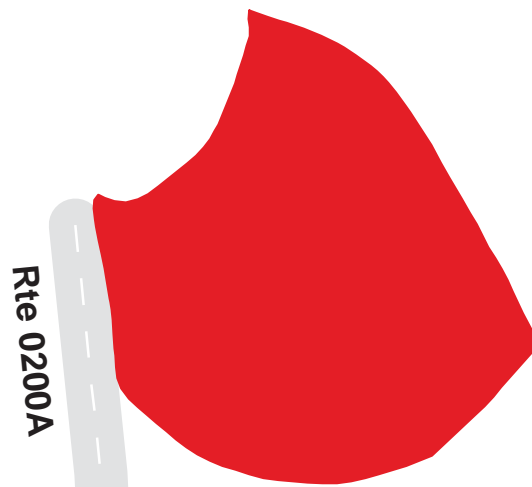
Route 0927A

Route	Public / NonPublic	Date Visited	Area (sq ft)	Lane Miles *	Surface Type	Condition / PCR
0927A	Public	4/23/2003	2418	0.04	OC	POOR / 45

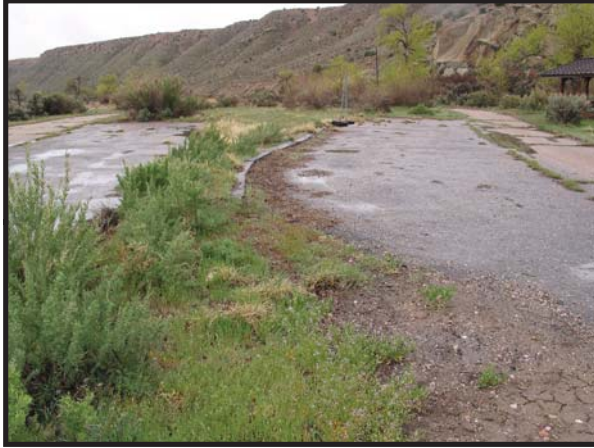
Route 0927B

Route	Public / NonPublic	Date Visited	Area (sq ft)	Lane Miles *	Surface Type	Condition / PCR
0927B	Public	4/23/2003	1790	0.03	OC	POOR / 45

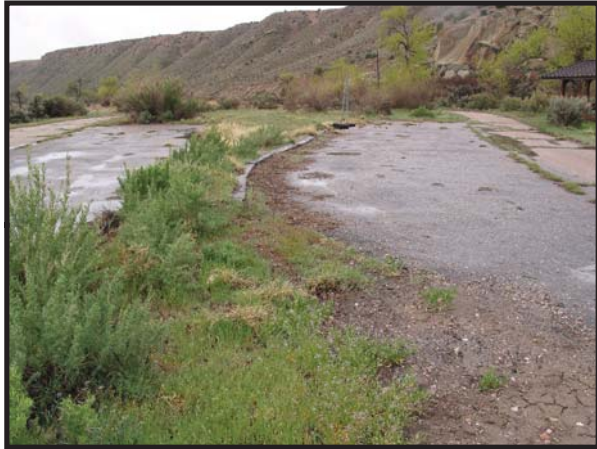
Route 0928

Route	Public / NonPublic	Date Visited	Area (sq ft)	Lane Miles *	Surface Type	Condition / PCR
0928	Public	4/23/2003	4289	0.07	OC	FAIR / 73
