The Road Inventory of Edison National Historic Site EDIS - 1840

Road Inventory Program

Prepared By:
Federal Highway Administration
Eastern Federal Lands Highway Division
Cycle 3

Edison National Historic Site in New Jersey

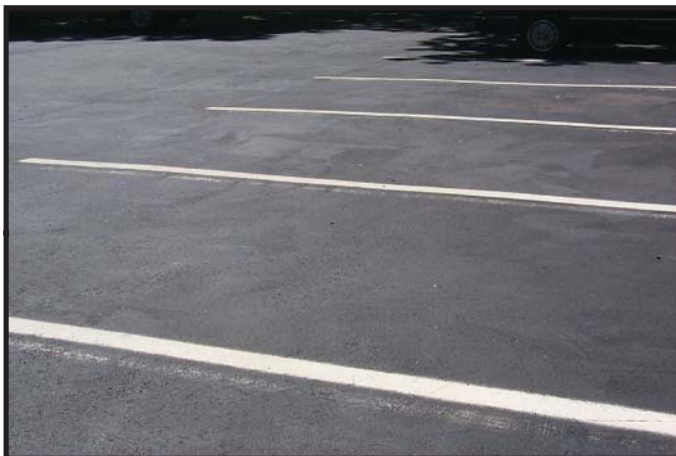
Route 0900

Route	Public / NonPublic	Date Visited	Area (sq ft)	Lane Miles *	Surface Type	Condition / PCR
0900	Public	8/8/2002	5266	0.09	AS	GOOD / 90

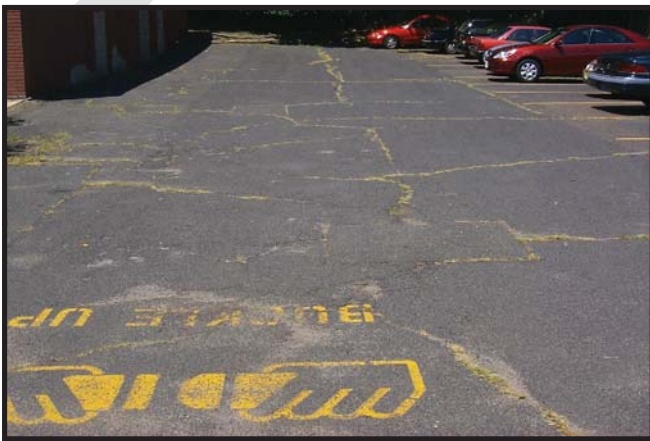
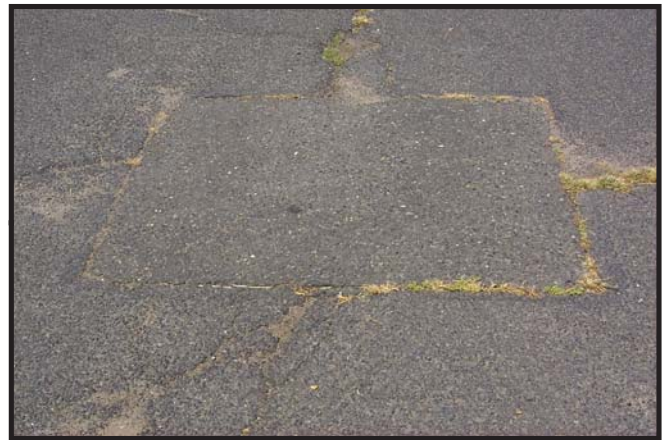
Route 0902A

Route	Public / NonPublic	Date Visited	Area (sq ft)	Lane Miles *	Surface Type	Condition / PCR
0902A	NonPublic	8/8/2002	5229	0.09	AS	POOR / 45

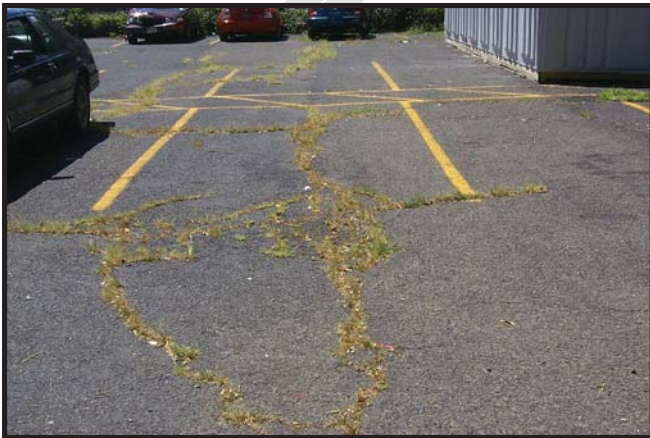
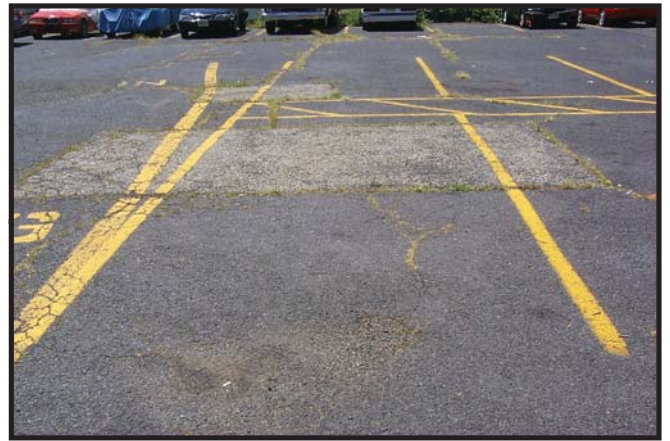
Route 0902B

Route	Public / NonPublic	Date Visited	Area (sq ft)	Lane Miles *	Surface Type	Condition / PCR
0902B	NonPublic	8/8/2002	17972	0.31	AS	POOR / 45
