The Road Inventory of Effigy Mounds National Monument EFMO – 6290

Road Inventory Program

Prepared By:
Federal Highway Administration
Eastern Federal Lands Highway Division
Cycle 3

Effigy Mounds National Monument in Iowa

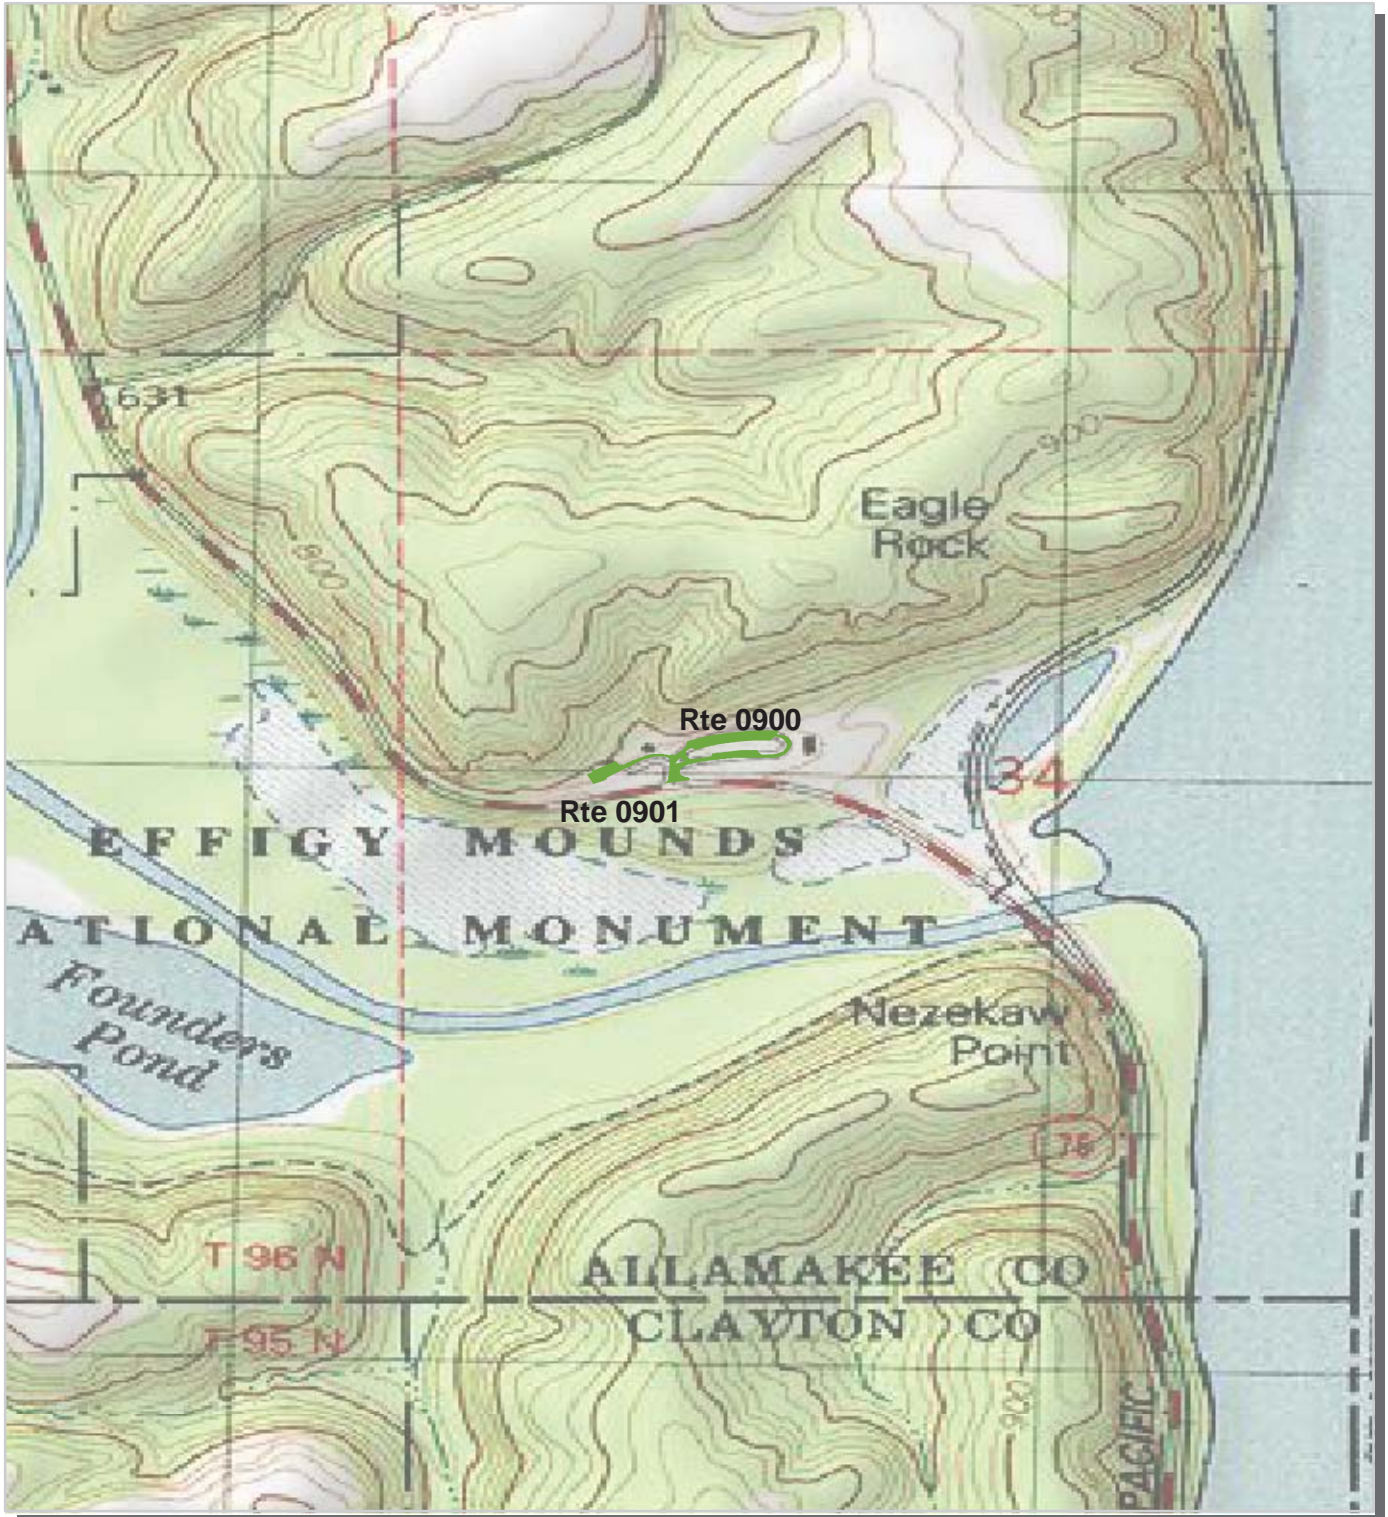
Cape Lookout National Seashore Route Condition Key Map PCR - Mile by Mile

| PCR | Poor | Fair | Good | Excellent |
| | (<=60) | (61 - 84) | (85 - 94) | (95 - 100) |

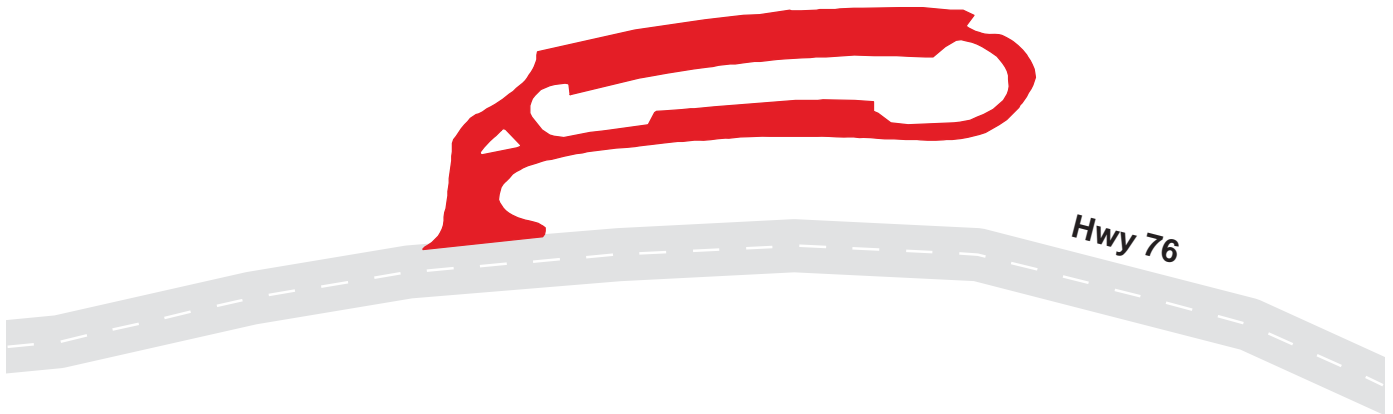
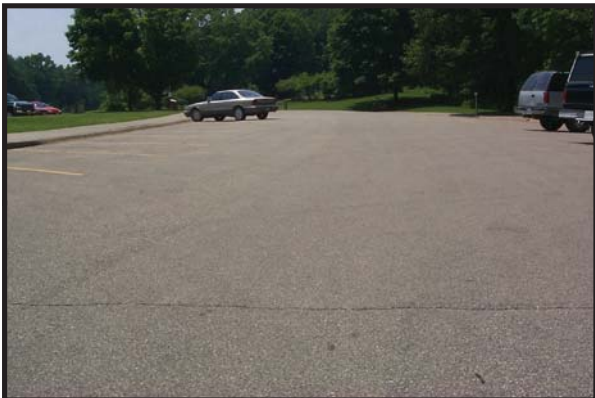
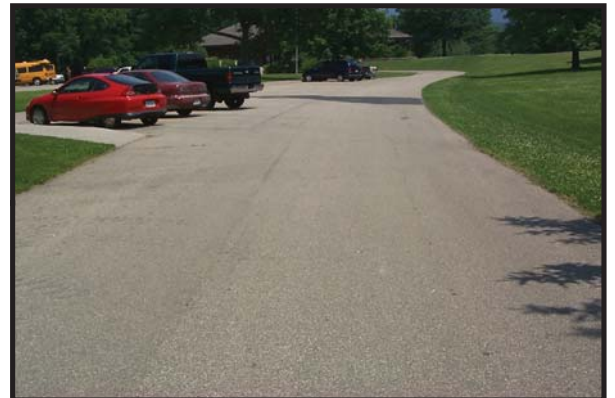
Effigy Mounds National Monument
Route 0900
 EFFIGY MOUNDS VISITOR CENTER PARKING
 From Highway 76

| Route | Public / NonPublic | Date Visited | Area (sq ft) | Lane Miles * | Surface Type | Condition / PCR |
|---|---|---|---|---|---|---|
| 0900 | Public | 6/26/2001 | 44723 | 0.77 | AS | GOOD / 90 |

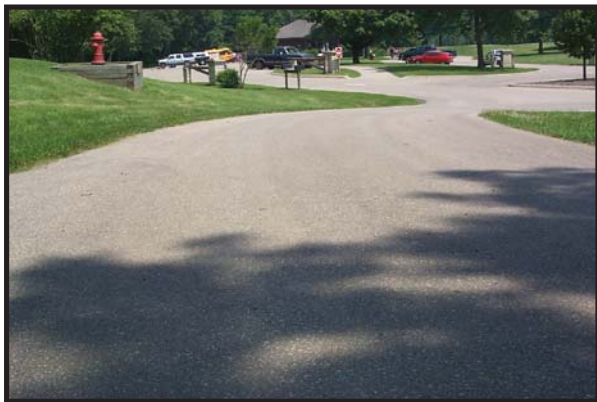
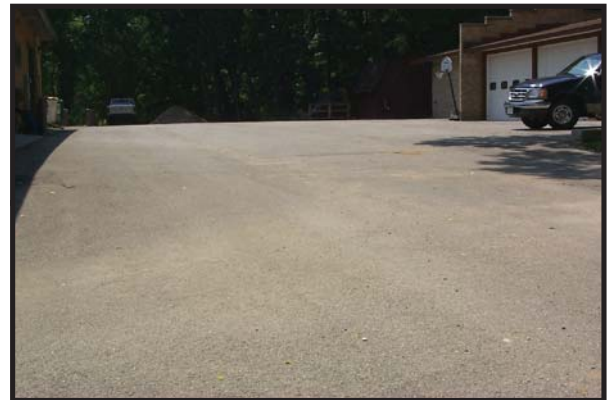
EFFIGY MOUNDS MAINTENANCE CENTER PARKING
From Route 0900

| Route | Public / NonPublic | Date Visited | Area (sq ft) | Lane Miles * | Surface Type | Condition / PCR |
|---|---|---|---|---|---|---|
| 0901 | NonPublic | 6/26/2001 | 13231 | 0.23 | AS | GOOD / 90 |
