# The Road Inventory of Eisenhower National Historic Site EISE – 4410

## Road Inventory Program

Prepared By:  
Federal Highway Administration  
Eastern Federal Lands Highway Division  
Cycle 3

# Eisenhower National Historic Site in Pennsylvania

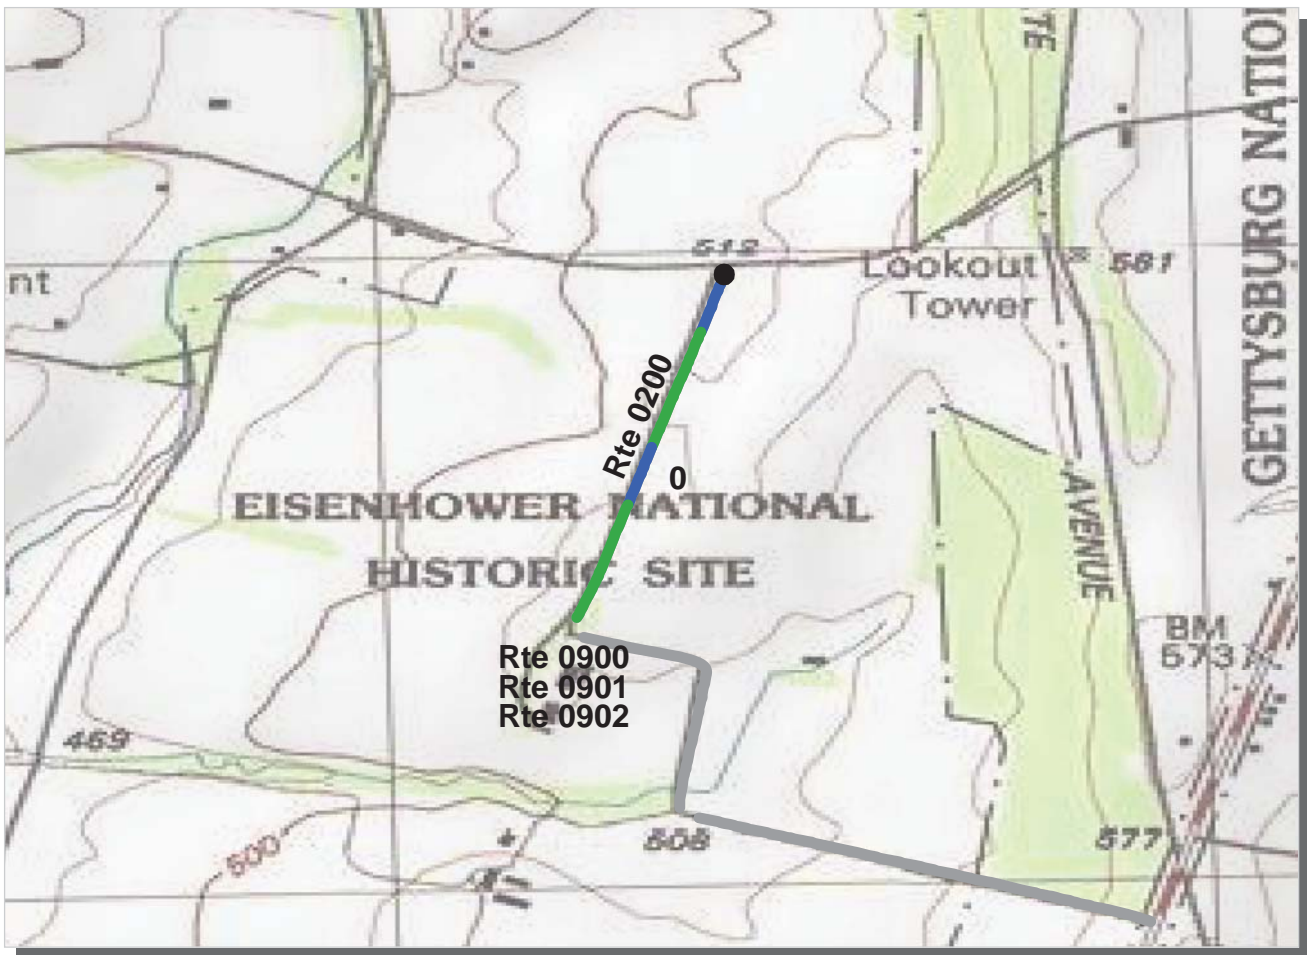
ROUTE: 0200 Eisenhower Drive

**ROUTE: 0200 Eisenhower Drive** **TOTAL LENGTH: 0.38 Miles**

Section Number	0				
Section Length (mi)	0.38				
AADT	**				
SADT	**				
ADT Date	**				
<b>Cross Section Information</b>					
Number of Lanes	1				
Paved Width (ft)	11				
Lane Width (ft)	11				
Shoulder Width (ft)	7				
<b>Roadway Condition Information</b>					
PCR (Pavement Condition Rating)	89				
RCI (Roughness Condition Index)	83				
SCR (Surface Condition Rating)	92				
Alligator Cracking Index	100				
Rutting Index	92				
Patching Index	100				
Transverse Cracking Index	100				
Longitudinal Cracking Index	100				
Shoulder Condition Rating	GOOD				
Drainage Condition Rating	GOOD

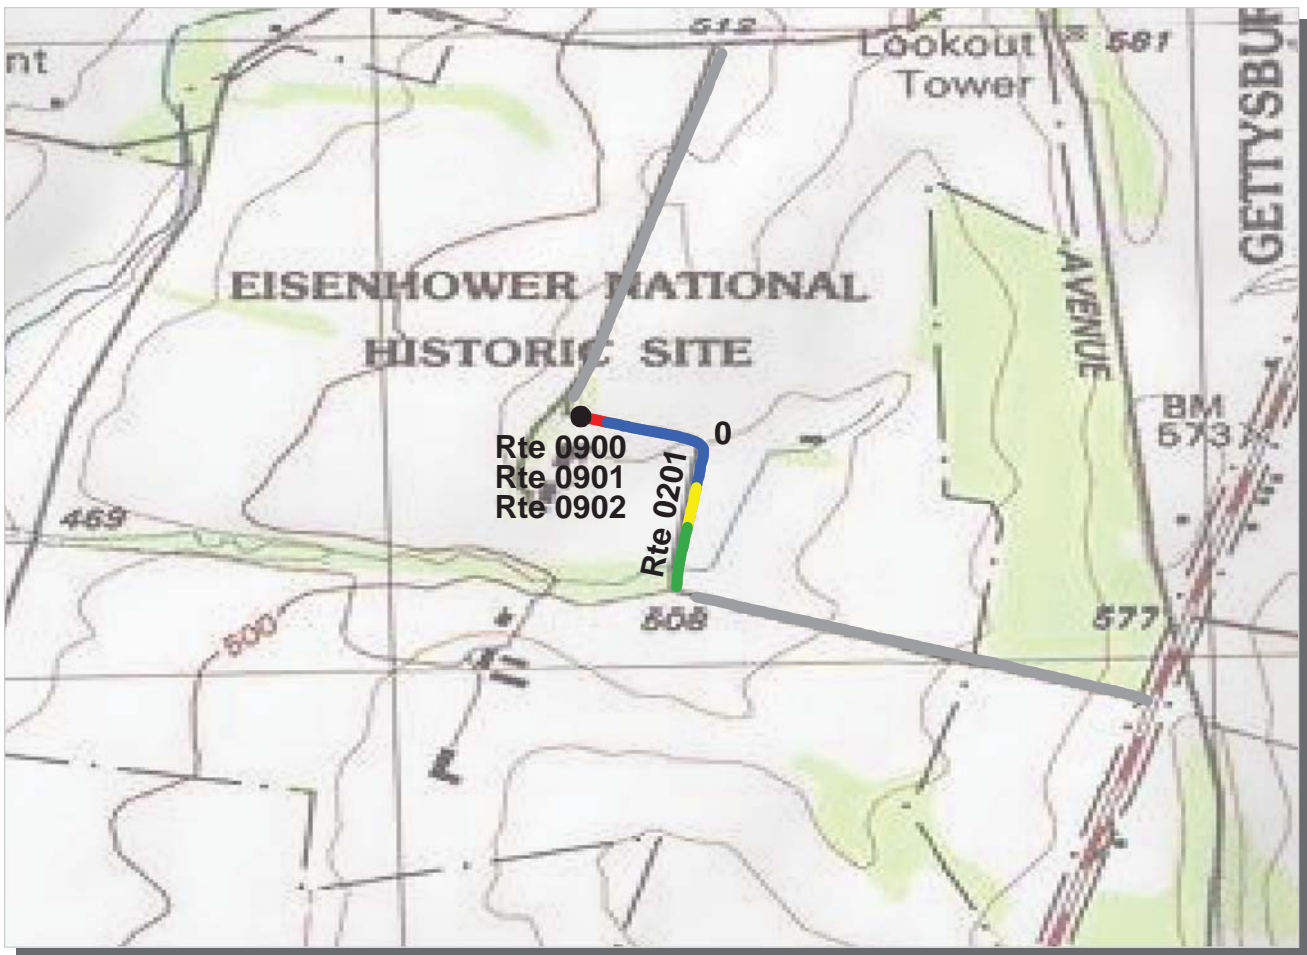
ROUTE: 0201 Nevins Lane

**ROUTE: 0201 Nevins Lane** **TOTAL LENGTH: 0.26 Miles**

Section Number	0				
Section Length (mi)	0.26				
AADT	**				
SADT	**				
ADT Date	**				
<b>Cross Section Information</b>					
Number of Lanes	1				
Paved Width (ft)	12				
Lane Width (ft)	12				
Shoulder Width (ft)	4				
<b>Roadway Condition Information</b>					
PCR (Pavement Condition Rating)	81				
RCI (Roughness Condition Index)	79				
SCR (Surface Condition Rating)	82				
Alligator Cracking Index	100				
Rutting Index	82				
Patching Index	100				
Transverse Cracking Index	100				
Longitudinal Cracking Index	100				
Shoulder Condition Rating	GOOD				
Drainage Condition Rating	GOOD

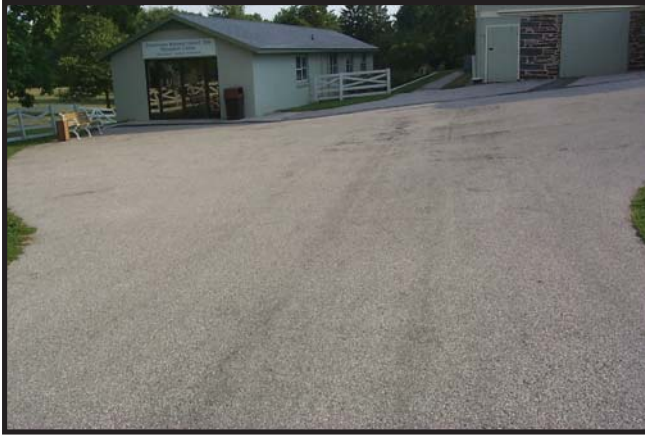
## Route 0900

Route	Public / NonPublic	Date Visited	Area (sq ft)	Lane Miles *	Surface Type	Condition / PCR
0900	NonPublic	8/22/2001	12004	0.21	AS	GOOD / 90

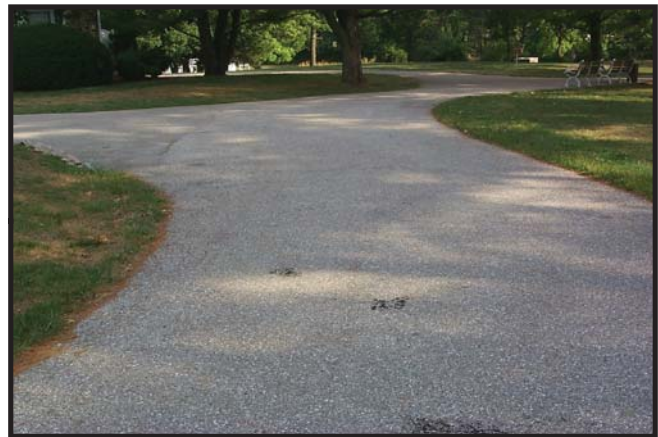
## Route 0901

Route	Public / NonPublic	Date Visited	Area (sq ft)	Lane Miles *	Surface Type	Condition / PCR
0901	NonPublic	8/22/2001	13996	0.24	AS	GOOD / 90
