# The Road Inventory of El Malpais National Monument ELMA - 7190

## Road Inventory Program

Prepared By:  
Federal Highway Administration  
Eastern Federal Lands Highway Division  
Cycle 3

# El Malpais National Monument in New Mexico

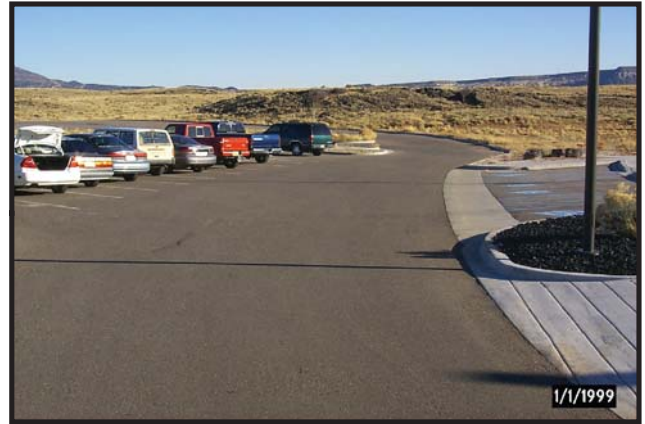
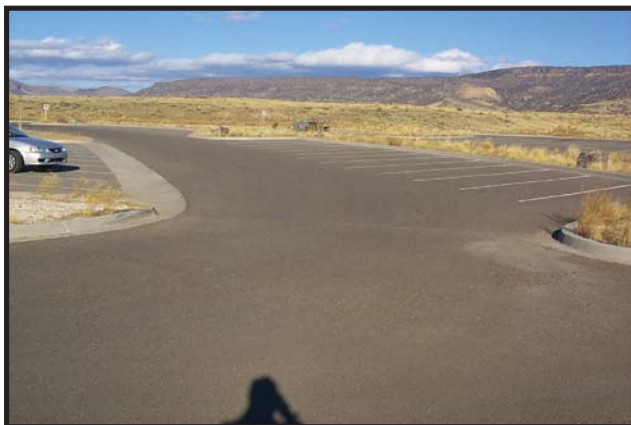
Route	Public / NonPublic	Date Visited	Area (sq ft)	Lane Miles *	Surface Type	Condition / PCR
0900	Public	12/7/2001	68700	1.18	AS	GOOD / 90

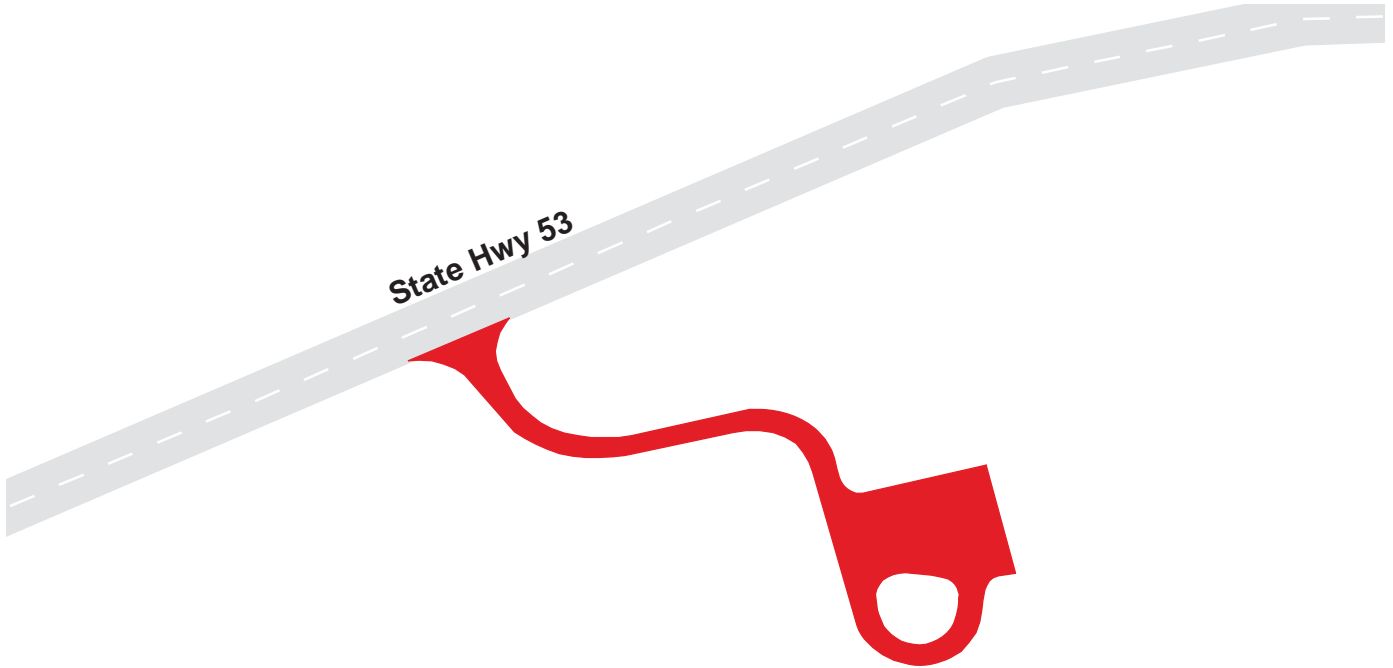
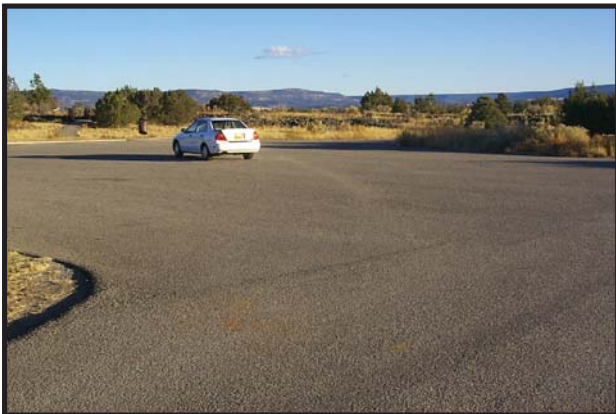
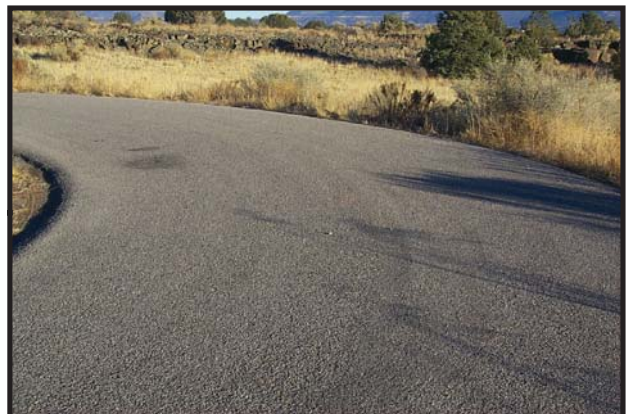
## Route 0901

Route	Public / NonPublic	Date Visited	Area (sq ft)	Lane Miles *	Surface Type	Condition / PCR
0901	Public	12/7/2001	23664	0.41	AS	GOOD / 90

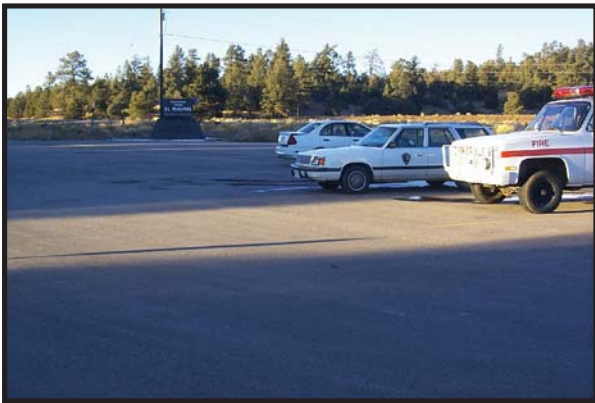
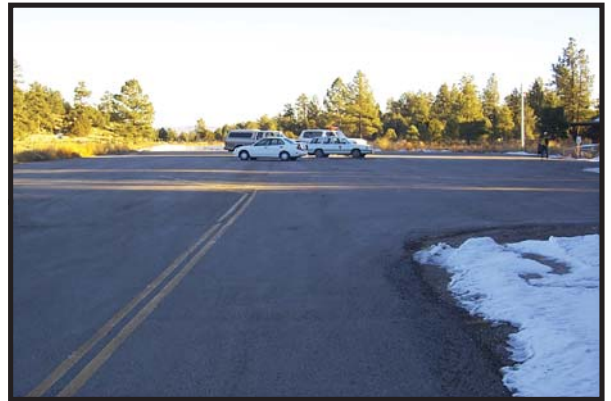
## Route 0902

Route	Public / NonPublic	Date Visited	Area (sq ft)	Lane Miles *	Surface Type	Condition / PCR
0902	Public	12/7/2001	30146	0.52	AS	GOOD / 90
