# The Road Inventory of El Morro National Monument ELMO - 7410

## Road Inventory Program

Prepared By:  
Federal Highway Administration  
Eastern Federal Lands Highway Division  
Cycle 3

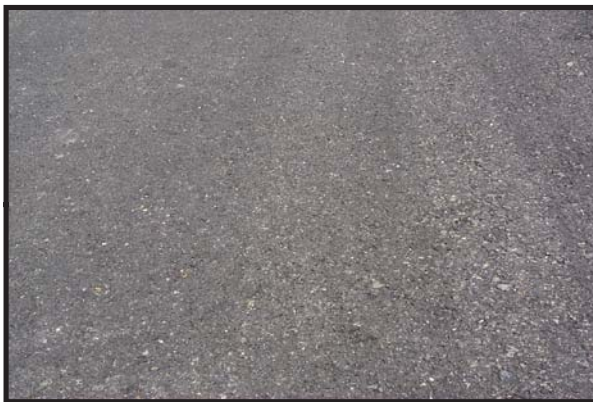
Route	Public / NonPublic	Date Visited	Area (sq ft)	Lane Miles *	Surface Type	Condition / PCR
0900	Public	4/2/2003	2235	0.04	AS	GOOD / 90

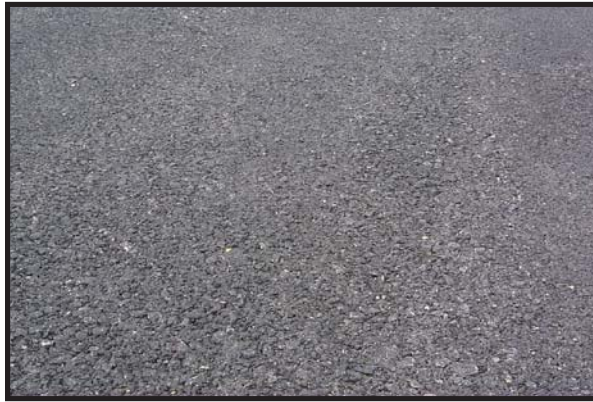
## Route 0901

Route	Public / NonPublic	Date Visited	Area (sq ft)	Lane Miles *	Surface Type	Condition / PCR
0901	Public	4/2/2003	1424	0.02	AS	GOOD / 90

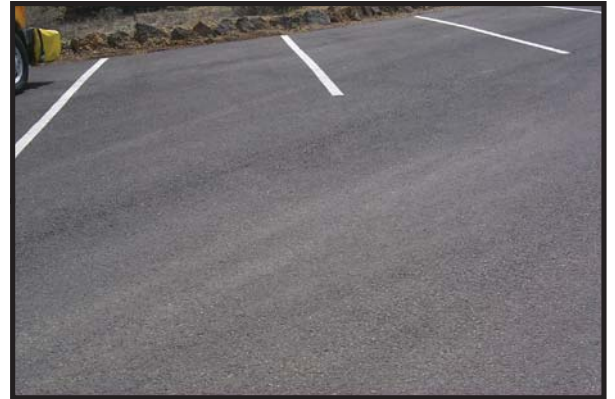
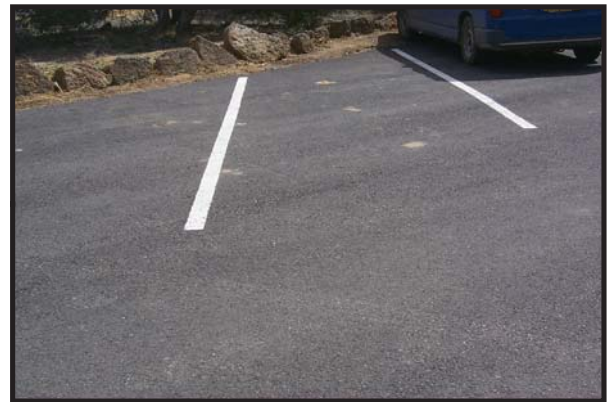
## Route 0902

Route	Public / NonPublic	Date Visited	Area (sq ft)	Lane Miles *	Surface Type	Condition / PCR
0902	Public	4/2/2003	20529	0.35	AS	GOOD / 90

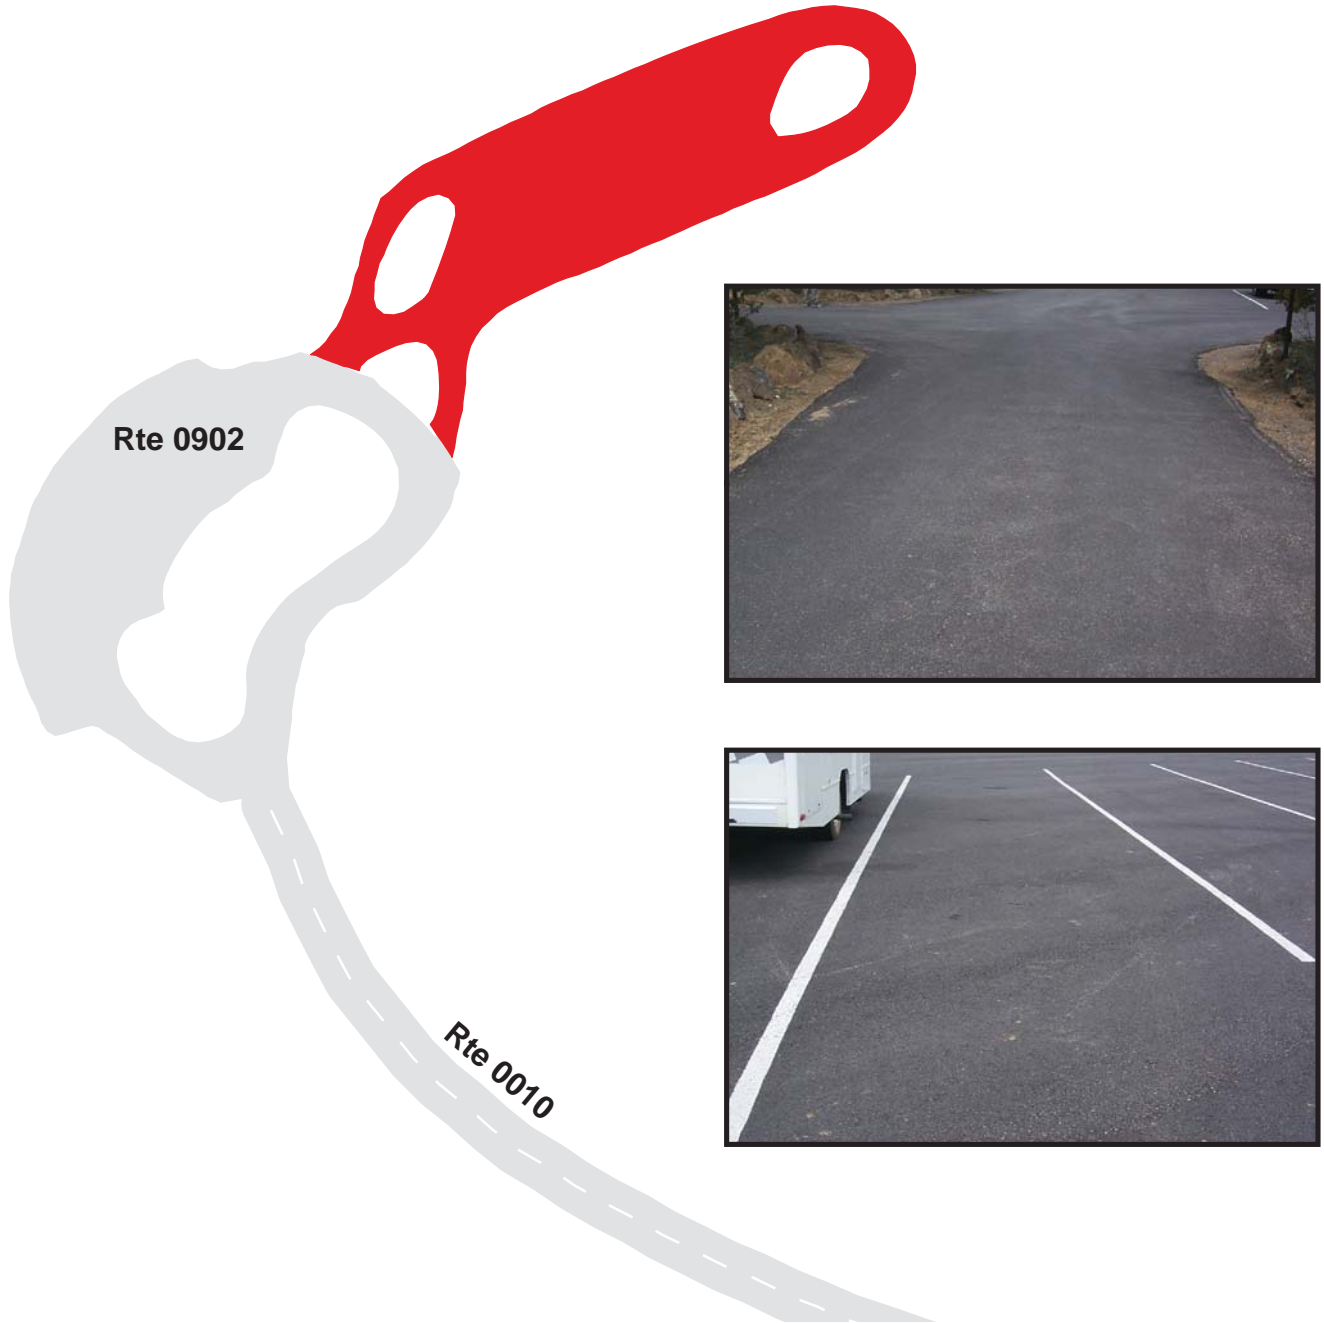
## Route 0903

Route	Public / NonPublic	Date Visited	Area (sq ft)	Lane Miles *	Surface Type	Condition / PCR
0903	Public	4/2/2003	20062	0.35	AS	GOOD / 90

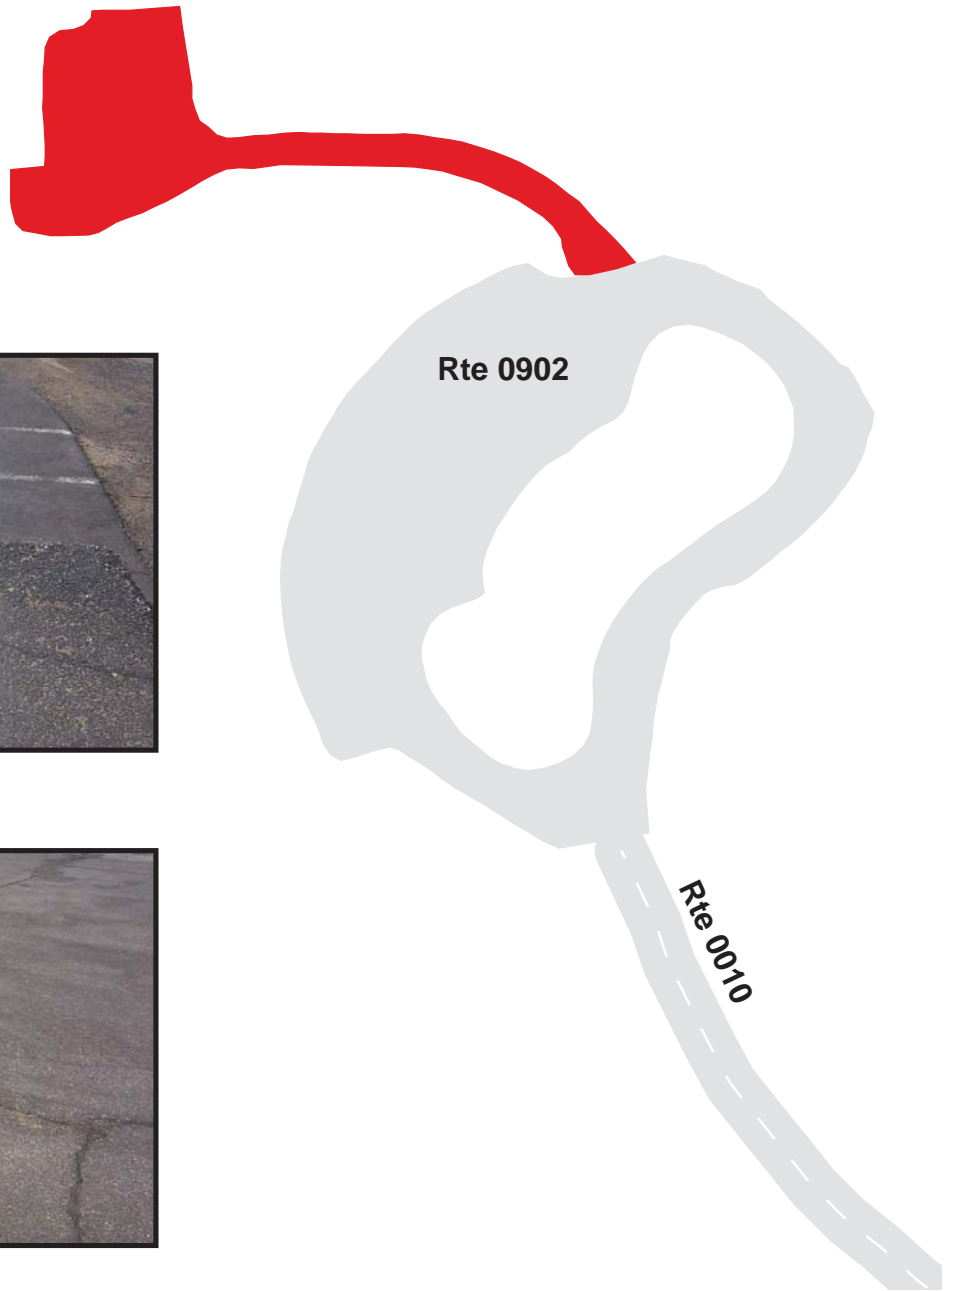
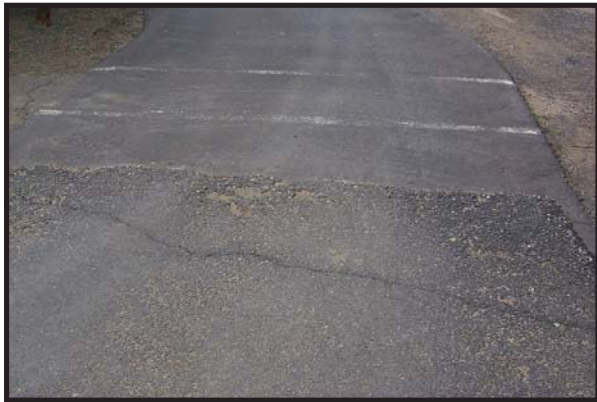
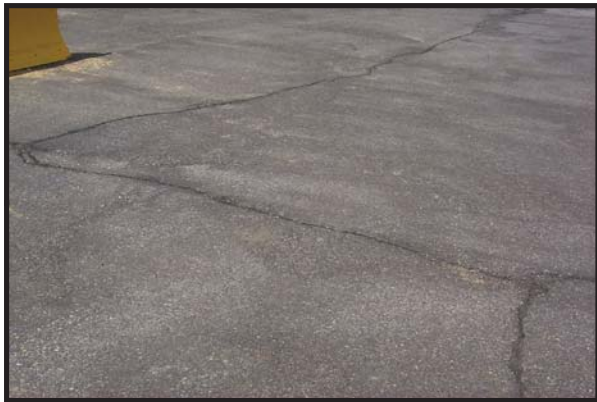
## Route 0904

Route	Public / NonPublic	Date Visited	Area (sq ft)	Lane Miles *	Surface Type	Condition / PCR
0904	NonPublic	4/2/2003	6499	0.11	AS	POOR / 45

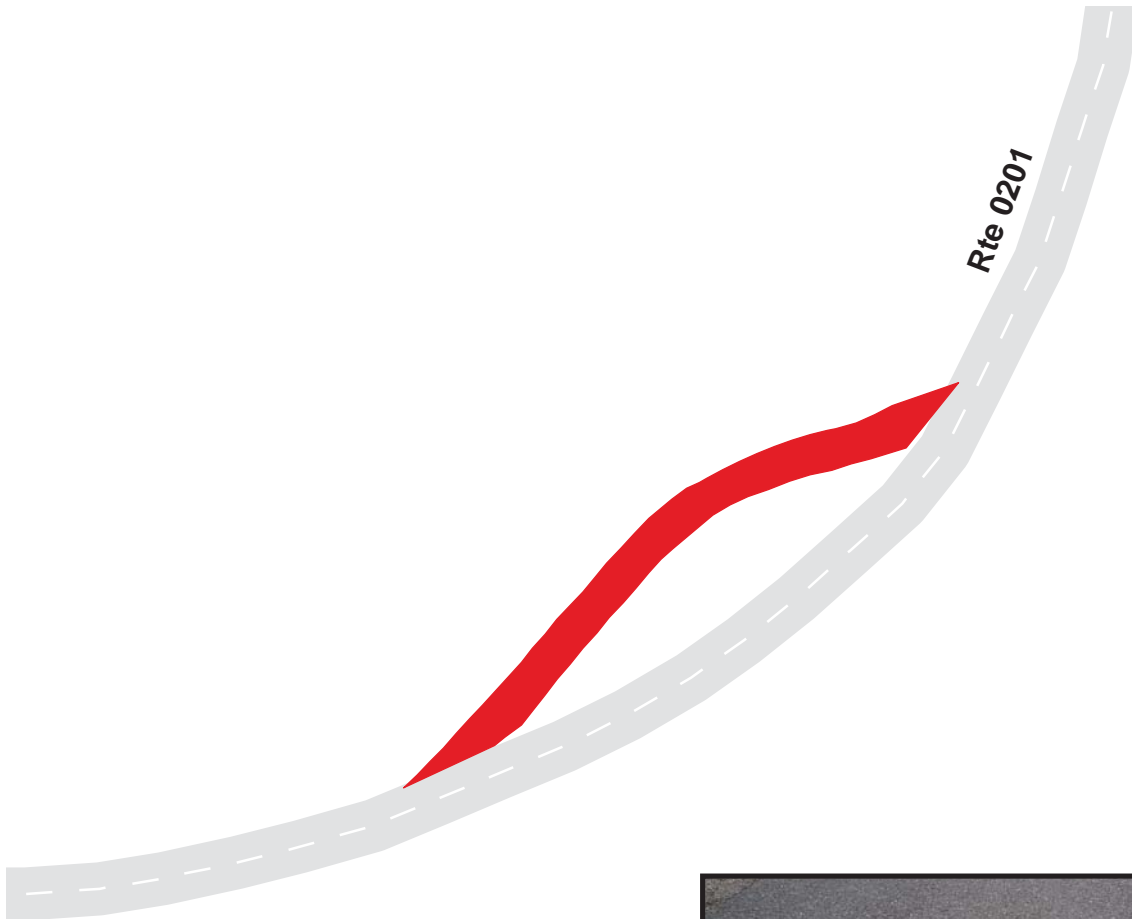
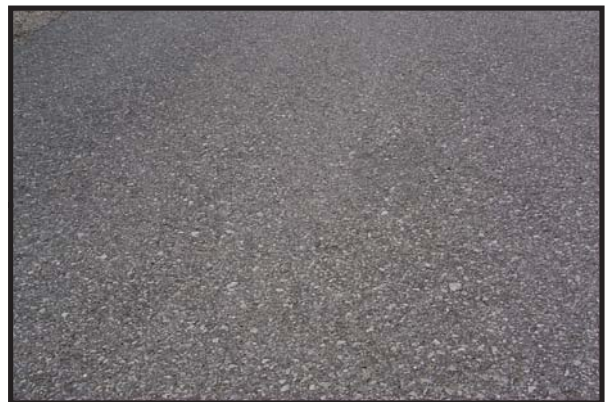
## Route 0906

Route	Public / NonPublic	Date Visited	Area (sq ft)	Lane Miles *	Surface Type	Condition / PCR
0906	Public	4/2/2003	1343	0.02	AS	GOOD / 90
