The Road Inventory of Eleanor Roosevelt National Historic Site ELRO - 1793

Road Inventory Program

Prepared By:
Federal Highway Administration
Eastern Federal Lands Highway Division
Cycle 3

Eleanor Roosevelt National Historic Site in New York

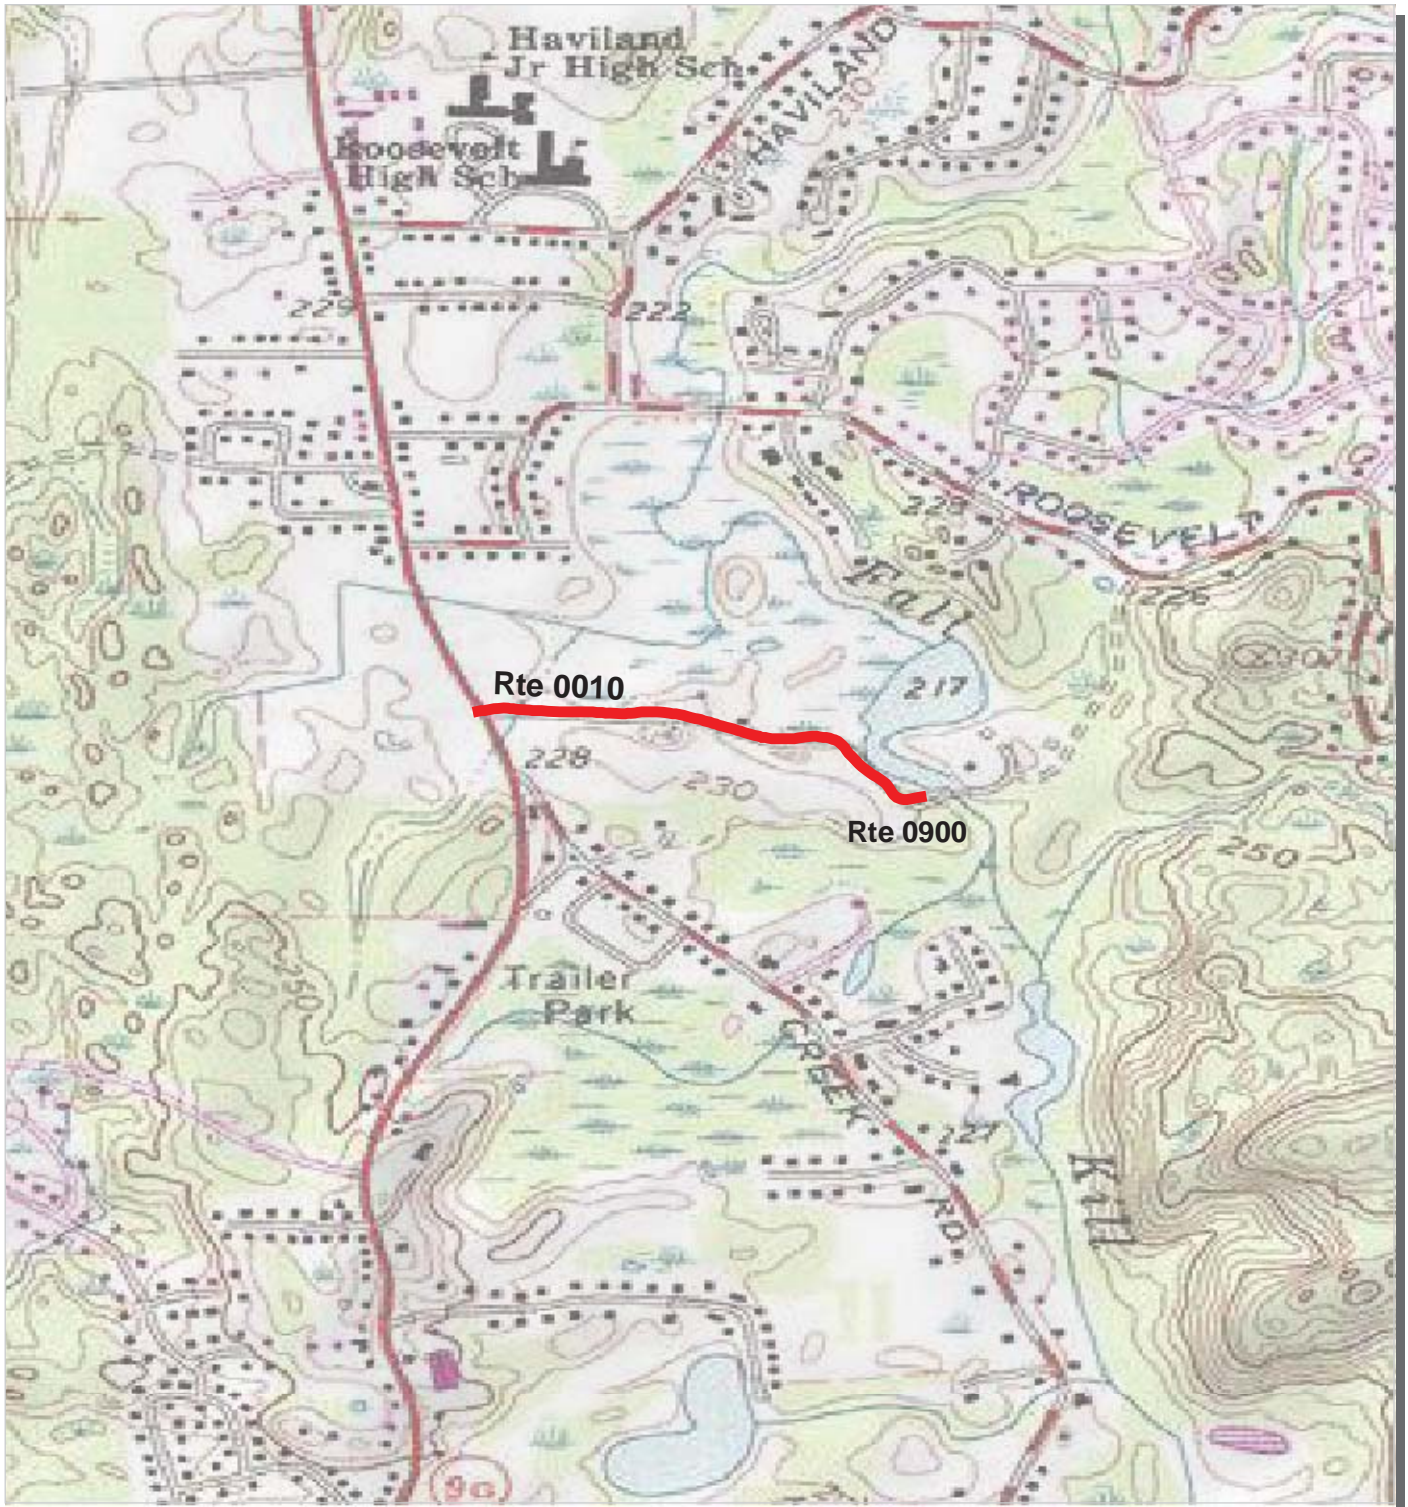
Eleanor Roosevelt National Historic Site Route Condition Key Map PCR - Mile by Mile

PCR	Poor		Fair		Good		Excellent	
	(<=60)		(61 - 84)		(85 - 94)		(95 - 100)

* If the PCR rating is not available for a section, the SCR rating will be displayed. See appendix for definitions and formulas.

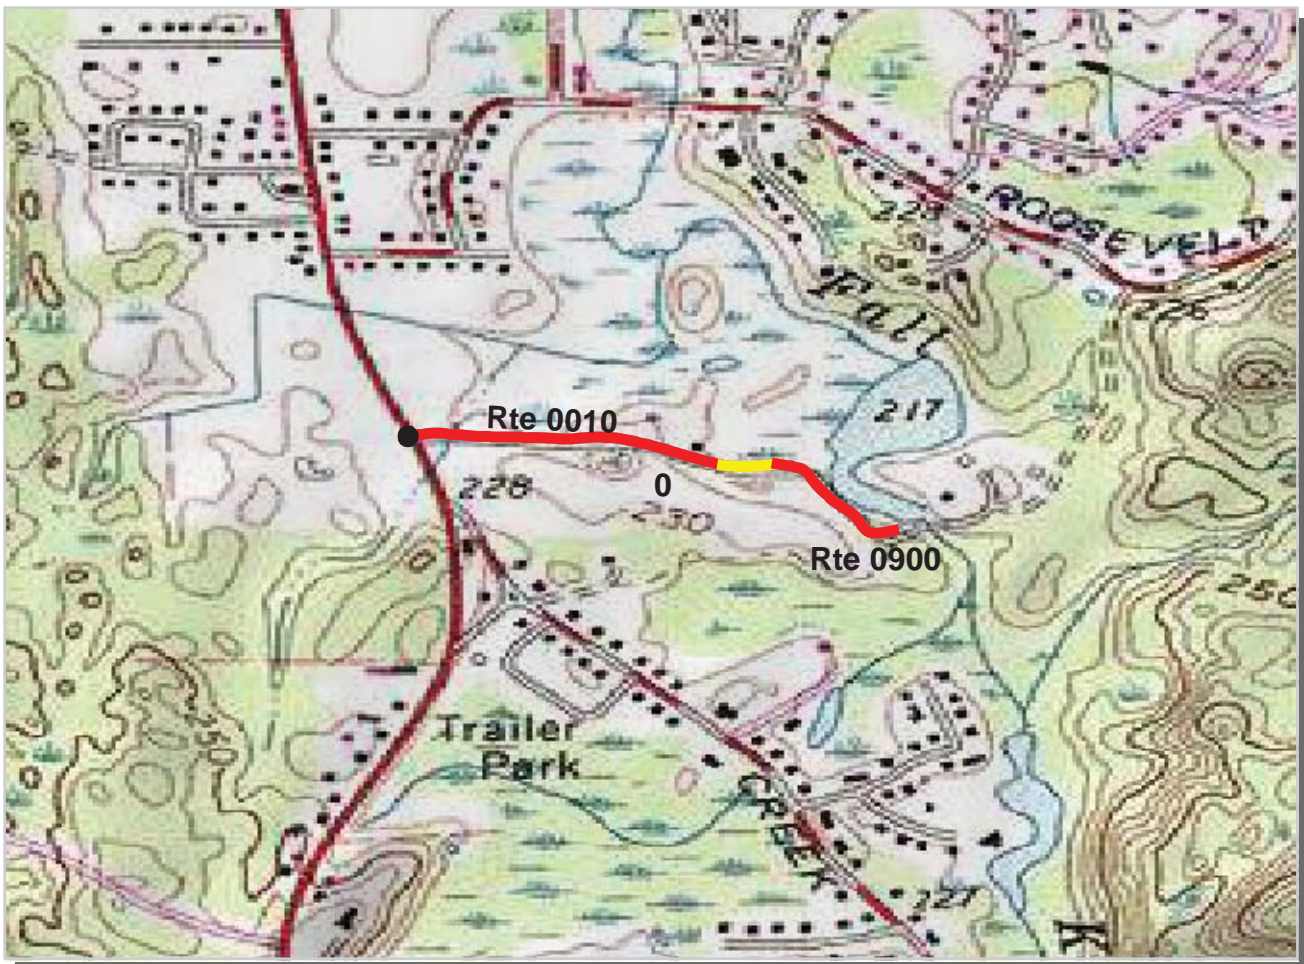
ROUTE: 0010 Main Entrance Road **TOTAL LENGTH: 0.42 Miles**

Section Number	0			
Section Length (mi)	0.42			
AADT	**			
SADT	**			
ADT Date	**			
Cross Section Information				
Number of Lanes	2			
Paved Width (ft)	18			
Lane Width (ft)	8			
Shoulder Width (ft)	0			
Roadway Condition Information				
PCR (Pavement Condition Rating)	49			
RCI (Roughness Condition Index)	71			
SCR (Surface Condition Rating)	40			
Alligator Cracking Index	100			
Rutting Index	40			
Patching Index	100			
Transverse Cracking Index	99			
Longitudinal Cracking Index	100			
Shoulder Condition Rating	N/A			
Drainage Condition Rating	GOOD

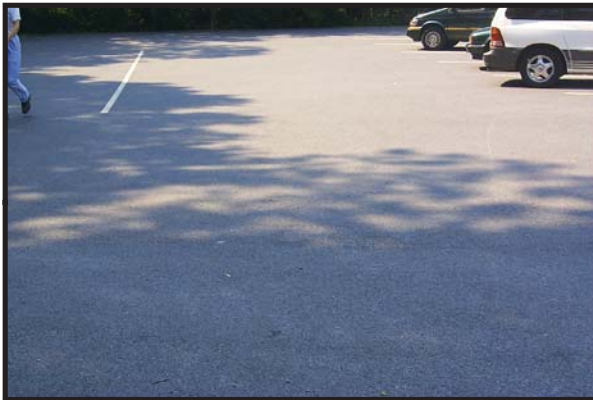
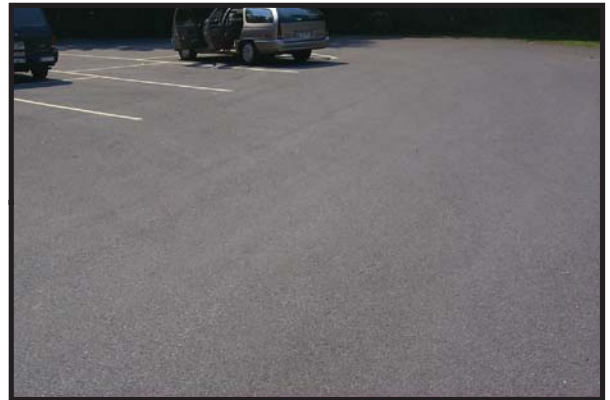
Route 0900

Main Parking
From Route 0010

Route	Public / NonPublic	Date Visited	Area (sq ft)	Lane Miles *	Surface Type	Condition / PCR
0900	Public	8/12/2002	13250	0.23	AS	GOOD / 90
