The Road Inventory of Eugene O'Neill National Historic Site EUON - 8190

Road Inventory Program

Prepared By:
Federal Highway Administration
Eastern Federal Lands Highway Division
Cycle 3

Eugene O'Neill National Historic Site in California

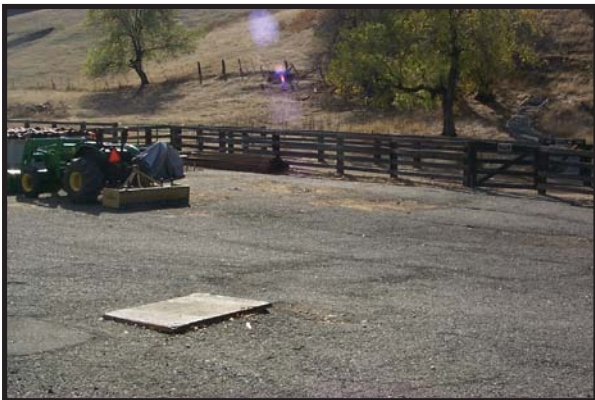
Route	Public / NonPublic	Date Visited	Area (sq ft)	Lane Miles *	Surface Type	Condition / PCR
0900	NonPublic	1/0/1900	19029	0.33	NC	POOR / 45

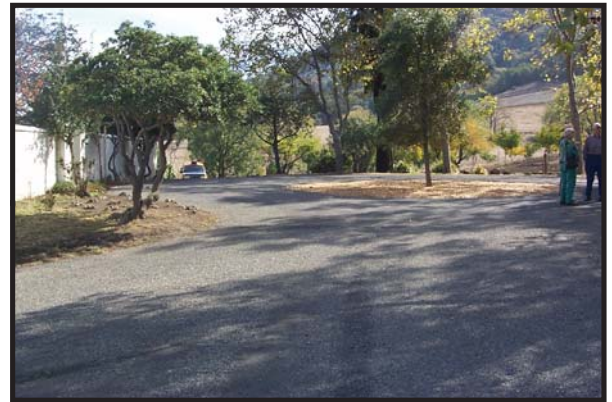
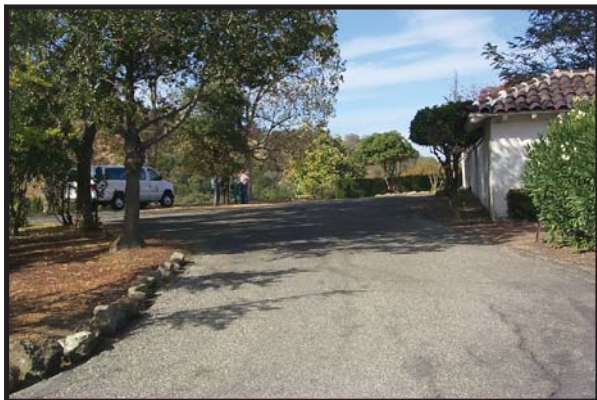
Route 0901

Route	Public / NonPublic	Date Visited	Area (sq ft)	Lane Miles *	Surface Type	Condition / PCR
0901	Public	1/0/1900	6012	0.10	NC	FAIR / 73

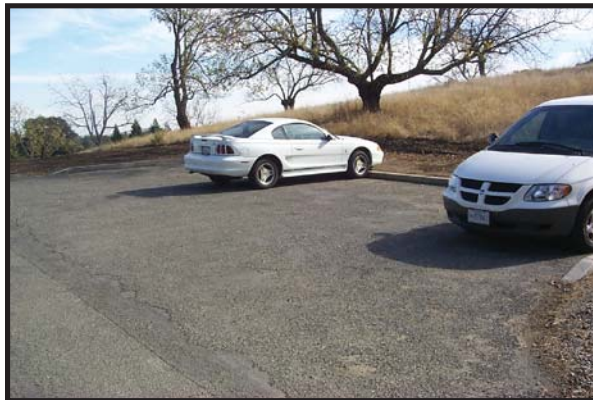
Route 0902

Route	Public / NonPublic	Date Visited	Area (sq ft)	Lane Miles *	Surface Type	Condition / PCR
0902	Public	1/0/1900	1428	0.02	NC	FAIR / 73

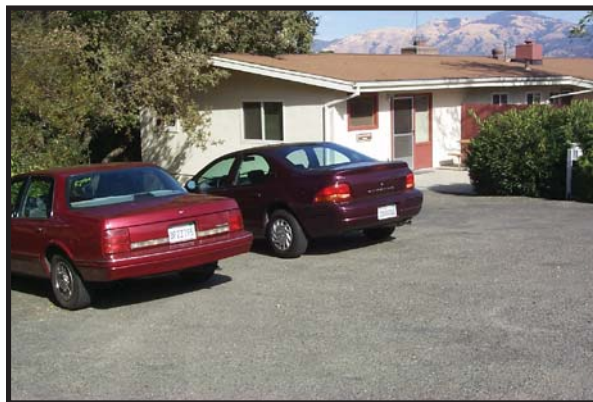
Route 0903

Route	Public / NonPublic	Date Visited	Area (sq ft)	Lane Miles *	Surface Type	Condition / PCR
0903	NonPublic	1/0/1900	1330	0.02	NC	FAIR / 73
