The Road Inventory of Everglades National Park EVER - 5280

Road Inventory Program

Prepared By:
Federal Highway Administration
Eastern Federal Lands Highway Division
Cycle 3

Everglades National Park in Florida

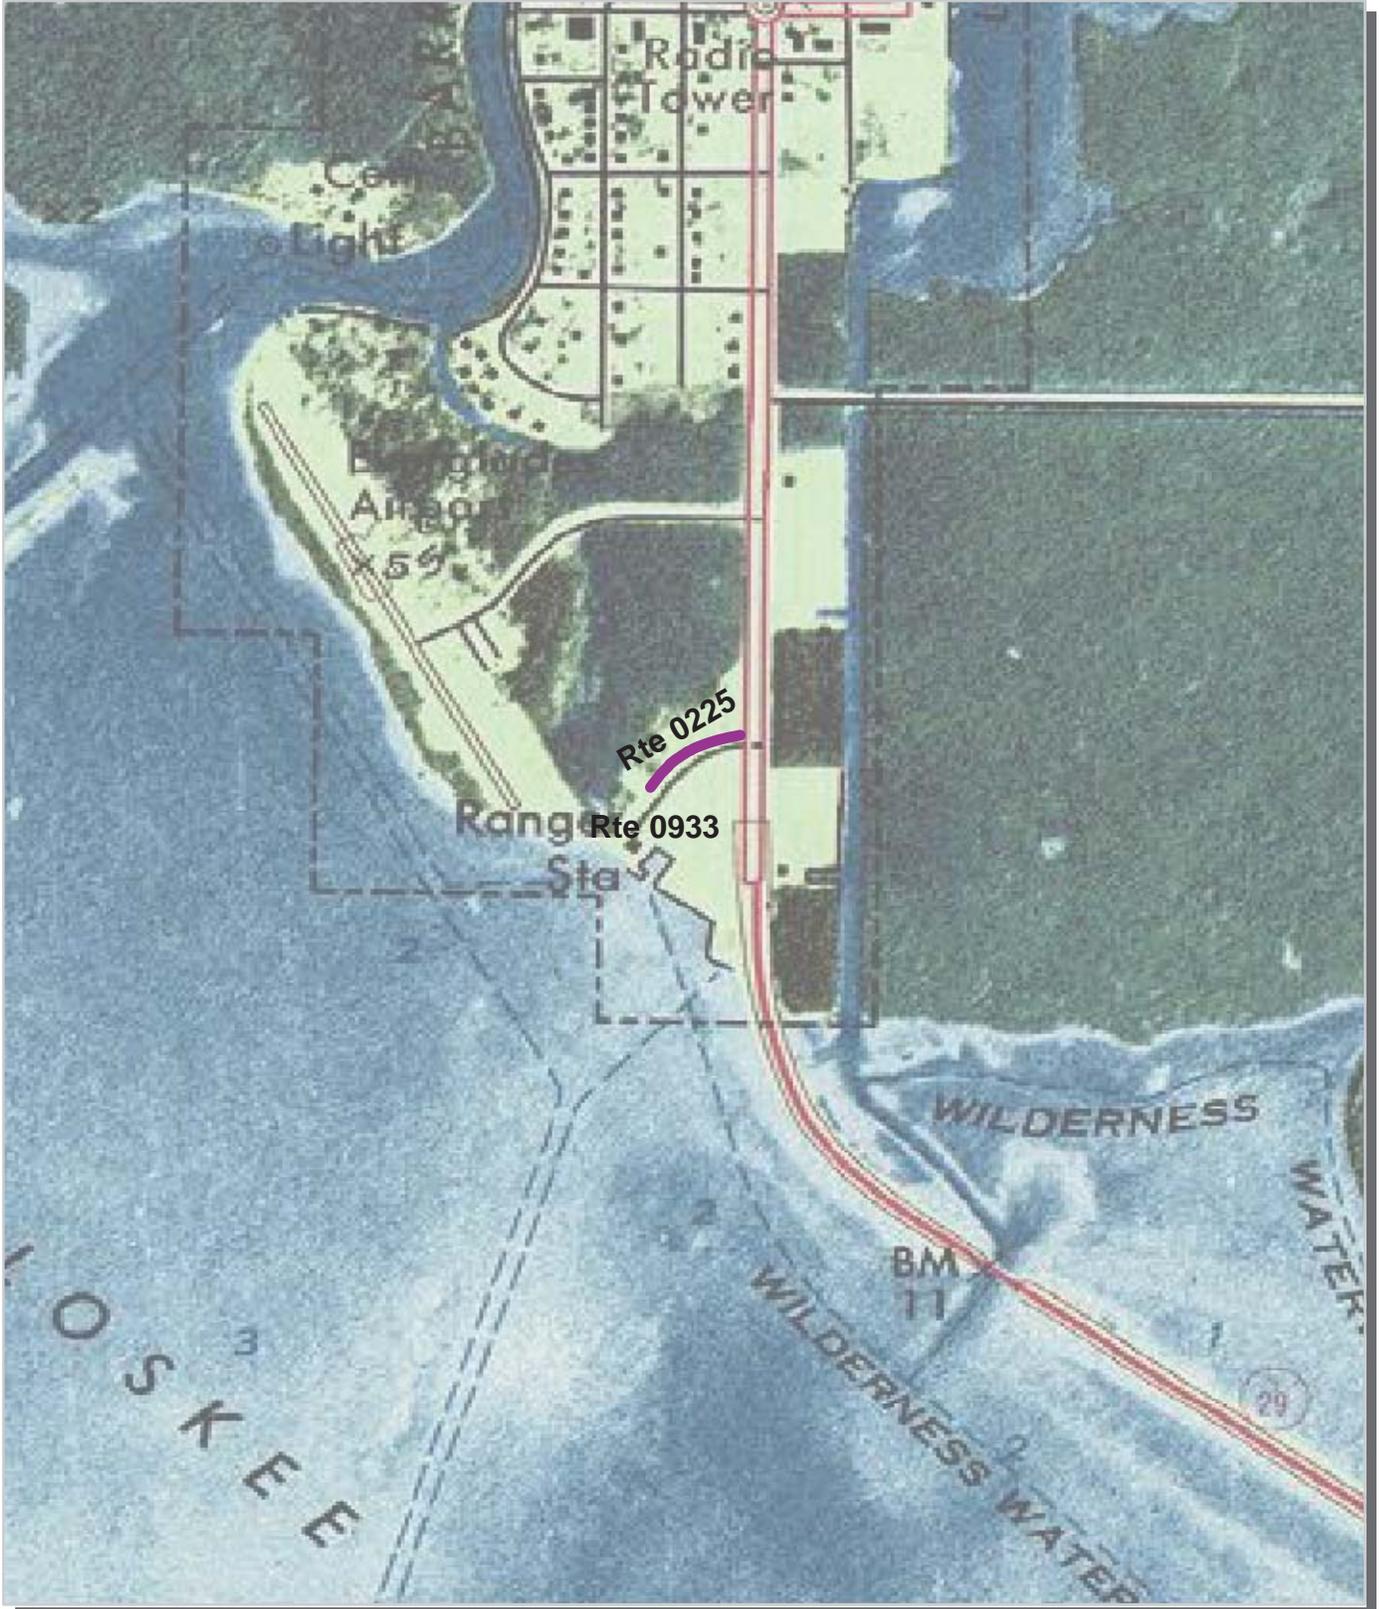
Everglades National Park Route Location Area Map 1

Unique colors used to differentiate routes

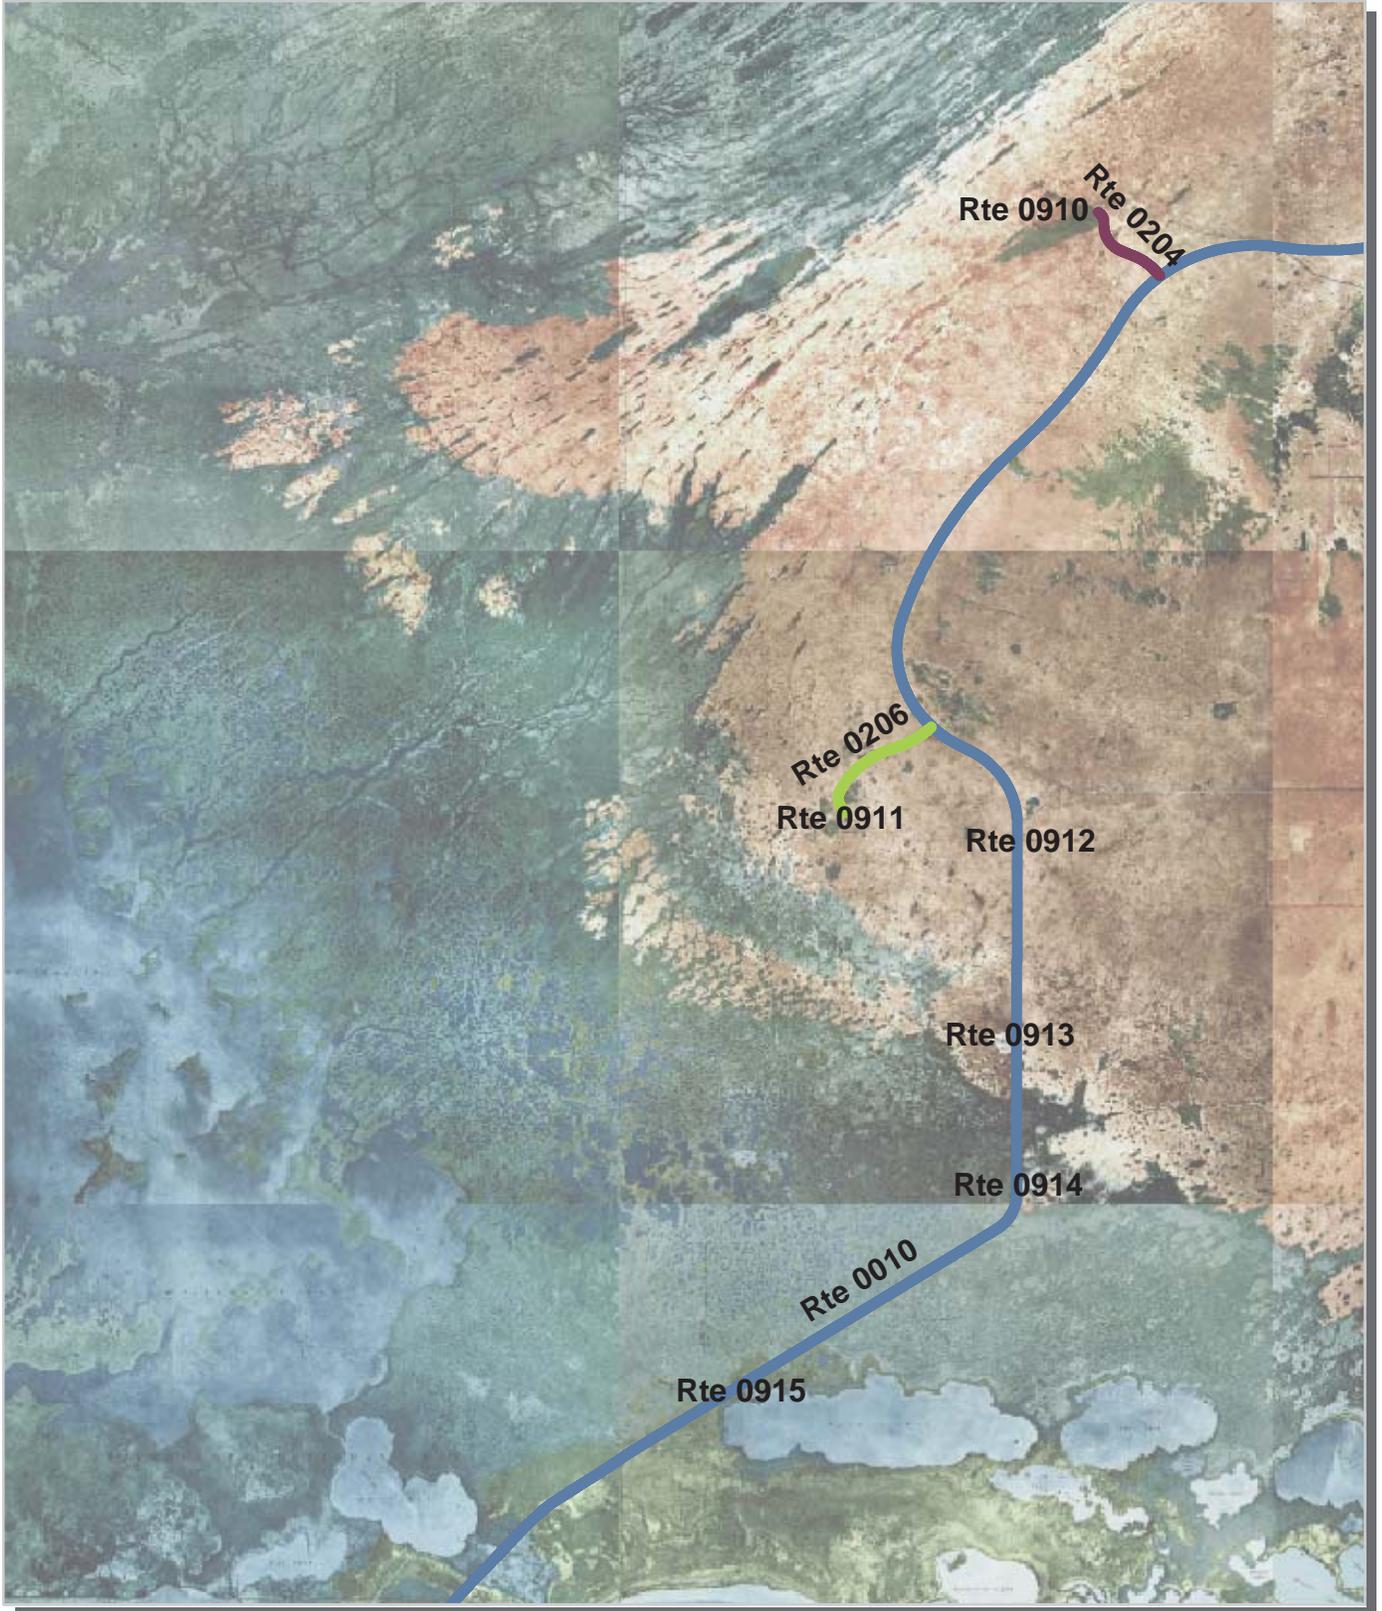
Everglades National Park Route Location Area Map 5

Unique colors used to differentiate routes

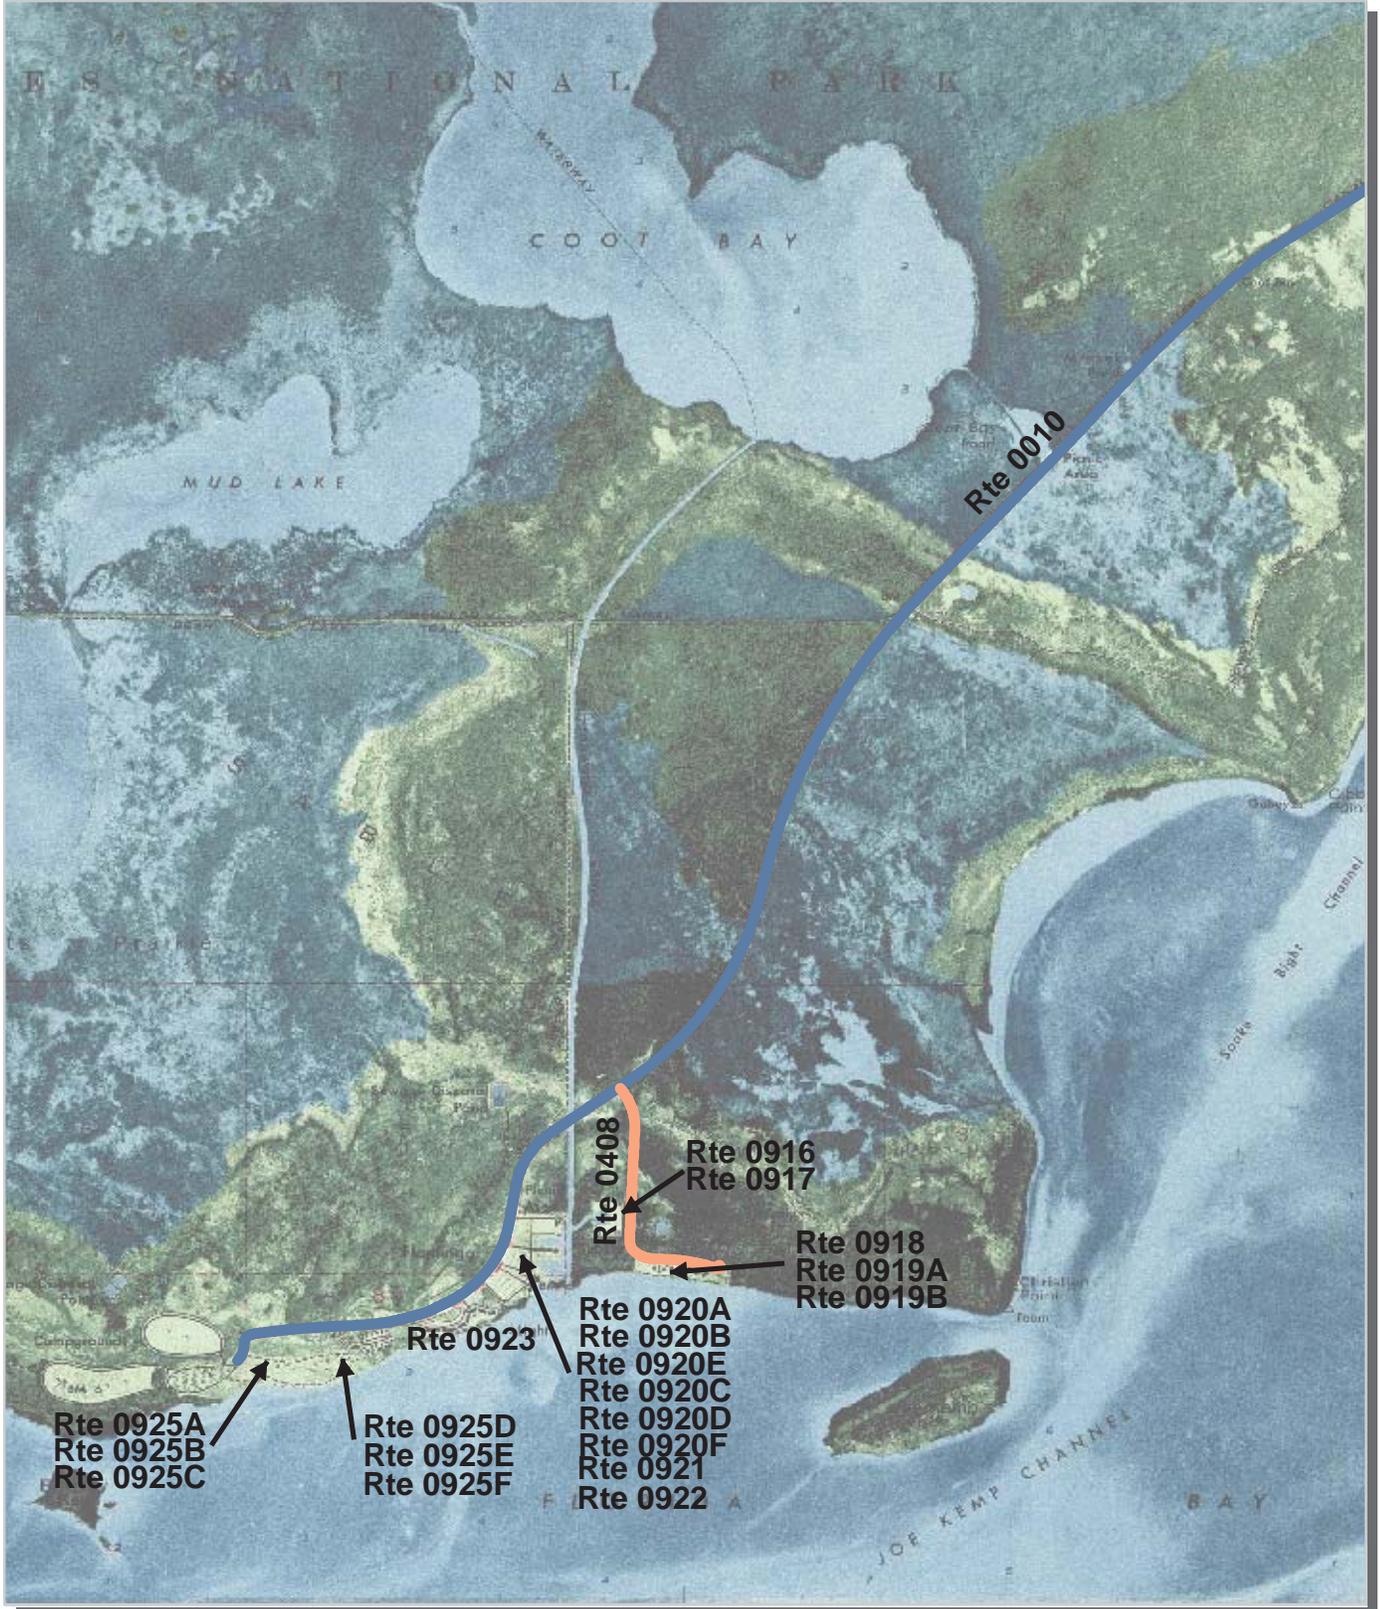
Everglades National Park Route Location Area Map 6

Unique colors used to differentiate routes

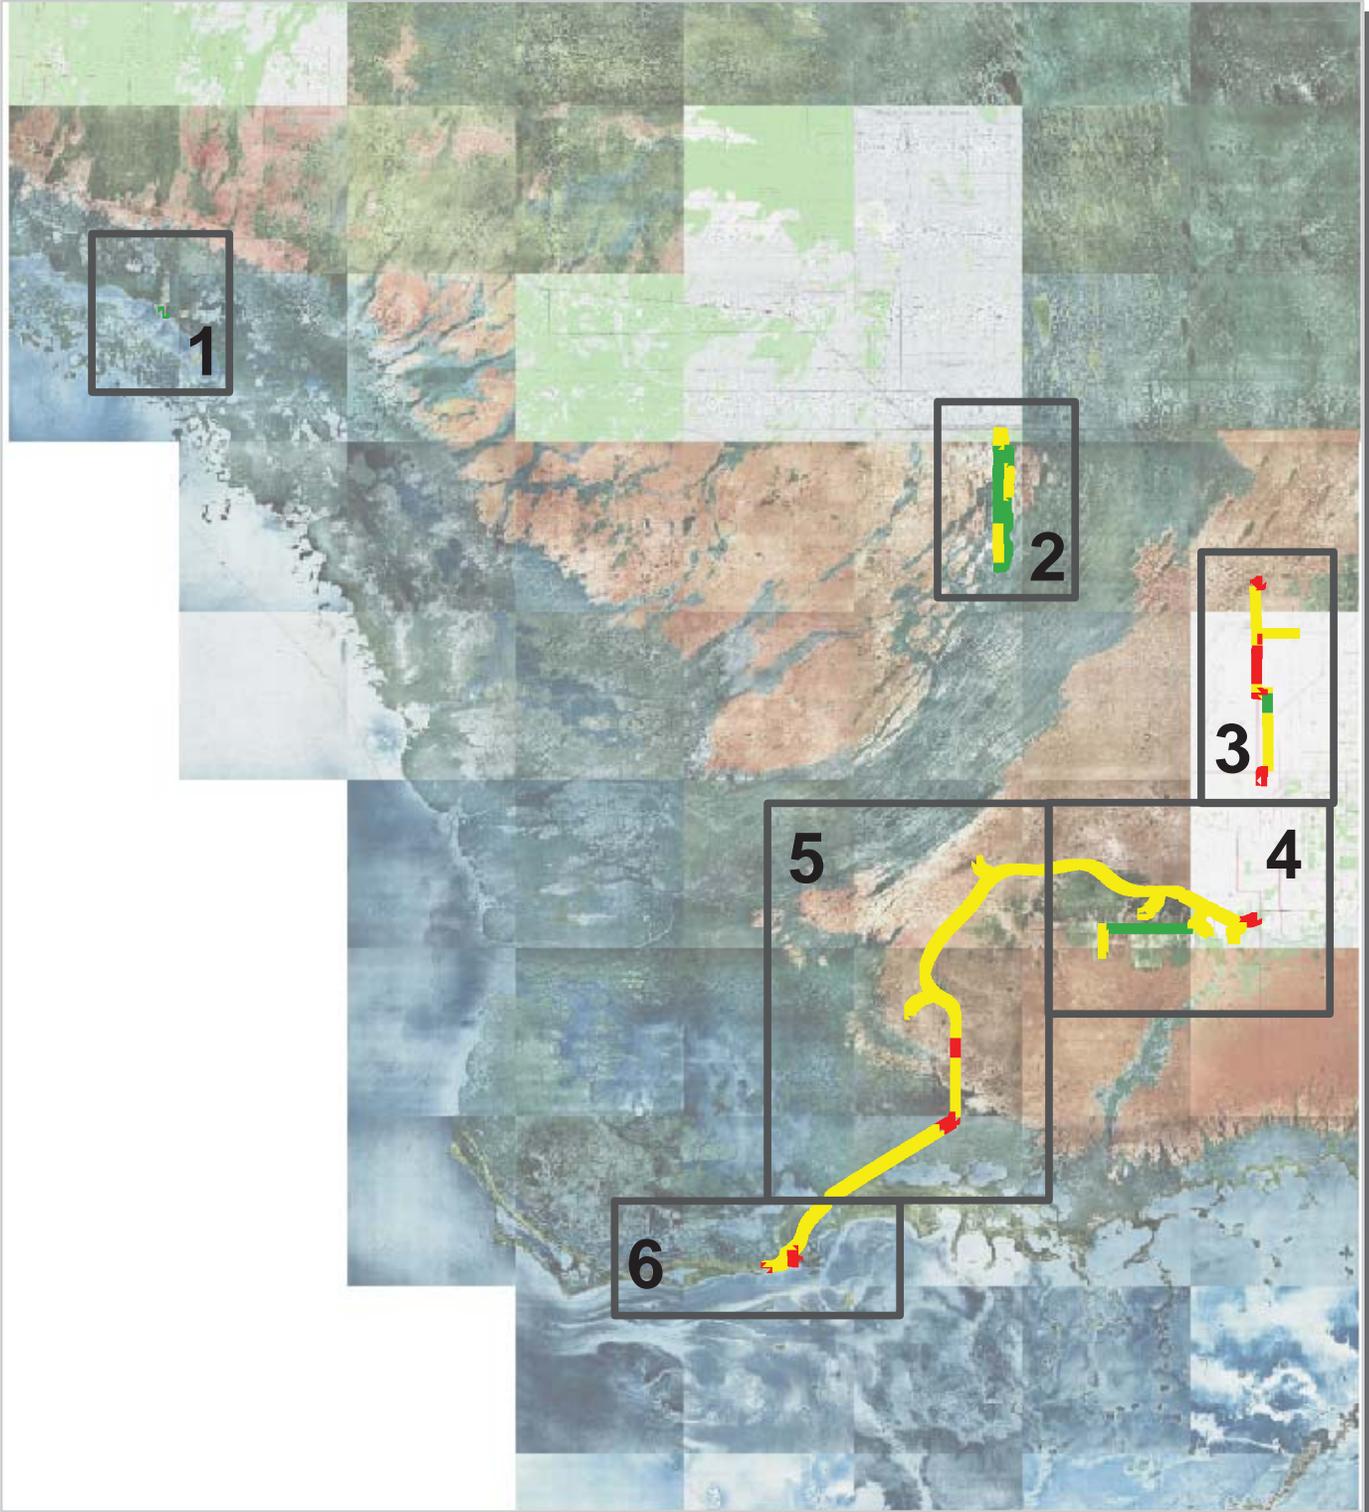
Everglades National Park Route Condition Key Map PCR - Mile by Mile

PCR	Poor		Fair		Good		Excellent	
		(<=60)		(61 - 84)		(85 - 94)		(95 - 100)

* If the PCR rating is not available for a section, the SCR rating will be displayed. See appendix for definitions and formulas.

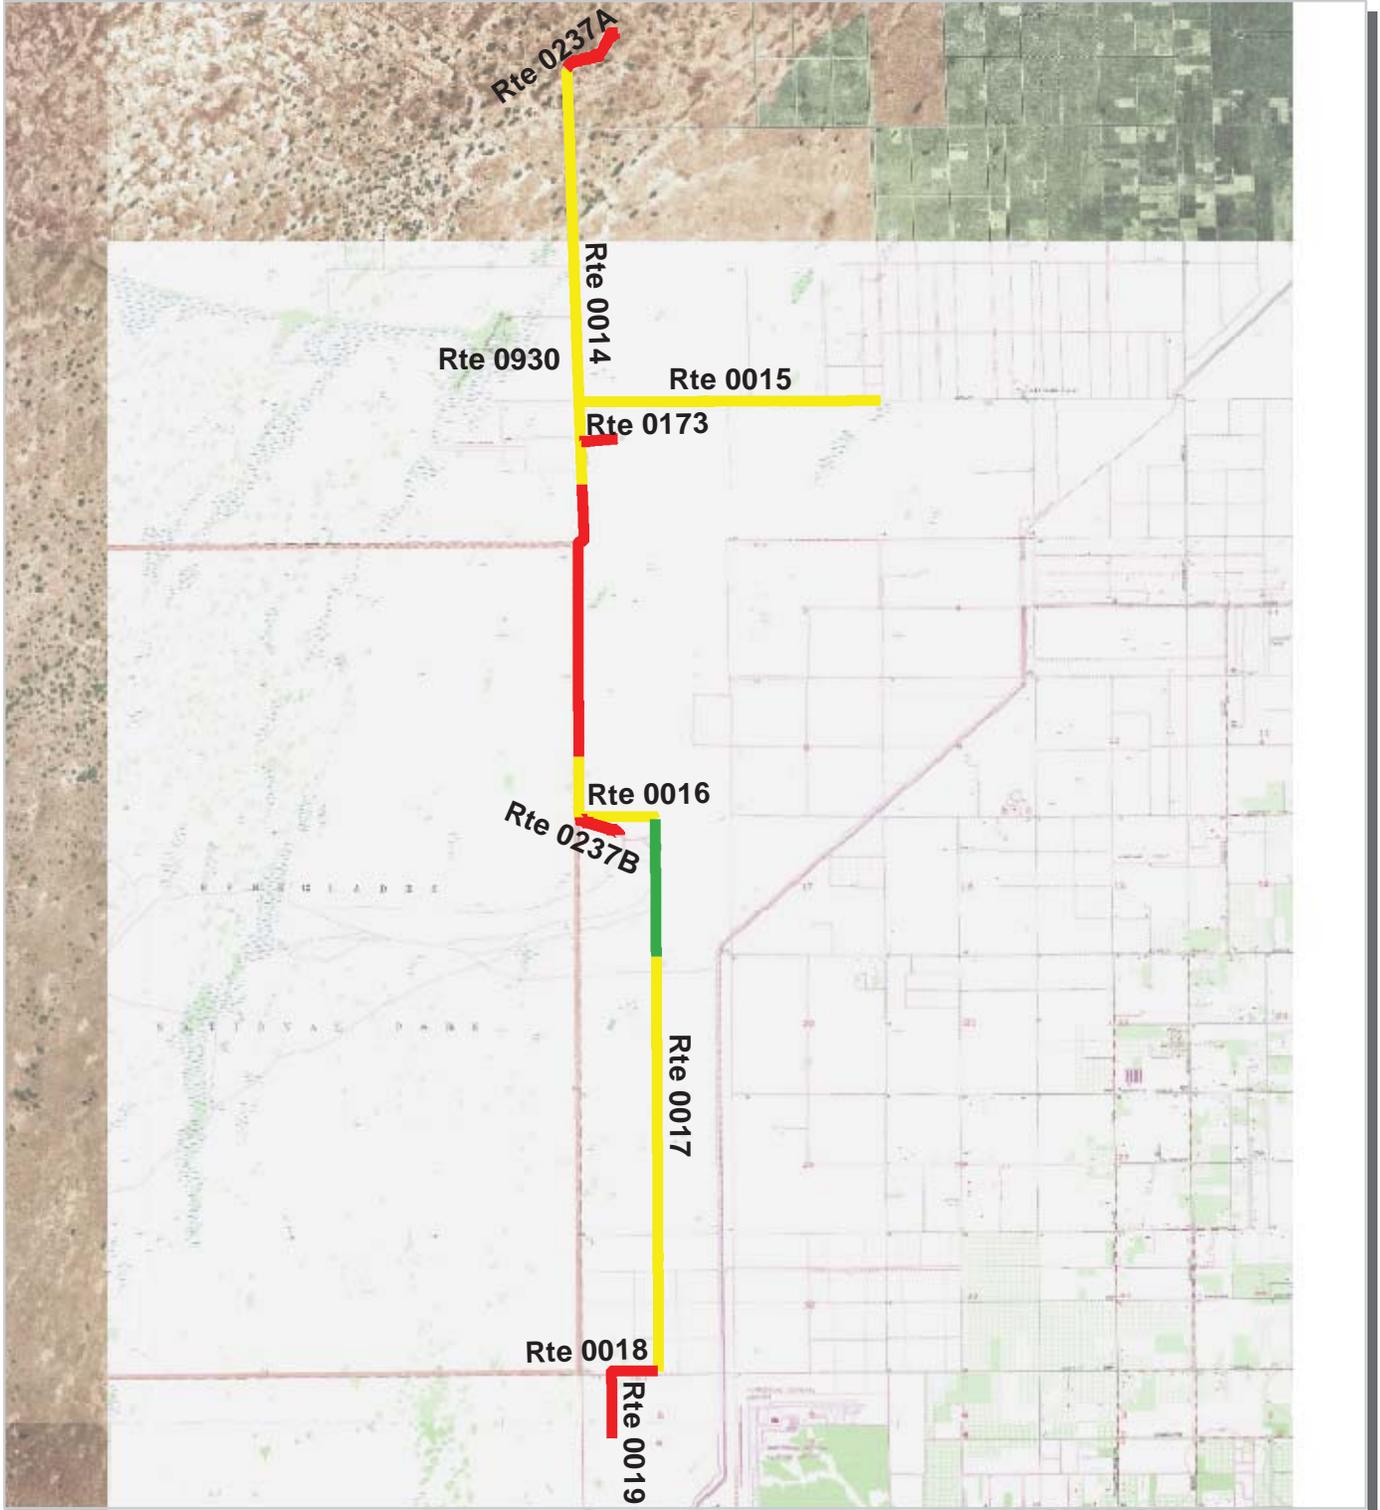
Everglades National Park Route Condition Area Map 3 PCR - Mile by Mile

PCR	Poor		Fair		Good		Excellent	
	(<=60)		(61 - 84)		(85 - 94)		(95 - 100)

* If the PCR rating is not available for a section, the SCR rating will be displayed. See appendix for definitions and formulas.

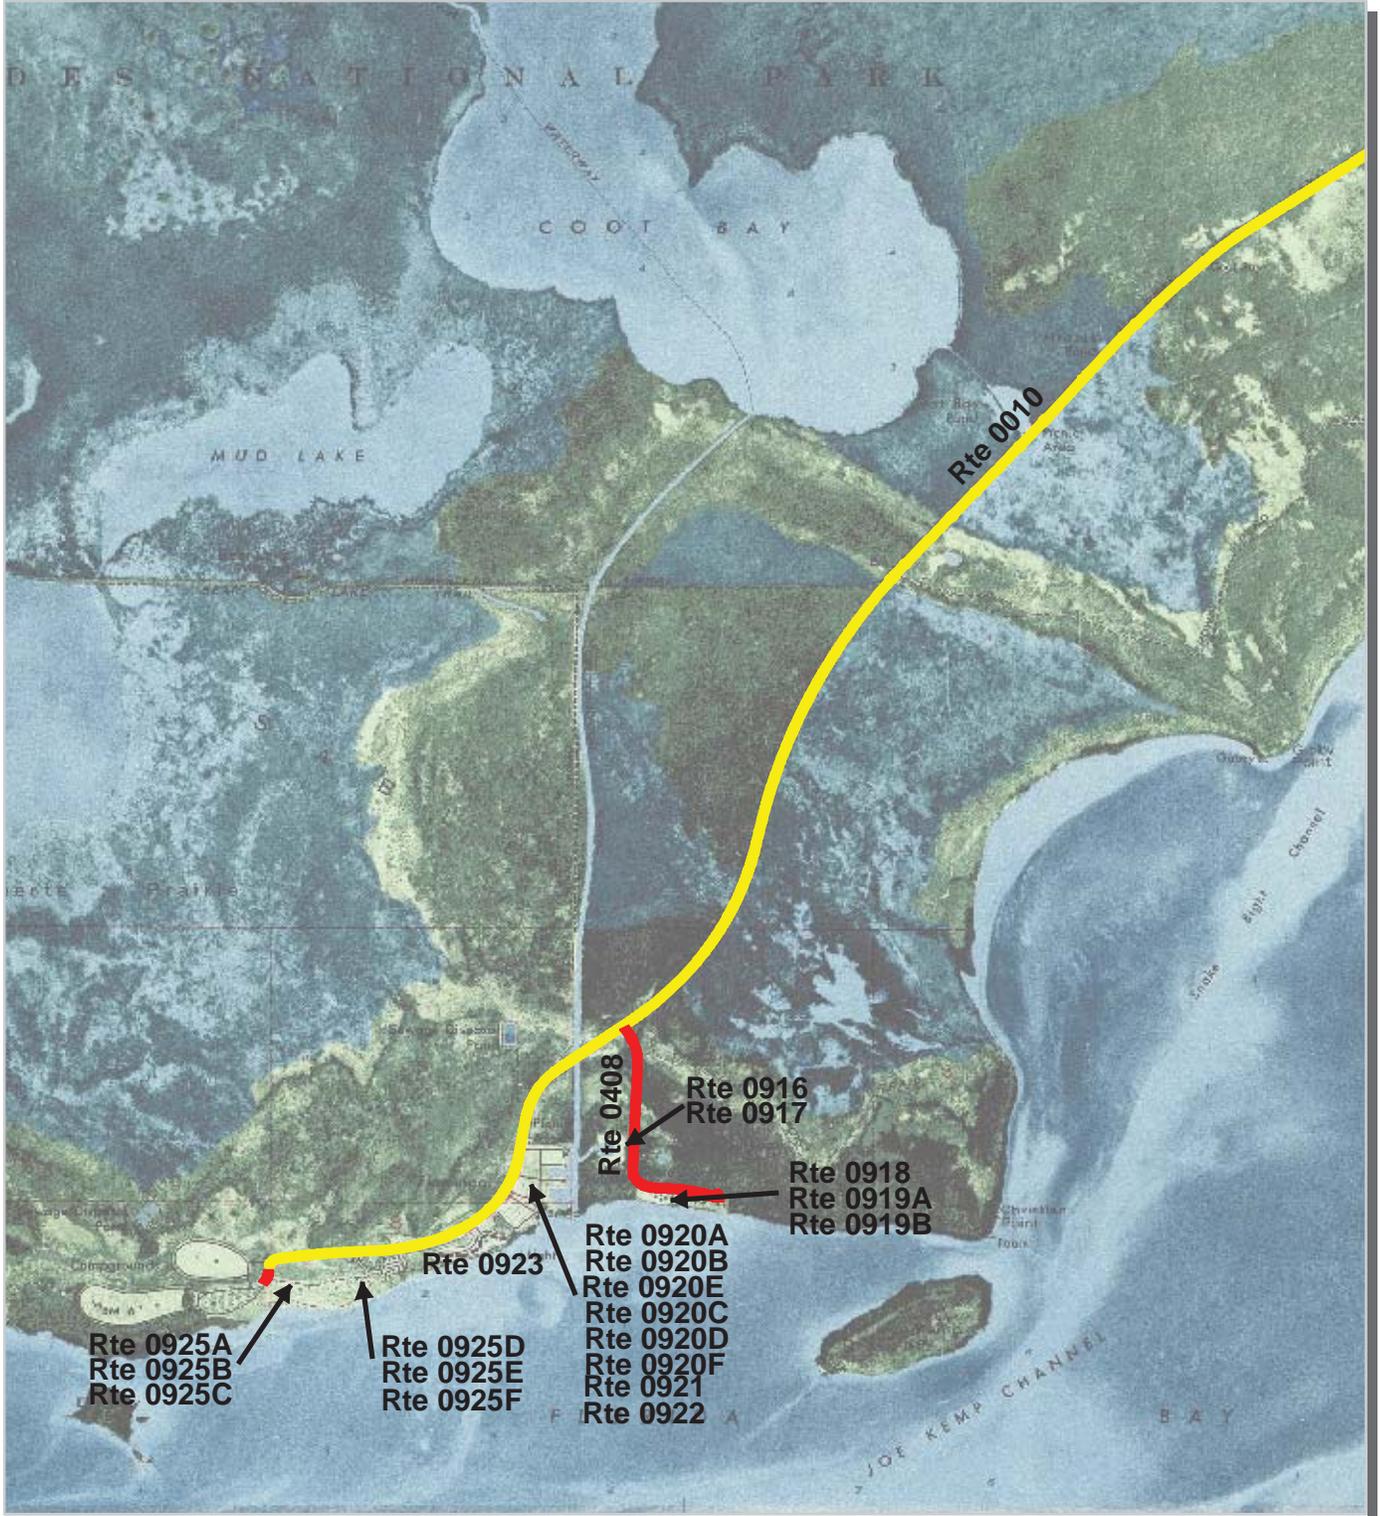
Everglades National Park Route Condition Area Map 6 PCR - Mile by Mile

PCR	Poor		Fair		Good		Excellent	
		(<=60)		(61 - 84)		(85 - 94)		(95 - 100)

* If the PCR rating is not available for a section, the SCR rating will be displayed. See appendix for definitions and formulas.

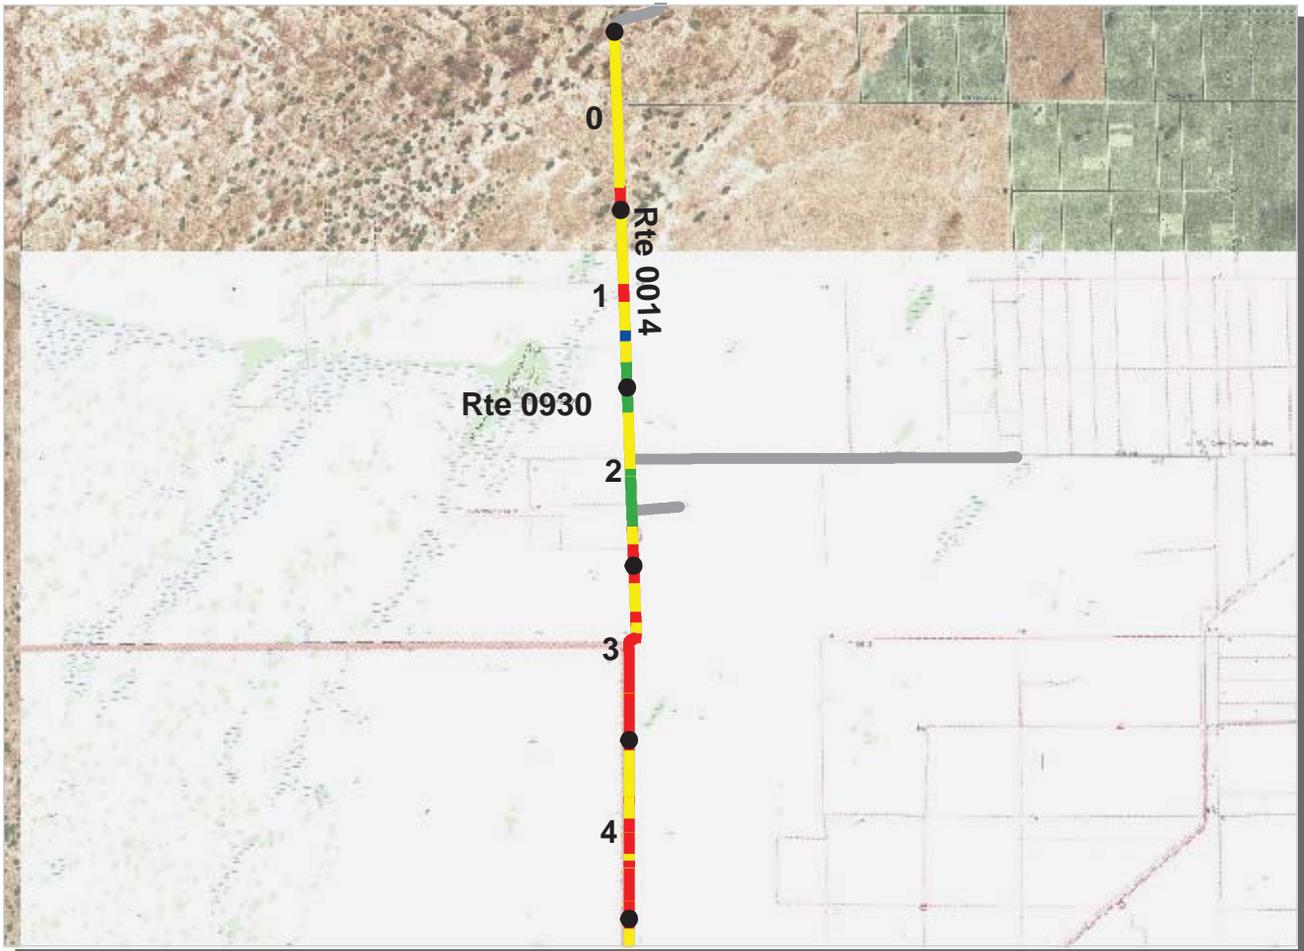
ROUTE: 0014 S.W. 237 Avenue **TOTAL LENGTH: 5.43 Miles**

Section Number	0	1	2	3	4
Section Length (mi)	1.00	1.00	1.00	1.00	1.00
AADT	**				
SADT	**				
ADT Date	**				
Cross Section Information					
Number of Lanes	2	2	2	2	2
Paved Width (ft)	17	17	19	18	16
Lane Width (ft)	8	8	10	10	8
Shoulder Width (ft)	0	0	0	0	0
Roadway Condition Information					
PCR (Pavement Condition Rating)	69	70	76	57	59
RCI (Roughness Condition Index)	94	90	96	80	82
SCR (Surface Condition Rating)	57	59	67	41	44
Alligator Cracking Index	100	89	100	100	100
Rutting Index	57	68	67	41	44
Patching Index	99	99	99	99	99
Transverse Cracking Index	99	99	99	99	99
Longitudinal Cracking Index	99	99	100	100	99
Shoulder Condition Rating	N/A	N/A	N/A	N/A	N/A
Drainage Condition Rating	GOOD	GOOD	GOOD	GOOD	GOOD

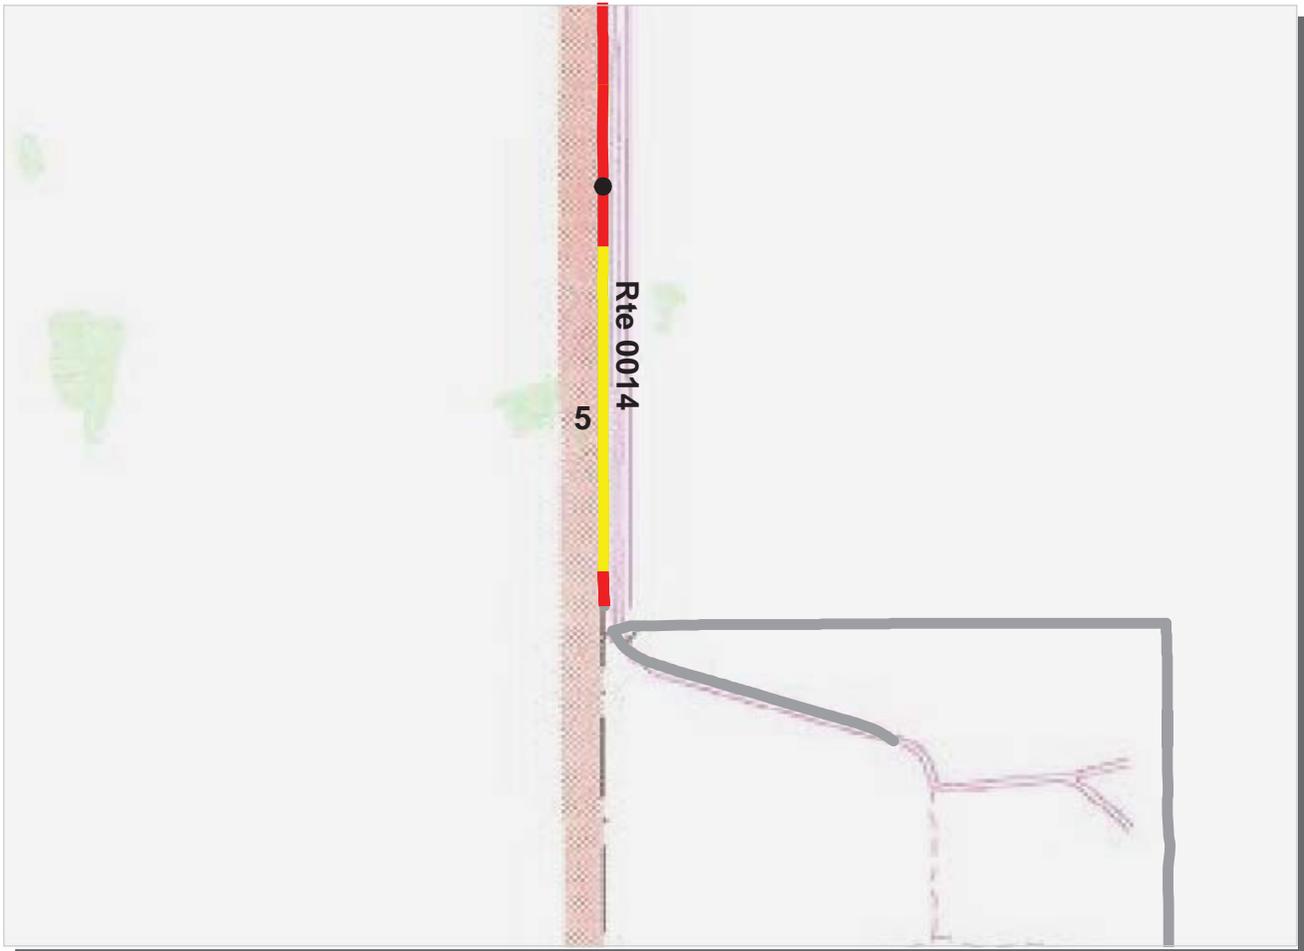
ROUTE: 0014 S.W. 237 Avenue **TOTAL LENGTH: 5.43 Miles**

Section Number	5				
Section Length (mi)	0.43				
AADT	**				
SADT	**				
ADT Date	**				
Cross Section Information					
Number of Lanes	2				
Paved Width (ft)	16				
Lane Width (ft)	8				
Shoulder Width (ft)	0				
Roadway Condition Information					
PCR (Pavement Condition Rating)	64				
RCI (Roughness Condition Index)	89				
SCR (Surface Condition Rating)	48				
Alligator Cracking Index	100				
Rutting Index	48				
Patching Index	100				
Transverse Cracking Index	99				
Longitudinal Cracking Index	99				
Shoulder Condition Rating	N/A				
Drainage Condition Rating	GOOD

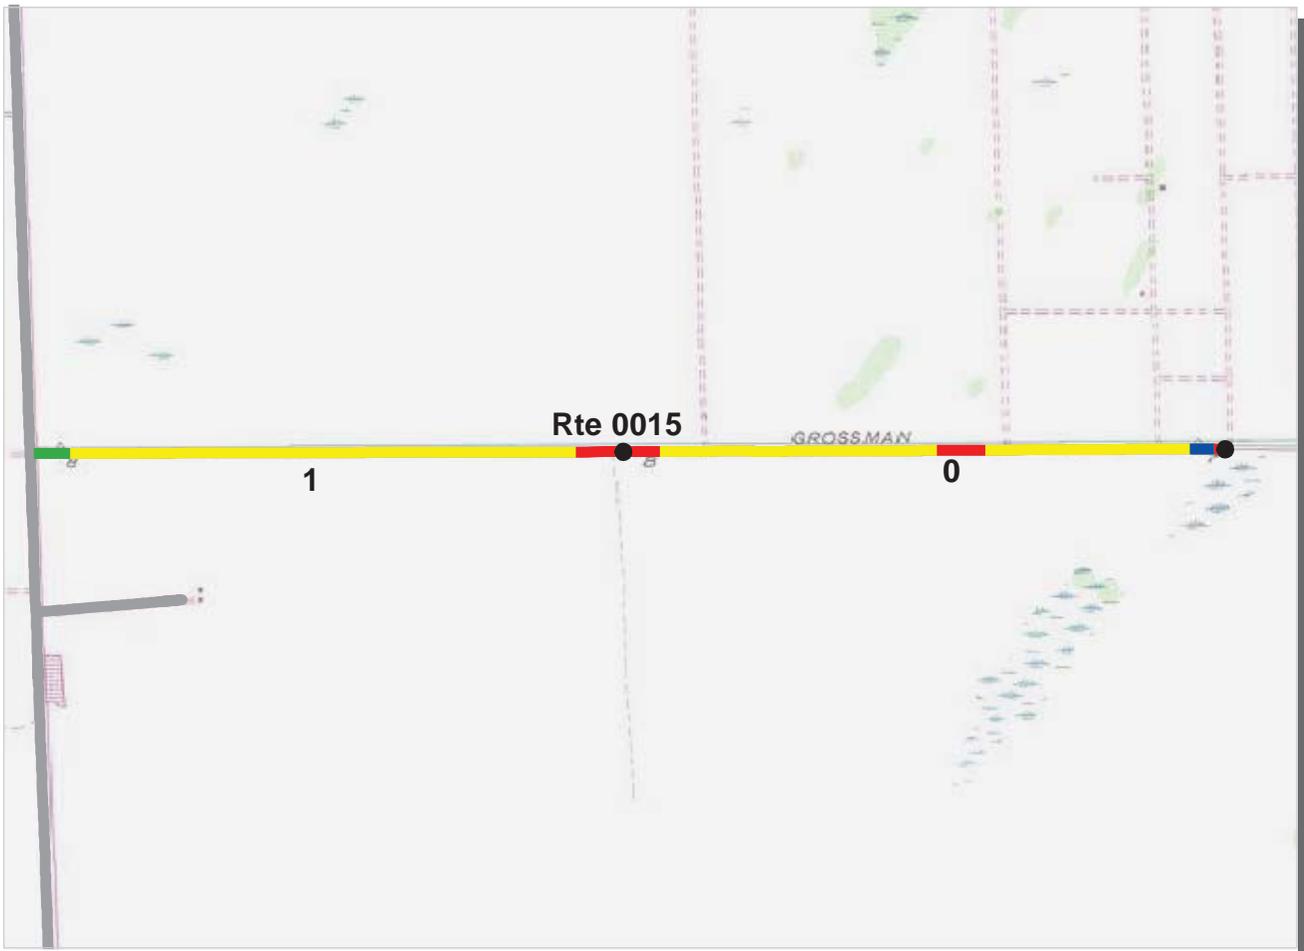
ROUTE: 0015 S.W. 168 St / Richmond Drive **TOTAL LENGTH: 1.99 Miles**

Section Number	0	1			
Section Length (mi)	1.00	0.99			
AADT	**				
SADT	**				
ADT Date	**				
Cross Section Information					
Number of Lanes	2	2			
Paved Width (ft)	21	19			
Lane Width (ft)	10	9			
Shoulder Width (ft)	0	0			
Roadway Condition Information					
PCR (Pavement Condition Rating)	71	69			
RCI (Roughness Condition Index)	57	51			
SCR (Surface Condition Rating)	79	79			
Alligator Cracking Index	99	99			
Rutting Index	81	80			
Patching Index	99	99			
Transverse Cracking Index	99	99			
Longitudinal Cracking Index	99	99			
Shoulder Condition Rating	N/A	N/A			
Drainage Condition Rating	GOOD	GOOD

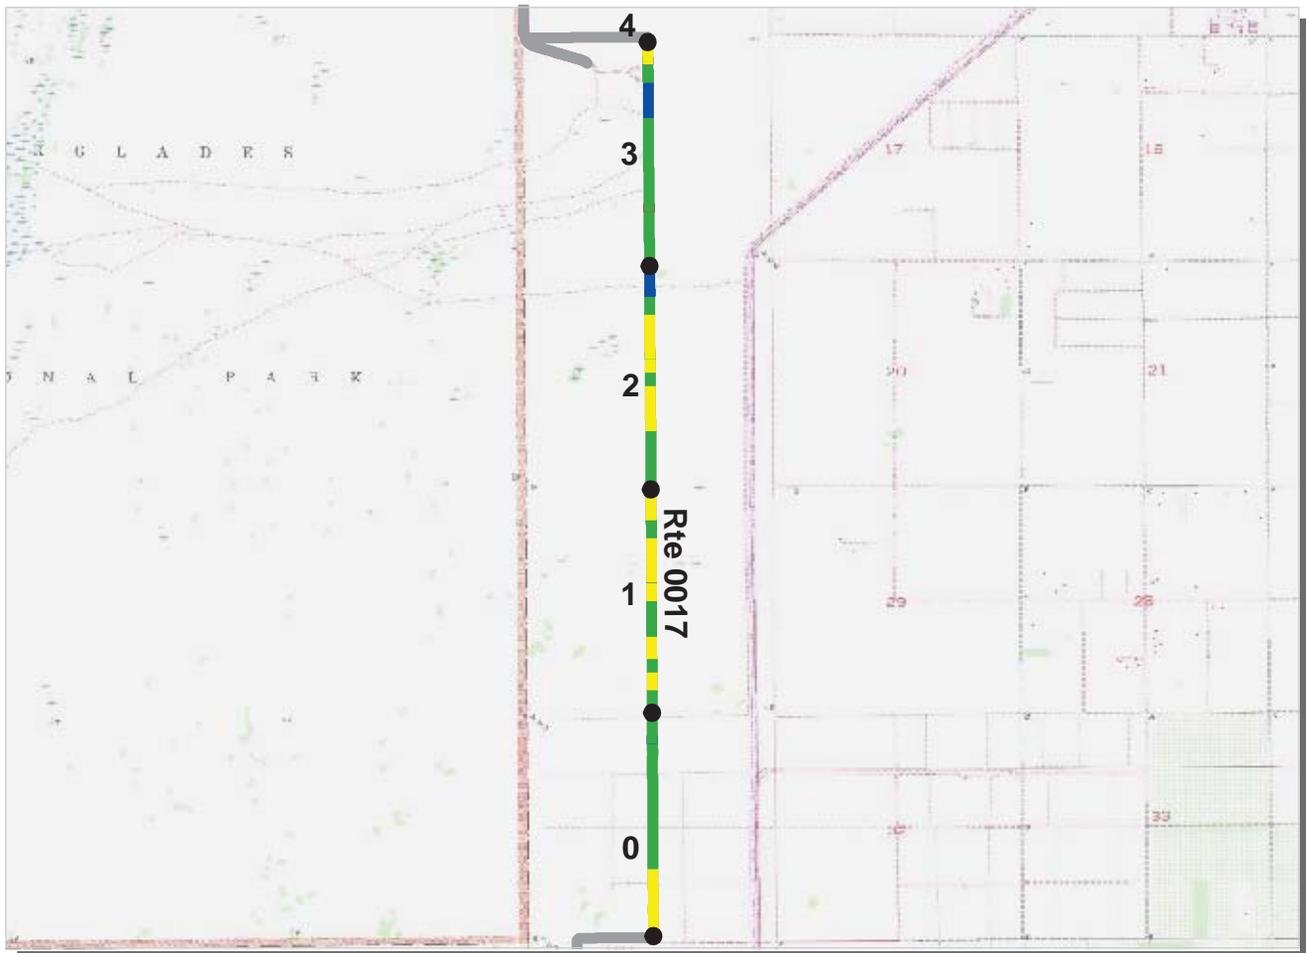
ROUTE: 0017 S.W. 232 Avenue **TOTAL LENGTH: 4.04 Miles**

Section Number	0	1	2	3	4
Section Length (mi)	1.00	1.00	1.00	1.00	0.04
AADT	**				
SADT	**				
ADT Date	**				
Cross Section Information					
Number of Lanes	2	2	2	2	2
Paved Width (ft)	19	18	19	20	24
Lane Width (ft)	10	10	9	10	14
Shoulder Width (ft)	0	0	0	3	0
Roadway Condition Information					
PCR (Pavement Condition Rating)	84	78	84	87	61
RCI (Roughness Condition Index)	89	81	89	94	0
SCR (Surface Condition Rating)	82	75	81	83	61
Alligator Cracking Index	99	100	99	99	100
Rutting Index	83	76	82	83	63
Patching Index	100	99	100	100	100
Transverse Cracking Index	99	99	99	100	98
Longitudinal Cracking Index	99	99	99	99	100
Shoulder Condition Rating	N/A	N/A	N/A	GOOD	N/A
Drainage Condition Rating	GOOD	GOOD	GOOD	GOOD	GOOD

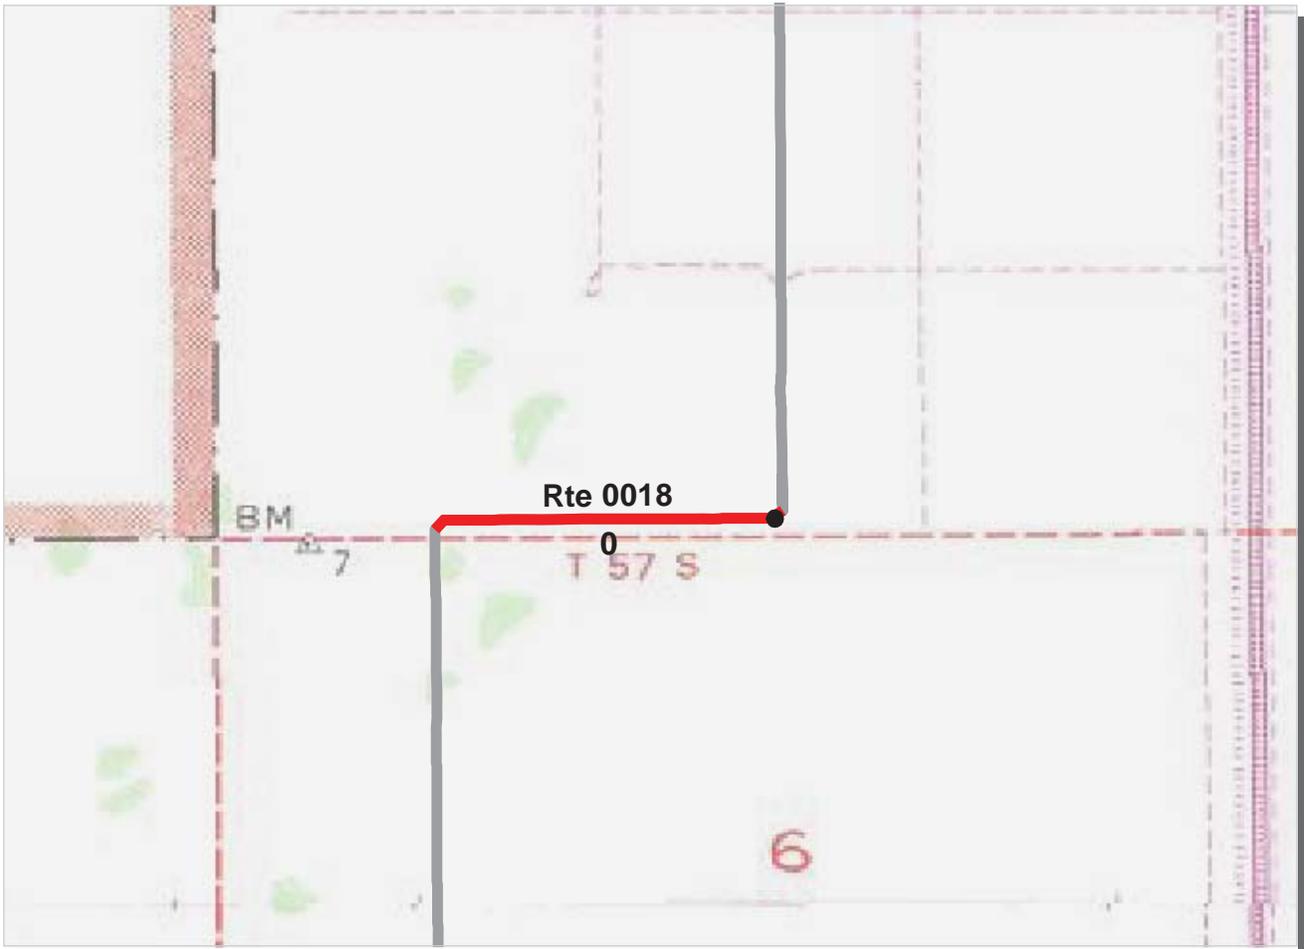
ROUTE: 0018 S.W. 280 Street **TOTAL LENGTH: 0.31 Miles**

Section Number	0				
Section Length (mi)	0.31				
AADT	**				
SADT	**				
ADT Date	**				
Cross Section Information					
Number of Lanes	2				
Paved Width (ft)	18				
Lane Width (ft)	8				
Shoulder Width (ft)	0				
Roadway Condition Information					
PCR (Pavement Condition Rating)	40				
RCI (Roughness Condition Index)	27				
SCR (Surface Condition Rating)	42				
Alligator Cracking Index	94				
Rutting Index	50				
Patching Index	100				
Transverse Cracking Index	98				
Longitudinal Cracking Index	98				
Shoulder Condition Rating	N/A				
Drainage Condition Rating	GOOD

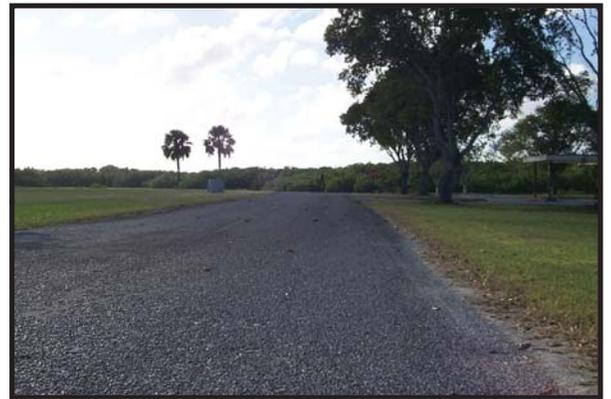
Everglades National Park
Route 0218
 Flamingo Cottage Access Road
 From Route 0010 at MP 38.7

Route	Length (mi)	Width (ft)	Area (sq ft)	Lane Miles *	Condition / PCR	Surface Type
0218	0.28	18.00	26326	0.45	FAIR / 73	OC

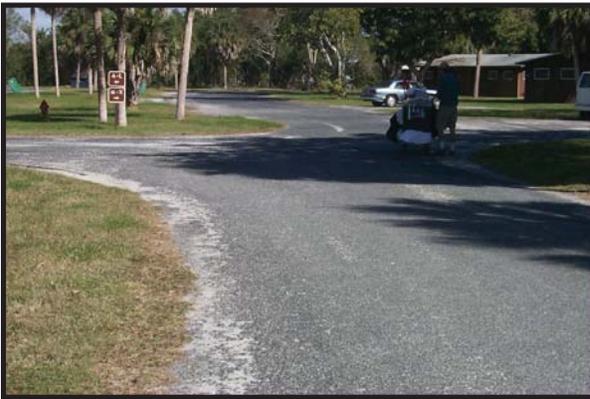
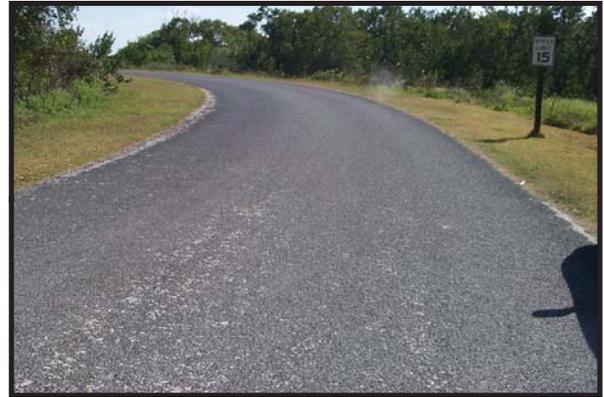
Everglades National Park
Route 0219
 Flamingo Picnic Area
 From End of Route 0010 keep Left

Route	Length (mi)	Width (ft)	Area (sq ft)	Lane Miles *	Condition / PCR	Surface Type
0219	0.39	18.00	36685	0.63	FAIR / 73	OC

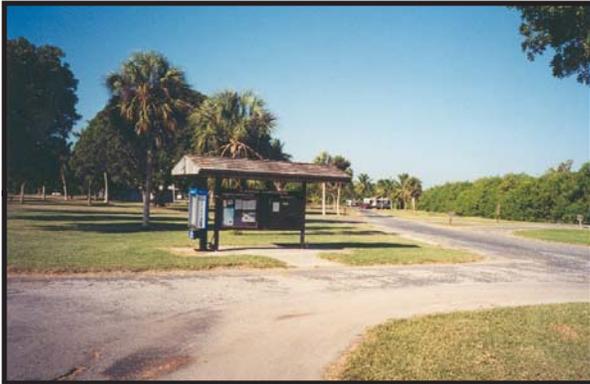
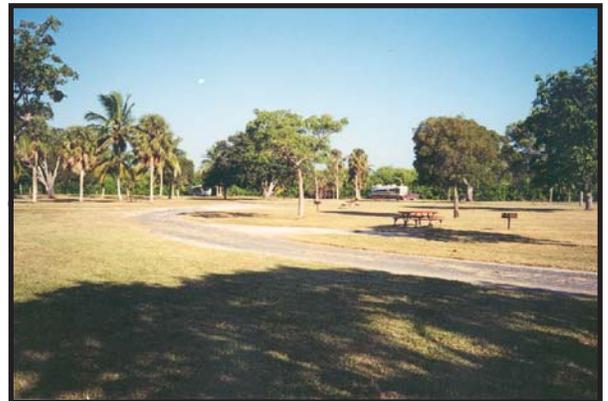
Route 0221

Route	Length (mi)	Width (ft)	Area (sq ft)	Lane Miles *	Condition / PCR	Surface Type
0221	2.54	11.00	147407	2.54	POOR / 45	OC

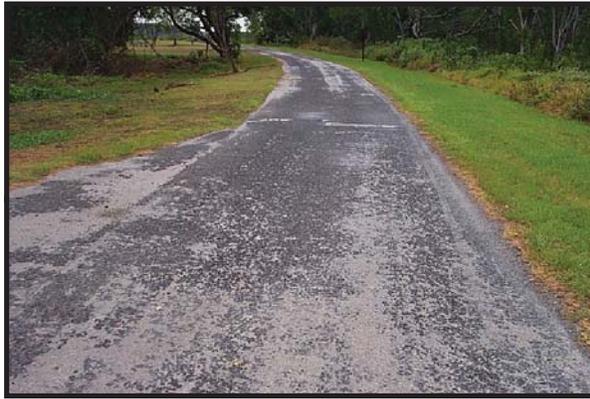
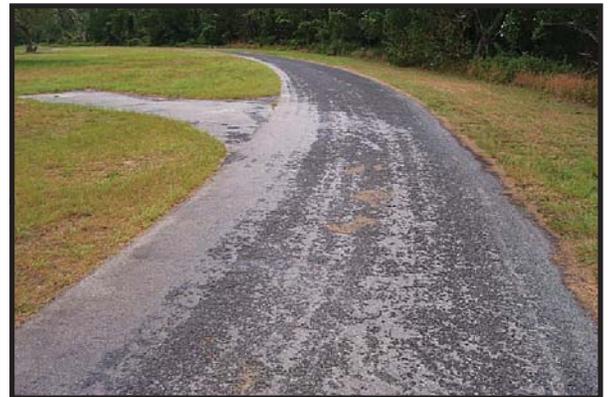
Route 0222

Route	Length (mi)	Width (ft)	Area (sq ft)	Lane Miles *	Condition / PCR	Surface Type
0222	2.19	11.00	127021	2.19	POOR / 45	OC

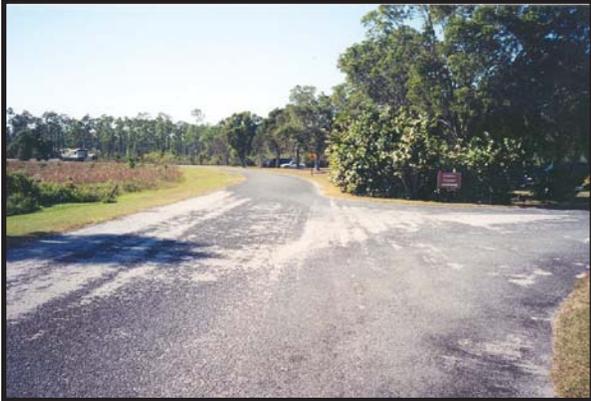
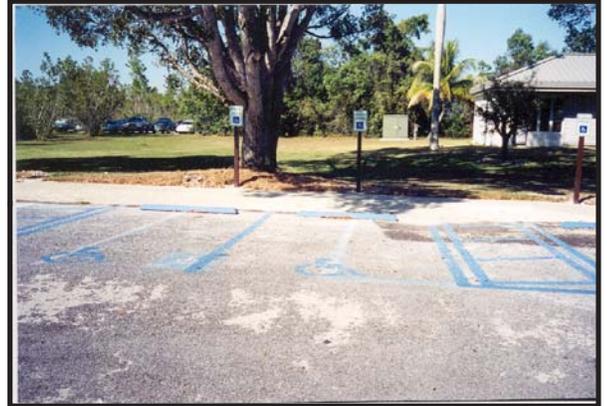
Route 0901

Route	Public / NonPublic	Date Visited	Area (sq ft)	Lane Miles *	Surface Type	Condition / PCR
0901	NonPublic	1/30/2002	8508	0.15	AS	FAIR / 73
