The Road Inventory of Everglades National Park EVER - 5280

Road Inventory Program

Prepared By:
Federal Highway Administration
Eastern Federal Lands Highway Division
Cycle 3

Everglades National Park in Florida

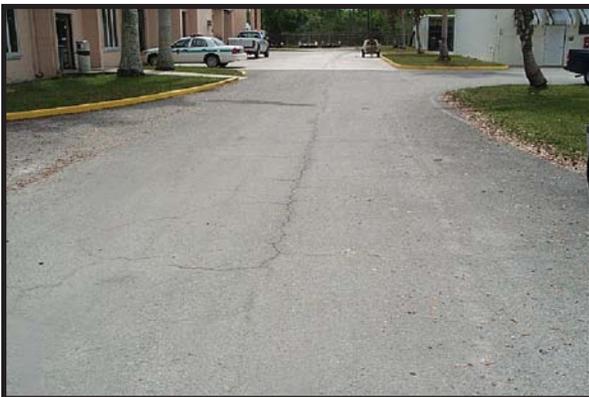
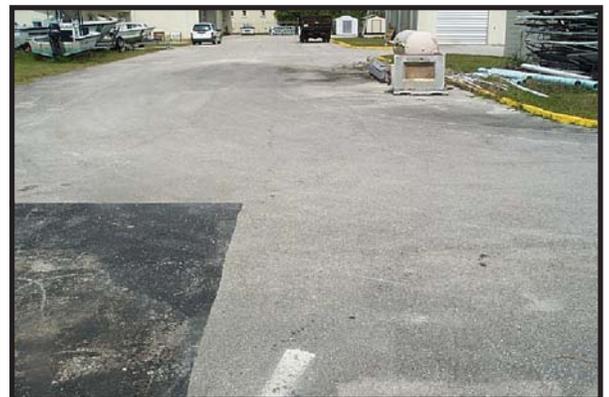
Route	Public / NonPublic	Date Visited	Area (sq ft)	Lane Miles *	Surface Type	Condition / PCR
0902A	NonPublic	1/30/2002	66690	1.15	AS	FAIR / 73

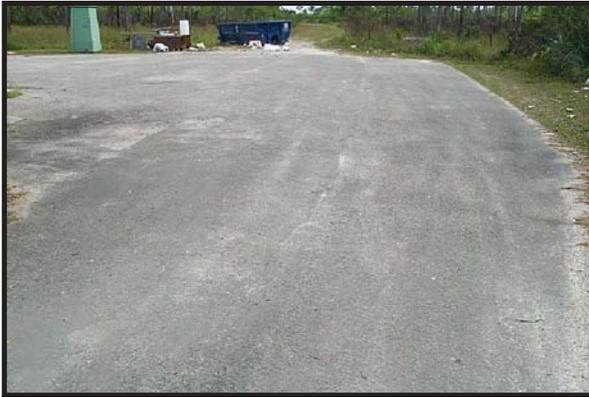
Route 0902B

Route	Public / NonPublic	Date Visited	Area (sq ft)	Lane Miles *	Surface Type	Condition / PCR
0902B	NonPublic	1/29/2002	4390	0.08	AS	FAIR / 73

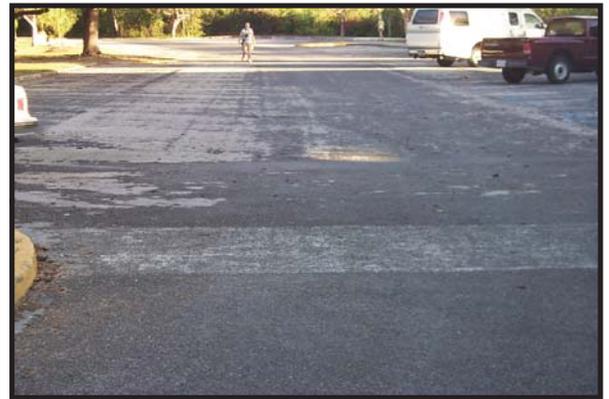
Route 0903

Route	Public / NonPublic	Date Visited	Area (sq ft)	Lane Miles *	Surface Type	Condition / PCR
0903	Public	1/29/2002	71854	1.24	OC	FAIR / 73

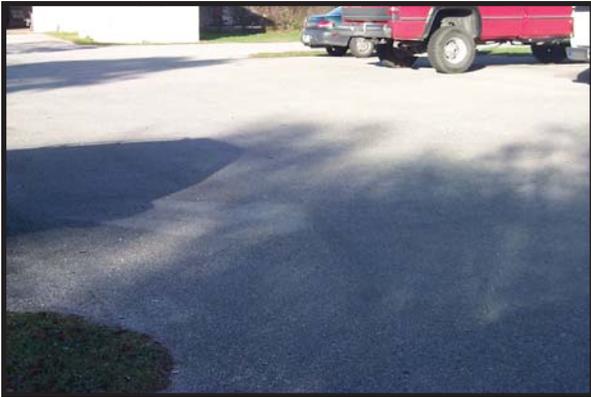
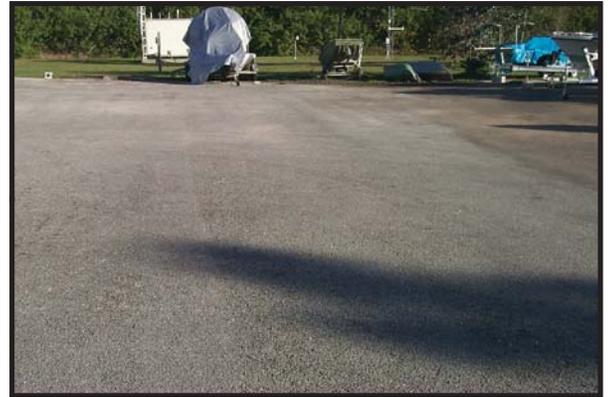
Route 0904

Route	Public / NonPublic	Date Visited	Area (sq ft)	Lane Miles *	Surface Type	Condition / PCR
0904	NonPublic	1/30/2002	42190	0.73	AS	GOOD / 90

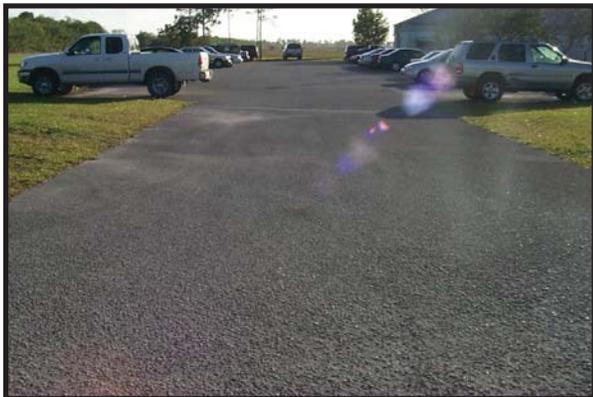
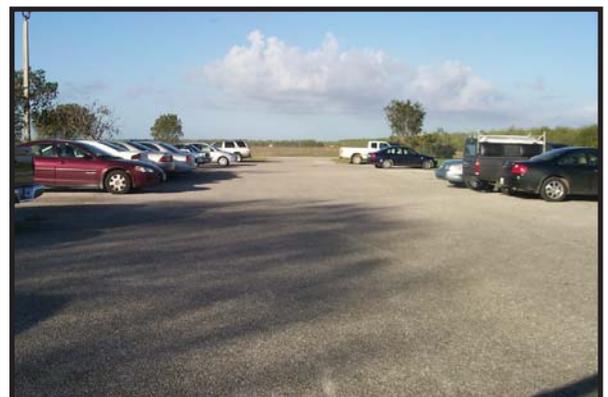
Route	Public / NonPublic	Date Visited	Area (sq ft)	Lane Miles *	Surface Type	Condition / PCR
0905	NonPublic	1/30/2002	35766	0.62	OC	FAIR / 73

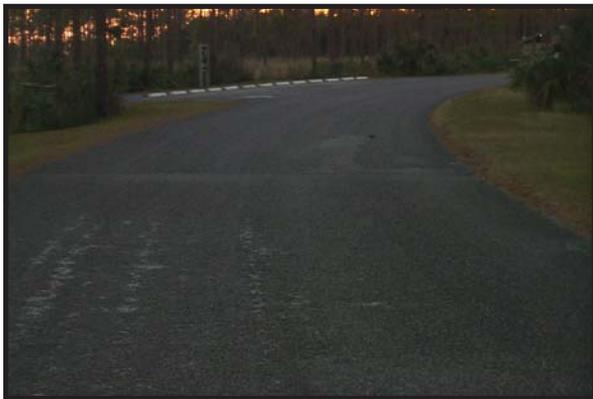
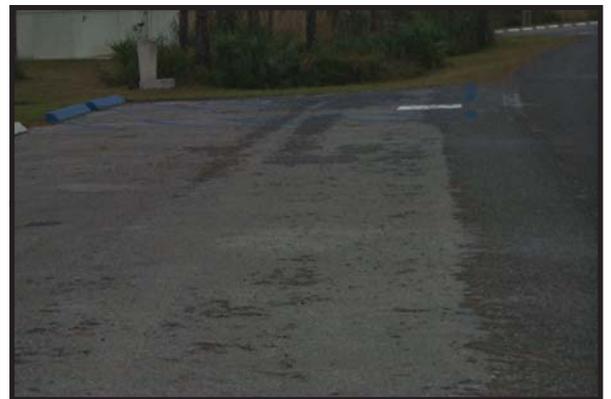
Route 0907

Route	Public / NonPublic	Date Visited	Area (sq ft)	Lane Miles *	Surface Type	Condition / PCR
0907	Public	1/29/2002	15523	0.27	OC	FAIR / 73

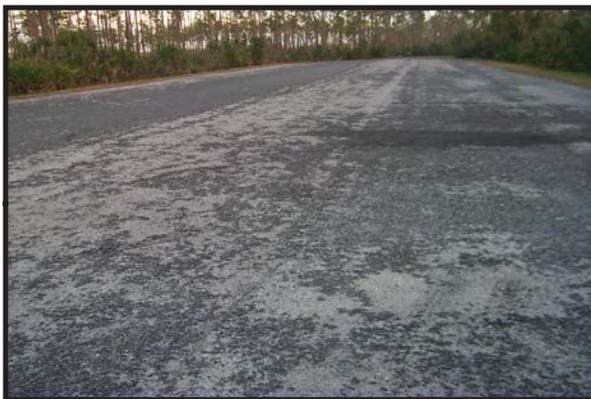
Route	Public / NonPublic	Date Visited	Area (sq ft)	Lane Miles *	Surface Type	Condition / PCR
0909	Public	1/29/2002	29345	0.51	OC	FAIR / 73

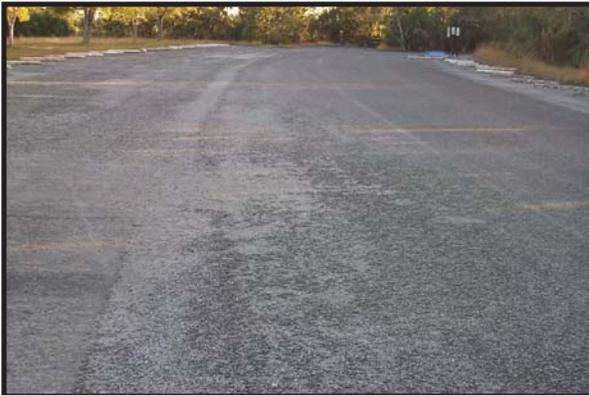
Route	Public / NonPublic	Date Visited	Area (sq ft)	Lane Miles *	Surface Type	Condition / PCR
0911	Public	1/29/2002	43158	0.74	OC	FAIR / 73

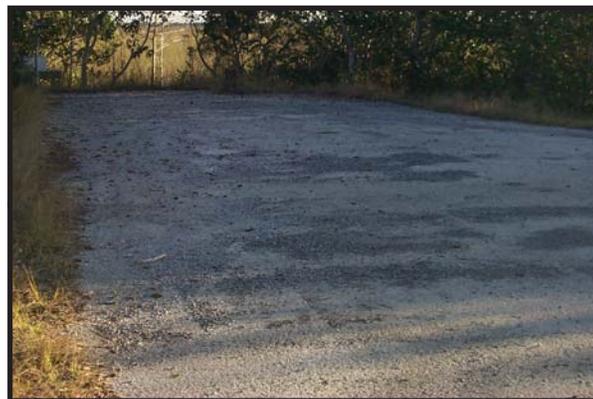
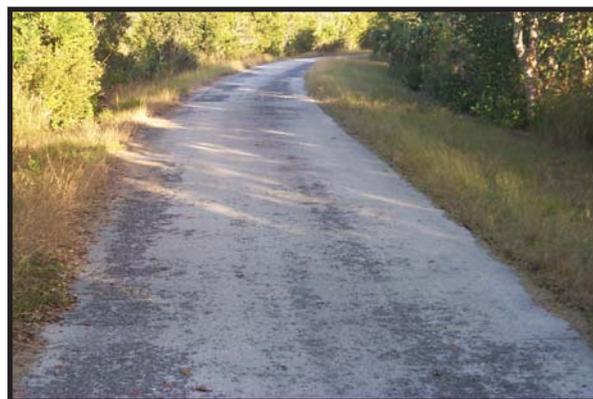
Route 0912

Route	Public / NonPublic	Date Visited	Area (sq ft)	Lane Miles *	Surface Type	Condition / PCR
0912	NonPublic	1/29/2002	11422	0.20	OC	POOR / 45

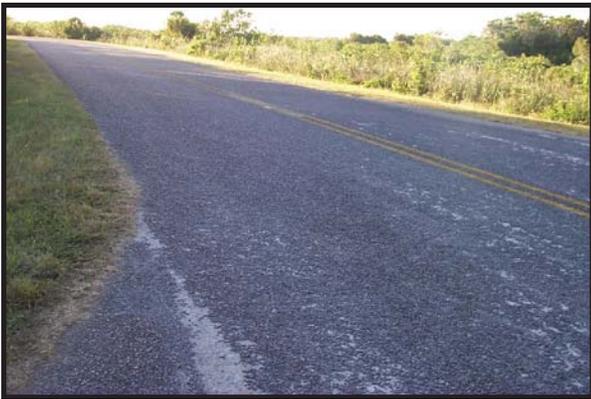
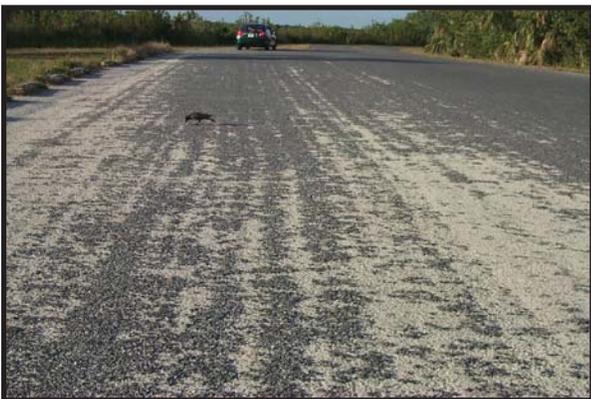
Route 0913

Route	Public / NonPublic	Date Visited	Area (sq ft)	Lane Miles *	Surface Type	Condition / PCR
0913	Public	1/29/2002	31167	0.54	OC	FAIR / 73

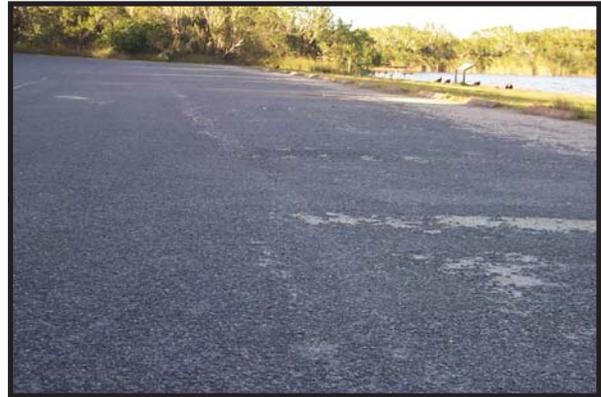
Route 0914

Route	Public / NonPublic	Date Visited	Area (sq ft)	Lane Miles *	Surface Type	Condition / PCR
0914	Public	1/30/2002	23556	0.41	OC	FAIR / 73

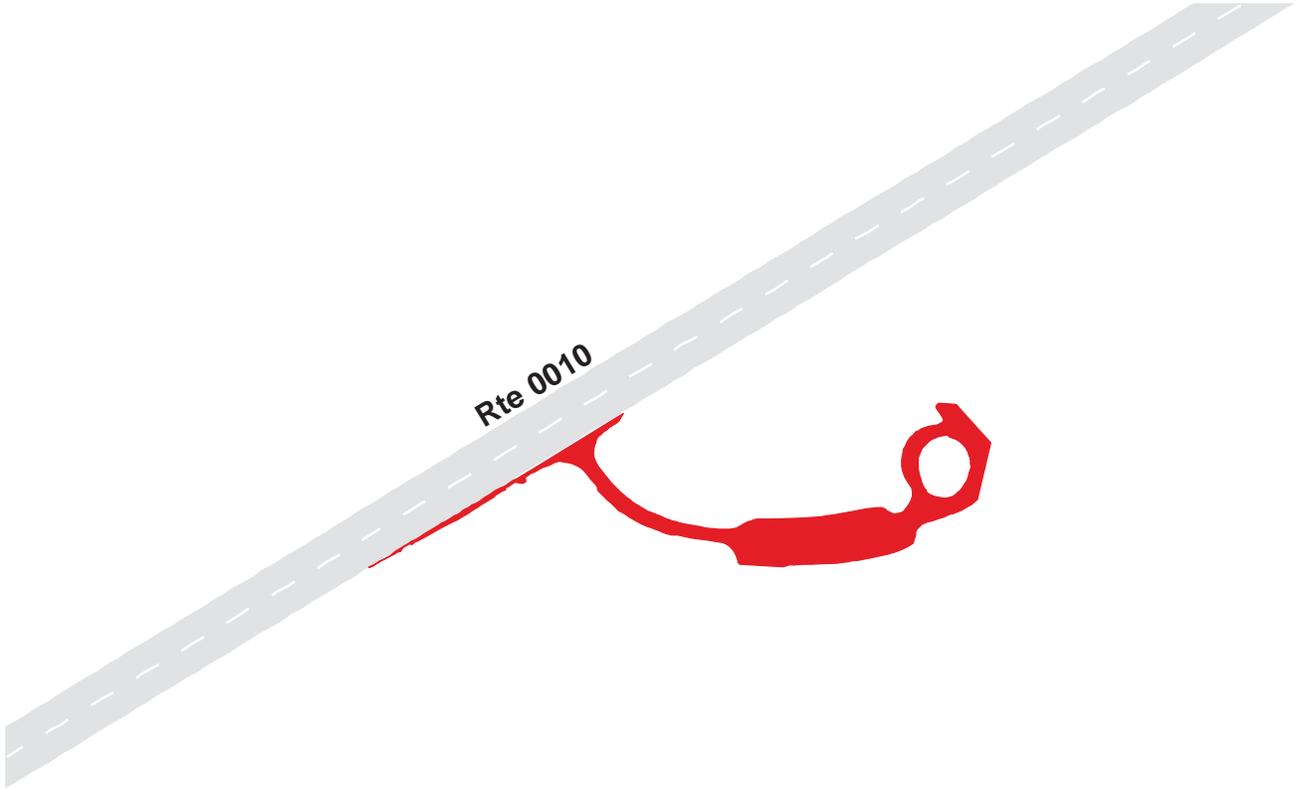
Everglades National Park
Route 0915
West Lake Access
Adjacent to Route 0010 at MP 31.2

Route	Public / NonPublic	Date Visited	Area (sq ft)	Lane Miles *	Surface Type	Condition / PCR
0915	Public	1/30/2002	34642	0.60	OC	FAIR / 73

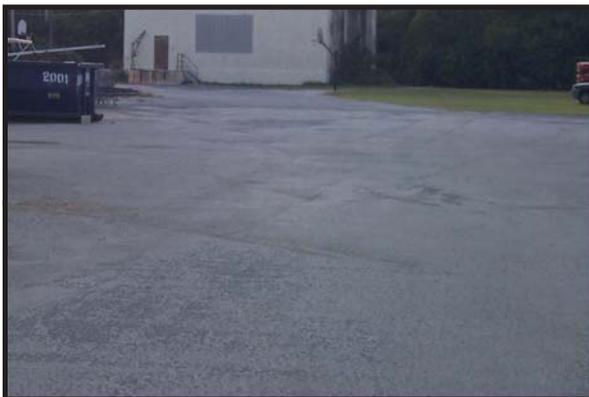
Route	Public / NonPublic	Date Visited	Area (sq ft)	Lane Miles *	Surface Type	Condition / PCR
0917	NonPublic	1/29/2002	36300	0.63	OC	POOR / 45

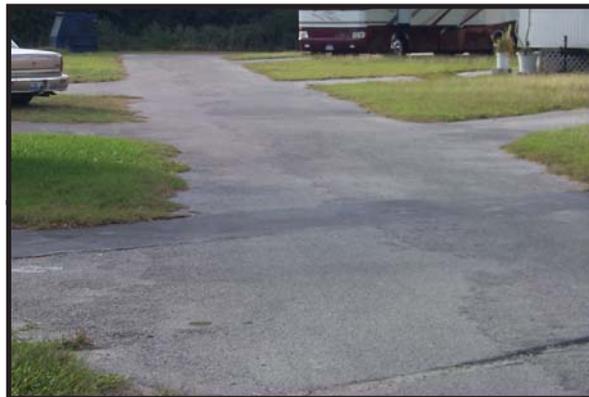
Route 0918

Route	Public / NonPublic	Date Visited	Area (sq ft)	Lane Miles *	Surface Type	Condition / PCR
0918	Public	1/29/2002	6476	0.11	AS	GOOD / 90

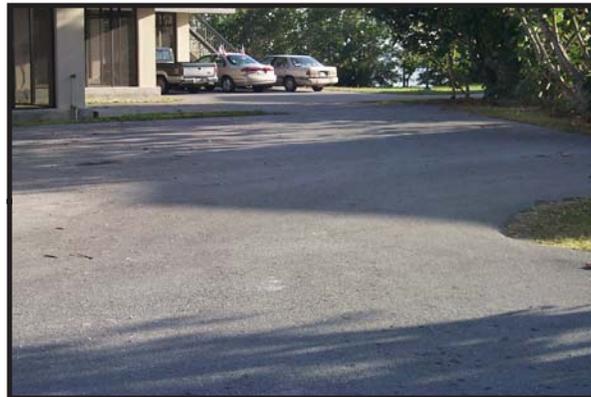
Route 0919A

Route	Public / NonPublic	Date Visited	Area (sq ft)	Lane Miles *	Surface Type	Condition / PCR
0919A	NonPublic	1/29/2002	10812	0.19	AS	GOOD / 90

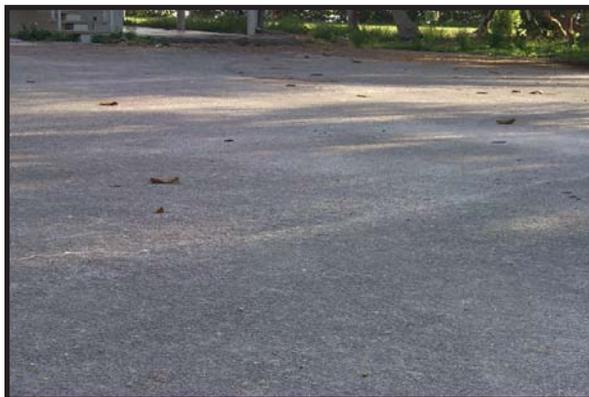
Route 0919B

Route	Public / NonPublic	Date Visited	Area (sq ft)	Lane Miles *	Surface Type	Condition / PCR
0919B	NonPublic	1/29/2002	7305	0.13	AS	GOOD / 90

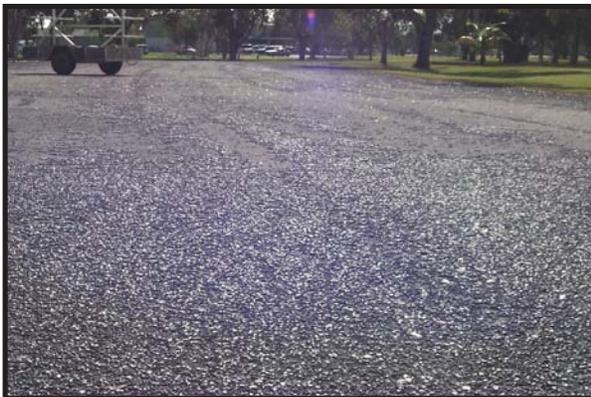
Route	Public / NonPublic	Date Visited	Area (sq ft)	Lane Miles *	Surface Type	Condition / PCR
0920D	Public	1/30/2002	19892	0.34	OC	POOR / 45

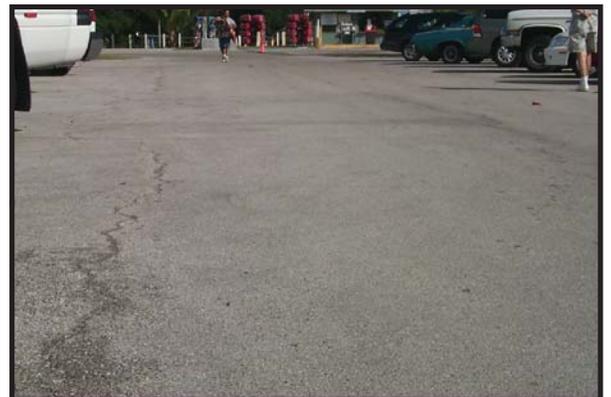
Route	Public / NonPublic	Date Visited	Area (sq ft)	Lane Miles *	Surface Type	Condition / PCR
0921	Public	1/29/2002	43485	0.75	AS	FAIR / 73

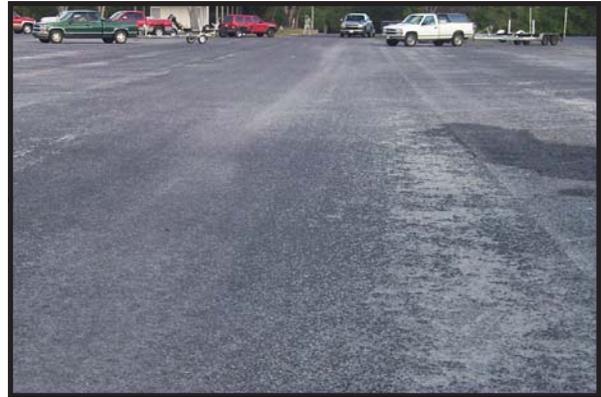
Route 0922

Route	Public / NonPublic	Date Visited	Area (sq ft)	Lane Miles *	Surface Type	Condition / PCR
0922	Public	1/29/2002	105945	1.82	OC	POOR / 45

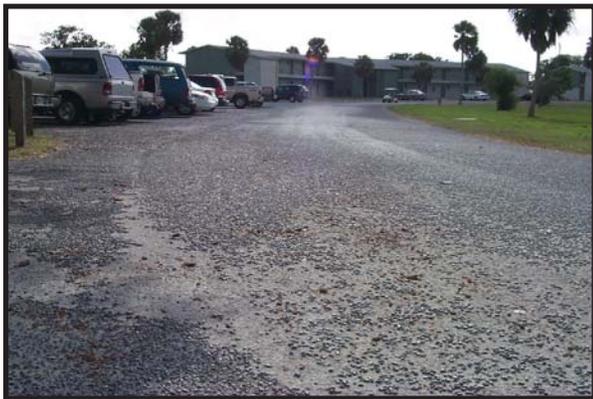
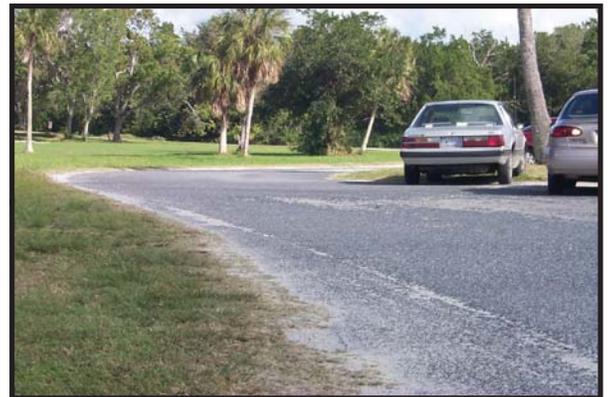
Route 0923

Route	Public / NonPublic	Date Visited	Area (sq ft)	Lane Miles *	Surface Type	Condition / PCR
0923	Public	1/29/2002	85979	1.48	OC	FAIR / 73

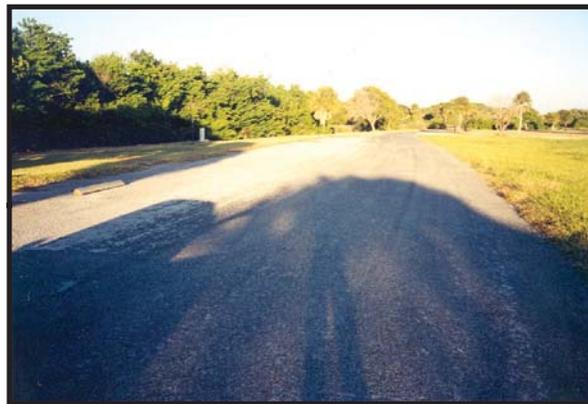
Route	Public / NonPublic	Date Visited	Area (sq ft)	Lane Miles *	Surface Type	Condition / PCR
0925B	Public	1/30/2002	2798	0.05	OC	POOR / 45

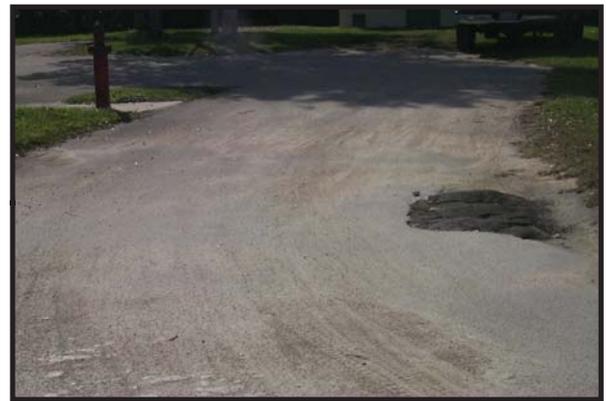
Route	Public / NonPublic	Date Visited	Area (sq ft)	Lane Miles *	Surface Type	Condition / PCR
0929	NonPublic	1/29/2002	6610	0.11	AS	GOOD / 90

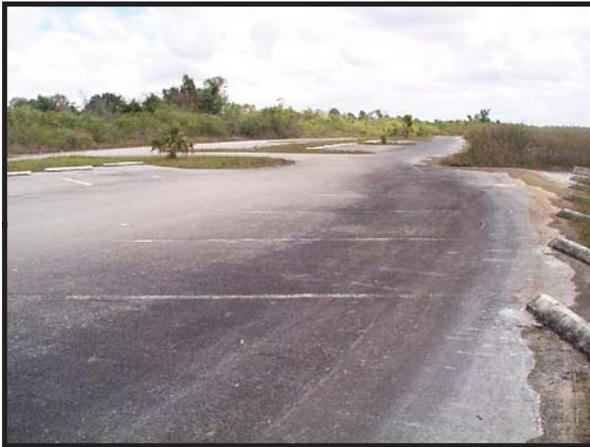
Route 0930

Route	Public / NonPublic	Date Visited	Area (sq ft)	Lane Miles *	Surface Type	Condition / PCR
0930	NonPublic	1/29/2002	70735	1.22	AS	GOOD / 90

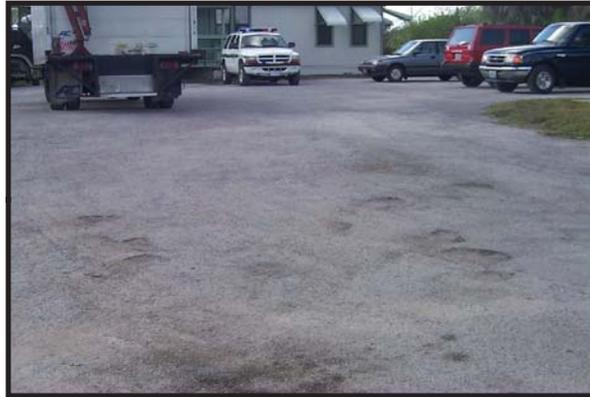
Route 0931

Route	Public / NonPublic	Date Visited	Area (sq ft)	Lane Miles *	Surface Type	Condition / PCR
0931	Public	1/29/2002	5132	0.09	OC	FAIR / 73

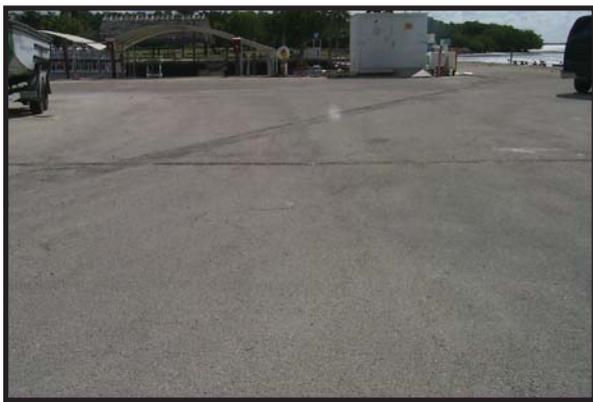
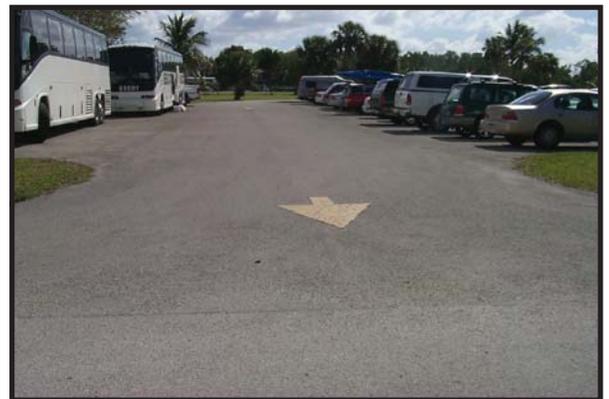
Route 0933

Route	Public / NonPublic	Date Visited	Area (sq ft)	Lane Miles *	Surface Type	Condition / PCR
0933	Public	1/29/2002	51593	0.89	AS	GOOD / 90

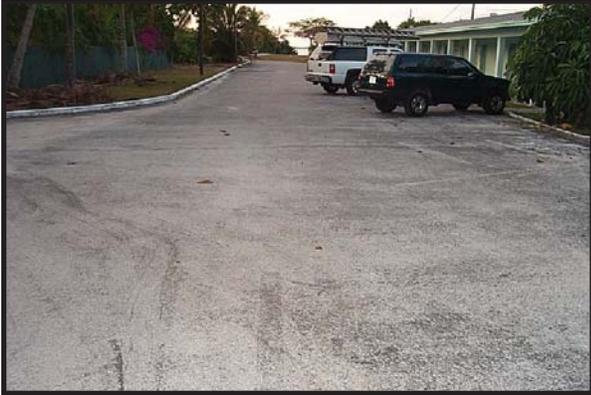
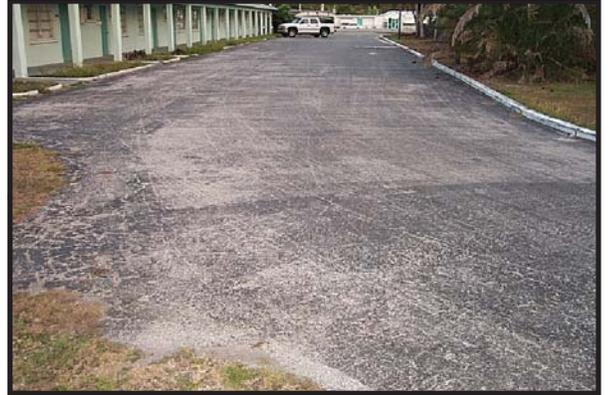
Route	Public / NonPublic	Date Visited	Area (sq ft)	Lane Miles *	Surface Type	Condition / PCR
0941	Public	1/29/2002	24819	0.43	AS	POOR / 45

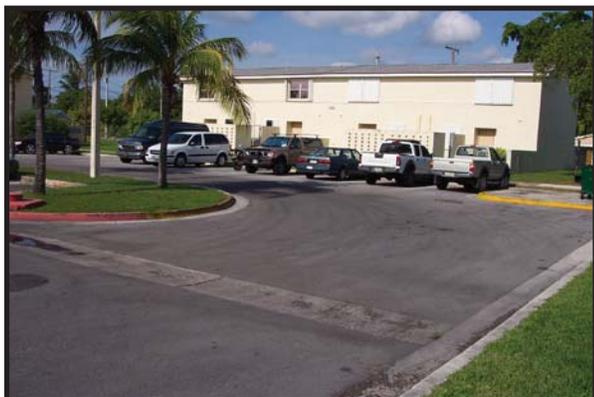
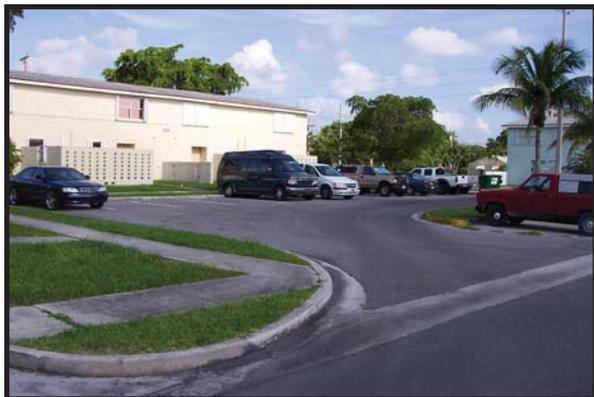
Route 0942

Route	Public / NonPublic	Date Visited	Area (sq ft)	Lane Miles *	Surface Type	Condition / PCR
0942	Public	9/24/2003	6388	0.11	AS	FAIR / 73
