The Road Inventory of Fire Island National Seashore FIIS - 1750

Road Inventory Program

Prepared By:
Federal Highway Administration
Eastern Federal Lands Highway Division
Cycle 3

Fire Island National Seashore in New York

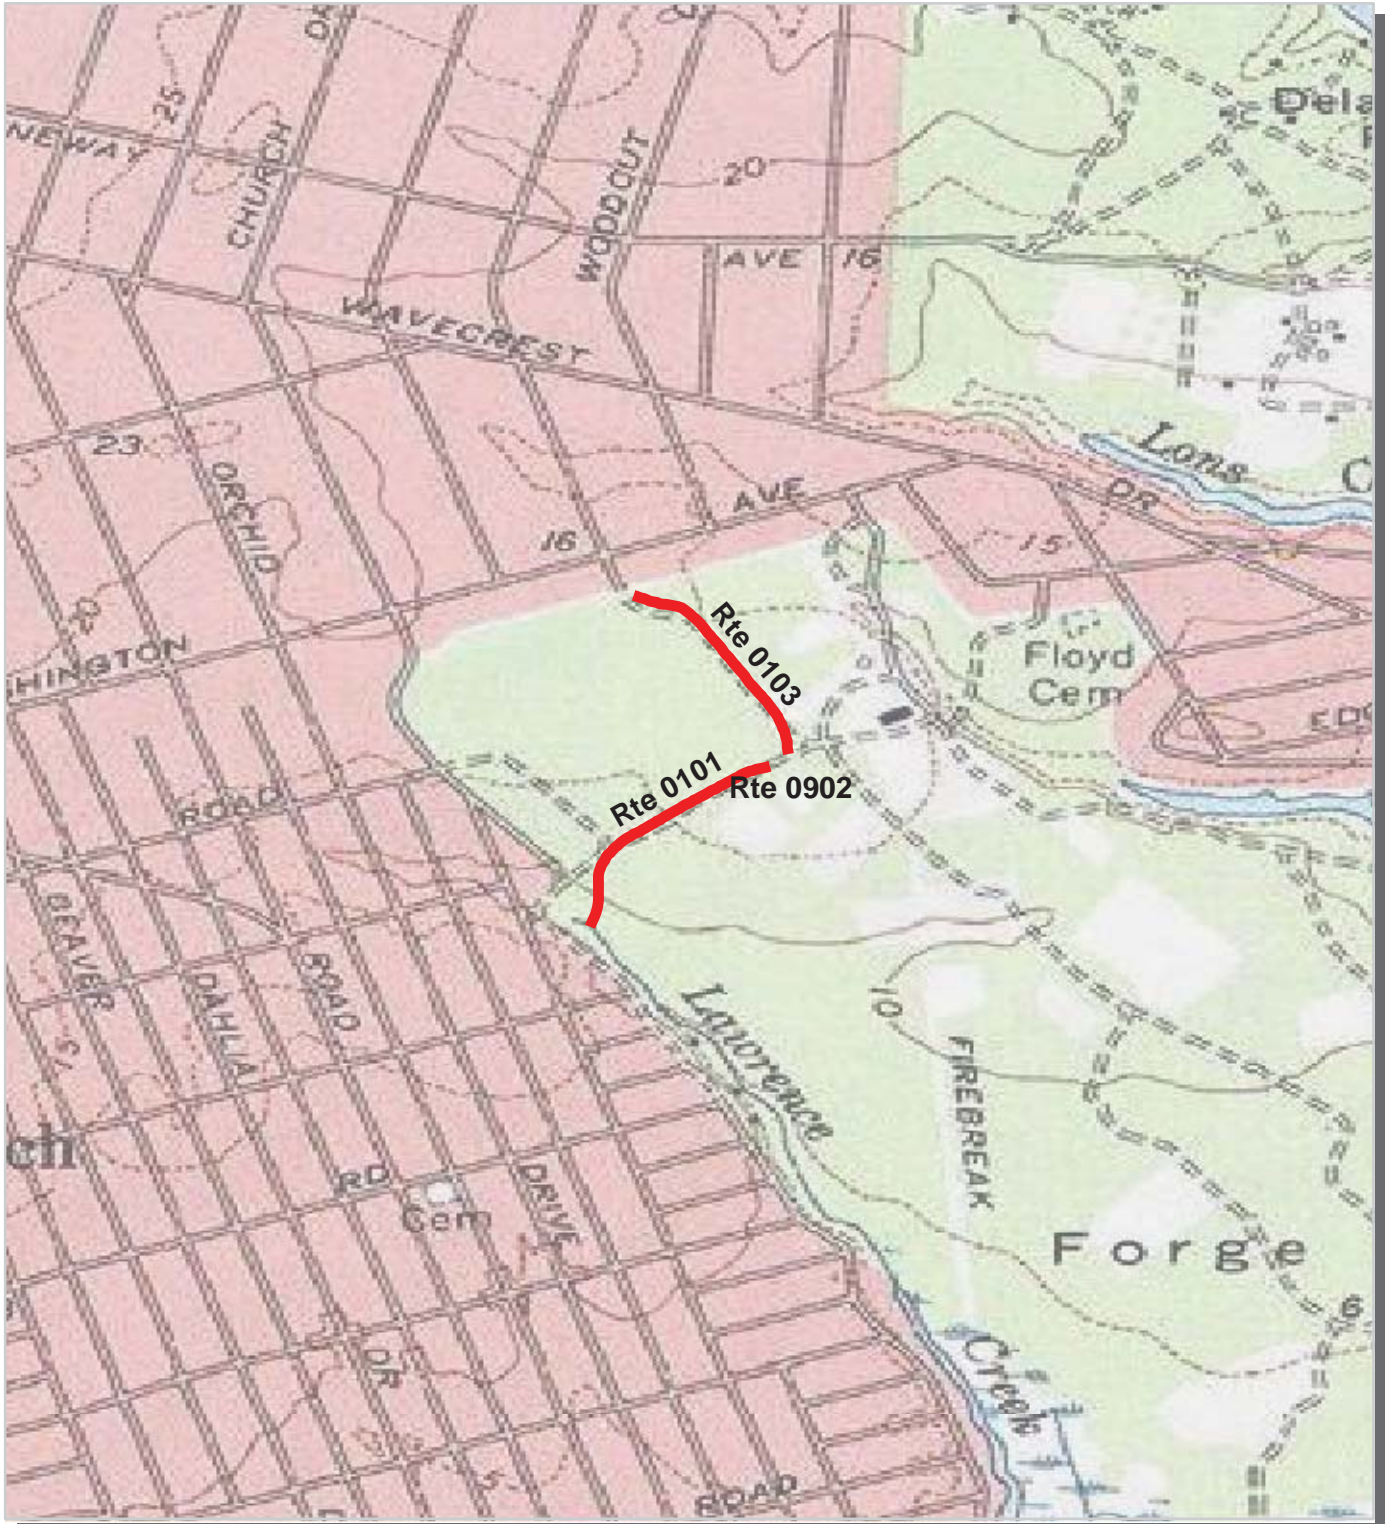
Fire Island National Seashore Route Condition Key Map PCR - Mile by Mile

PCR	Poor		Fair		Good		Excellent	
		(<=60)		(61 - 84)		(85 - 94)		(95 - 100)

* If the PCR rating is not available for a section, the SCR rating will be displayed. See appendix for definitions and formulas.

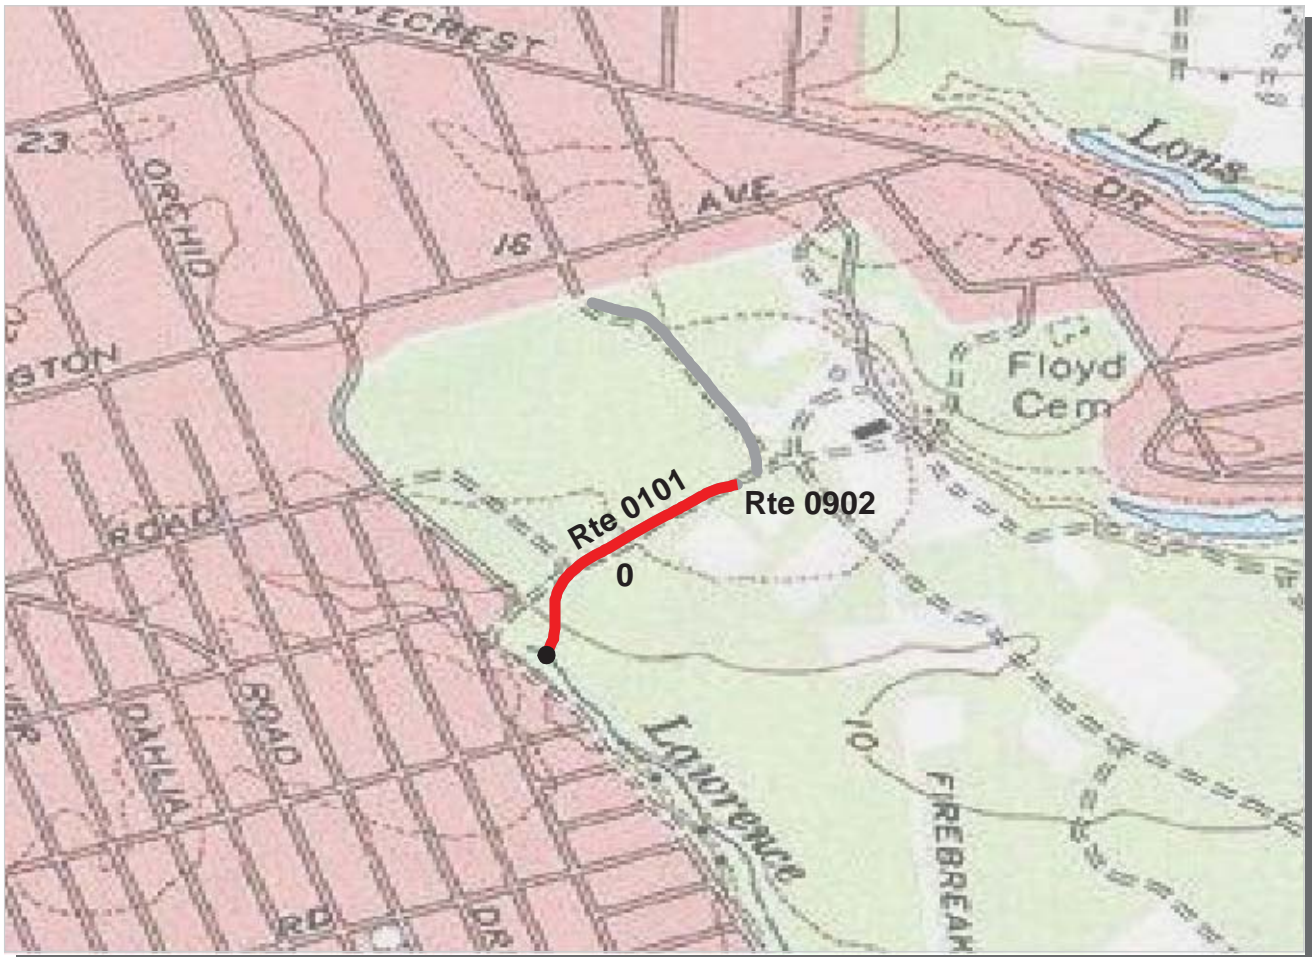
ROUTE: 0101 Main Entrance **TOTAL LENGTH: 0.25 Miles**

Section Number	0				
Section Length (mi)	0.25				
AADT	**				
SADT	**				
ADT Date	**				
Cross Section Information					
Number of Lanes	1				
Paved Width (ft)	9				
Lane Width (ft)	9				
Shoulder Width (ft)	6				
Roadway Condition Information					
PCR (Pavement Condition Rating)	42				
RCI (Roughness Condition Index)	56				
SCR (Surface Condition Rating)	38				
Alligator Cracking Index	99				
Rutting Index	44				
Patching Index	100				
Transverse Cracking Index	97				
Longitudinal Cracking Index	97				
Shoulder Condition Rating	POOR				
Drainage Condition Rating	POOR

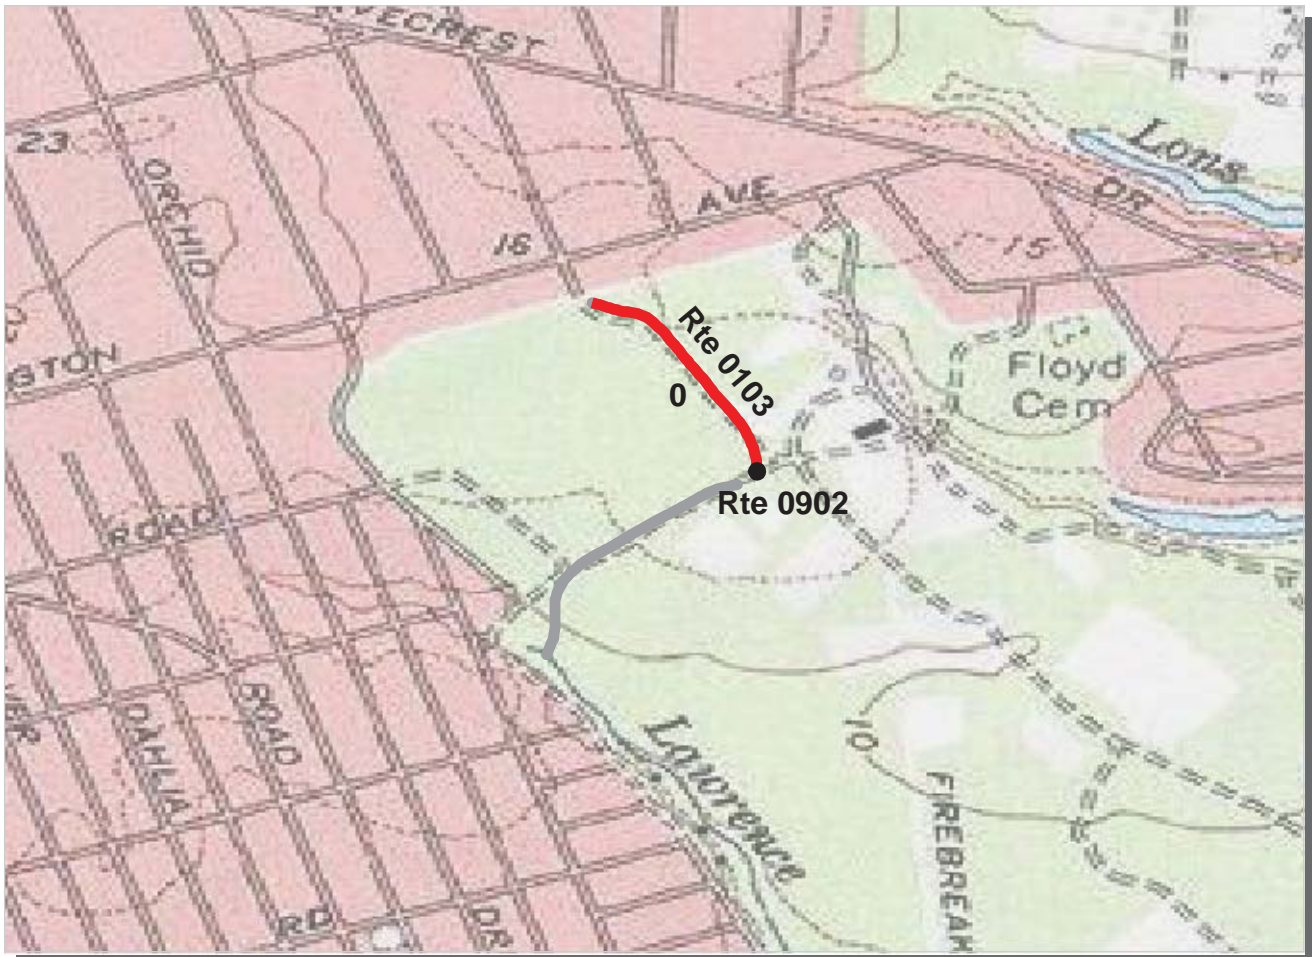
ROUTE: 0103 Main Exit **TOTAL LENGTH: 0.23 Miles**

Section Number	0				
Section Length (mi)	0.23				
AADT	**				
SADT	**				
ADT Date	**				
Cross Section Information					
Number of Lanes	1				
Paved Width (ft)	8				
Lane Width (ft)	8				
Shoulder Width (ft)	4				
Roadway Condition Information					
PCR (Pavement Condition Rating)	39				
RCI (Roughness Condition Index)	48				
SCR (Surface Condition Rating)	34				
Alligator Cracking Index	98				
Rutting Index	59				
Patching Index	100				
Transverse Cracking Index	80				
Longitudinal Cracking Index	95				
Shoulder Condition Rating	POOR				
Drainage Condition Rating	POOR

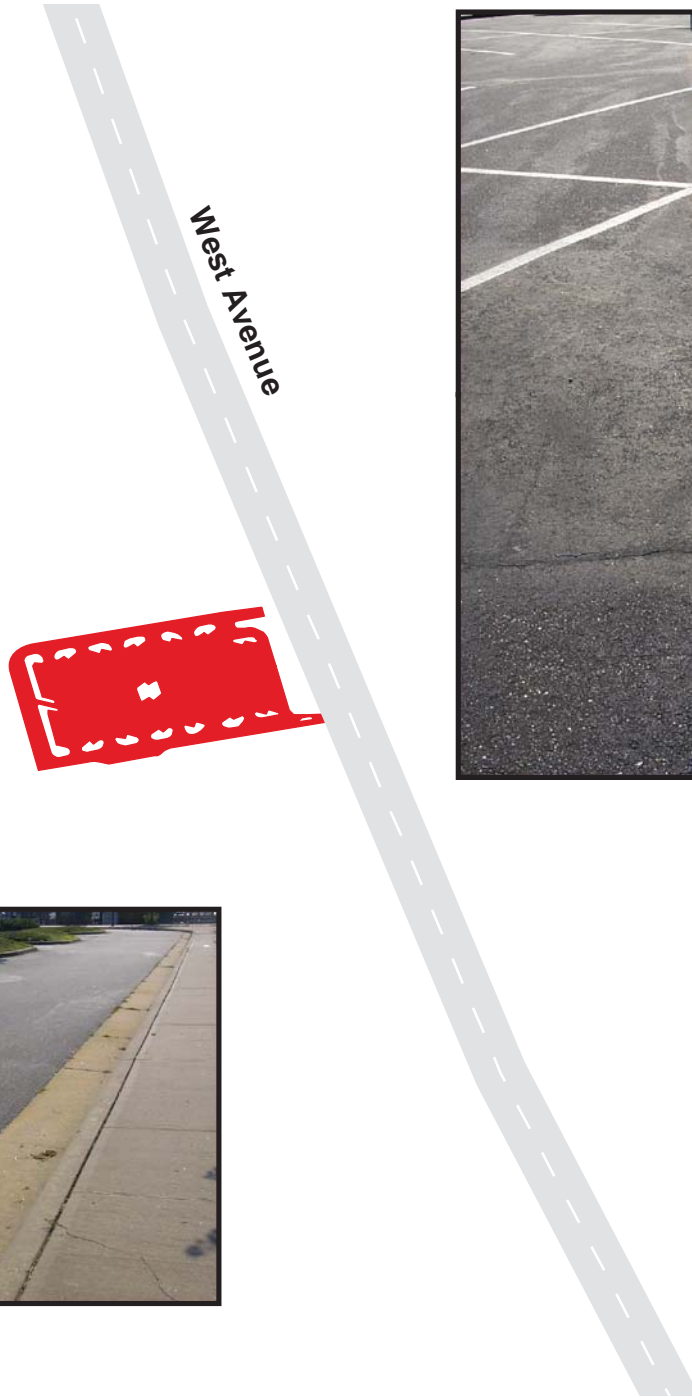
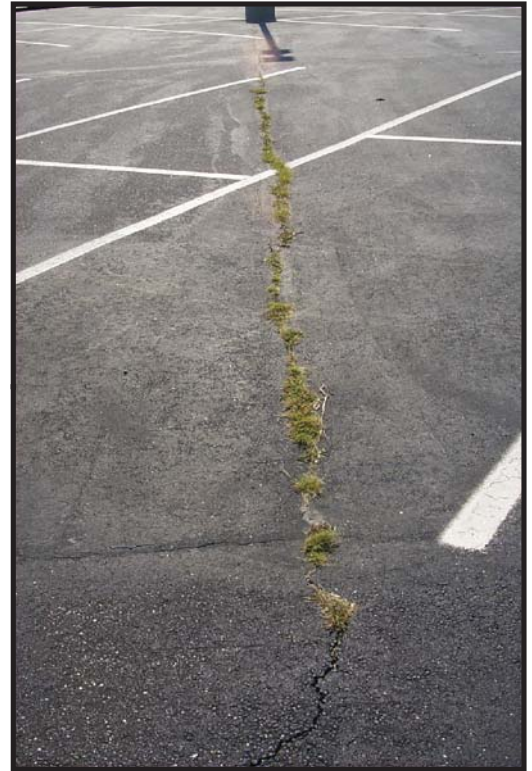
Route	Public / NonPublic	Date Visited	Area (sq ft)	Lane Miles *	Surface Type	Condition / PCR
0900	Public	8/10/2002	81910	1.41	AS	GOOD / 90

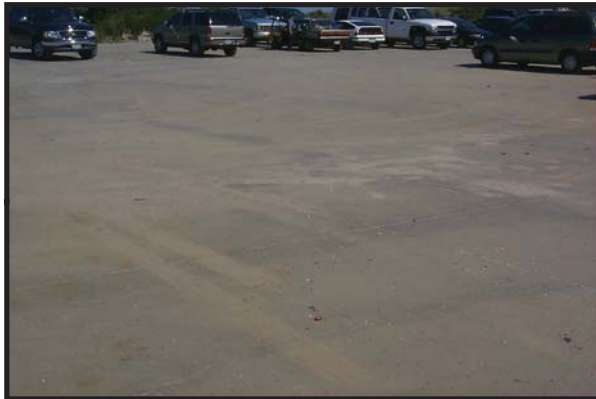
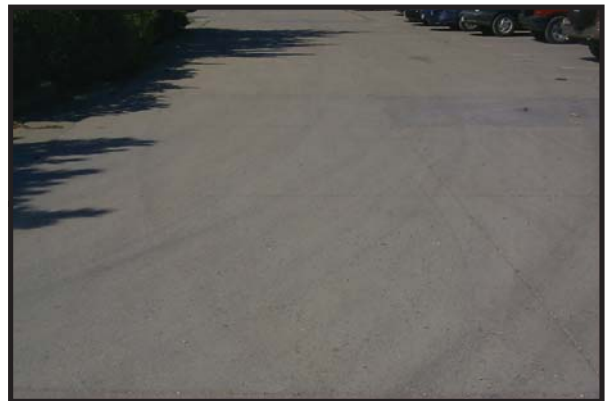
Fire Island National Seashore
Route 0901
 LIGHTHOUSE STATION ANNEX PARKING
 From Route 0100

Route	Public / NonPublic	Date Visited	Area (sq ft)	Lane Miles *	Surface Type	Condition / PCR
0901	NonPublic	8/10/2002	20009	0.34	CO	GOOD / 90

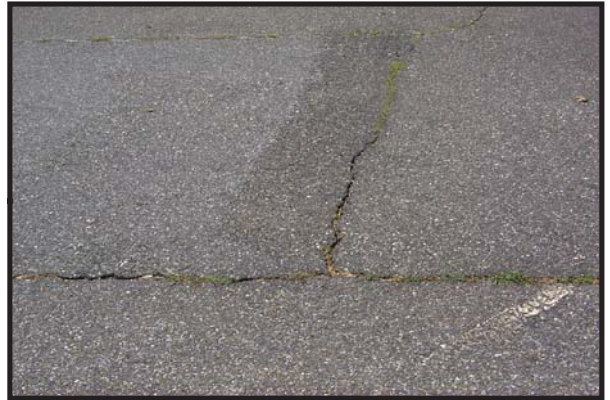
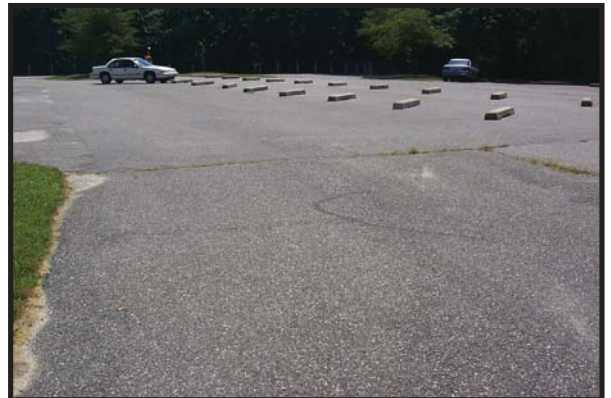
Route 0902

Route	Public / NonPublic	Date Visited	Area (sq ft)	Lane Miles *	Surface Type	Condition / PCR
0902	Public	8/10/2002	30471	0.52	AS	GOOD / 90

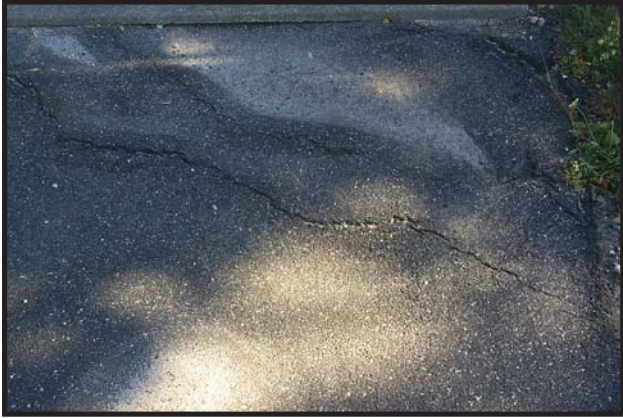
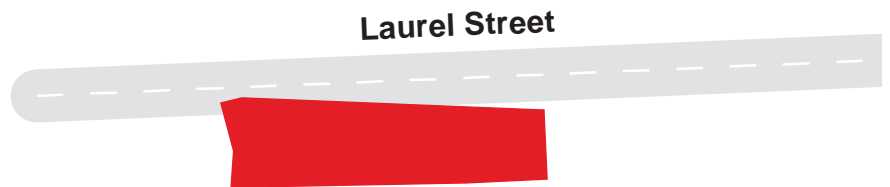
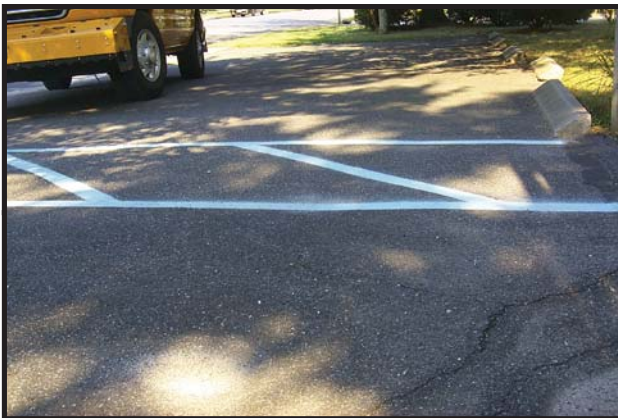
Route 0906

Route	Public / NonPublic	Date Visited	Area (sq ft)	Lane Miles *	Surface Type	Condition / PCR
0906	Public	8/10/2002	1222	0.02	AS	FAIR / 73
