The Road Inventory of First Ladies National Historic Site FILE – 6170

Road Inventory Program

Prepared By:
Federal Highway Administration
Eastern Federal Lands Highway Division
Cycle 3

First Ladies National Historic Site in Ohio

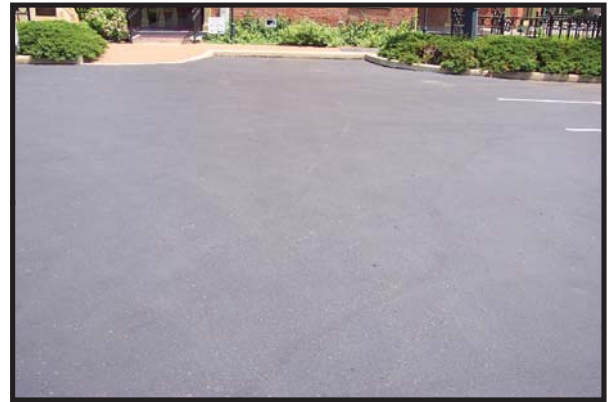
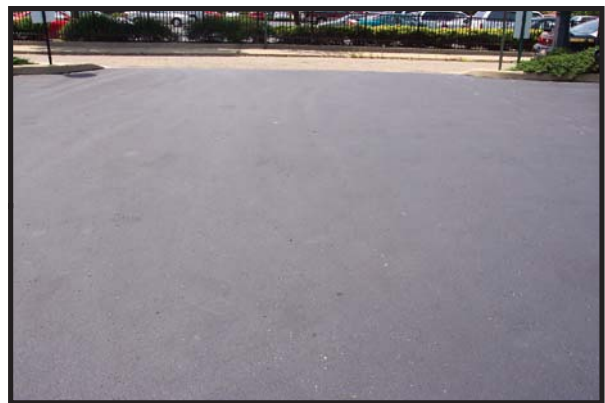
Route 0900

SAXTON MCKINLEY HOUSE PARKING
FROM COURT AVENUE SOUTHWEST

Route	Public / NonPublic	Date Visited	Area (sq ft)	Lane Miles *	Surface Type	Condition / PCR
0900	PUBLIC	7/9/2004	5605	0.10	AS	FAIR / 73
