**The Road Inventory
of
Fort Bowie National Historic Site
FOBO - 8640**

Road Inventory Program

Prepared By:
Federal Highway Administration
Eastern Federal Lands Highway Division
Cycle 3

Fort Bowie National Historic Site in Arizona

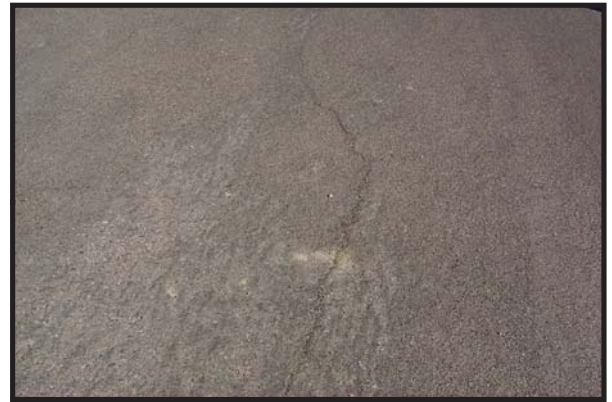
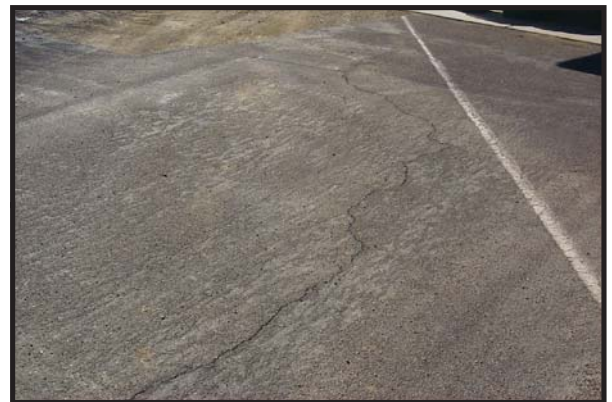
Route 0900

VISITOR PARKING

From Route 0010

Route	Public / NonPublic	Date Visited	Area (sq ft)	Lane Miles *	Surface Type	Condition / PCR
0900	Public	3/6/2003	6402	0.11	AS	GOOD / 90
