# The Road Inventory Of Fossil Butte National Monument FOBU - 1468

Prepared By:  
Federal Highway Administration  
Eastern Federal Lands Highway Division  
Cycle 3

# Fossil Butte National Monument in Wyoming

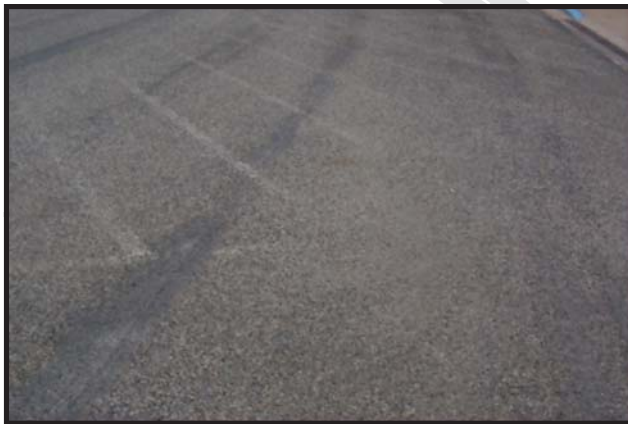
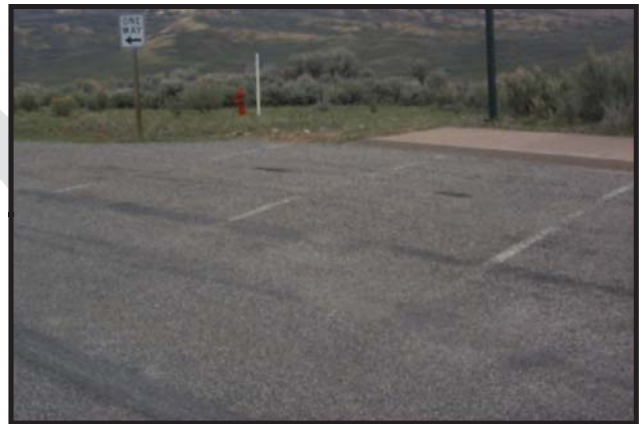
Route	Public / NonPublic	Date Visited	Area (sq ft)	Lane Miles *	Surface Type	Condition / PCR
0900	Public	5/3/2003	39506	0.68	OC	FAIR / 73

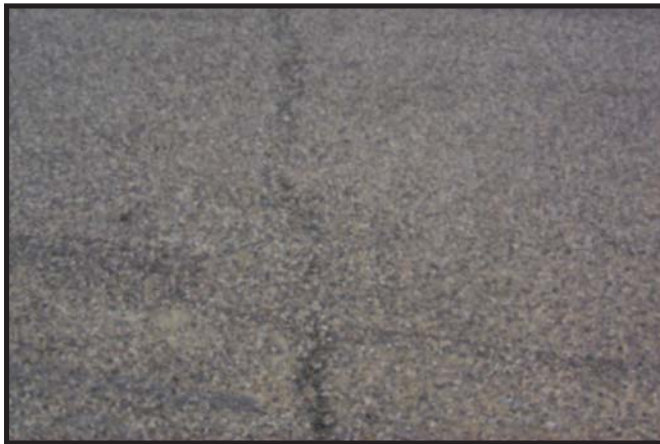
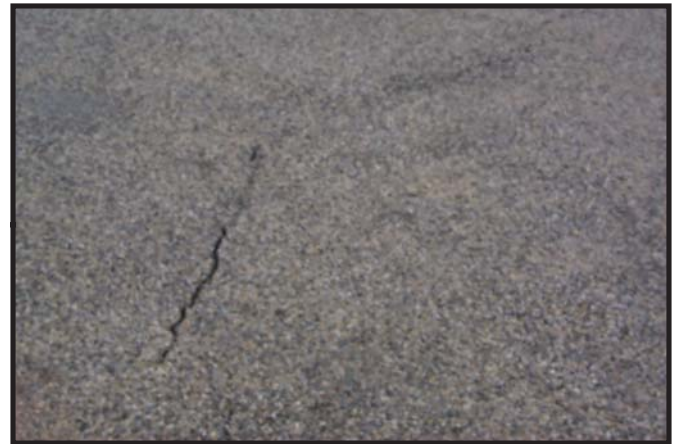
## Route 0901

Route	Public / NonPublic	Date Visited	Area (sq ft)	Lane Miles *	Surface Type	Condition / PCR
0901	NonPublic	5/3/2003	22427	0.39	OC	FAIR / 73

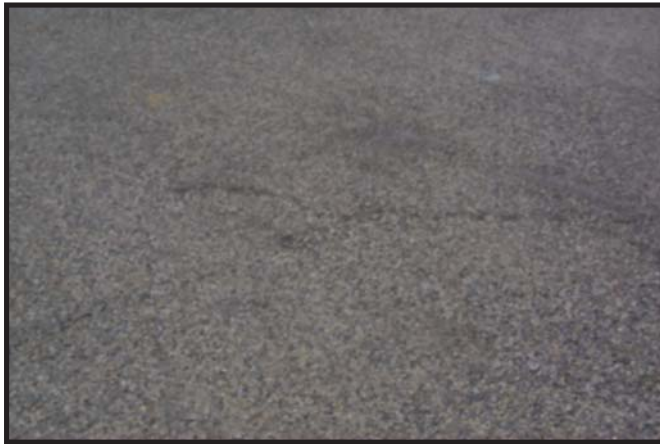
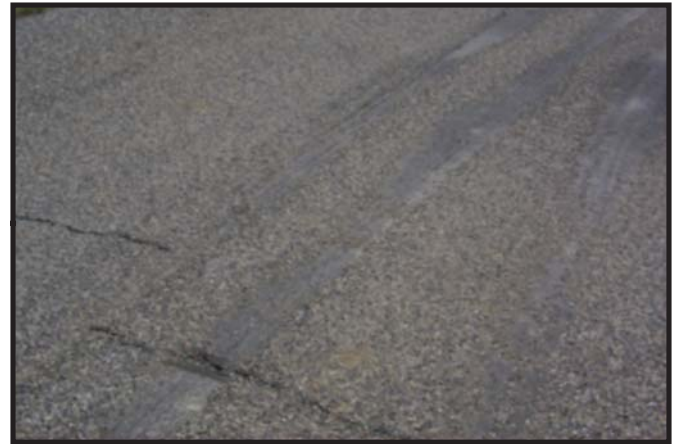
## Route 0902

Route	Public / NonPublic	Date Visited	Area (sq ft)	Lane Miles *	Surface Type	Condition / PCR
0902	NonPublic	5/3/2003	9134	0.16	OC	FAIR / 73

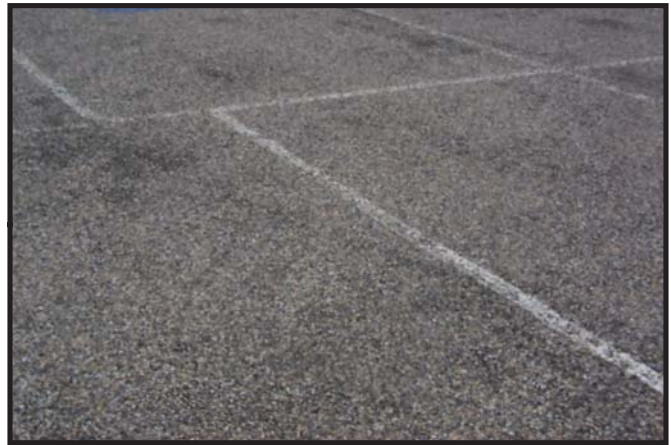
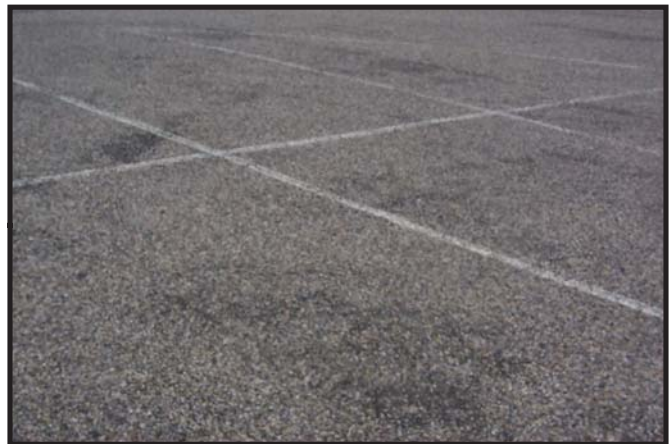
## Route 0903

Route	Public / NonPublic	Date Visited	Area (sq ft)	Lane Miles *	Surface Type	Condition / PCR
0903	Public	5/3/2003	9461	0.16	OC	GOOD / 90

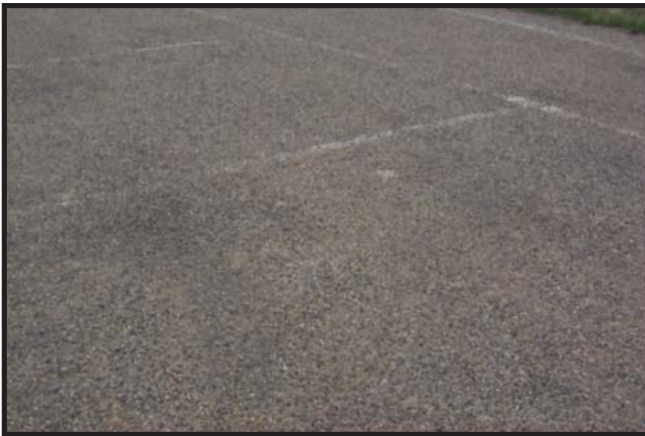
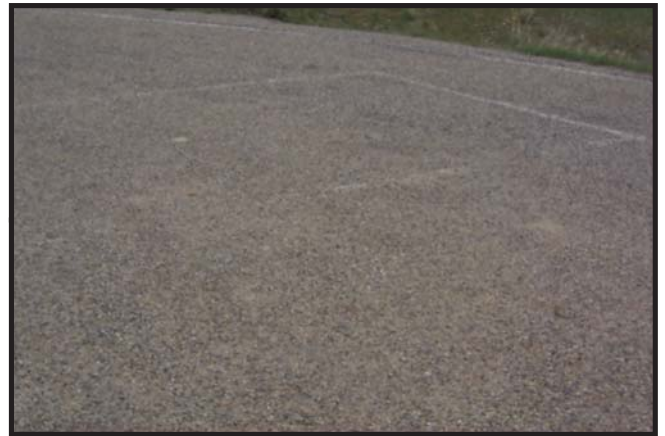
## Route 0904

Route	Public / NonPublic	Date Visited	Area (sq ft)	Lane Miles *	Surface Type	Condition / PCR
0904	Public	5/3/2003	4011	0.07	OC	GOOD / 90

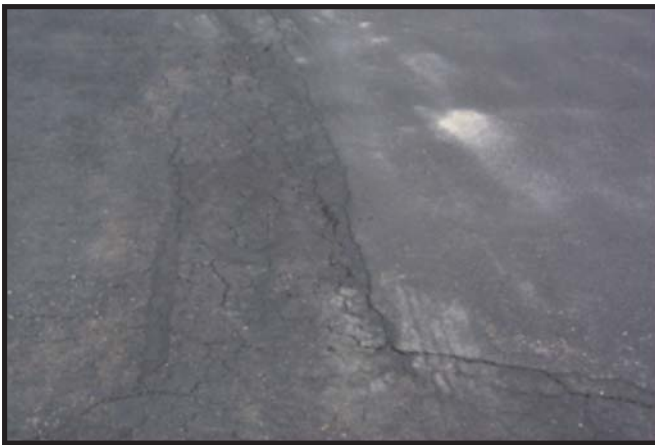
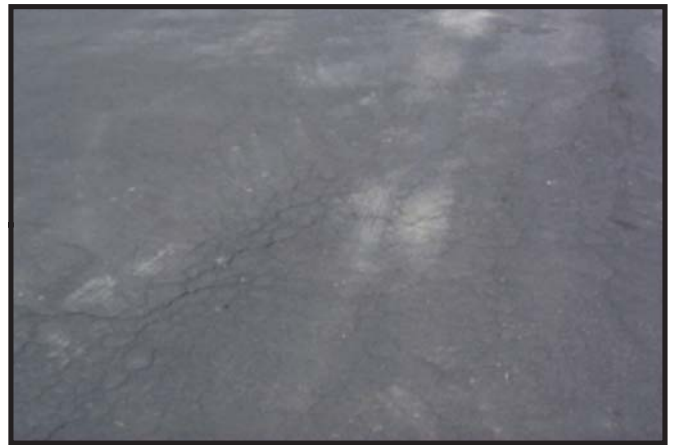
## Route 0905

Route	Public / NonPublic	Date Visited	Area (sq ft)	Lane Miles *	Surface Type	Condition / PCR
0905	Public	5/3/2003	22922	0.39	AS	FAIR / 73
