The Road Inventory of Fort Caroline National Memorial FOCA - 5310

Road Inventory Program

Prepared By:
Federal Highway Administration
Eastern Federal Lands Highway Division
Cycle 3

Fort Caroline National Memorial in Florida

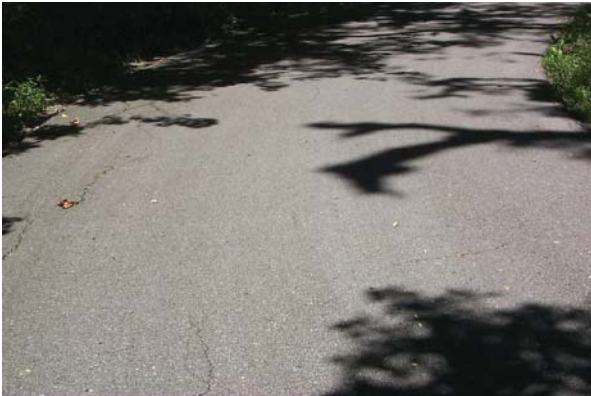
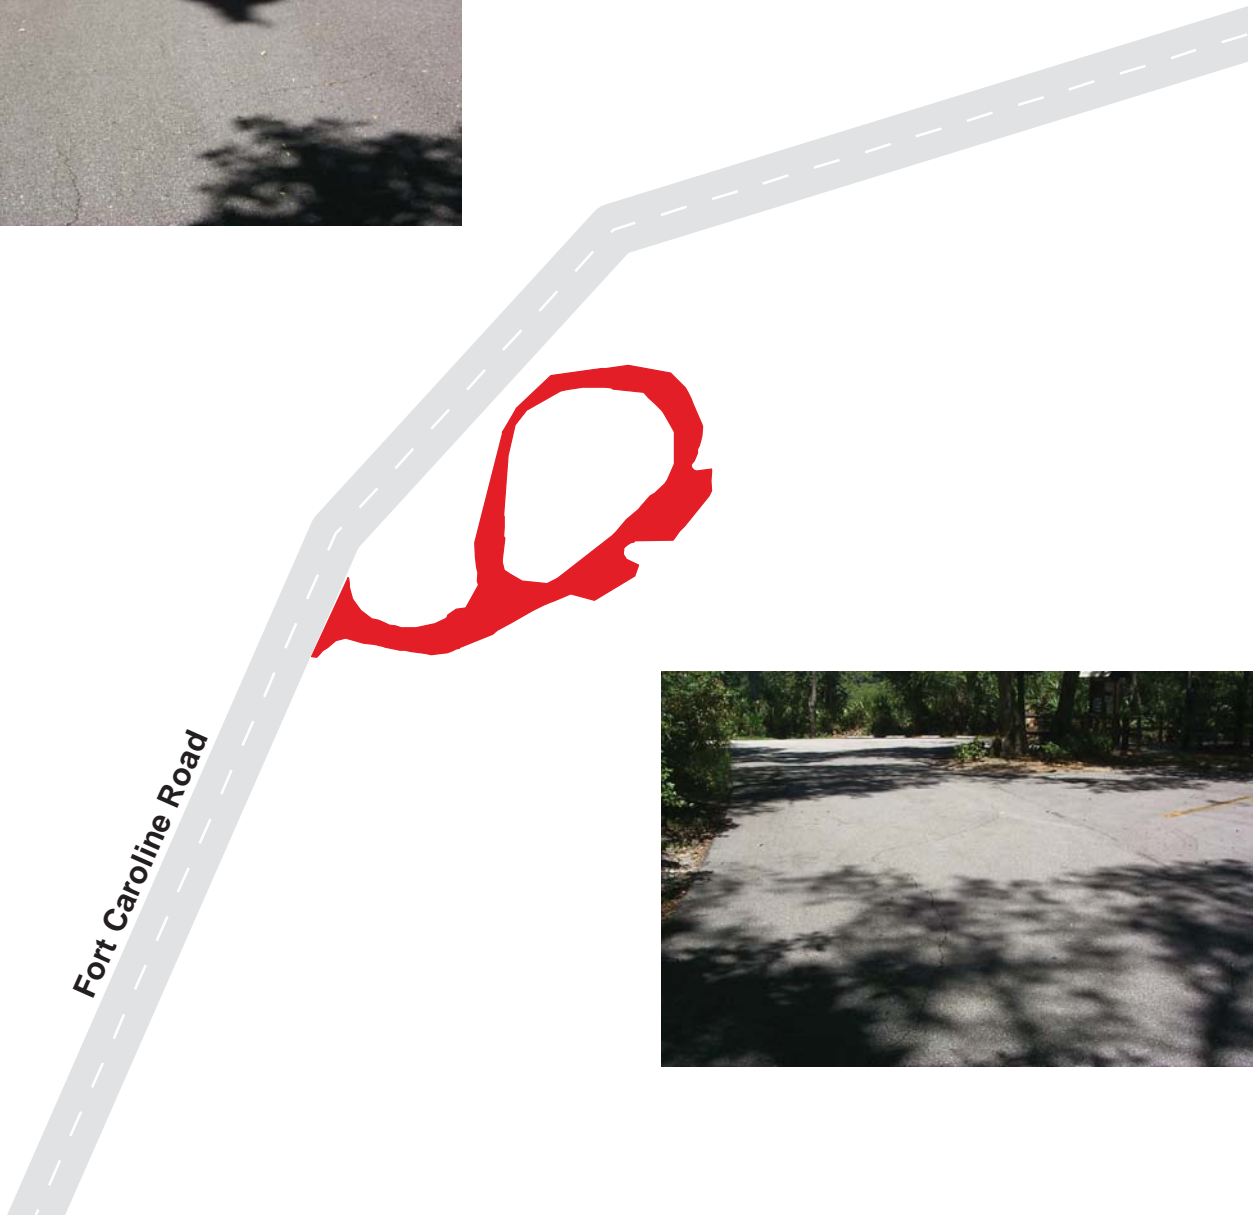
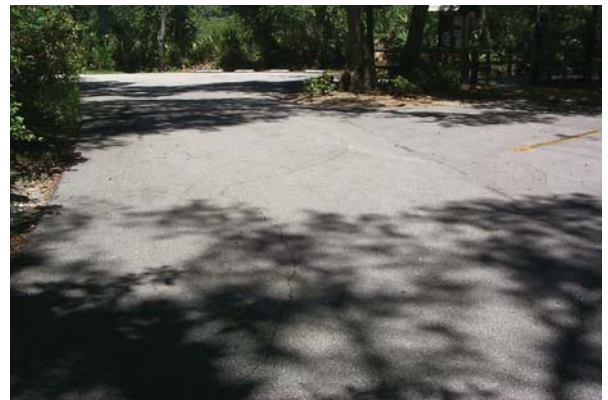
Route 0901

SPANISH POND PARKING

Route	Public / NonPublic	Date Visited	Area (sq ft)	Lane Miles *	Surface Type	Condition / PCR
0901	Public	7/3/2001	14114	0.24	AS	GOOD / 90

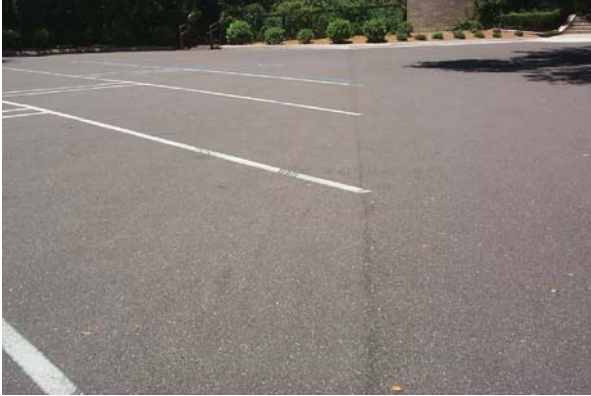
Route 0902

COLUMN ROAD PARKING

Route	Public / NonPublic	Date Visited	Area (sq ft)	Lane Miles *	Surface Type	Condition / PCR
0902	Public	7/3/2001	21248	0.37	AS	EXCELLENT / 97

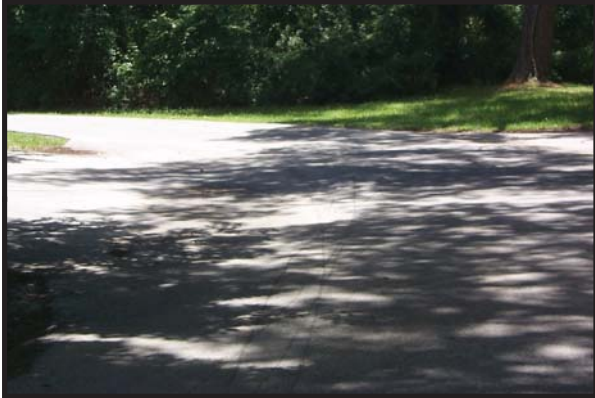
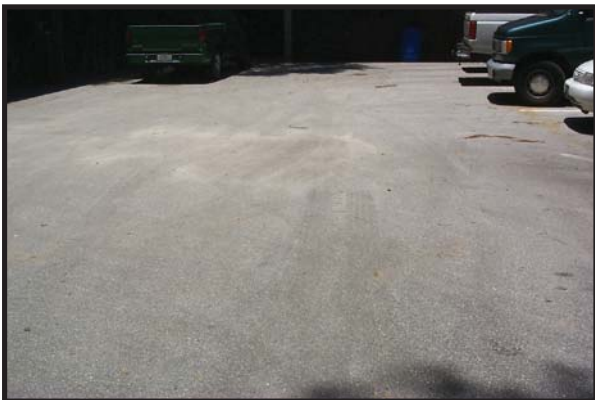
Route 0903

MAINTENANCE ROAD PARKING

Route	Public / NonPublic	Date Visited	Area (sq ft)	Lane Miles *	Surface Type	Condition / PCR
0903	NonPublic	7/3/2001	10081	0.17	AS	GOOD / 90
