The Road Inventory of Fort Davis National Historic Site FODA – 7220

Road Inventory Program

Prepared By:
Federal Highway Administration
Eastern Federal Lands Highway Division
Cycle 3

Fort Davis National Historic Site in Texas

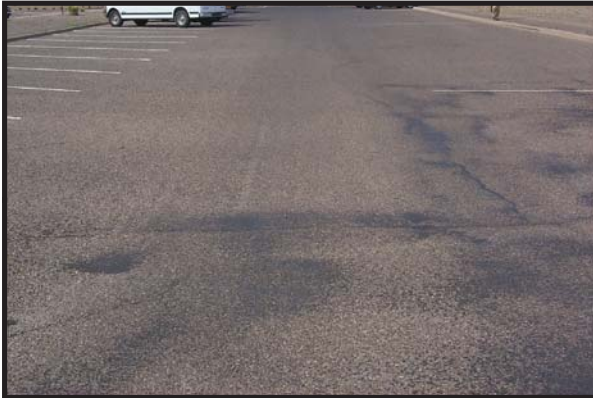
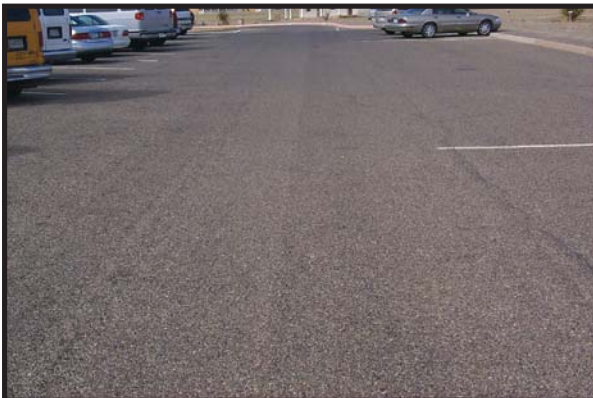
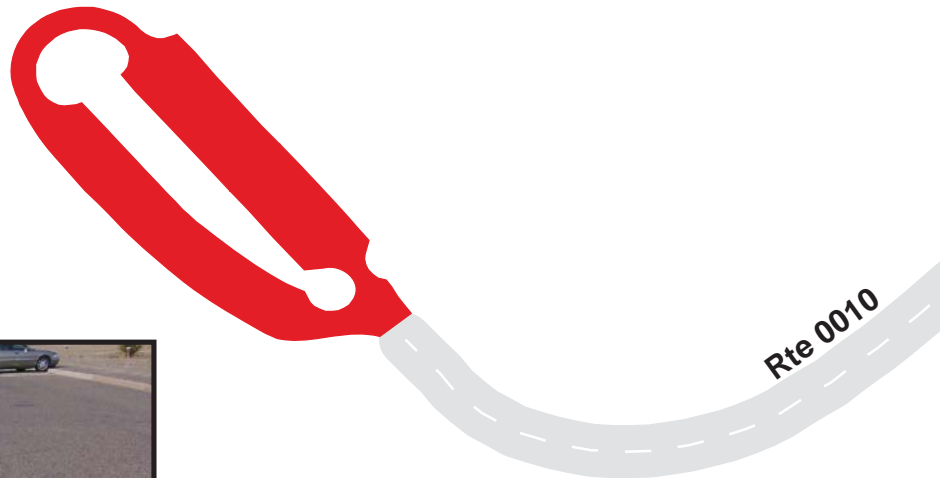
Route 0900

VISITOR CENTER PARKING

Route	Public / NonPublic	Date Visited	Area (sq ft)	Lane Miles *	Surface Type	Condition / PCR
0900	Public	3/1/2003	35893	0.62	AS	GOOD / 90

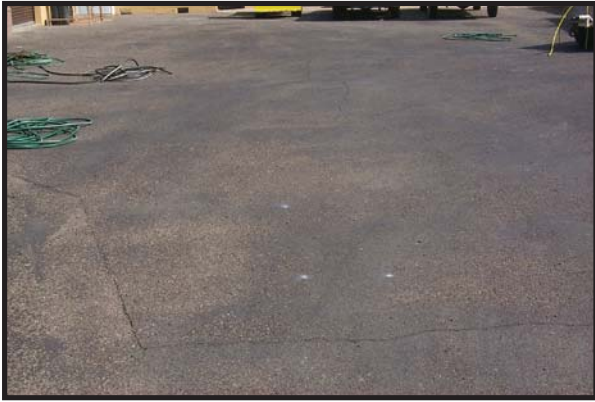
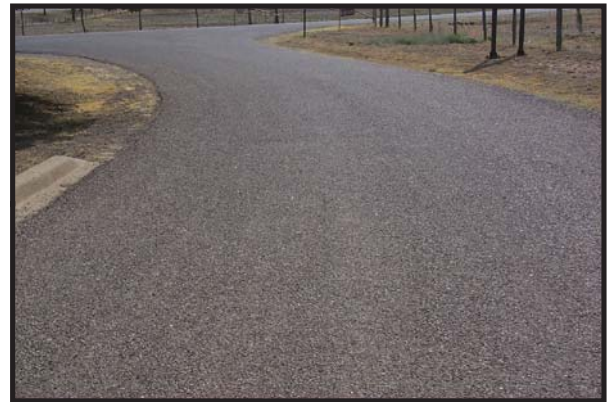
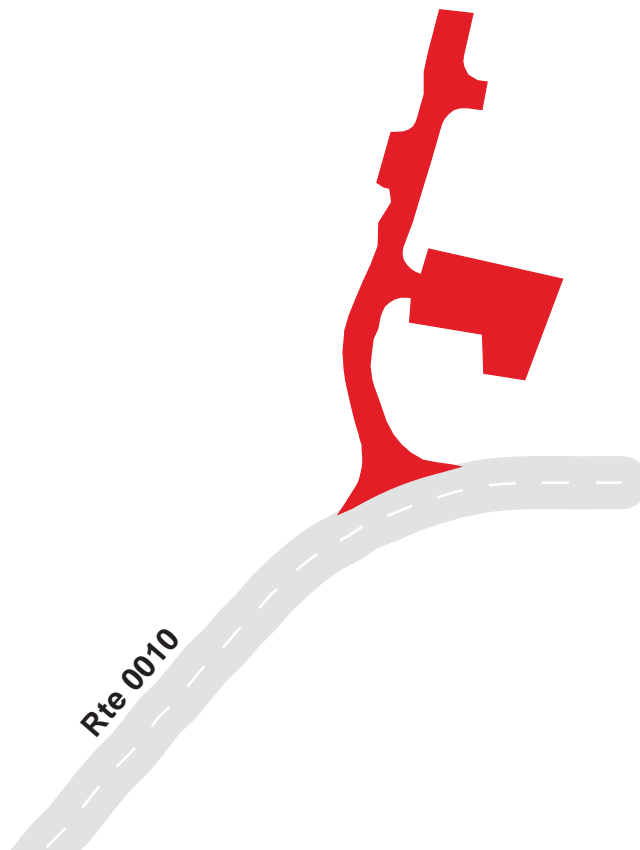
Route	Public / NonPublic	Date Visited	Area (sq ft)	Lane Miles *	Surface Type	Condition / PCR
0901	NonPublic	3/1/2003	15576	0.27	AS	GOOD / 90

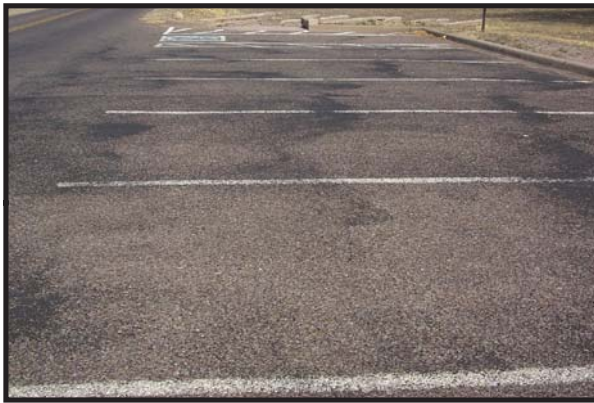
Route 0904

Route	Public / NonPublic	Date Visited	Area (sq ft)	Lane Miles *	Surface Type	Condition / PCR
0904	Public	3/1/2003	1835	0.03	AS	GOOD / 90
