The Road Inventory of Fort Donelson National Battlefield FODO - 5400

Prepared By:
Federal Highway Administration
Eastern Federal Lands Highway Division
Cycle 3

Fort Donelson National Battlefield in Tennessee

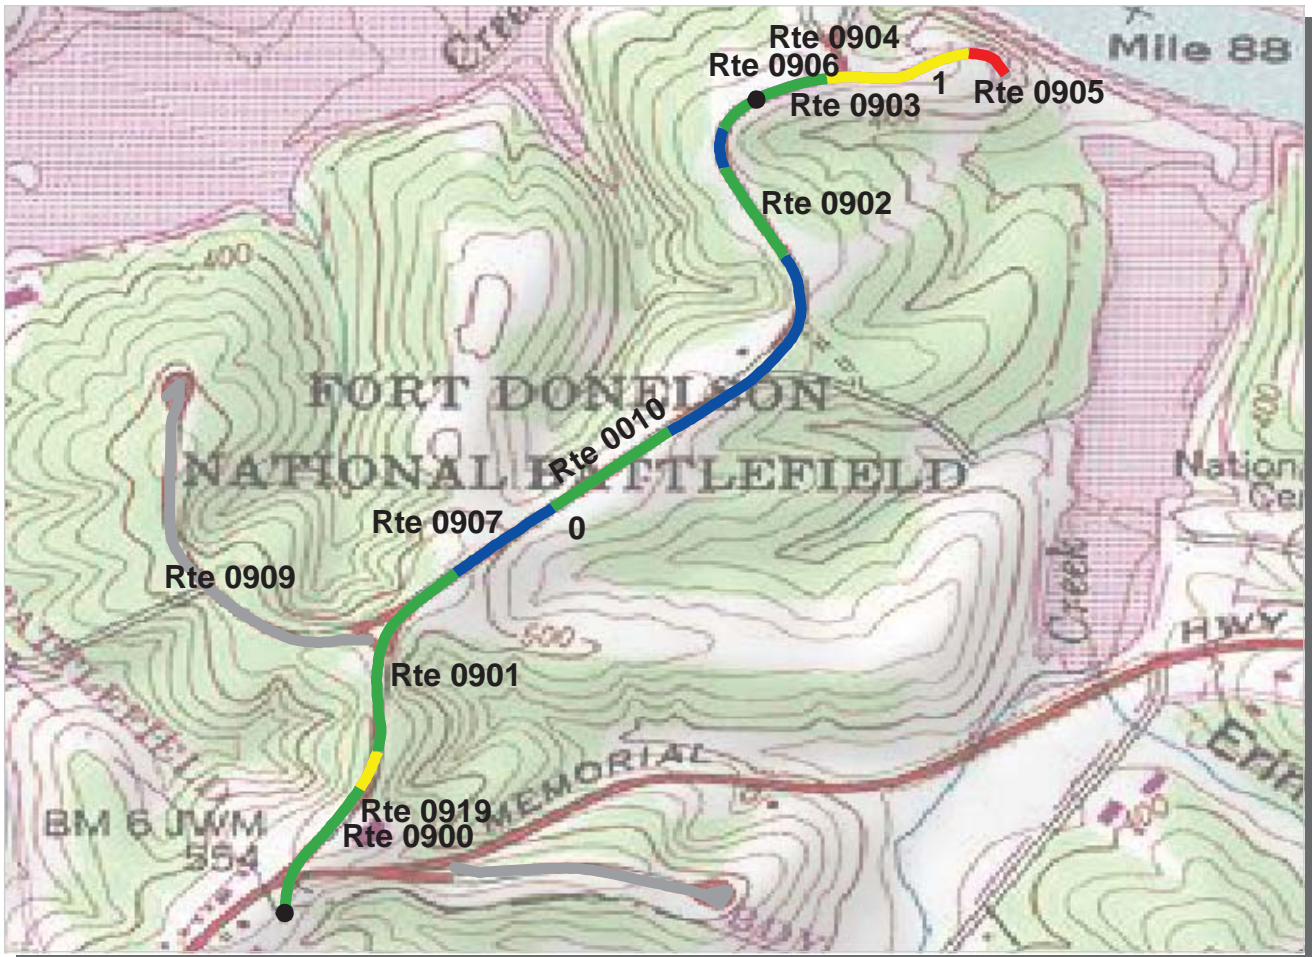
ROUTE: 0010 Lock Road **TOTAL LENGTH: 1.24 Miles**

Section Number	0	1			
Section Length (mi)	1.00	0.24			
AADT	**				
SADT	**				
ADT Date	**				
Cross Section Information					
Number of Lanes	2	2			
Paved Width (ft)	21	18			
Lane Width (ft)	10	8			
Shoulder Width (ft)	3	2			
Roadway Condition Information					
PCR (Pavement Condition Rating)	88	72			
RCI (Roughness Condition Index)	92	50			
SCR (Surface Condition Rating)	87	78			
Alligator Cracking Index	100	100			
Rutting Index	87	78			
Patching Index	100	100			
Transverse Cracking Index	100	100			
Longitudinal Cracking Index	99	99			
Shoulder Condition Rating	GOOD	GOOD			
Drainage Condition Rating	GOOD	GOOD

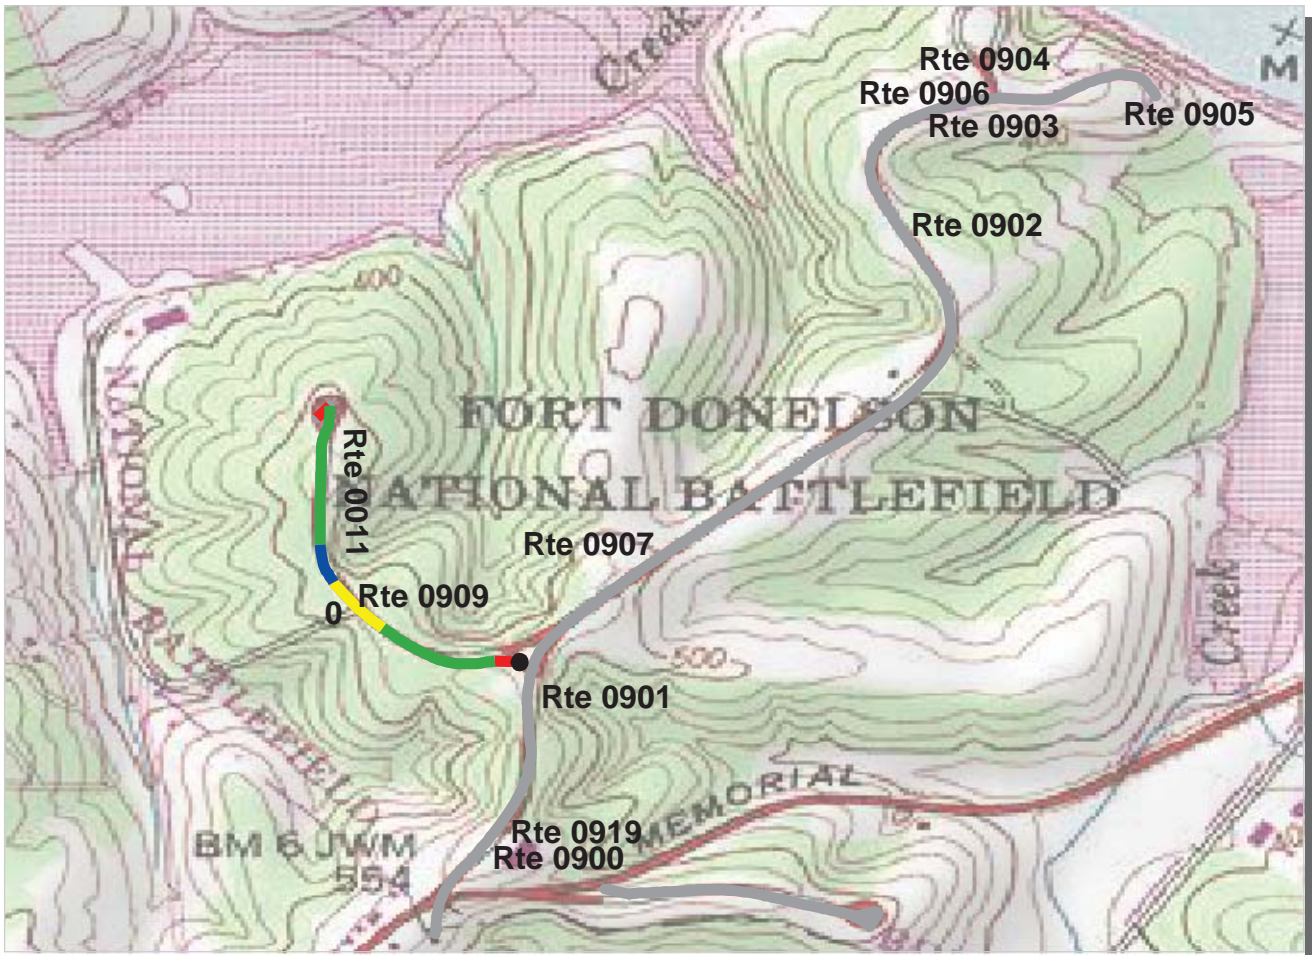
ROUTE: 0011 Eddyville Loop **TOTAL LENGTH: 0.40 Miles**

Section Number	0			
Section Length (mi)	0.40			
AADT	**			
SADT	**			
ADT Date	**			
Cross Section Information				
Number of Lanes	2			
Paved Width (ft)	18			
Lane Width (ft)	9			
Shoulder Width (ft)	2			
Roadway Condition Information				
PCR (Pavement Condition Rating)	84			
RCI (Roughness Condition Index)	90			
SCR (Surface Condition Rating)	81			
Alligator Cracking Index	100			
Rutting Index	82			
Patching Index	100			
Transverse Cracking Index	100			
Longitudinal Cracking Index	99			
Shoulder Condition Rating	GOOD			
Drainage Condition Rating	GOOD

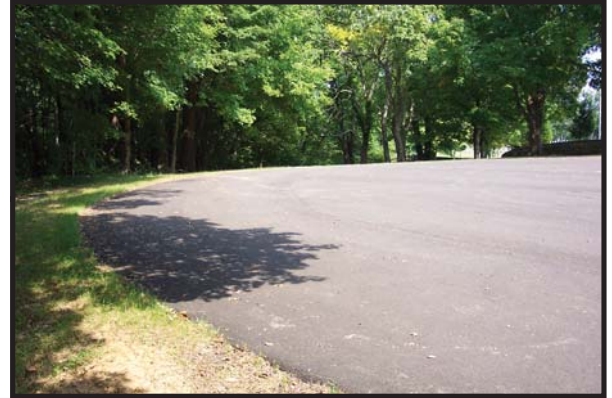
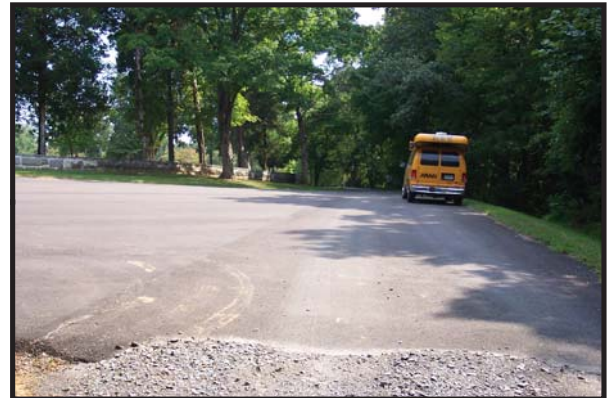
Route 0917

Route	Public / NonPublic	Date Visited	Area (sq ft)	Lane Miles *	Surface Type	Condition / PCR
0917	Public	8/17/2004	10107	0.17	AS	FAIR / 73
