The Road Inventory of Fort Frederica National Monument FOFR - 5410

Prepared By:
Federal Highway Administration
Eastern Federal Lands Highway Division
Cycle 3

Fort Frederica National Monument in Georgia

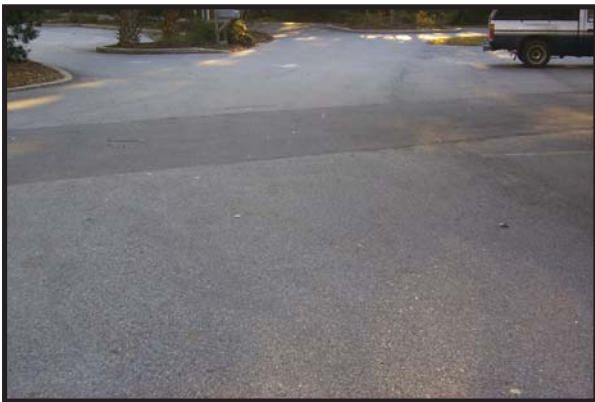
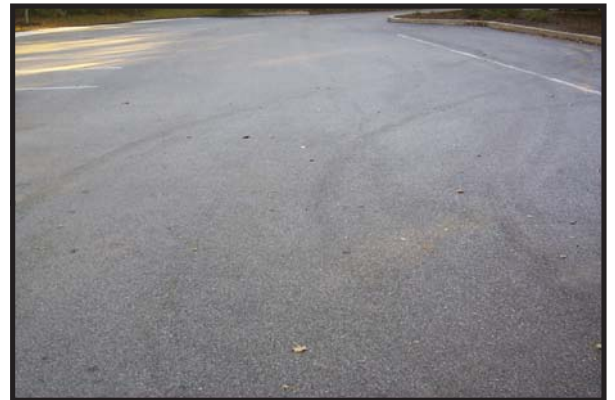
Route 0900

VISITOR CENTER PARKING From Frederica Road

Route	Public / NonPublic	Date Visited	Area (sq ft)	Lane Miles *	Surface Type	Condition / PCR
0900	Public	12/16/2002	51439	0.89	AS	GOOD / 90

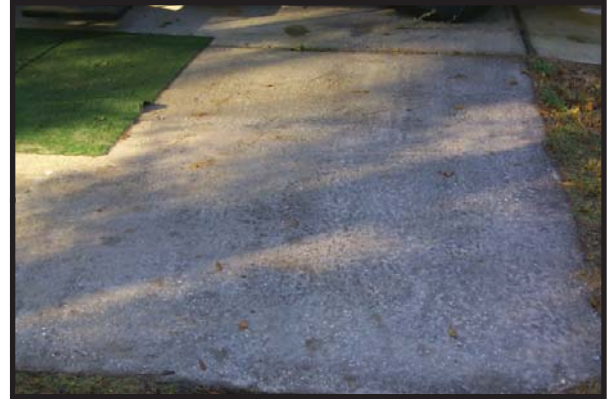
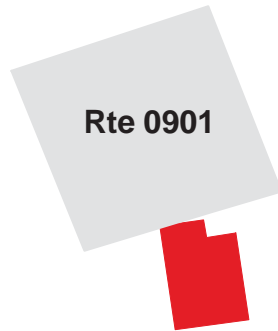
Route 0902

MAINTENANCE HANDICAP PARKING

Route	Public / NonPublic	Date Visited	Area (sq ft)	Lane Miles *	Surface Type	Condition / PCR
0902	NonPublic	12/16/2002	572	0.01	CO	GOOD / 90

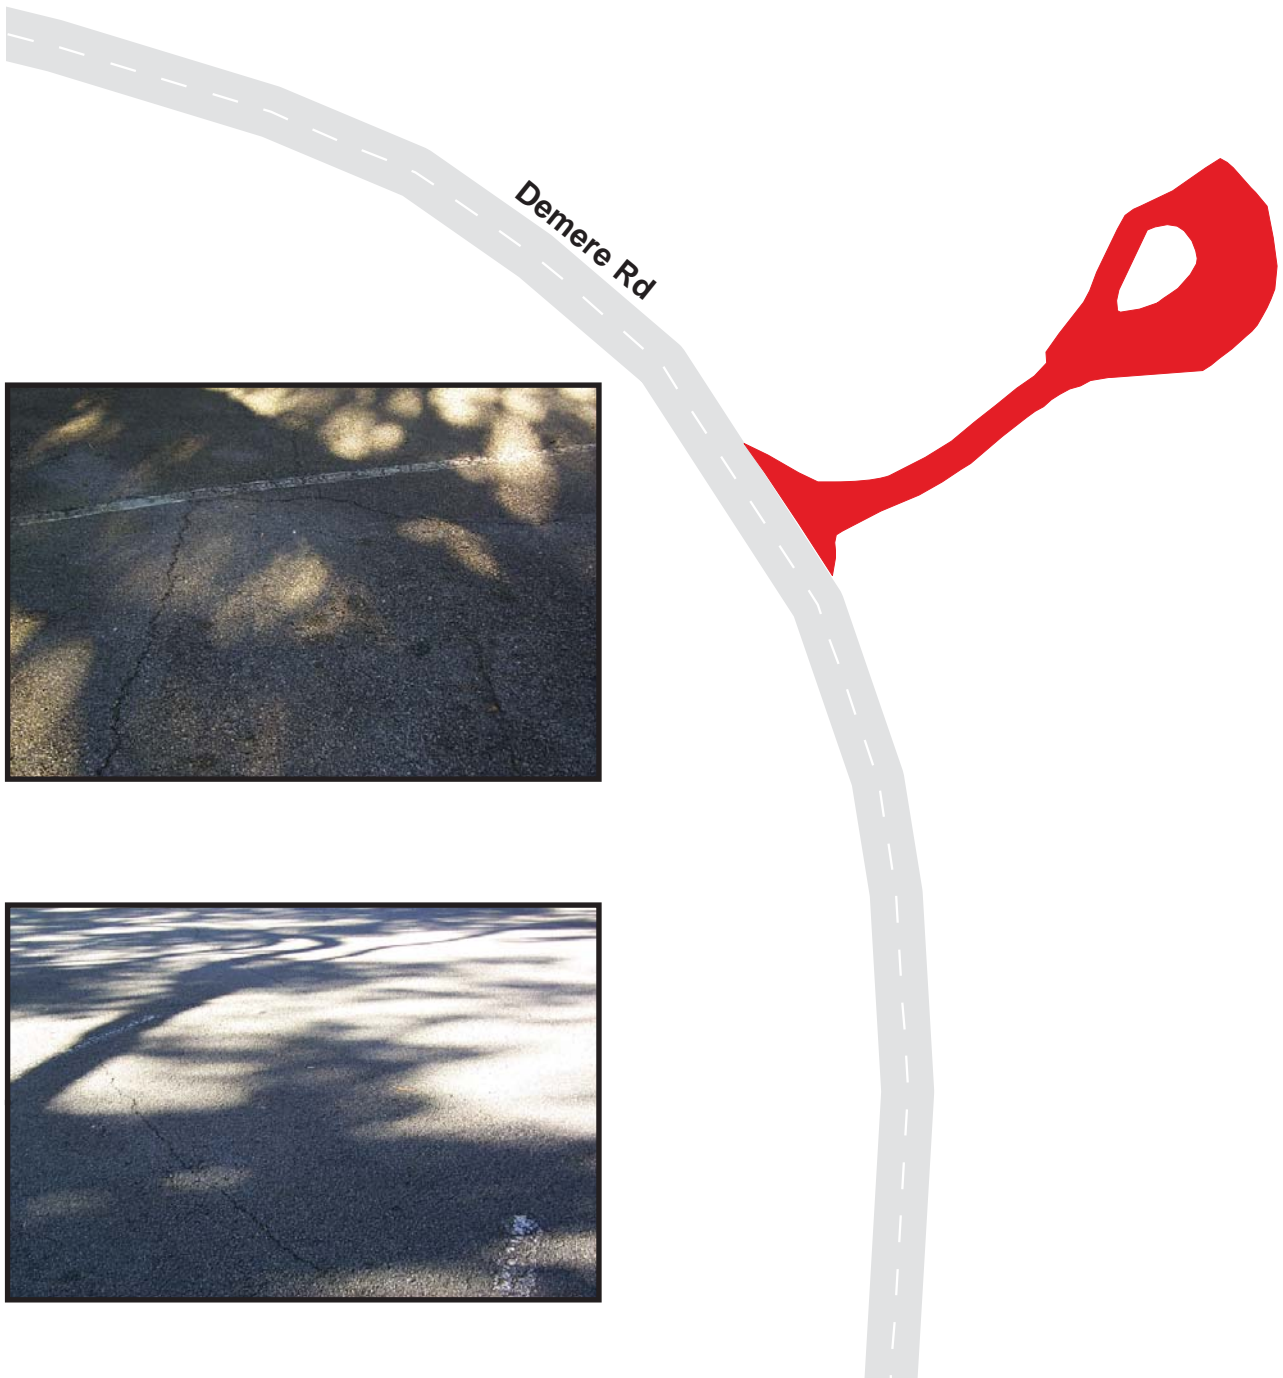
Route 0903

BLOODY MARSH BATTLE SITE PARKING

Route	Public / NonPublic	Date Visited	Area (sq ft)	Lane Miles *	Surface Type	Condition / PCR
0903	Public	12/16/2002	14643	0.25	AS	FAIR / 73
