The Road Inventory of Fort Laramie National Historic Site FOLA – 1420

Road Inventory Program

Prepared By:
Federal Highway Administration
Eastern Federal Lands Highway Division
Cycle 3

Fort Laramie National Historic Site in Wyoming

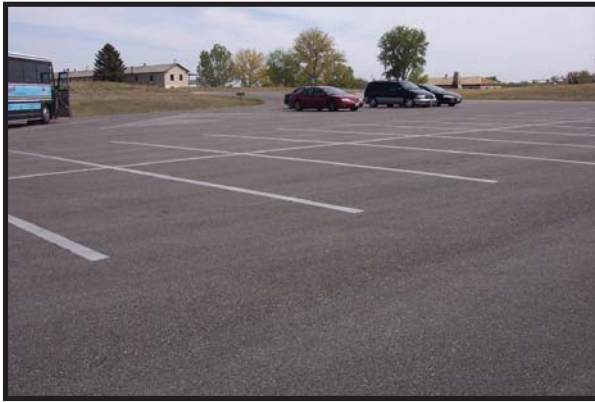
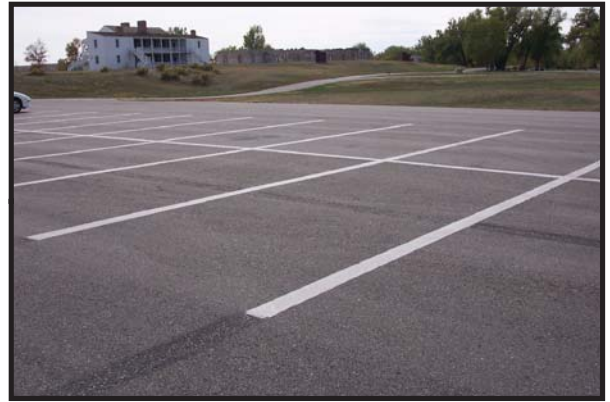
Route 0900

Route	Public / NonPublic	Date Visited	Area (sq ft)	Lane Miles *	Surface Type	Condition / PCR
0900	Public	10/2/2003	45332	0.78	AS	GOOD / 90

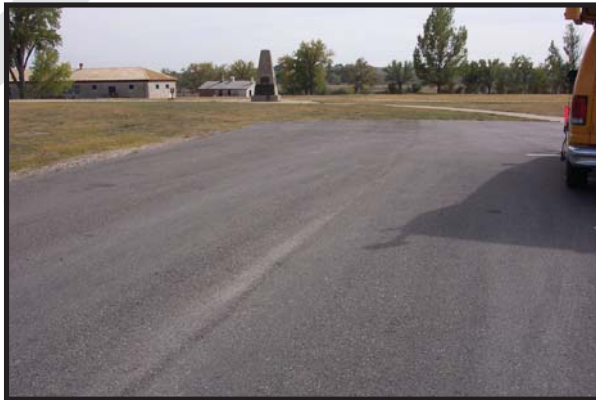
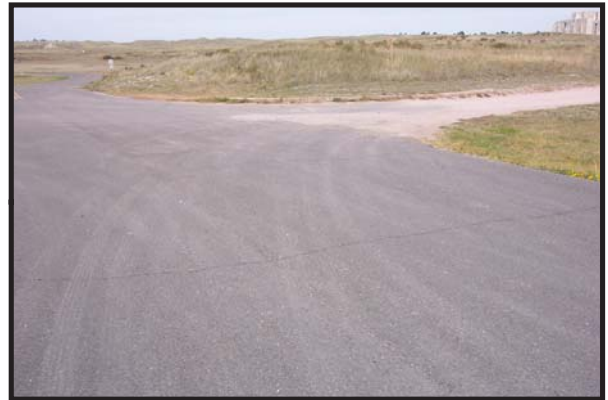
Route 0904

Route	Public / NonPublic	Date Visited	Area (sq ft)	Lane Miles *	Surface Type	Condition / PCR
0904	Public	10/2/2003	3636	0.06	AS	GOOD / 90
