The Road Inventory of Fort Larned National Historic Site FOLS – 6340

Road Inventory Program

Prepared By:
Federal Highway Administration
Eastern Federal Lands Highway Division
Cycle 3

Fort Larned National Historic Site in Kansas

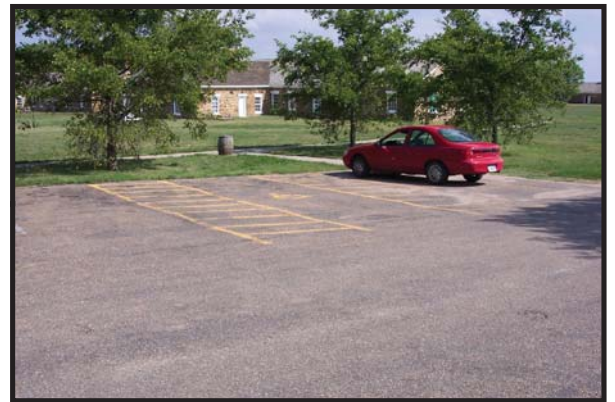
Route 0900

Route	Public / NonPublic	Date Visited	Area (sq ft)	Lane Miles *	Surface Type	Condition / PCR
0900	Public	9/16/2003	1000	0.02	AS	GOOD / 90
