The Road Inventory of Fort Matanzas National Monument FOMA - 5270

Road Inventory Program

Prepared By:
Federal Highway Administration
Eastern Federal Lands Highway Division
Cycle 3

Fort Matanzas National Monument in Florida

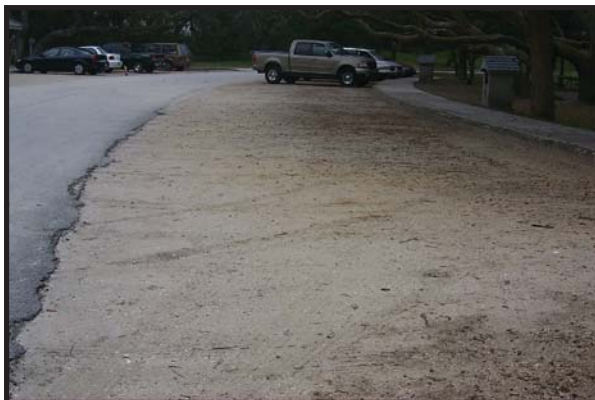
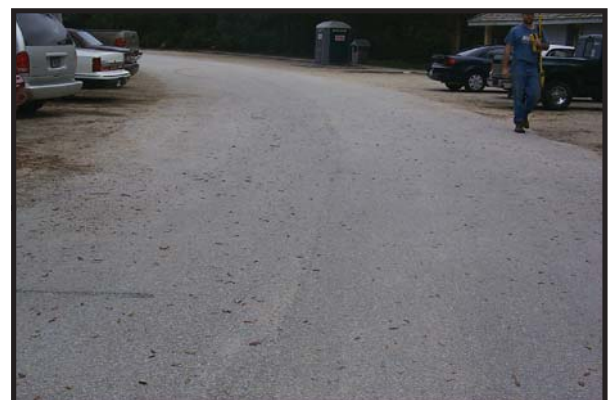
Route 0900A

VISITOR CENTER PARKING

From Route 0900

Route	Public / NonPublic	Date Visited	Area (sq ft)	Lane Miles *	Surface Type	Condition / PCR
0900A	Public	2/2/2002	2946	0.05	OT	GOOD / 90

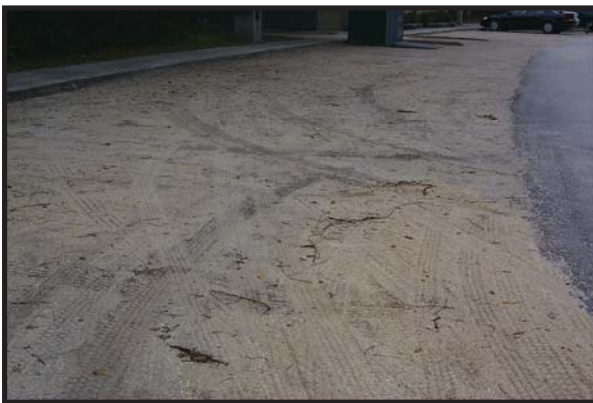
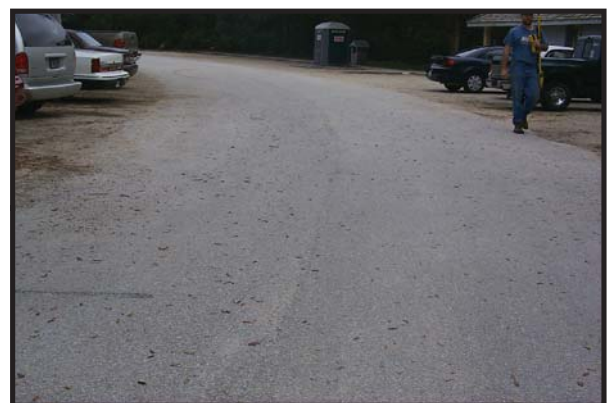
Route 0900B

VISITOR CENTER PARKING

From Route 0900

Route	Public / NonPublic	Date Visited	Area (sq ft)	Lane Miles *	Surface Type	Condition / PCR
0900B	Public	2/2/2002	2779	0.05	OT	GOOD / 90

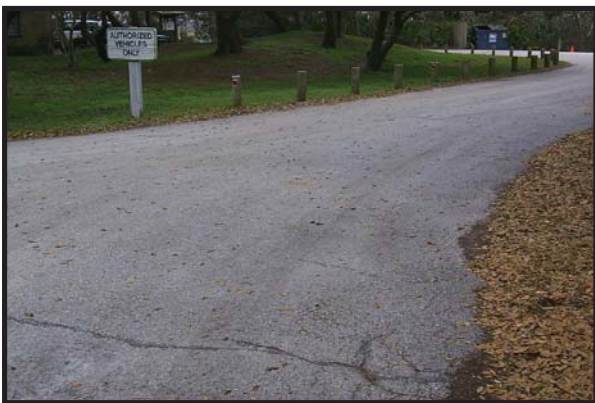
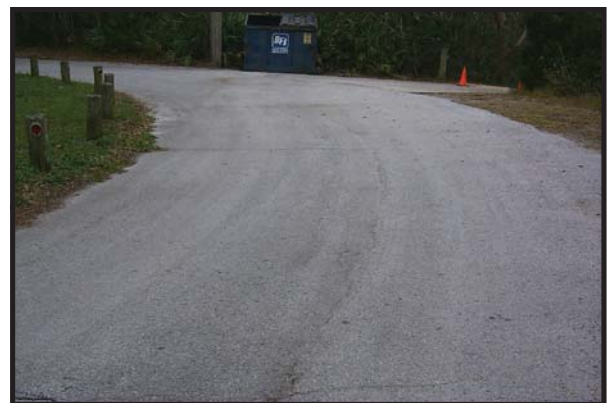
Route 0901

MAINTENANCE AREA PARKING

From Route 0900

Route	Public / NonPublic	Date Visited	Area (sq ft)	Lane Miles *	Surface Type	Condition / PCR
0901	NonPublic	2/2/2002	5297	0.09	OC	GOOD / 90

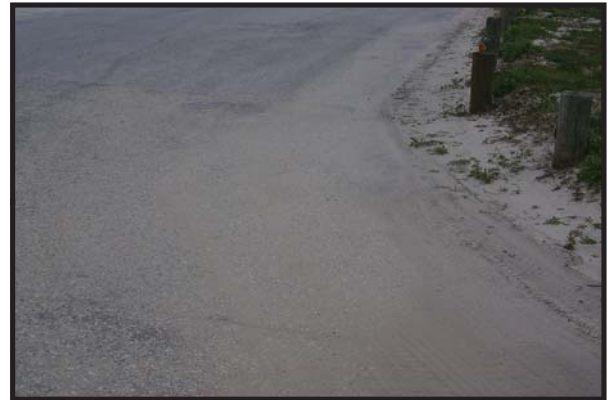
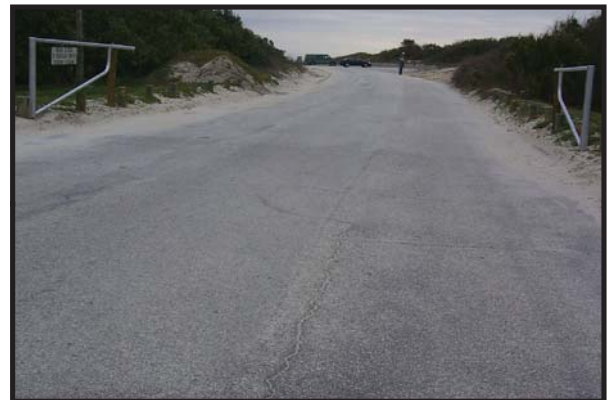
Route 0902

BEACH ACCESS PARKING

From Highway A1A

Route	Public / NonPublic	Date Visited	Area (sq ft)	Lane Miles *	Surface Type	Condition / PCR
0902	Public	2/2/2002	21171	0.36	AS	GOOD / 90

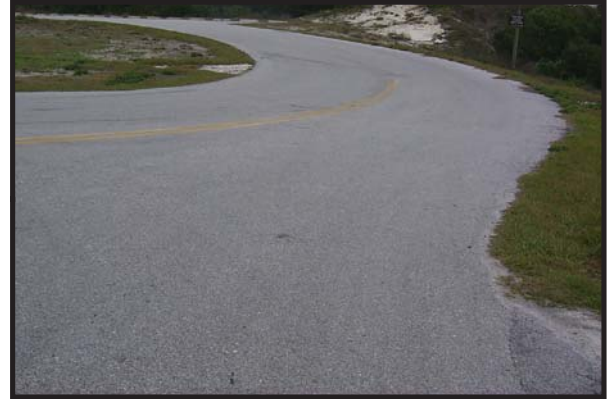
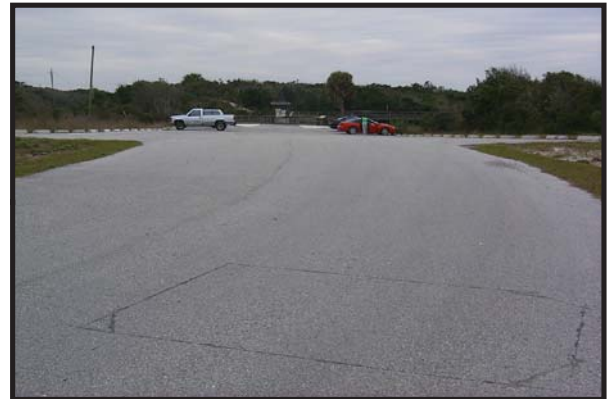
Route 0905

DUNES PARKING
From Highway A1A

Route	Public / NonPublic	Date Visited	Area (sq ft)	Lane Miles *	Surface Type	Condition / PCR
0905	Public	2/2/2002	19346	0.33	AS	GOOD / 90

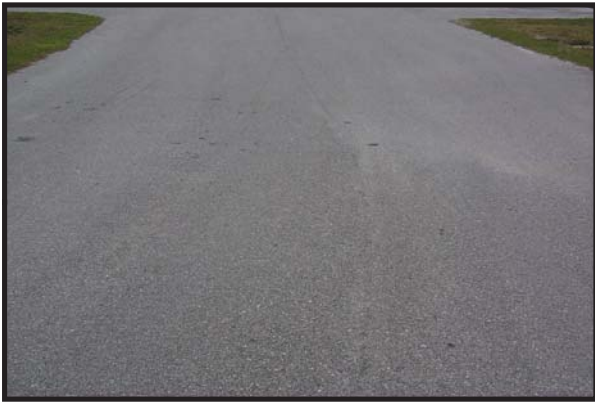
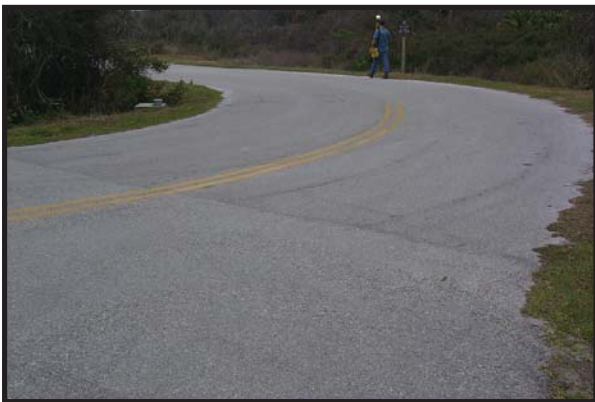
Route 0906

RIVER PARKING
From Highway A1A

Route	Public / NonPublic	Date Visited	Area (sq ft)	Lane Miles *	Surface Type	Condition / PCR
0906	Public	2/2/2002	11636	0.20	AS	GOOD / 90
