**The Road Inventory
of
Fort McHenry National Monument &
Historic Shrine
FOMC – 4340**

Road Inventory Program

Prepared By:
Federal Highway Administration
Eastern Federal Lands Highway Division
Cycle 3

Fort McHenry National Monument in Maryland

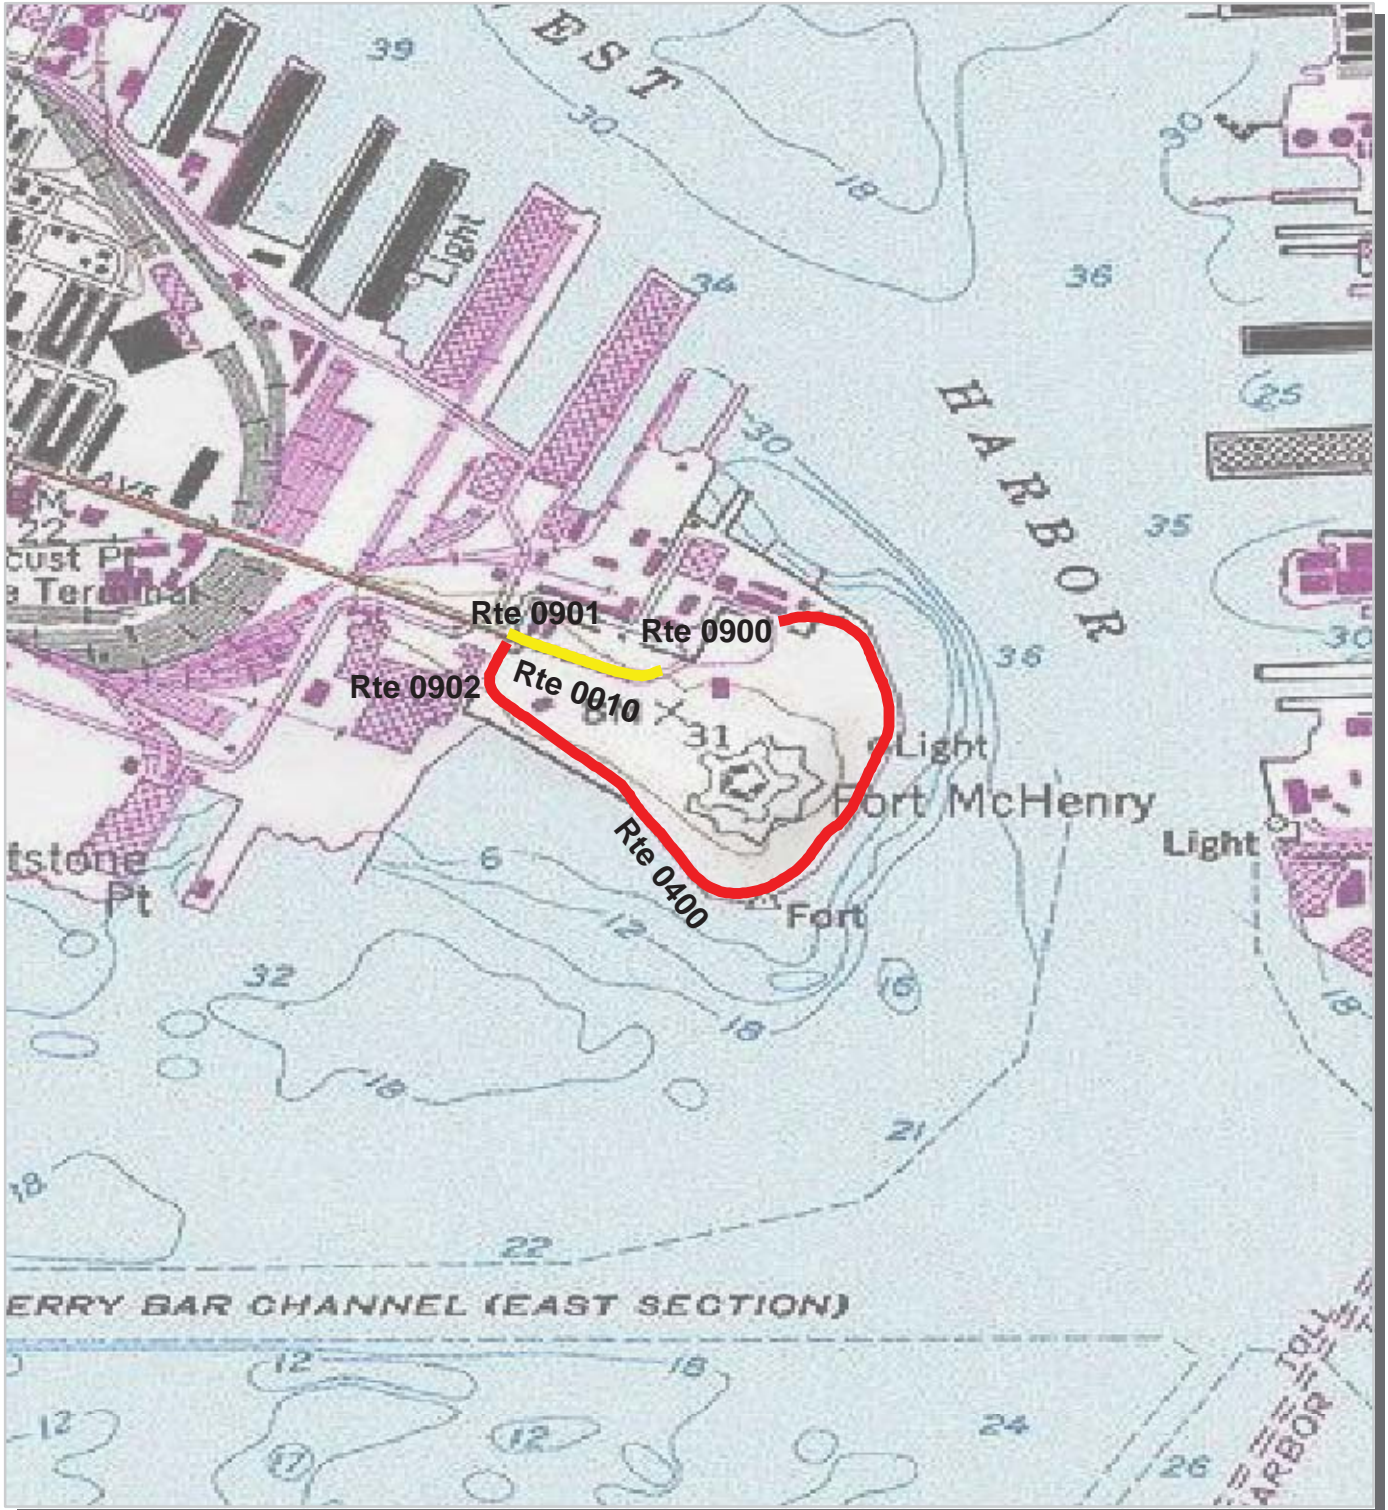
Route Condition Key Map

PCR - Mile by Mile

PCR	Poor		Fair		Good		Excellent	
		(<=60)		(61 - 84)		(85 - 94)		(95 - 100)

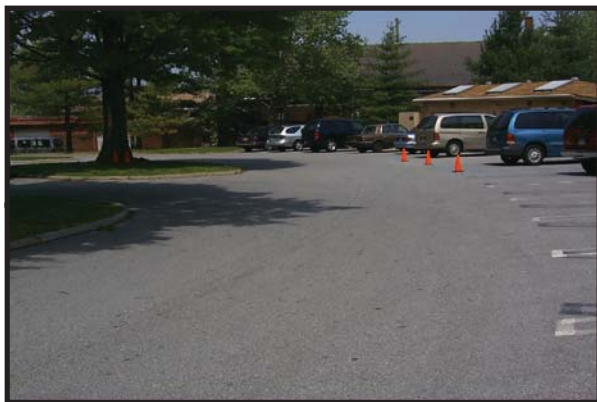
Route	Public / NonPublic	Date Visited	Area (sq ft)	Lane Miles *	Surface Type	Condition / PCR
0900	Public	5/6/2002	81093	1.40	AS	GOOD / 90

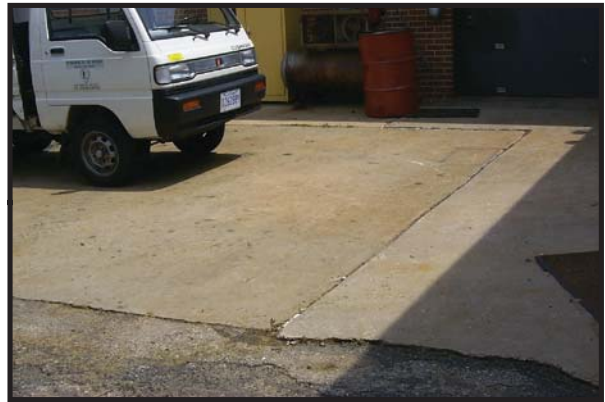
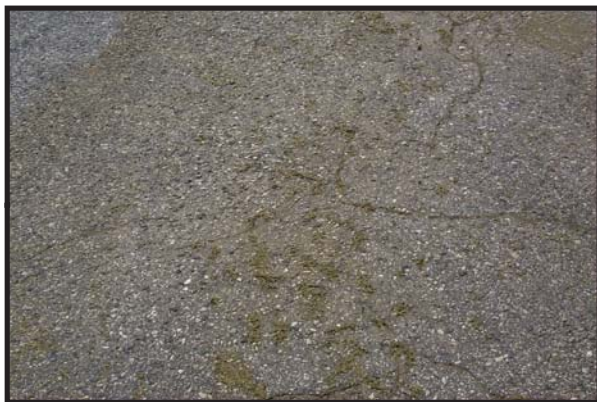
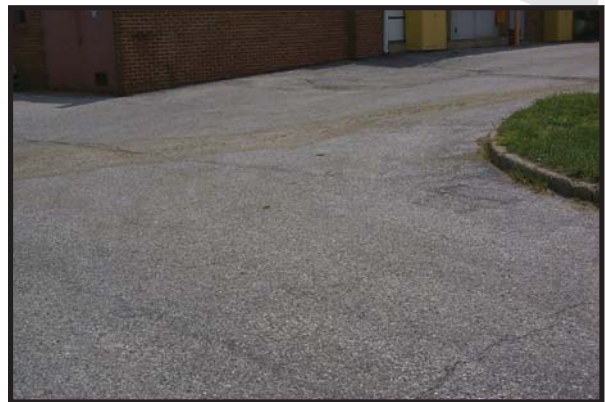
Route 0901

Route	Public / NonPublic	Date Visited	Area (sq ft)	Lane Miles *	Surface Type	Condition / PCR
0901	NonPublic	5/6/2002	6292	0.11	AS	POOR / 45
