# The Road Inventory of Fort Necessity National Battlefield FONE - 4160

## Road Inventory Program

Prepared By:  
Federal Highway Administration  
Eastern Federal Lands Highway Division  
Cycle 3

# Fort Necessity National Battlefield in Pennsylvania

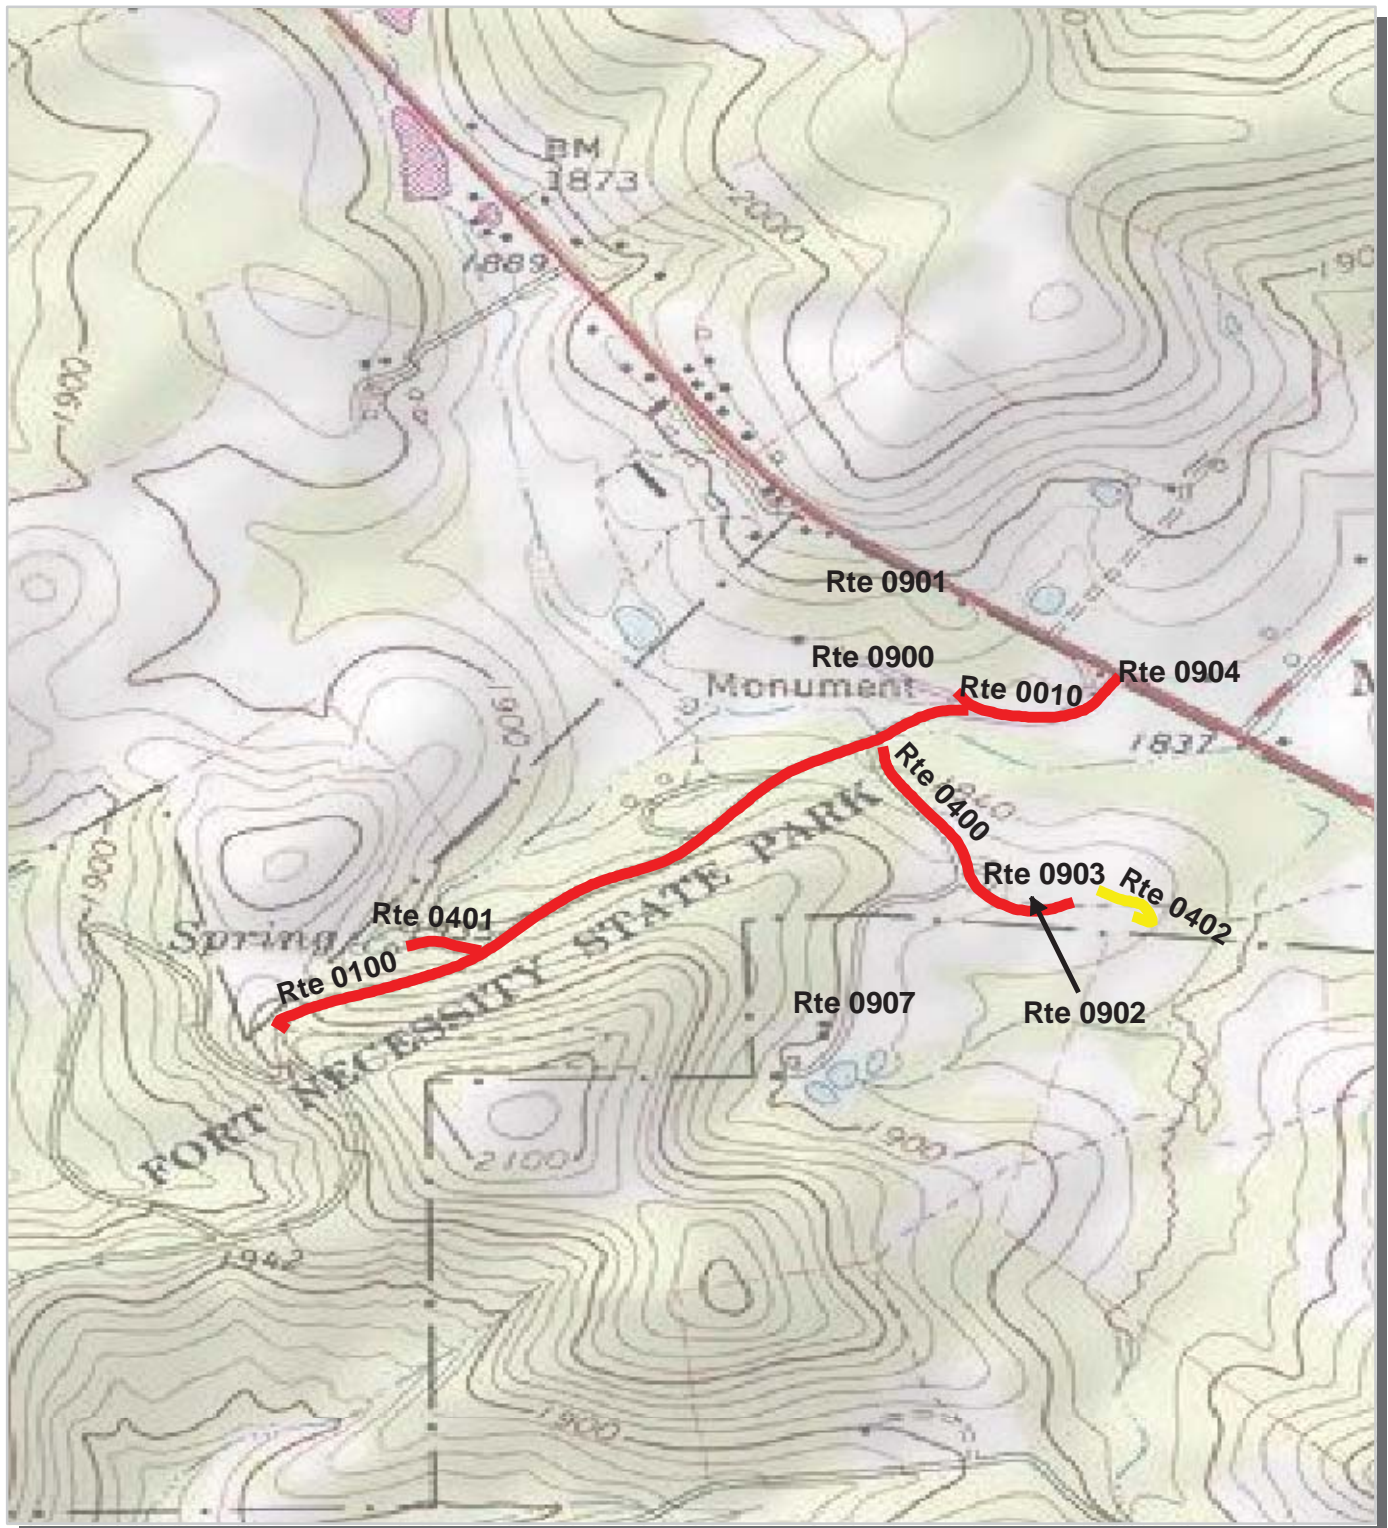
## Route Condition Area Map 2

### PCR - Mile by Mile

PCR	Poor	<span style="display:inline-block; width:20px; height:10px; background-color:red;"></span>	Fair	<span style="display:inline-block; width:20px; height:10px; background-color:yellow;"></span>	Good	<span style="display:inline-block; width:20px; height:10px; background-color:green;"></span>	Excellent	<span style="display:inline-block; width:20px; height:10px; background-color:blue;"></span>
	( $\leq 60$ )		(61 - 84)		(85 - 94)		(95 - 100)

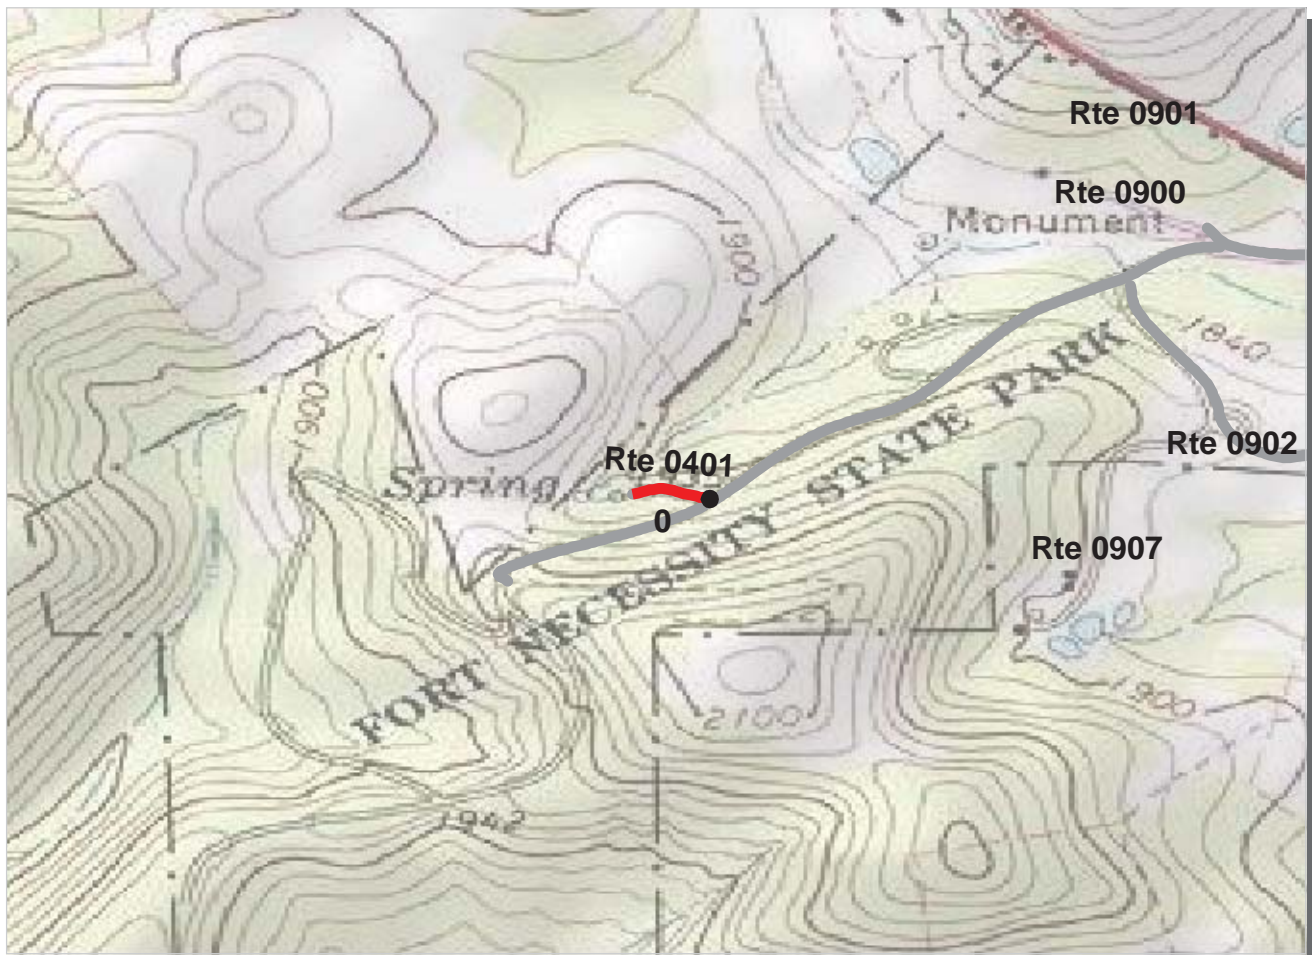
ROUTE: 0400 Headquarters/Maintenance Entrance Road

Section Number	0				
Section Length (mi)	0.07				
AADT	**				
SADT	**				
ADT Date	**				
<b>Cross Section Information</b>					
Number of Lanes	1				
Paved Width (ft)	9				
Lane Width (ft)	9				
Shoulder Width (ft)	0				
<b>Roadway Condition Information</b>					
PCR (Pavement Condition Rating)	0				
RCI (Roughness Condition Index)	NC				
SCR (Surface Condition Rating)	0				
Alligator Cracking Index	0				
Rutting Index	37				
Patching Index	99				
Transverse Cracking Index	100				
Longitudinal Cracking Index	100				
Shoulder Condition Rating	N/A				
Drainage Condition Rating	N/A

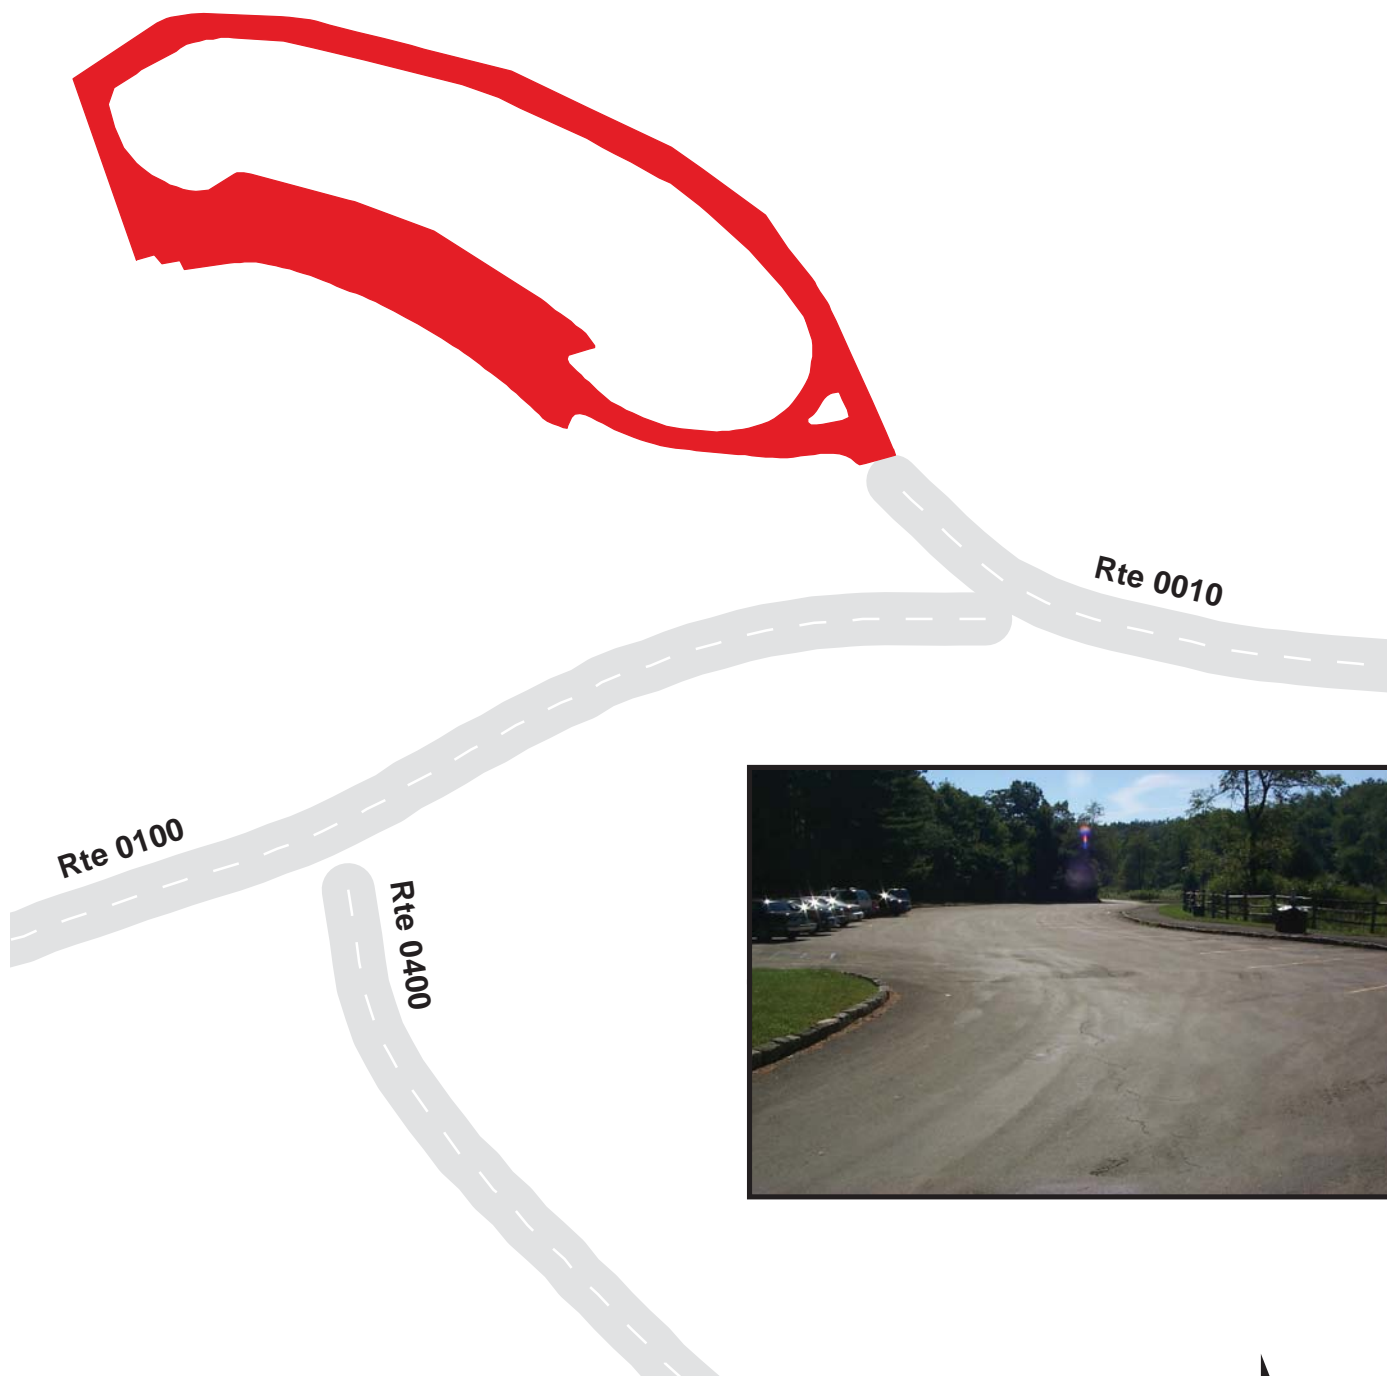
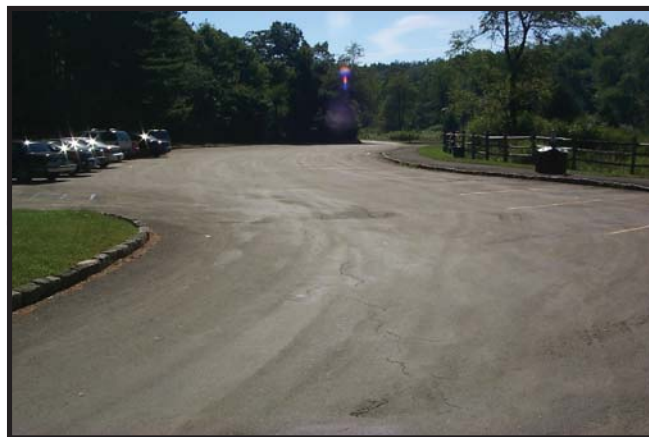
Route	Public / NonPublic	Date Visited	Area (sq ft)	Lane Miles *	Surface Type	Condition / PCR
0900	Public	9/12/2001	35397	0.61	AS	FAIR / 73

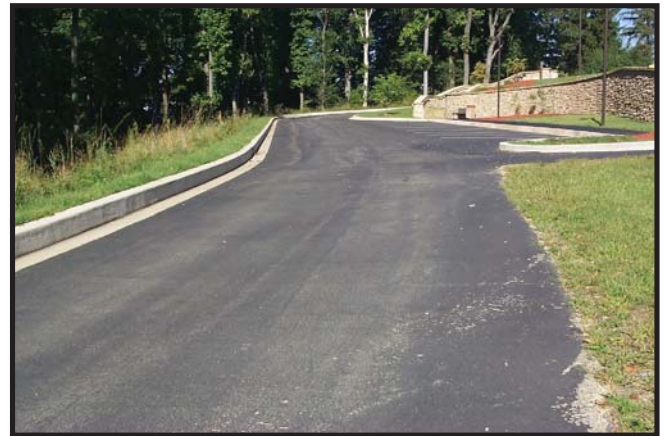
Route 0902

Route	Public / NonPublic	Date Visited	Area (sq ft)	Lane Miles *	Surface Type	Condition / PCR
0902	NonPublic	9/11/2001	11523	0.20	AS	EXCELLENT / 97

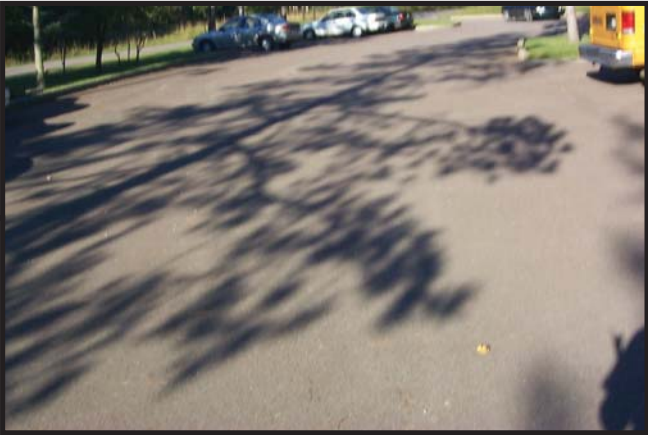
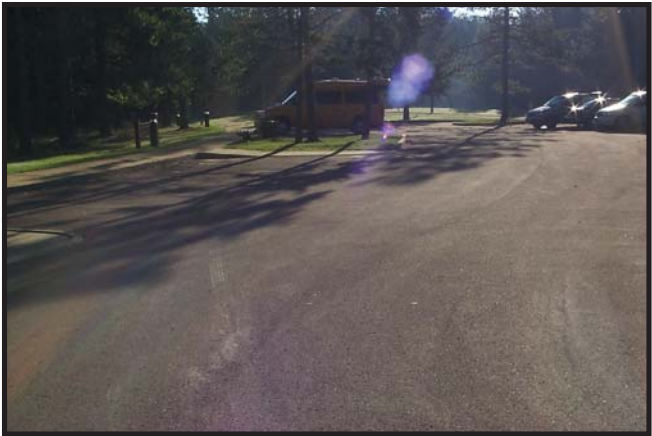
Route 0903

Route	Public / NonPublic	Date Visited	Area (sq ft)	Lane Miles *	Surface Type	Condition / PCR
0903	NonPublic	9/12/2001	20378	0.35	AS	EXCELLENT / 97

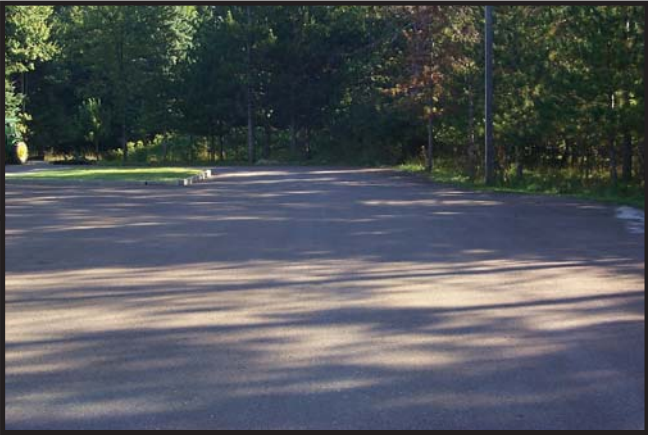
## Route 0904

Route	Public / NonPublic	Date Visited	Area (sq ft)	Lane Miles *	Surface Type	Condition / PCR
0904	NonPublic	9/12/2001	2863	0.05	AS	FAIR / 73

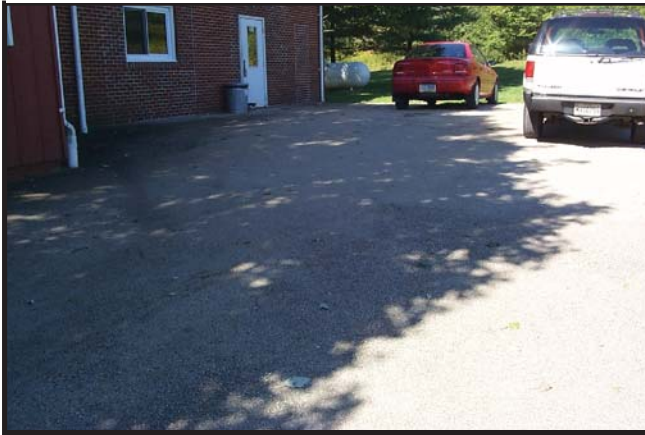
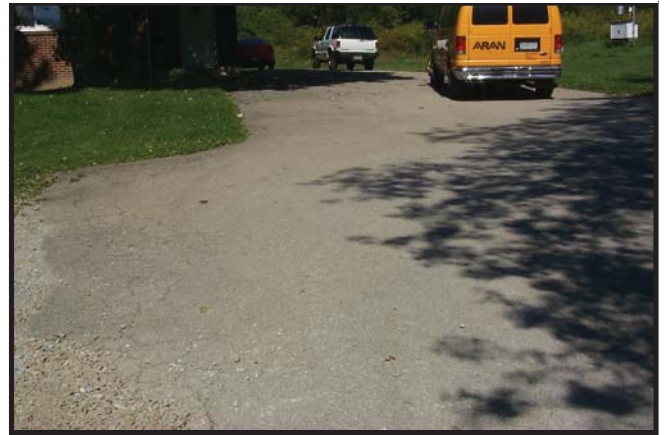
## Route 0905

Route	Public / NonPublic	Date Visited	Area (sq ft)	Lane Miles *	Surface Type	Condition / PCR
0905	Public	9/12/2001	20512	0.35	AS	GOOD / 90
