The Road Inventory of Fort Pulaski National Monument FOPU - 5420

Prepared By:
Federal Highway Administration
Eastern Federal Lands Highway Division
Cycle 3

Fort Pulaski National Monument in Georgia

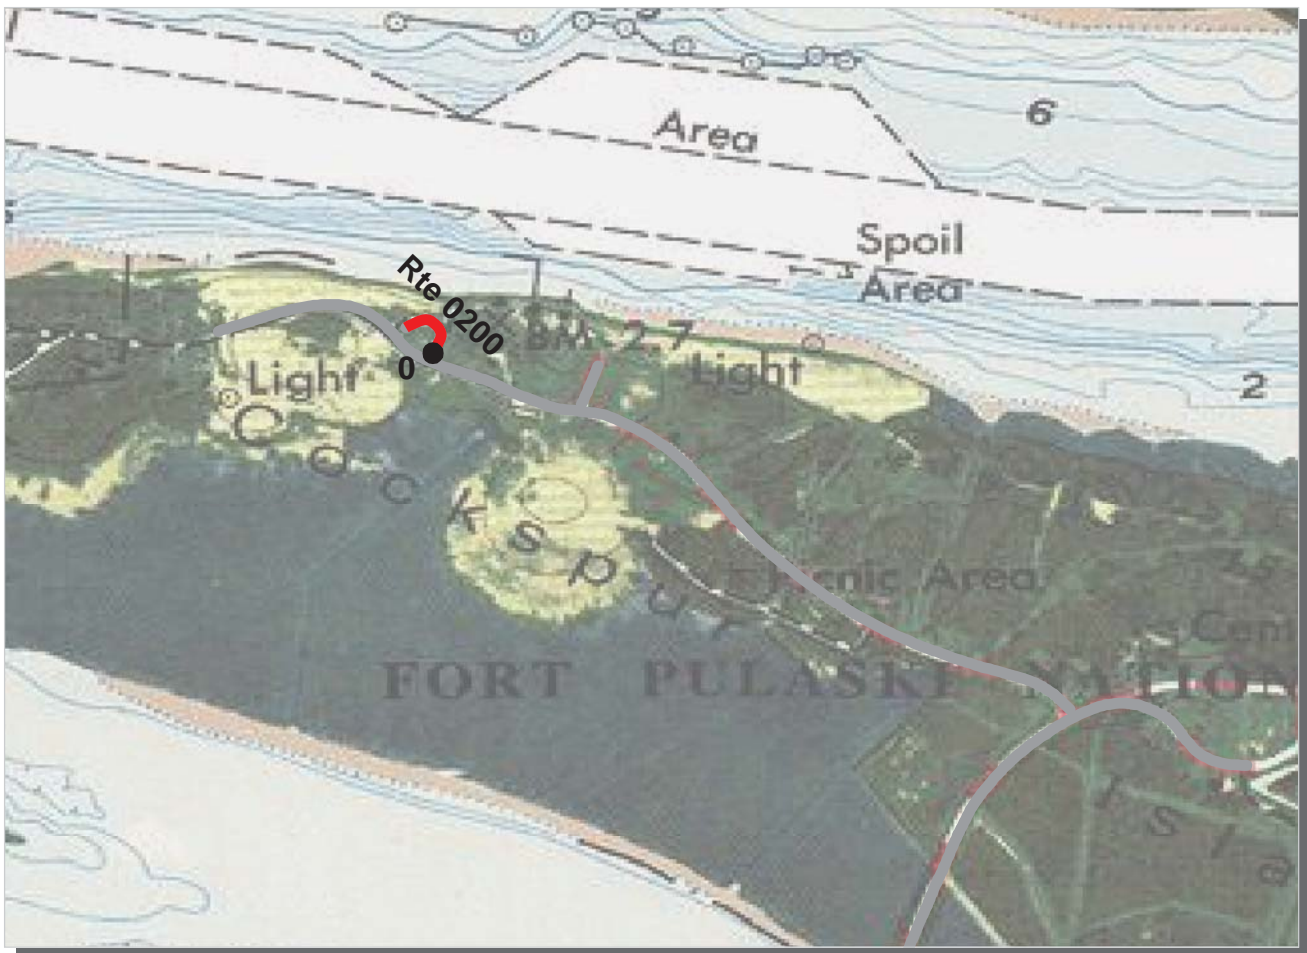
ROUTE: 0200 Loop Drive **TOTAL LENGTH: 0.08 Miles**

Section Number	0				
Section Length (mi)	0.08				
AADT	**				
SADT	**				
ADT Date	**				
Cross Section Information					
Number of Lanes	1				
Paved Width (ft)	9				
Lane Width (ft)	9				
Shoulder Width (ft)	0				
Roadway Condition Information					
PCR (Pavement Condition Rating)	49				
RCI (Roughness Condition Index)	NC				
SCR (Surface Condition Rating)	49				
Alligator Cracking Index	96				
Rutting Index	66				
Patching Index	100				
Transverse Cracking Index	91				
Longitudinal Cracking Index	94				
Shoulder Condition Rating	N/A				
Drainage Condition Rating	N/C

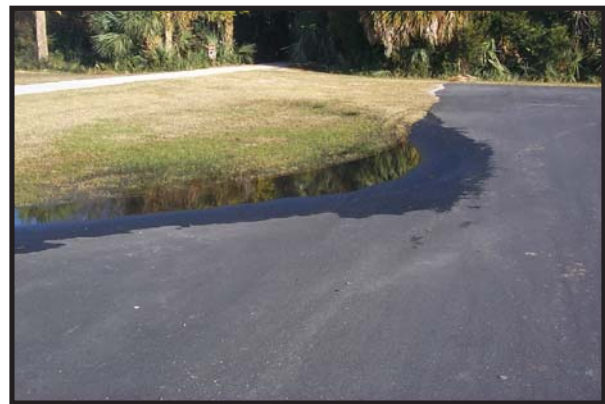
Route	Public / NonPublic	Date Visited	Area (sq ft)	Lane Miles *	Surface Type	Condition / PCR
0900	Public	12/15/2002	52648	0.91	AS	GOOD / 90

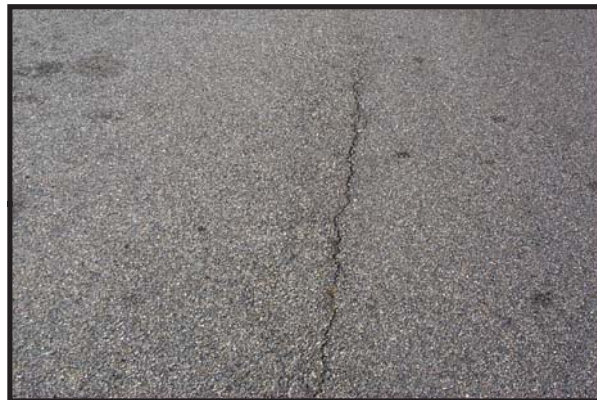
Route 0901A

Route	Public / NonPublic	Date Visited	Area (sq ft)	Lane Miles *	Surface Type	Condition / PCR
0901A	Public	12/15/2002	956	0.02	AS	GOOD / 90

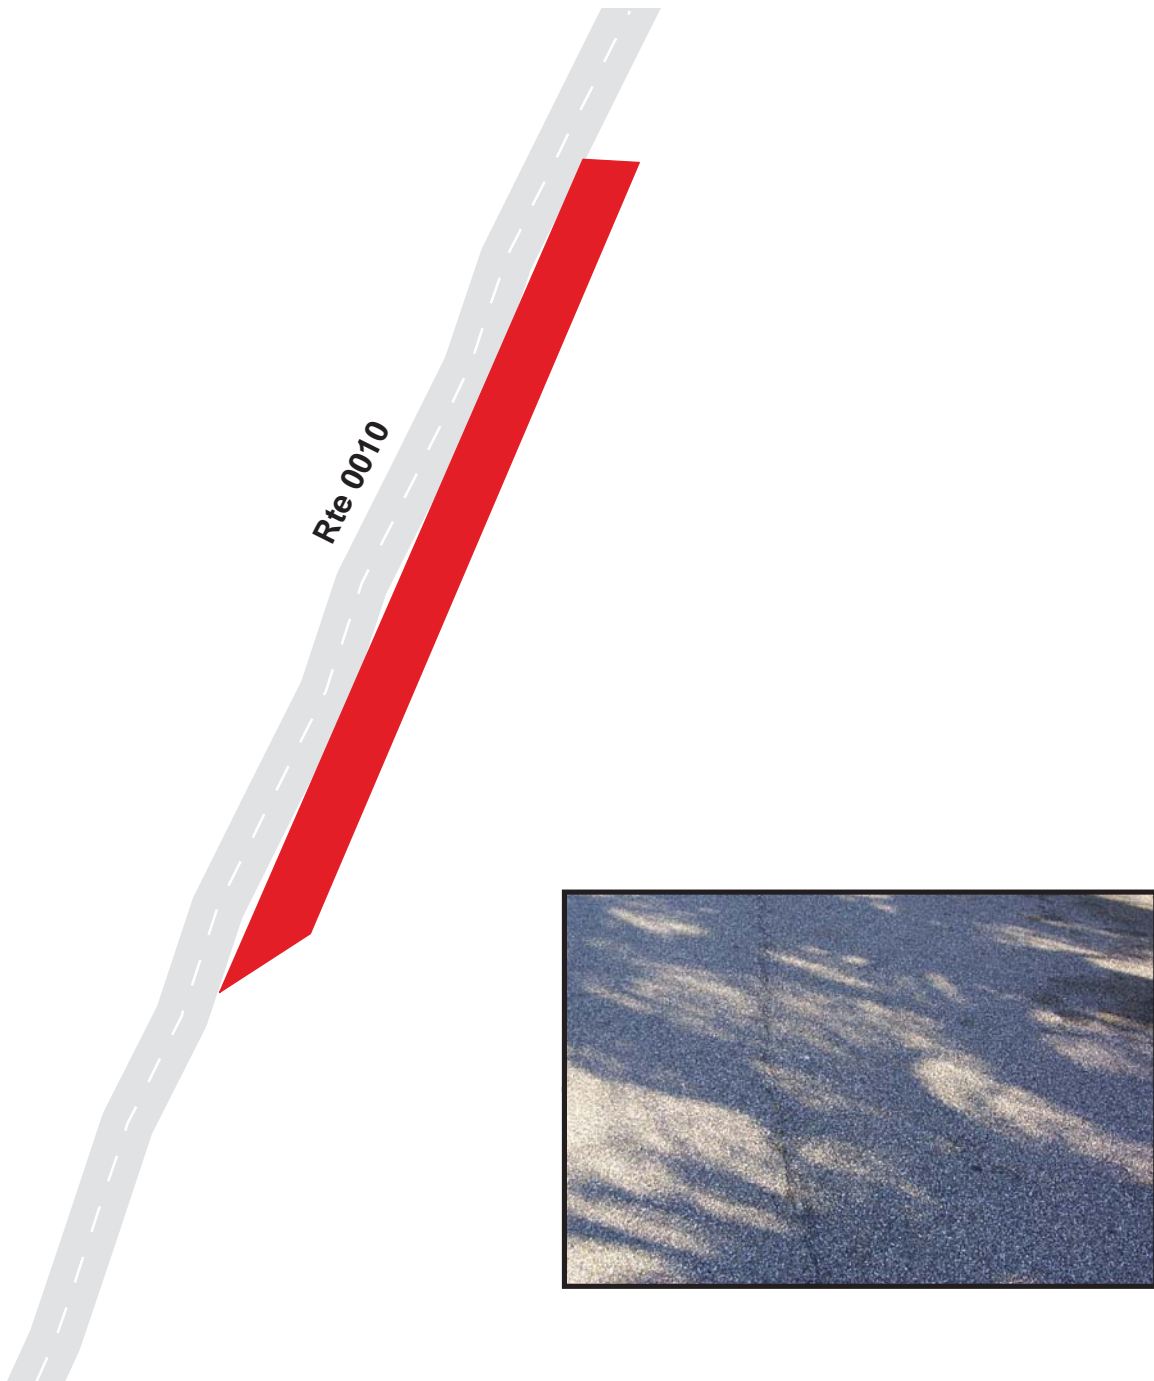
Route 0901B

Route	Public / NonPublic	Date Visited	Area (sq ft)	Lane Miles *	Surface Type	Condition / PCR
0901B	Public	12/15/2002	1000	0.02	AS	GOOD / 90

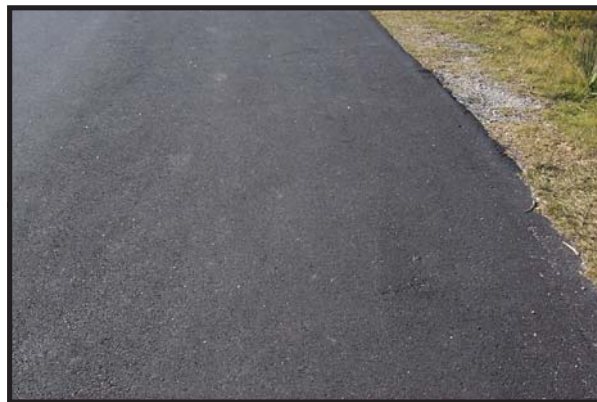
Route 0901C

Route	Public / NonPublic	Date Visited	Area (sq ft)	Lane Miles *	Surface Type	Condition / PCR
0901C	Public	12/15/2002	763	0.01	AS	GOOD / 90

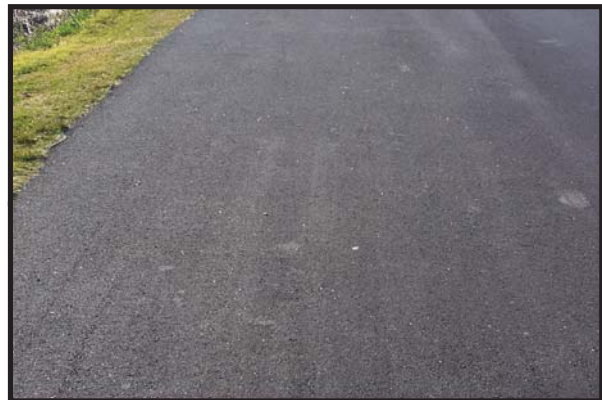
Route 0901D

Route	Public / NonPublic	Date Visited	Area (sq ft)	Lane Miles *	Surface Type	Condition / PCR
0901D	Public	12/15/2002	819	0.01	AS	GOOD / 90

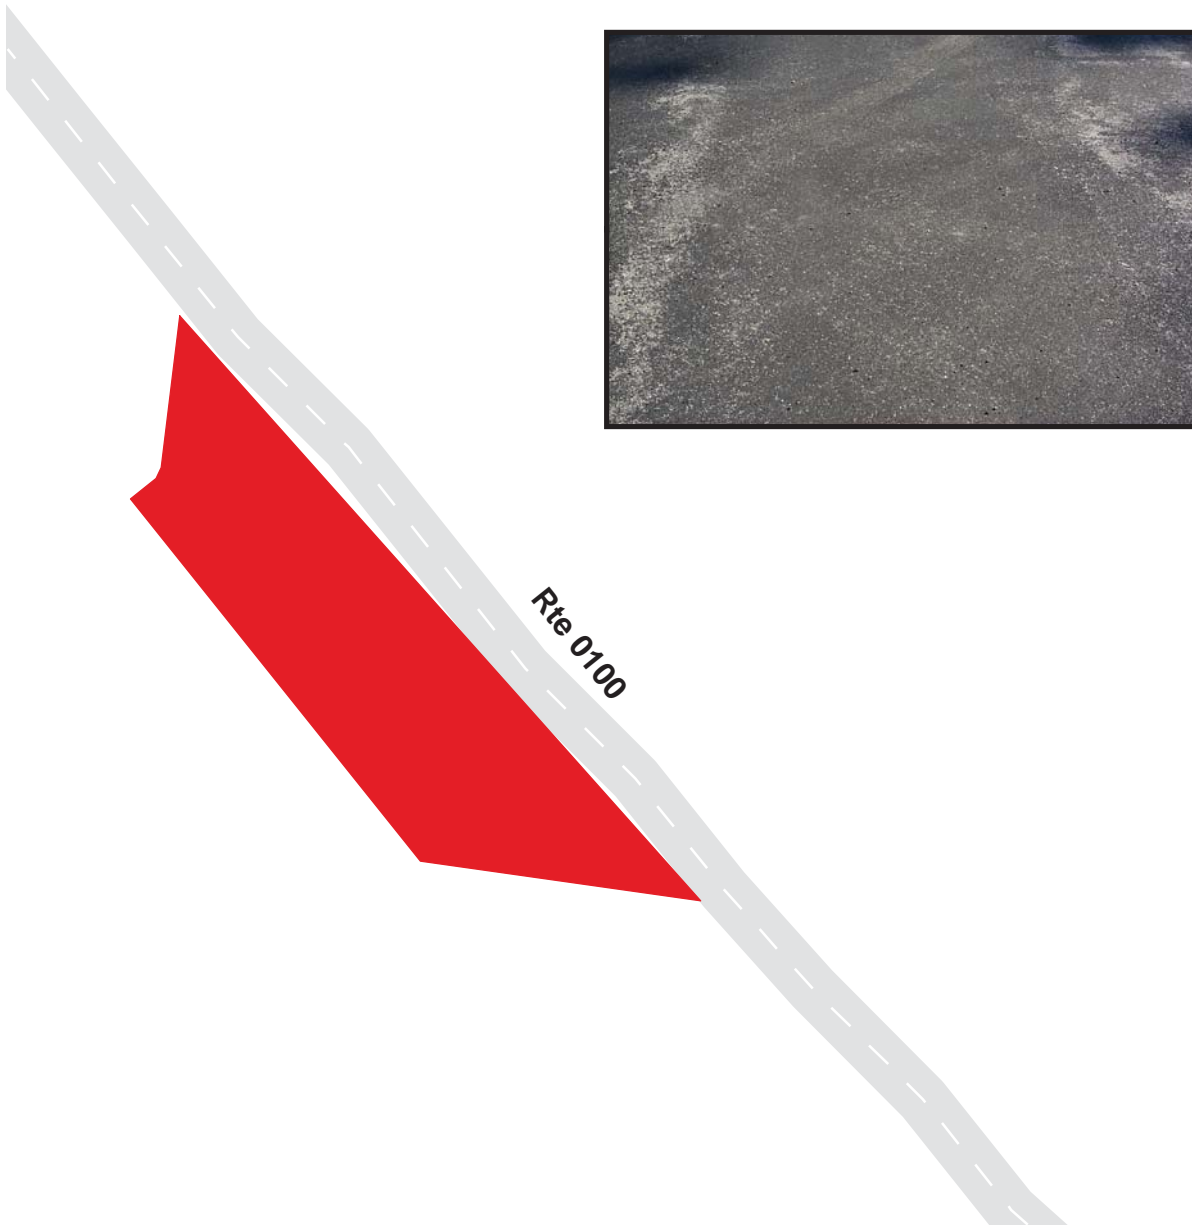
Route 0902

Route	Public / NonPublic	Date Visited	Area (sq ft)	Lane Miles *	Surface Type	Condition / PCR
0902	Public	12/15/2002	1411	0.02	AS	GOOD / 90

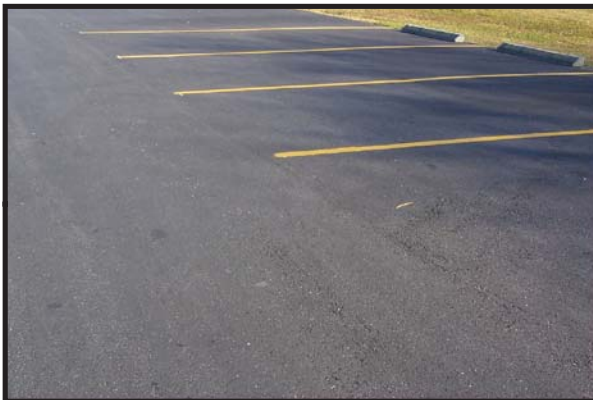
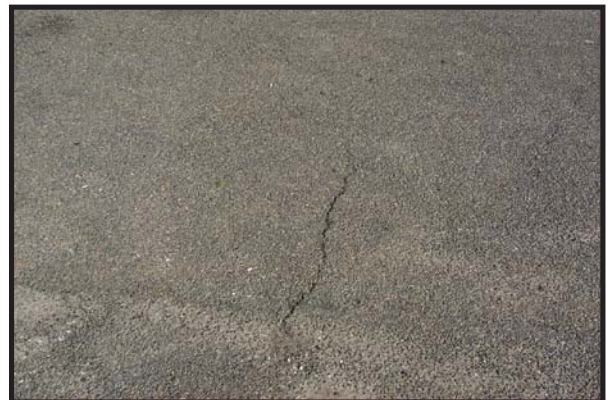
Route 0903

Route	Public / NonPublic	Date Visited	Area (sq ft)	Lane Miles *	Surface Type	Condition / PCR
0903	NonPublic	12/15/2002	8126	0.14	AS	FAIR / 73
