The Road Inventory of Fort Raleigh National Historic Site FORA – 5185

Road Inventory Program

Prepared By:
Federal Highway Administration
Eastern Federal Lands Highway Division
Cycle 3

Fort Raleigh National Historic Site in North Carolina

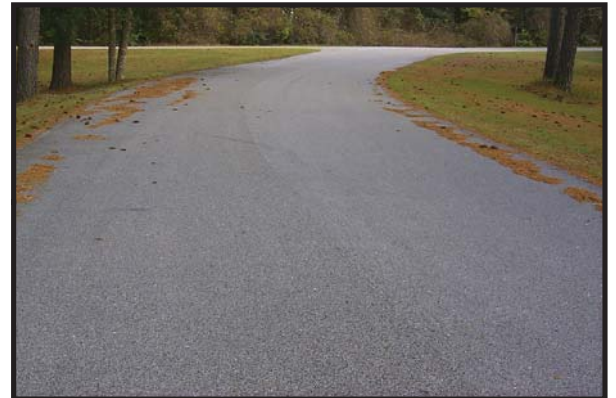
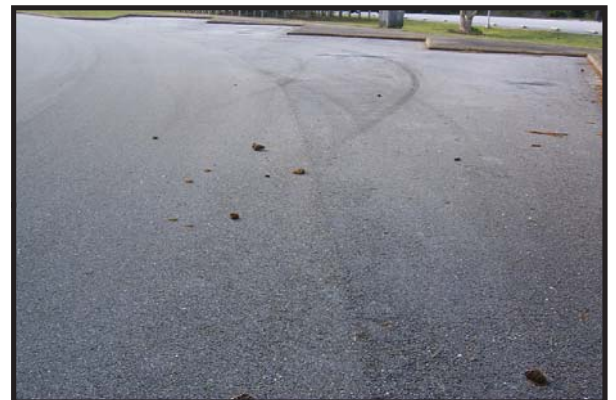
Route 0901

Route	Public / NonPublic	Date Visited	Area (sq ft)	Lane Miles *	Surface Type	Condition / PCR
0901	NonPublic	4/8/2002	12555	0.22	AS	GOOD / 90

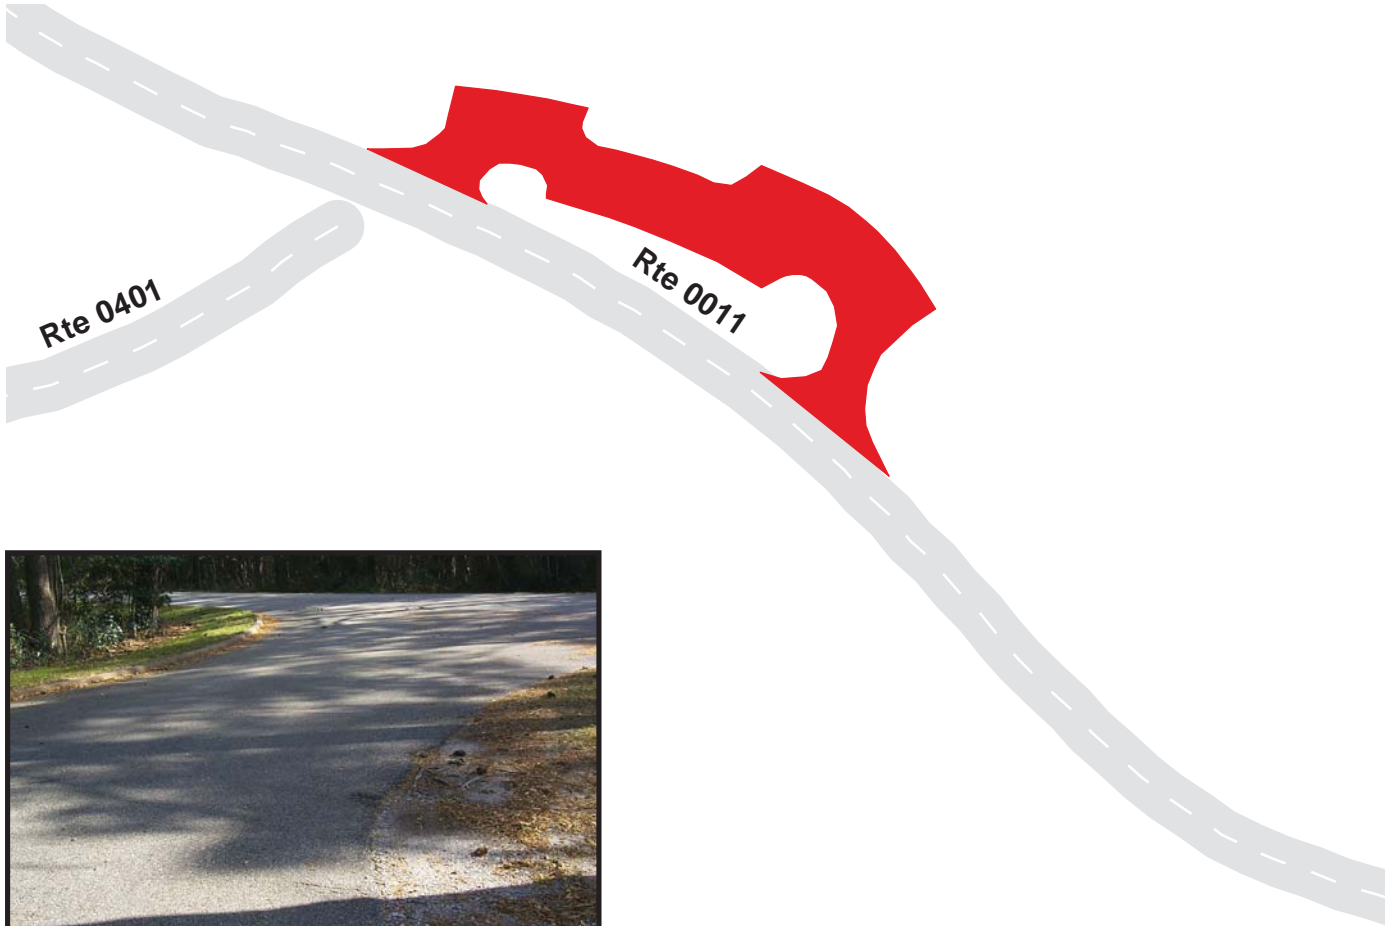
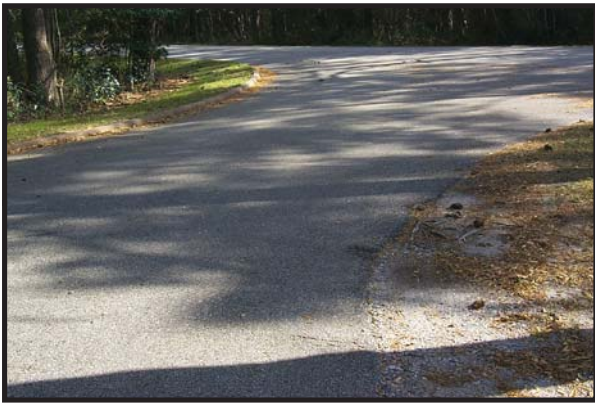
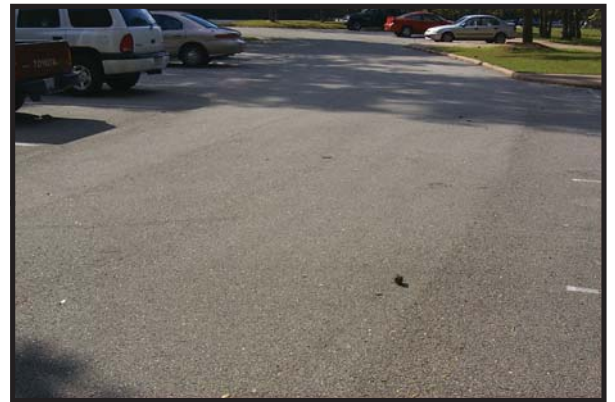
Route 0902

Route	Public / NonPublic	Date Visited	Area (sq ft)	Lane Miles *	Surface Type	Condition / PCR
0902	NonPublic	4/8/2002	32047	0.55	AS	FAIR / 73

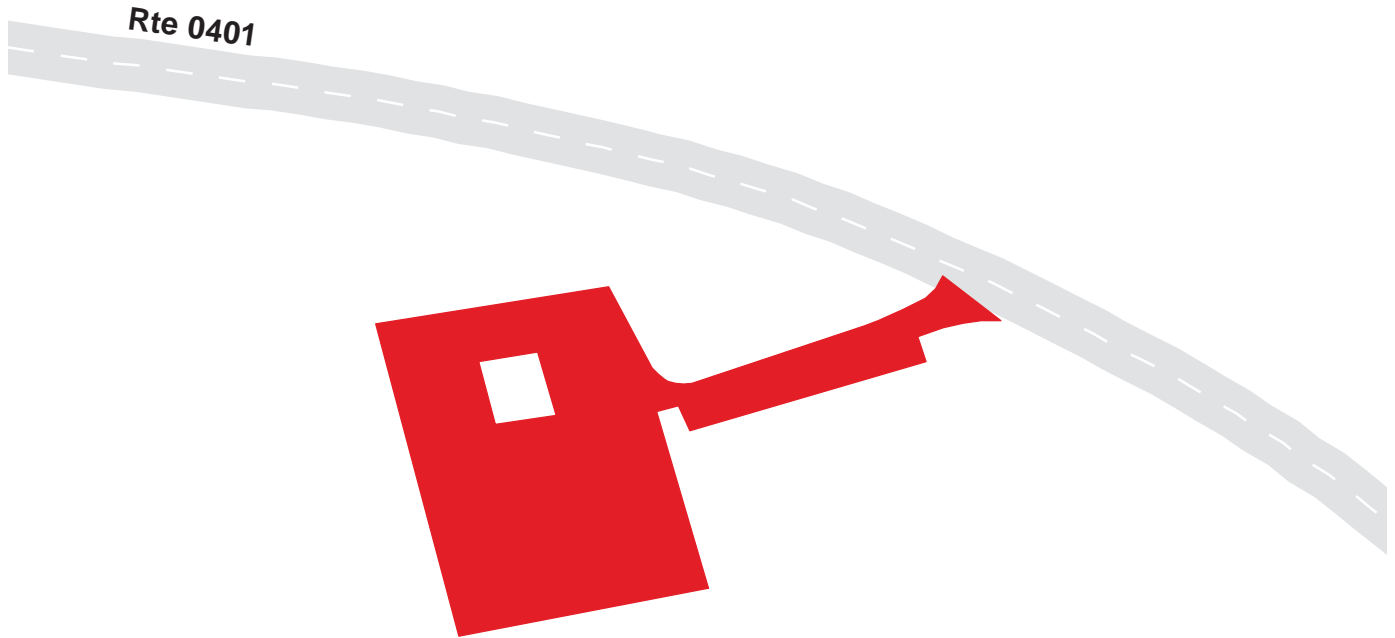
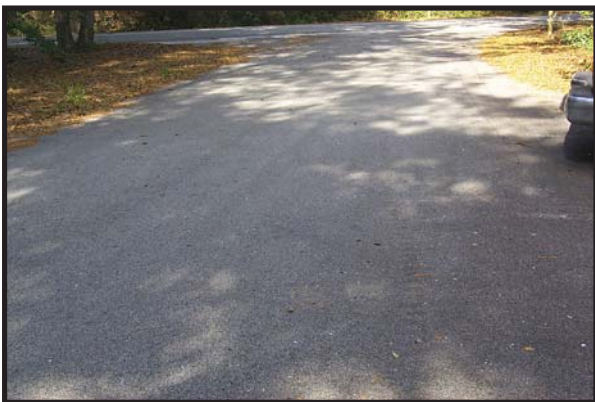
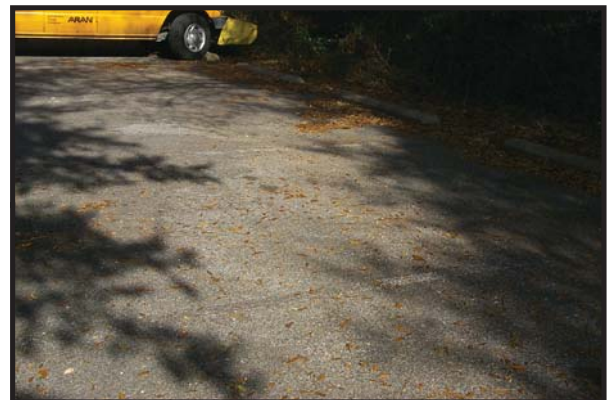
Route 0903

Route	Public / NonPublic	Date Visited	Area (sq ft)	Lane Miles *	Surface Type	Condition / PCR
0903	Public	4/8/2002	190797	3.29	AS	GOOD / 90
