The Road Inventory of Fort Scott National Historic Site FOSC - 6350

Road Inventory Program

Prepared By:
Federal Highway Administration
Eastern Federal Lands Highway Division
Cycle 3

Fort Scott National Historic Site in Kansas

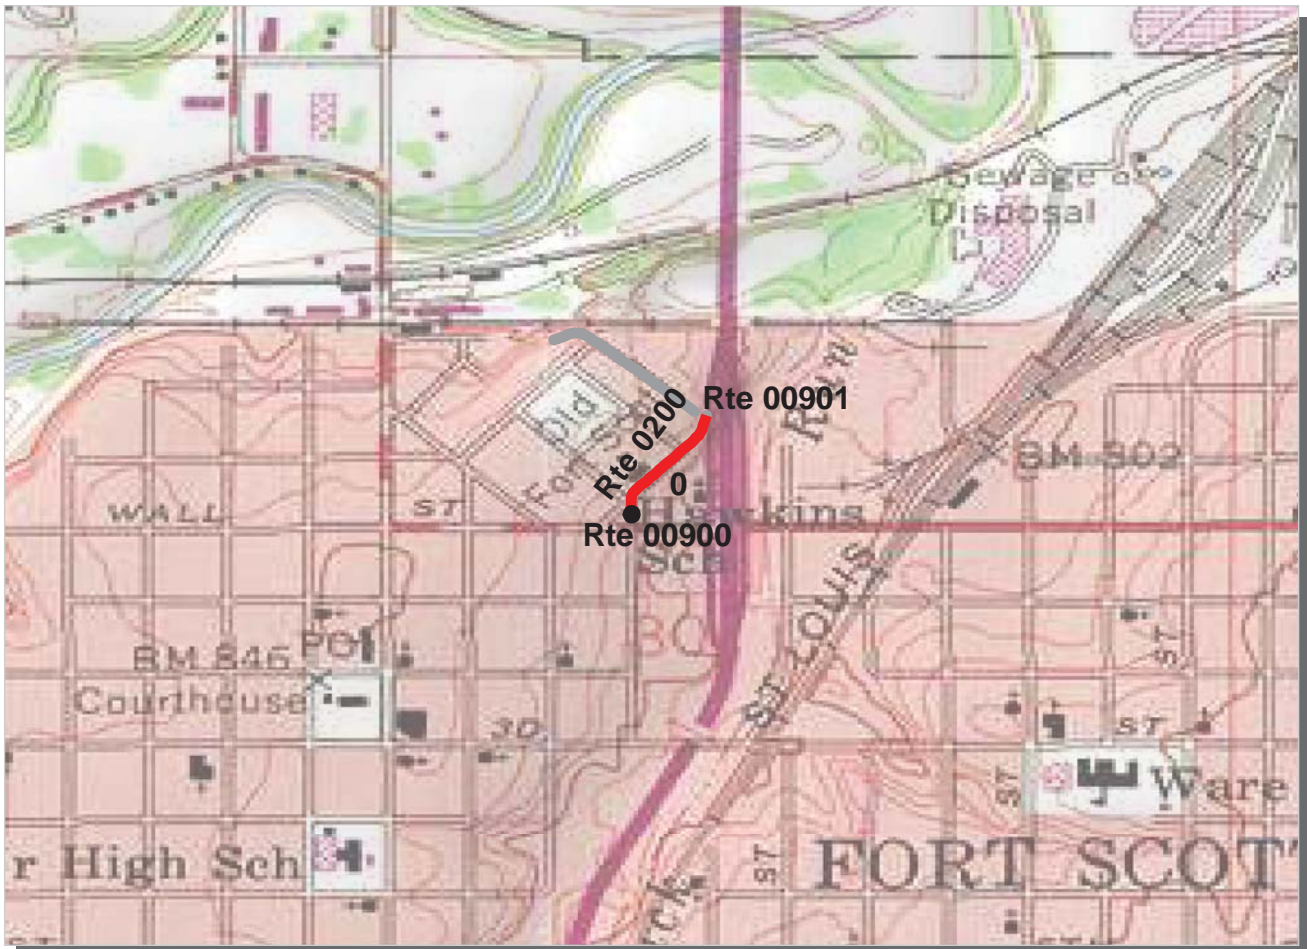
ROUTE: 0200 Service Delivery Road **TOTAL LENGTH: 0.14 Miles**

Section Number	0				
Section Length (mi)	0.14				
AADT	**				
SADT	**				
ADT Date	**				
Cross Section Information					
Number of Lanes	2				
Paved Width (ft)	19				
Lane Width (ft)	9				
Shoulder Width (ft)	5				
Roadway Condition Information					
PCR (Pavement Condition Rating)	40				
RCI (Roughness Condition Index)	38				
SCR (Surface Condition Rating)	38				
Alligator Cracking Index	100				
Rutting Index	40				
Patching Index	100				
Transverse Cracking Index	99				
Longitudinal Cracking Index	99				
Shoulder Condition Rating	GOOD				
Drainage Condition Rating	GOOD

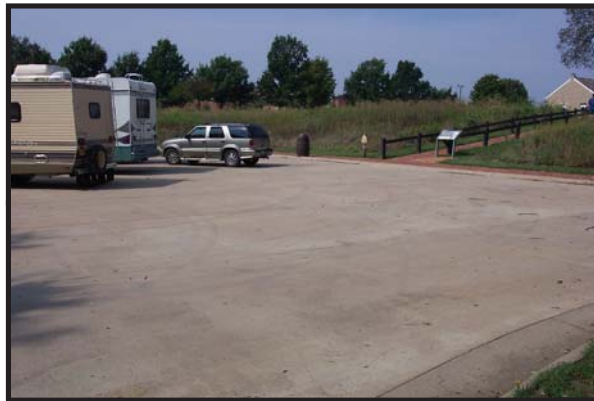
Route 0900

Route	Public / NonPublic	Date Visited	Area (sq ft)	Lane Miles *	Surface Type	Condition / PCR
0900	Public	9/10/2003	10333	0.18	CO	GOOD / 90

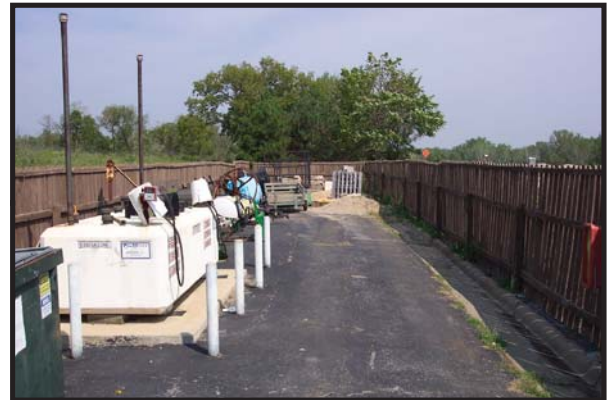
Route	Public / NonPublic	Date Visited	Area (sq ft)	Lane Miles *	Surface Type	Condition / PCR
0901	NonPublic	9/10/2003	2495	0.04	AS	FAIR / 73
