The Road Inventory of Fort Smith National Historic Site FOSM - 7320

Road Inventory Program

Prepared By:
Federal Highway Administration
Eastern Federal Lands Highway Division
Cycle 3

Fort Smith National Historical Site in Arkansas

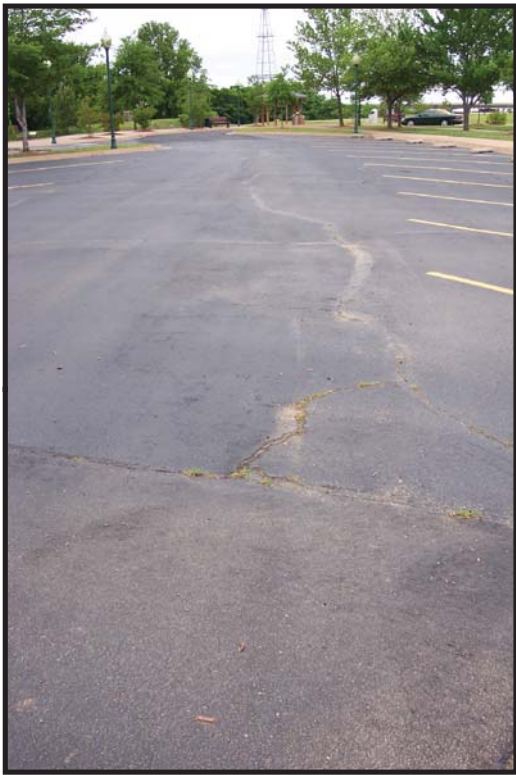
Route 0900

Visitor Center Parking
From South Third Street

Route	Public / NonPublic	Date Visited	Area (sq ft)	Lane Miles *	Surface Type	Condition / PCR
0900	Public	5/12/2004	28148	0.48	AS	FAIR / 73

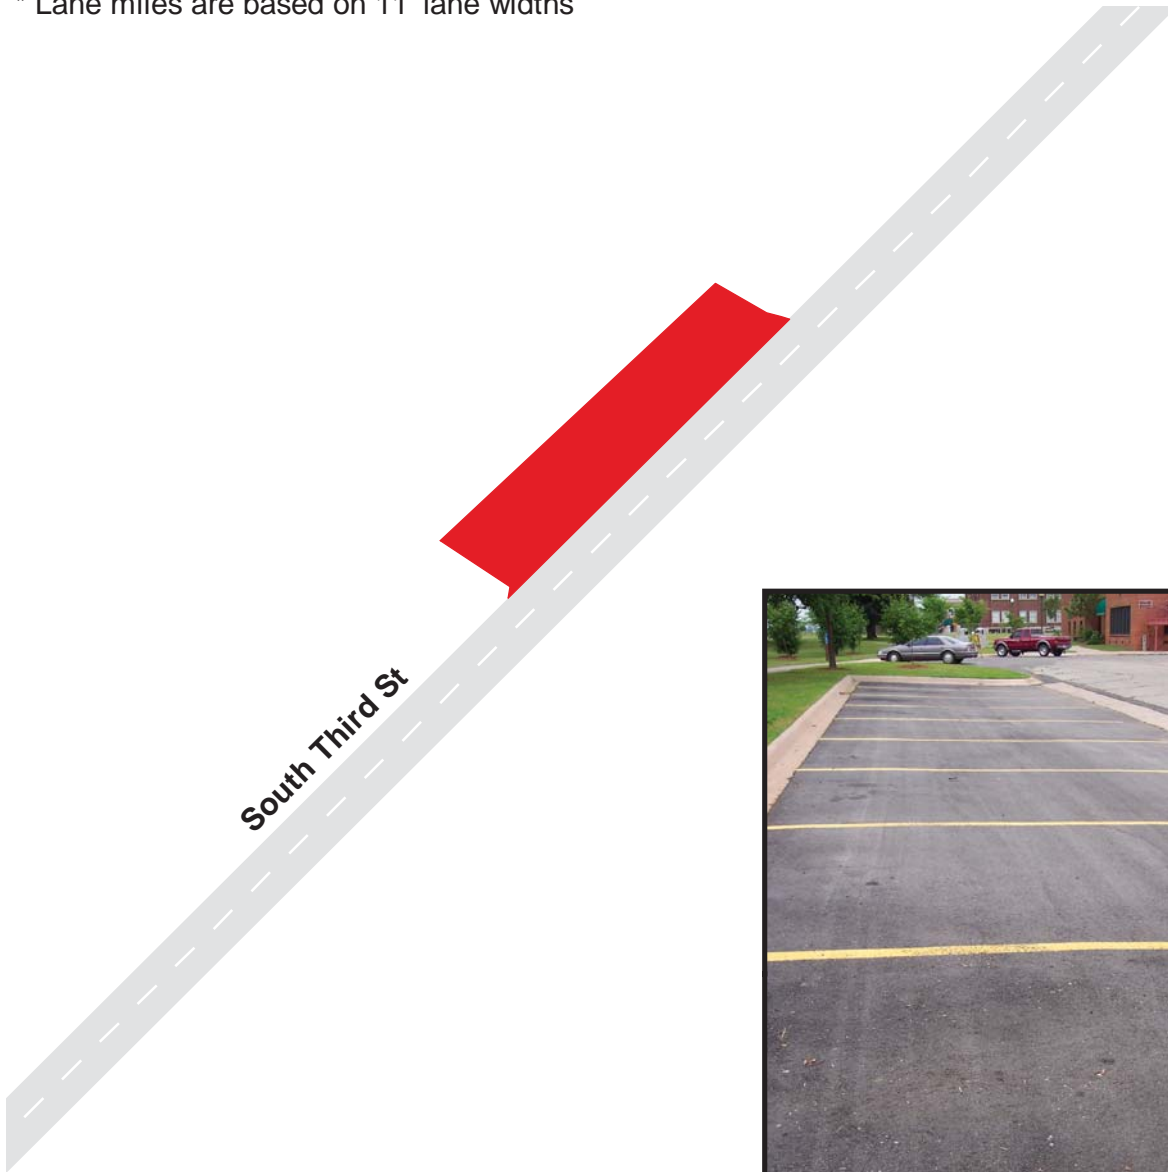
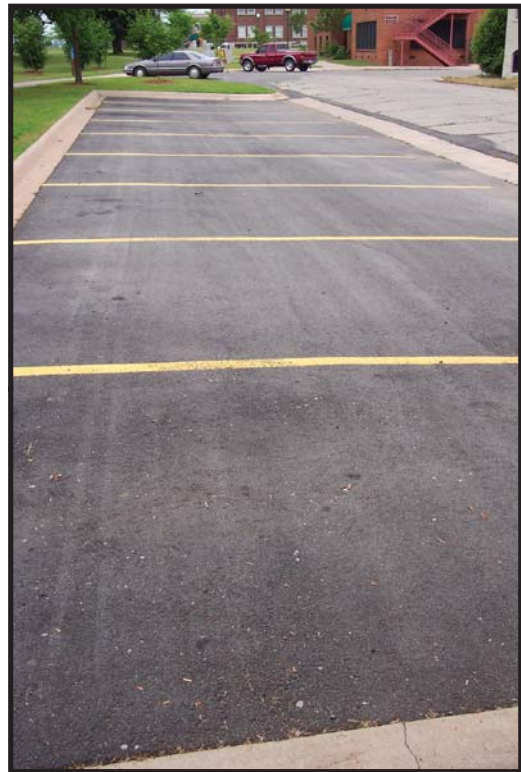
Route 0901B

Visitor Street Parking B
From South Third Street

Route	Public / NonPublic	Date Visited	Area (sq ft)	Lane Miles *	Surface Type	Condition / PCR
0901B	Public	5/12/2004	1654	0.03	AS	GOOD / 90

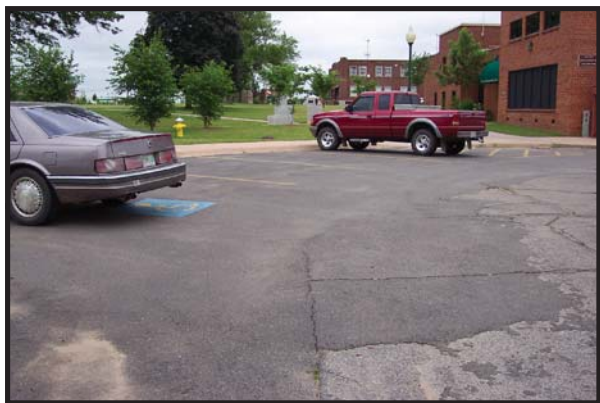
Route 0901C

Visitor Street Parking C

From Intersection Between South Third Street and Parker Avenue

Route	Public / NonPublic	Date Visited	Area (sq ft)	Lane Miles *	Surface Type	Condition / PCR
0901C	Public	5/12/2004	1847	0.03	AS	GOOD / 90

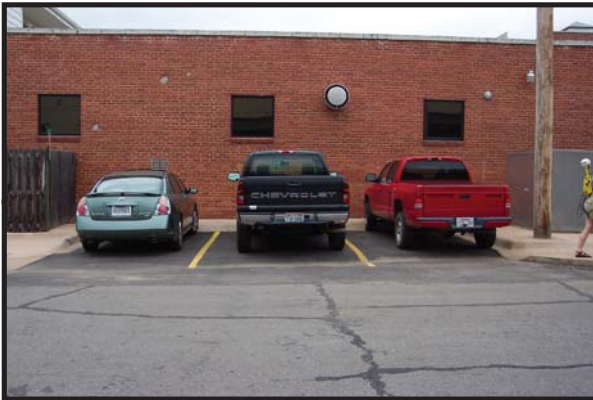
Route 0902A

Employee Street Parking A
From Parker Avenue

Route	Public / NonPublic	Date Visited	Area (sq ft)	Lane Miles *	Surface Type	Condition / PCR
0902A	NonPublic	5/12/2004	853	0.01	AS	GOOD / 90

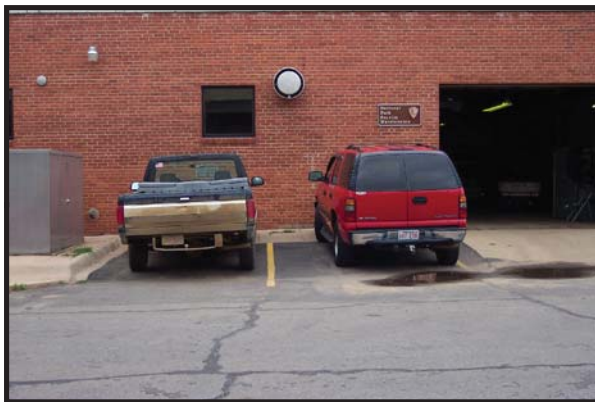
Route 0902B

Employee Street Parking B
From Parker Avenue

Route	Public / NonPublic	Date Visited	Area (sq ft)	Lane Miles *	Surface Type	Condition / PCR
0902B	NonPublic	5/12/2004	555	0.01	AS	GOOD / 90

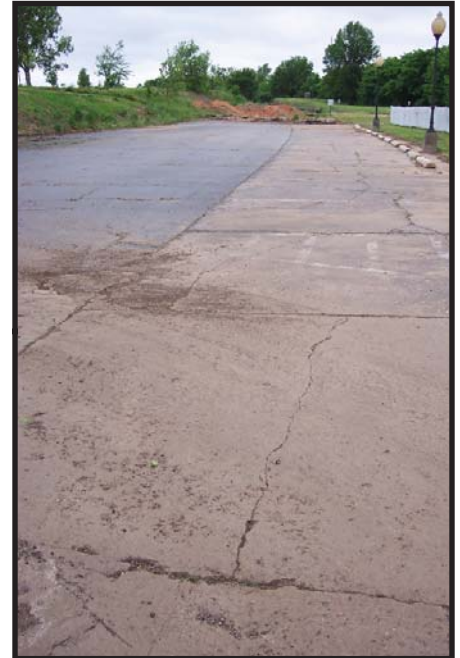
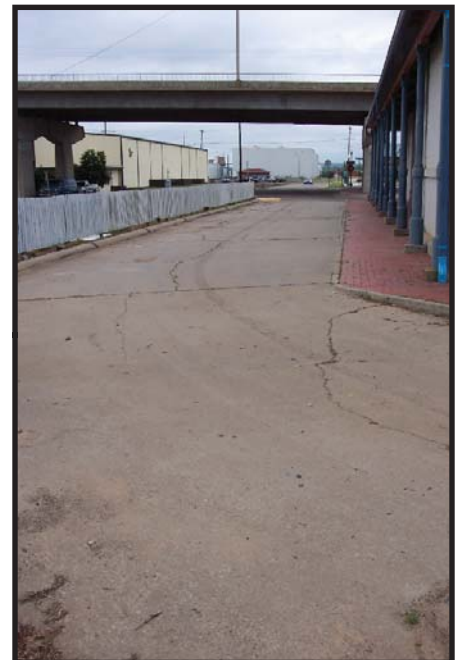
Fort Smith National Historic Site
Route 0903A
 Frisco Station Parking A
 From City Parking for Ross Pendergraft Park

Route	Public / NonPublic	Date Visited	Area (sq ft)	Lane Miles *	Surface Type	Condition / PCR
0903A	Public	5/12/2004	31835	0.55	AS	POOR / 45

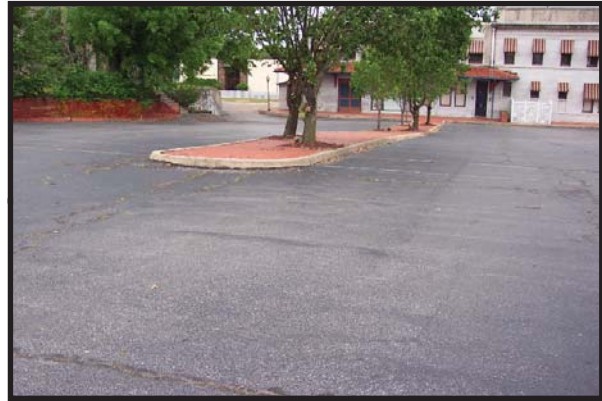
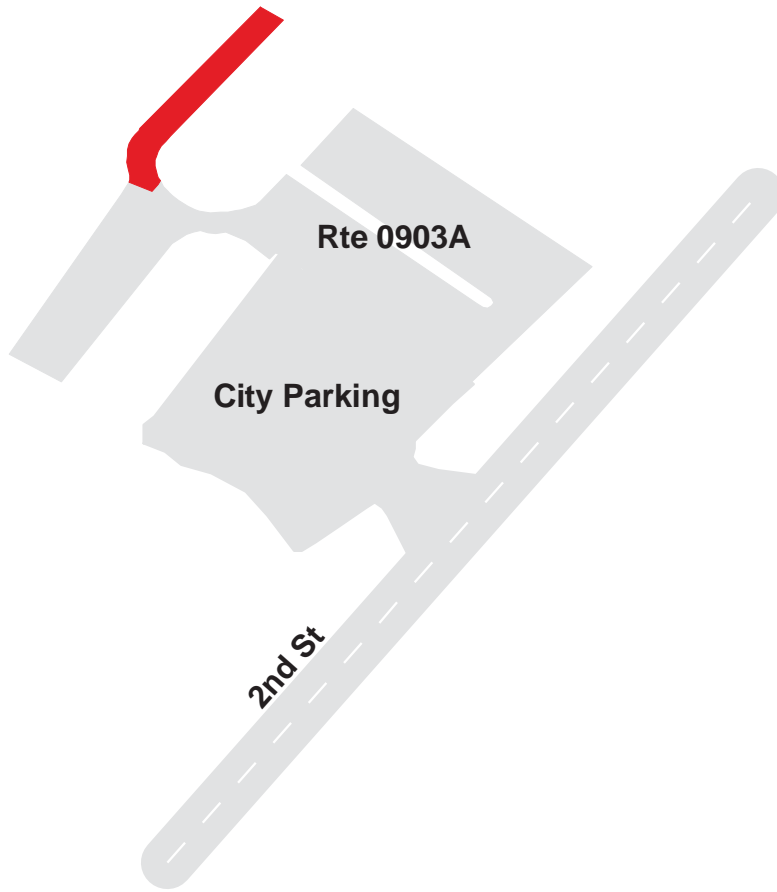
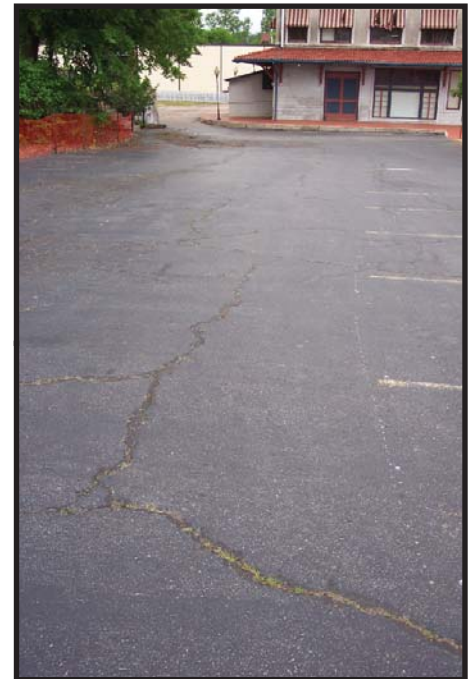
Route 0903B

Frisco Station Parking B

From City Parking for Ross Pendergraft Park

Route	Public / NonPublic	Date Visited	Area (sq ft)	Lane Miles *	Surface Type	Condition / PCR
0903B	Public	5/12/2004	3262	0.06	CO	POOR / 45
