The Road Inventory of Fort Stanwix National Monument FOST – 1760

Road Inventory Program

Prepared By:
Federal Highway Administration
Eastern Federal Lands Highway Division
Cycle 3

Fort Stanwix National Monument in New York

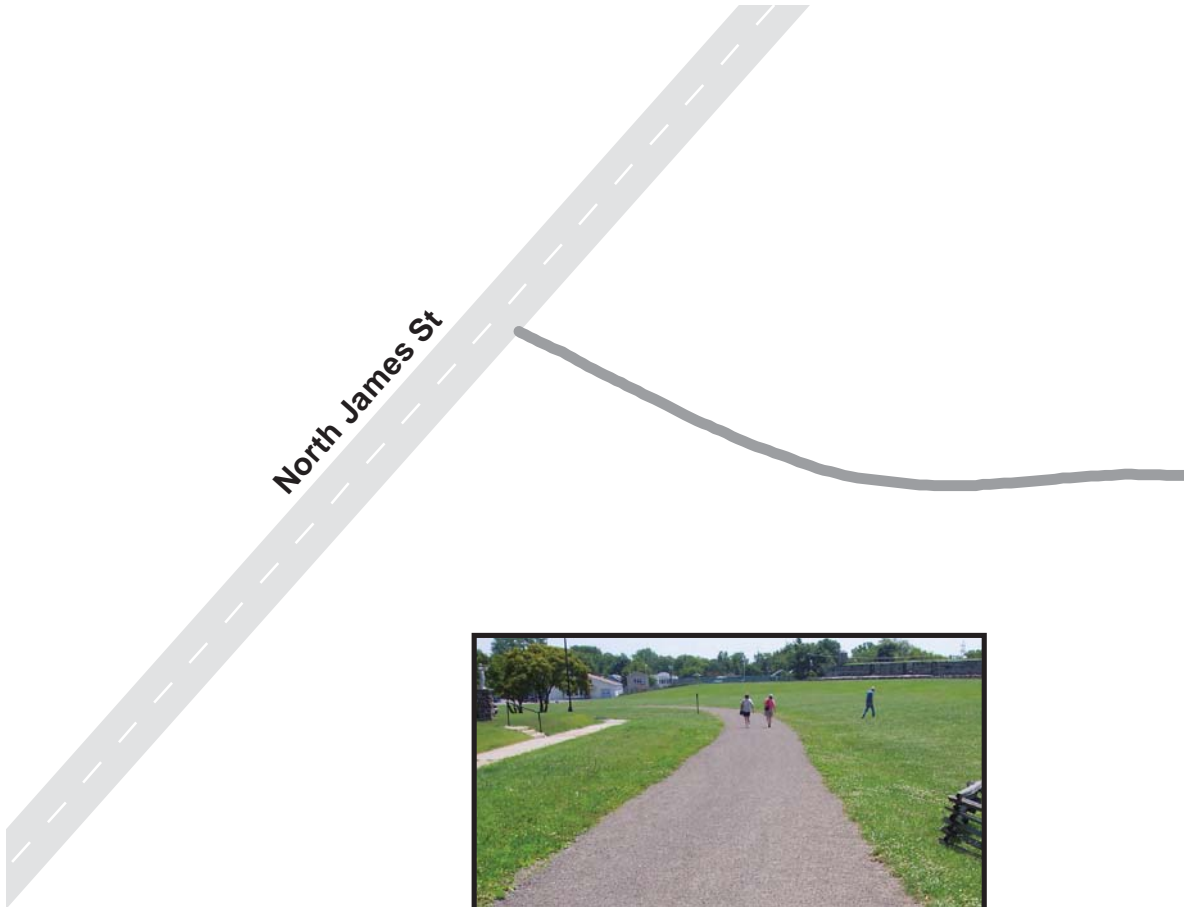
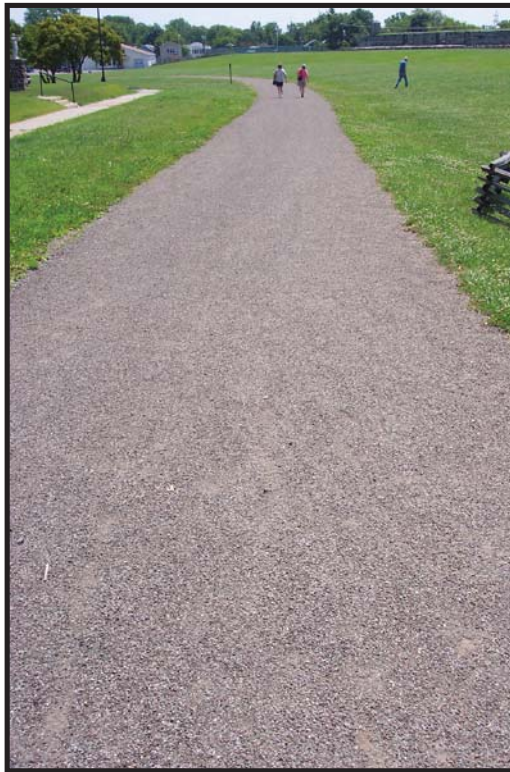
Route 0400

North Road
From North James Street

Route	Length (mi)	Width (ft)	Area (sq ft)	Lane Miles *	Condition / PCR	Surface Type
0400	0.99	12.00	62726	1.08	POOR / 45	AS

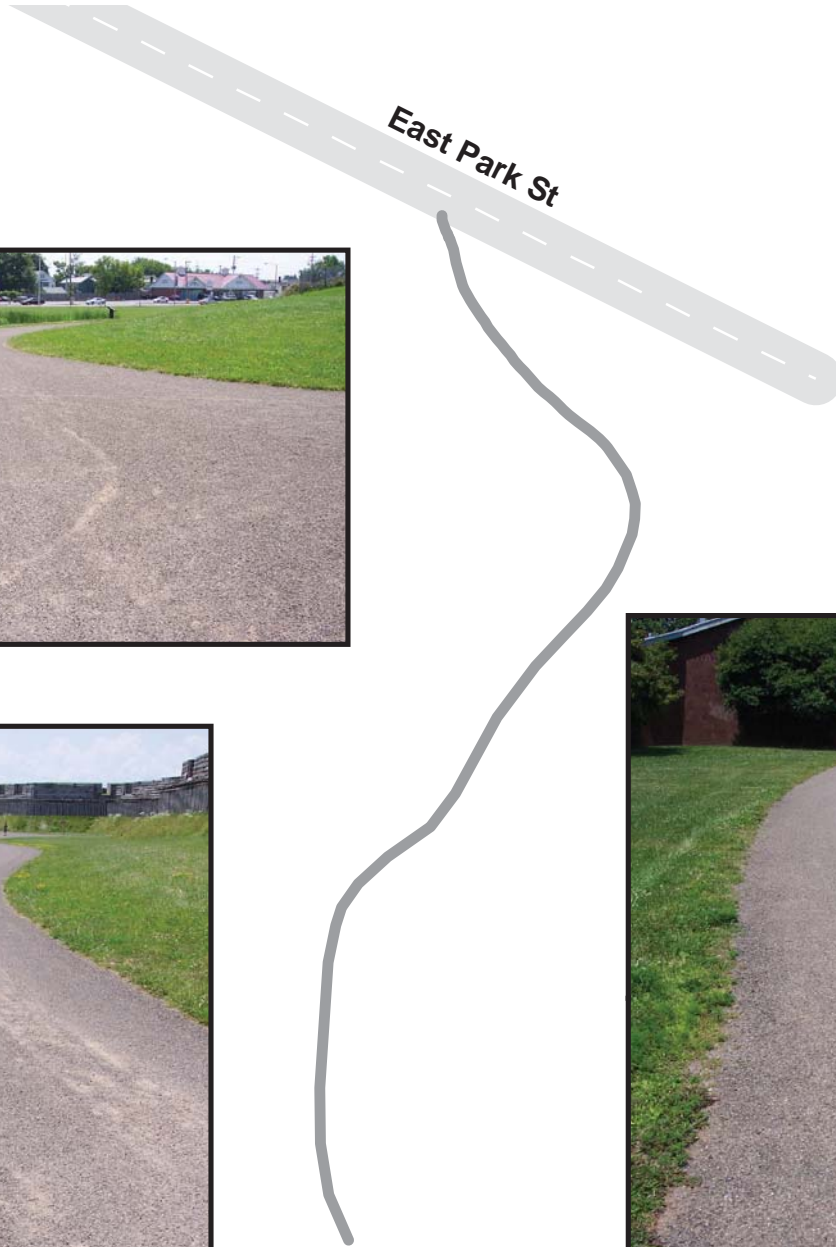
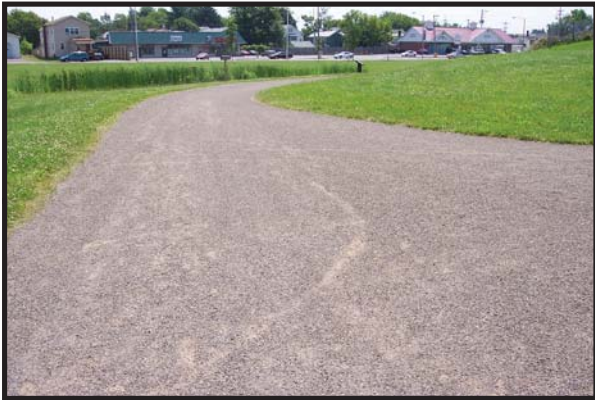
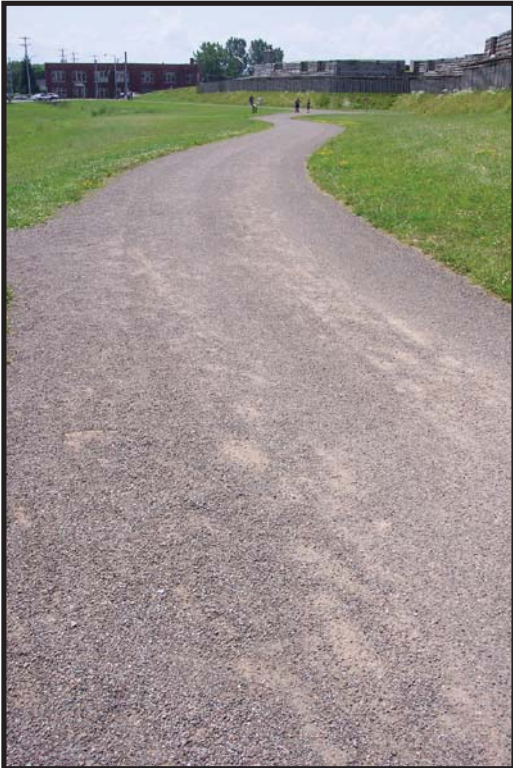
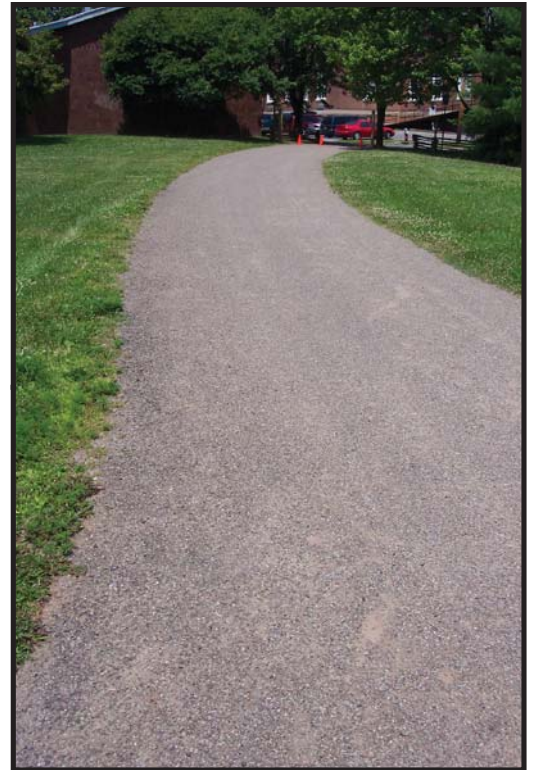
Route 0401

East Road
From East Park Street

Route	Length (mi)	Width (ft)	Area (sq ft)	Lane Miles *	Condition / PCR	Surface Type
0401	0.17	12.00	10581	0.18	POOR / 45	AS

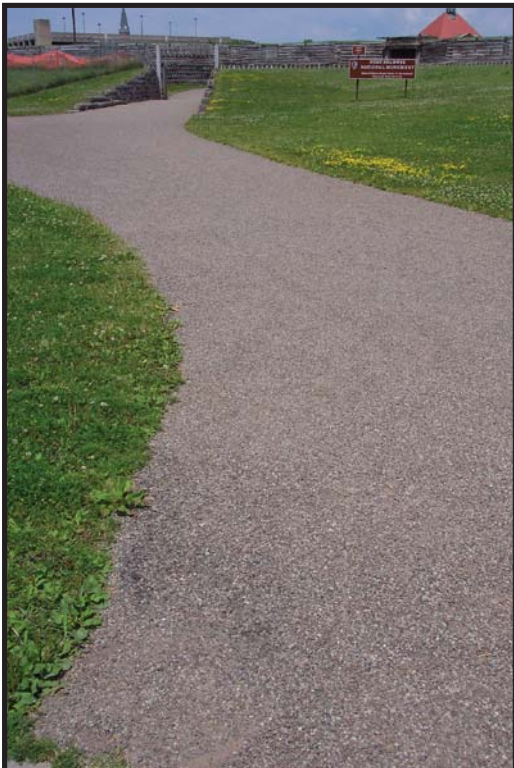
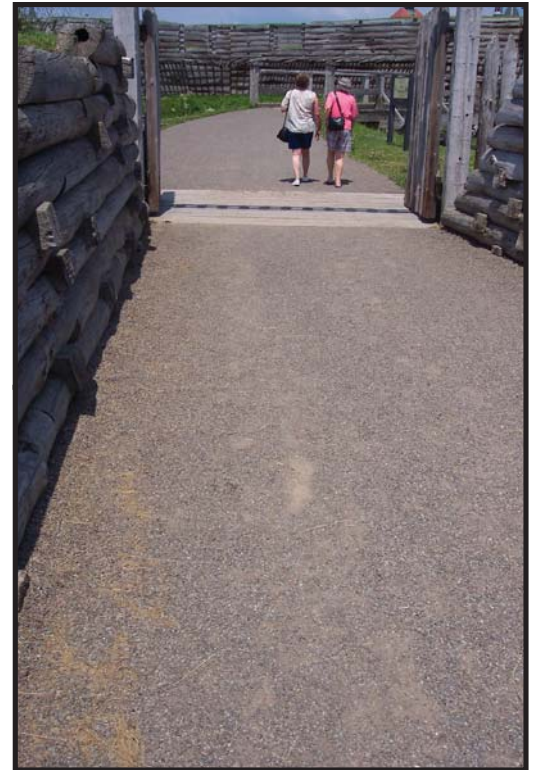
Route 0402

Fort Entrance Road

From Black River Boulevard

Route	Length (mi)	Width (ft)	Area (sq ft)	Lane Miles *	Condition / PCR	Surface Type
0402	0.05	12.00	2851	0.05	POOR / 45	AS

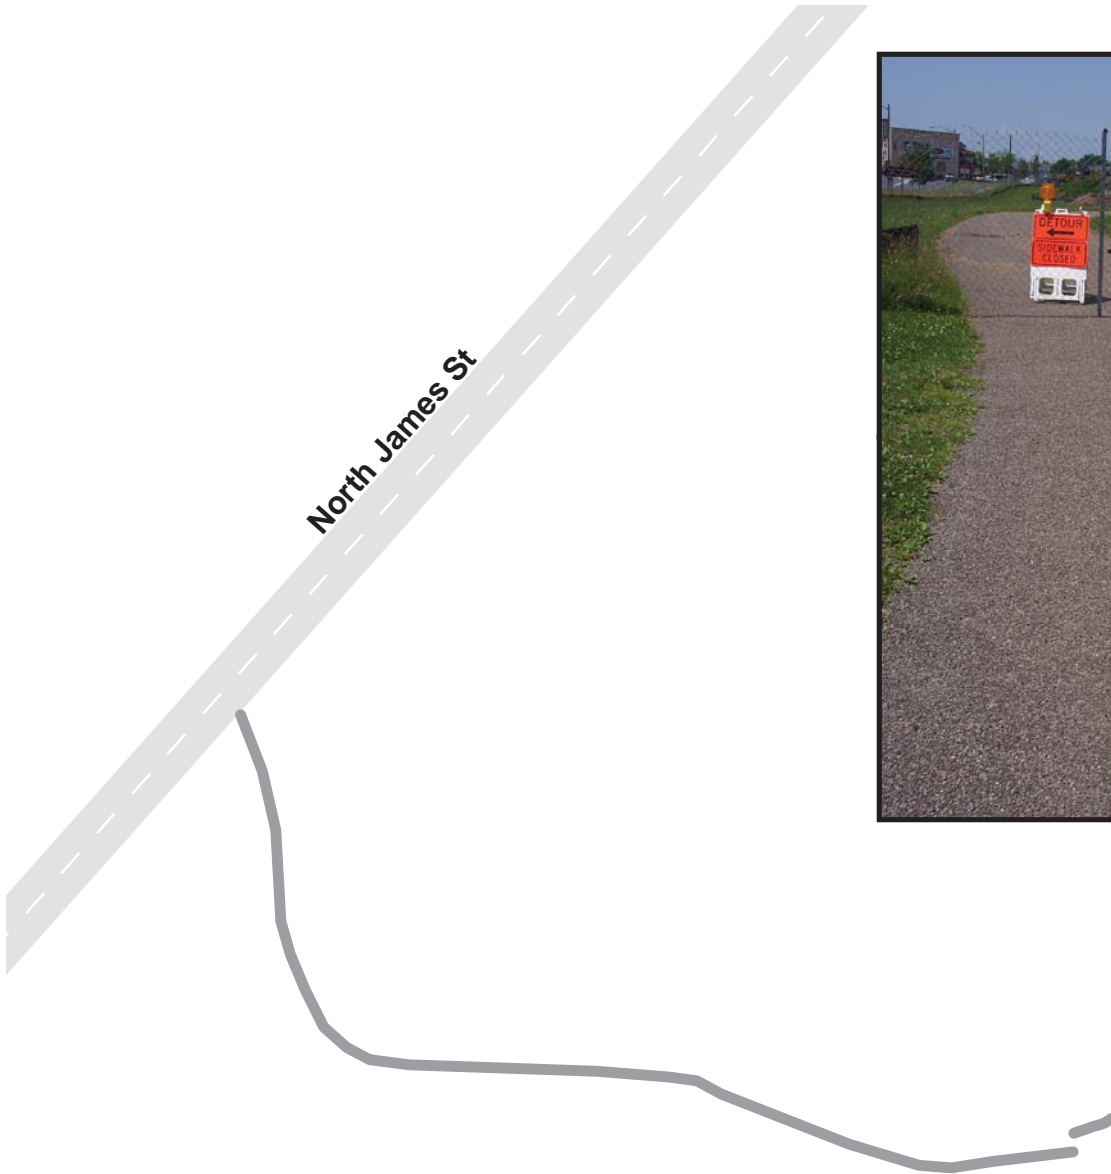
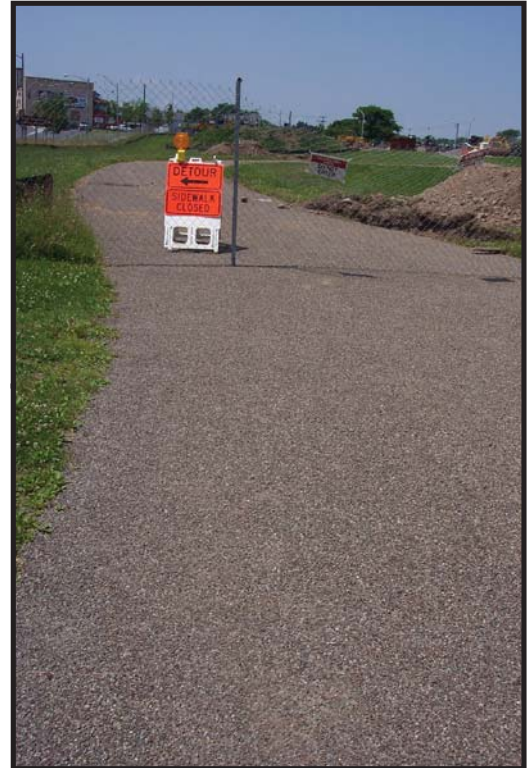
Route 0403

South Road

From North James Street

Route	Length (mi)	Width (ft)	Area (sq ft)	Lane Miles *	Condition / PCR	Surface Type
0403	0.15	12.00	9504	0.16	POOR / 45	AS
