The Road Inventory of Fort Sumter National Monument FOSU – 5430

Road Inventory Program

Prepared By:
Federal Highway Administration
Eastern Federal Lands Highway Division
Cycle 3

Fort Sumter National Monument in South Carolina

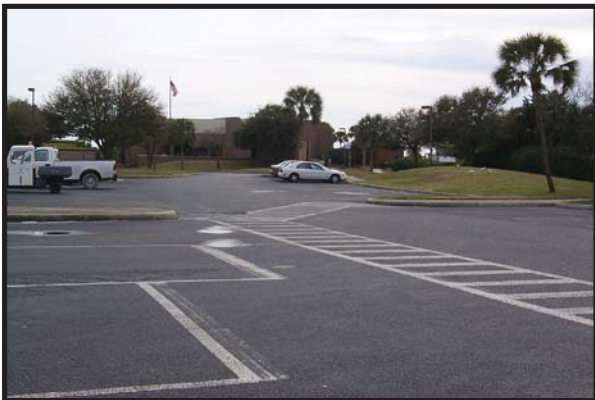
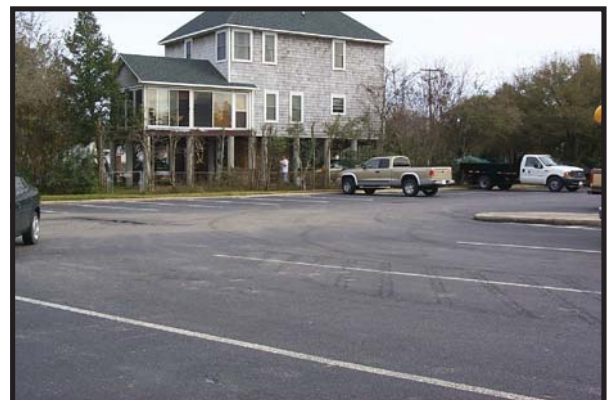
Fort Sumter National Monument
Route 0900
 FORT MOULTRIE VISITOR CENTER PARKING
 From Middle Street

Route	Public / NonPublic	Date Visited	Area (sq ft)	Lane Miles *	Surface Type	Condition / PCR
0900	Public	3/9/2002	45184	0.78	AS	POOR / 45

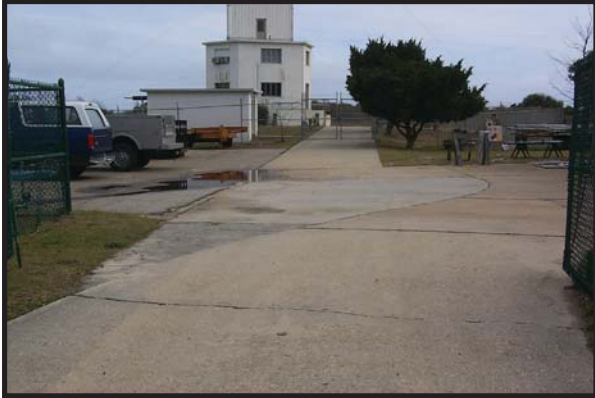
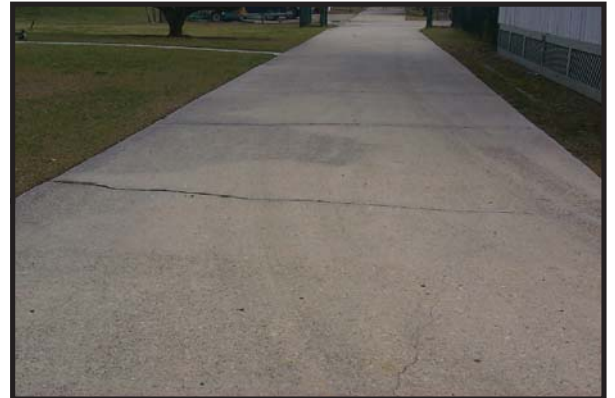
Route 0901

Route	Public / NonPublic	Date Visited	Area (sq ft)	Lane Miles *	Surface Type	Condition / PCR
0901	NonPublic	3/9/2002	6824	0.12	CO	POOR / 45

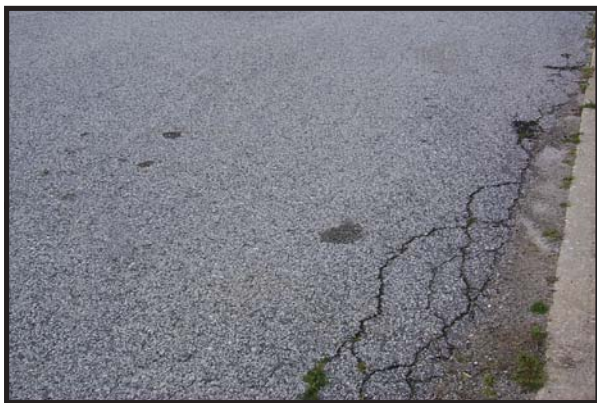
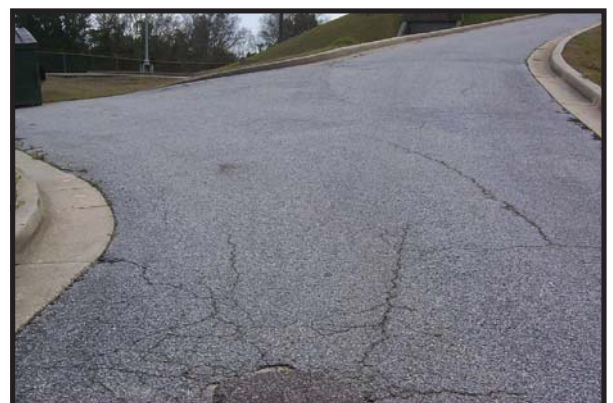
Route 0902

Route	Public / NonPublic	Date Visited	Area (sq ft)	Lane Miles *	Surface Type	Condition / PCR
0902	NonPublic	3/9/2002	4382	0.08	AS	FAIR / 73
