The Road Inventory of Fort Union National Monument FOUN – 7230

Road Inventory Program

Prepared By:
Federal Highway Administration
Eastern Federal Lands Highway Division
Cycle 3

Fort Union National Monument in New Mexico

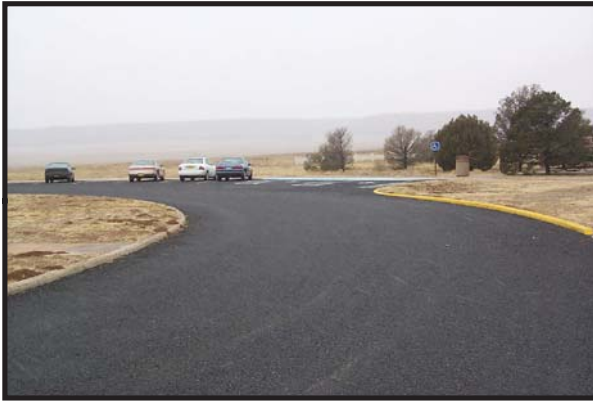
Route	Public / NonPublic	Date Visited	Area (sq ft)	Lane Miles *	Surface Type	Condition / PCR
0900	Public	12/11/2001	35565	0.61	NC	GOOD / 90

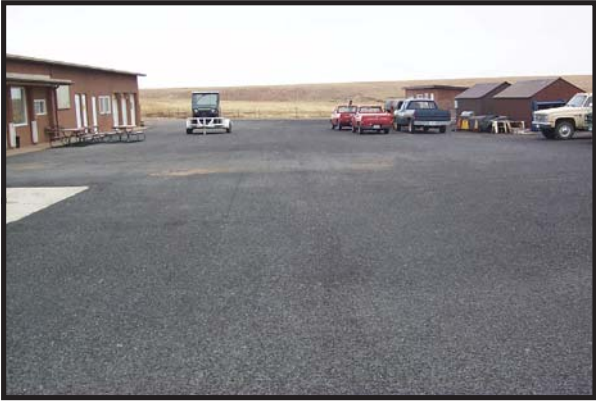
Route 0901

Route	Public / NonPublic	Date Visited	Area (sq ft)	Lane Miles *	Surface Type	Condition / PCR
0901	NonPublic	12/11/2001	26062	0.45	NC	GOOD / 90

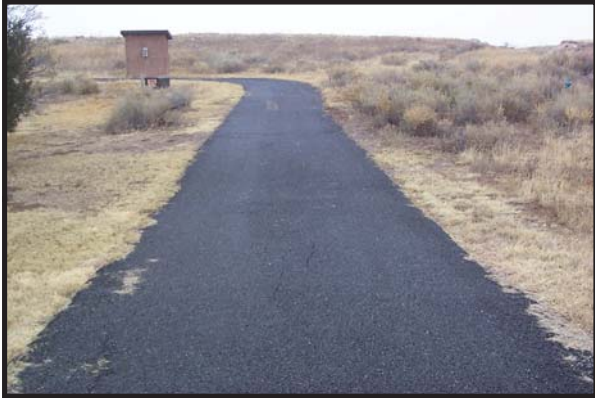
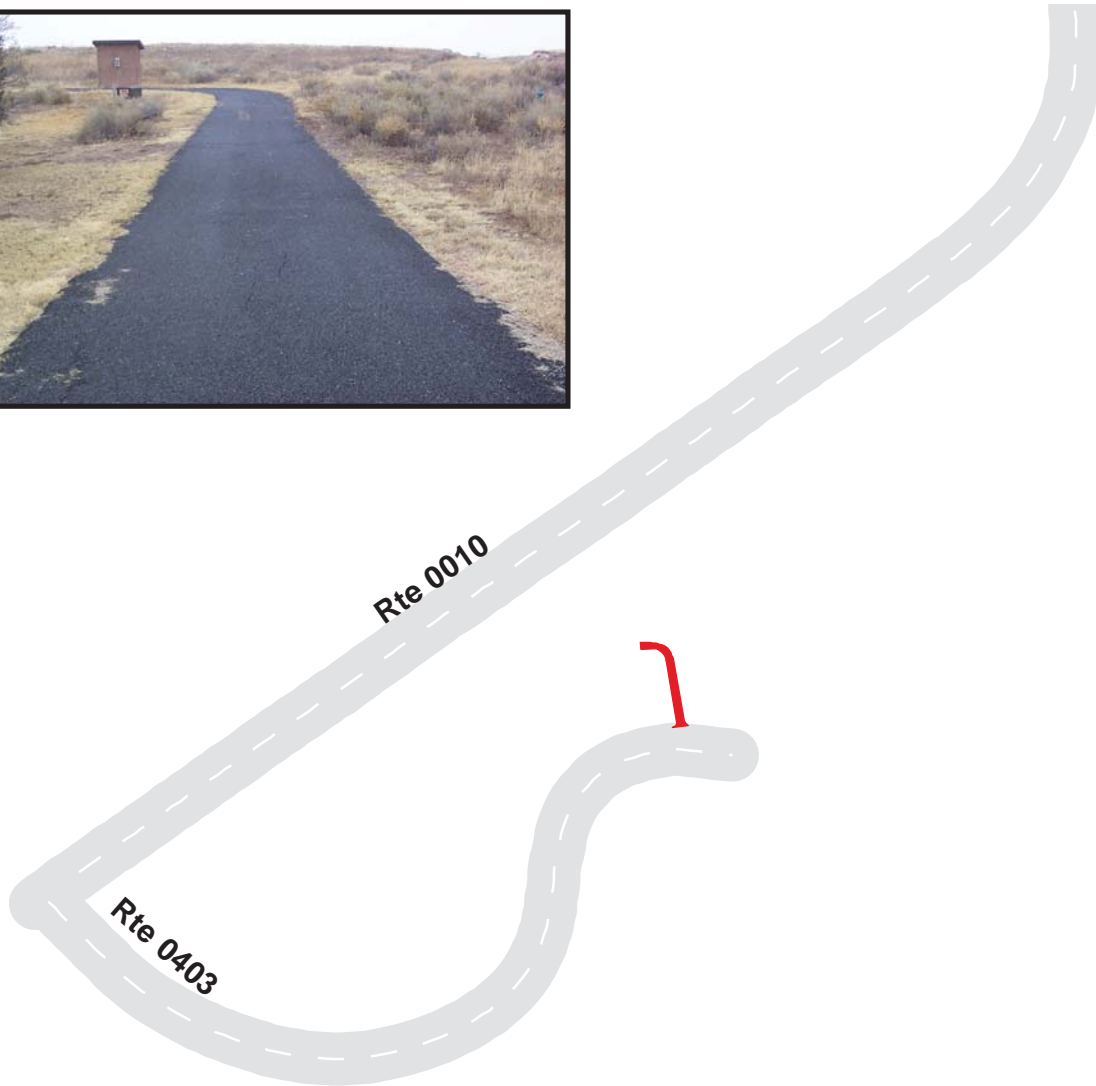
Route 0902

Route	Public / NonPublic	Date Visited	Area (sq ft)	Lane Miles *	Surface Type	Condition / PCR
0902	NonPublic	12/11/2001	2337	0.04	NC	GOOD / 90
