**The Road Inventory
of
Fort Union Trading Post
National Historic Site
FOUS – 1549**

Road Inventory Program

Prepared By:
Federal Highway Administration
Eastern Federal Lands Highway Division
Cycle 3

Fort Union Trading Post National Historic Site in North Dakota

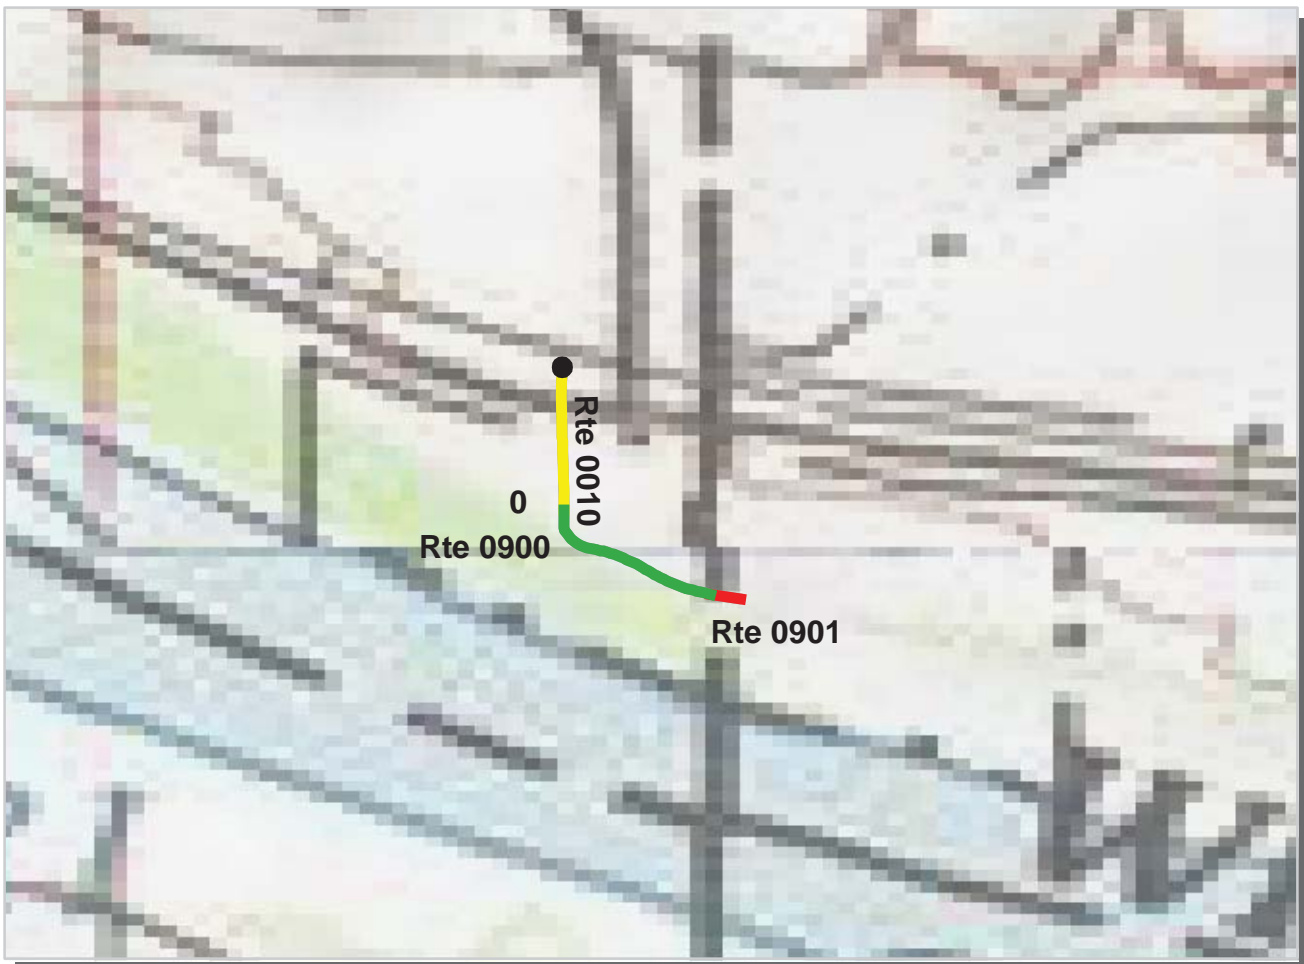
ROUTE: 0010 Fort Union Access Road **TOTAL LENGTH: 0.31 Miles**

Section Number	0				
Section Length (mi)	0.31				
AADT	**				
SADT	**				
ADT Date	**				
Cross Section Information					
Number of Lanes	2				
Paved Width (ft)	25				
Lane Width (ft)	12				
Shoulder Width (ft)	7				
Roadway Condition Information					
PCR (Pavement Condition Rating)	80				
RCI (Roughness Condition Index)	55				
SCR (Surface Condition Rating)	84				
Alligator Cracking Index	100				
Rutting Index	85				
Patching Index	100				
Transverse Cracking Index	99				
Longitudinal Cracking Index	100				
Shoulder Condition Rating	GOOD				
Drainage Condition Rating	GOOD

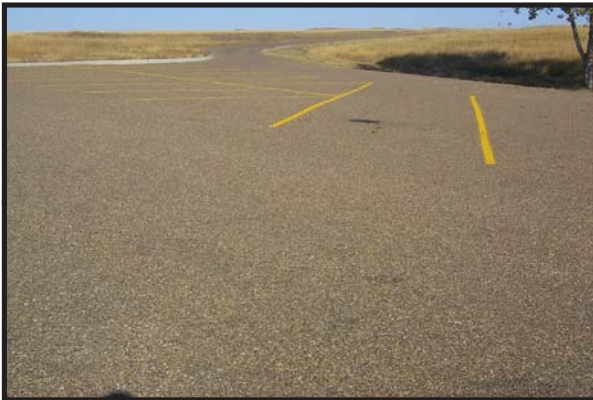
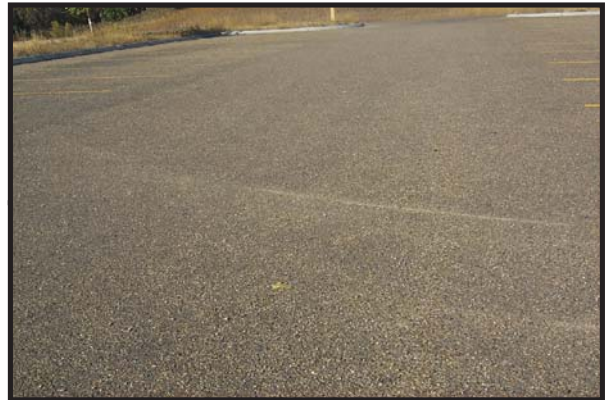
Route	Public / NonPublic	Date Visited	Area (sq ft)	Lane Miles *	Surface Type	Condition / PCR
0900	Public	10/11/2000	36503	0.63	OC	GOOD / 90

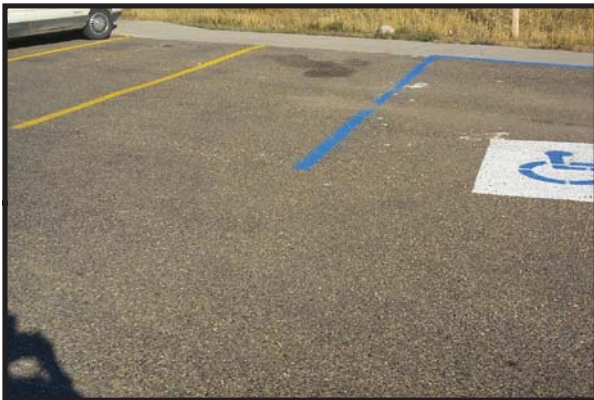
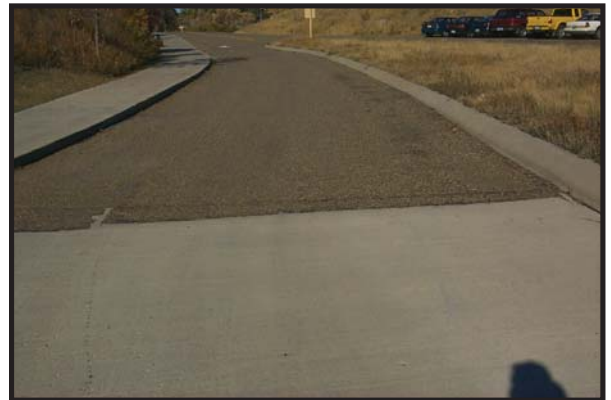
Route 0901

Route	Public / NonPublic	Date Visited	Area (sq ft)	Lane Miles *	Surface Type	Condition / PCR
0901	Public	10/11/2000	11963	0.21	OC	GOOD / 90

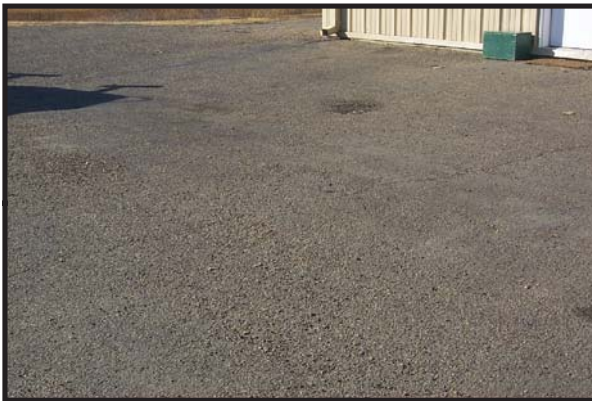
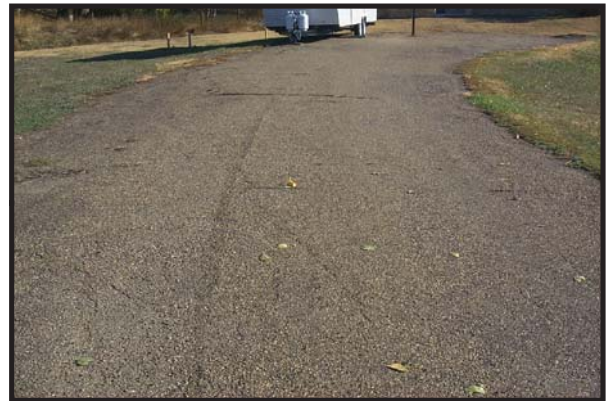
Route 0903

Route	Public / NonPublic	Date Visited	Area (sq ft)	Lane Miles *	Surface Type	Condition / PCR
0903	NonPublic	10/11/2000	12691	0.22	OC	FAIR / 73

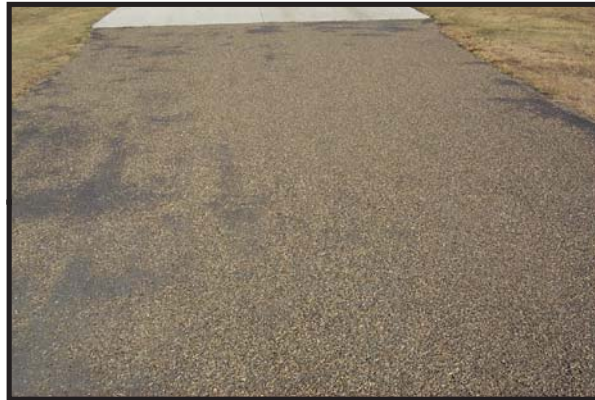
Route 0904A

Route	Public / NonPublic	Date Visited	Area (sq ft)	Lane Miles *	Surface Type	Condition / PCR
0904A	NonPublic	10/11/2000	1288	0.02	OC	GOOD / 90

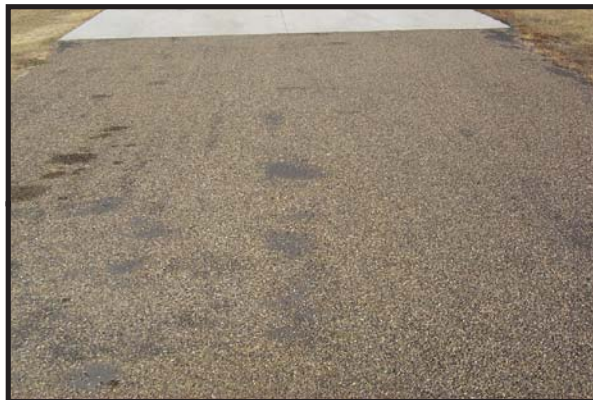
Route 0904B

Route	Public / NonPublic	Date Visited	Area (sq ft)	Lane Miles *	Surface Type	Condition / PCR
0904B	NonPublic	10/11/2000	976	0.02	OC	GOOD / 90
