The Road Inventory of Fort Vancouver National Historic Site FOVA - 9340

Prepared By:
Federal Highway Administration
Eastern Federal Lands Highway Division
Cycle 3

Fort Vancouver National Historic Site in Washington

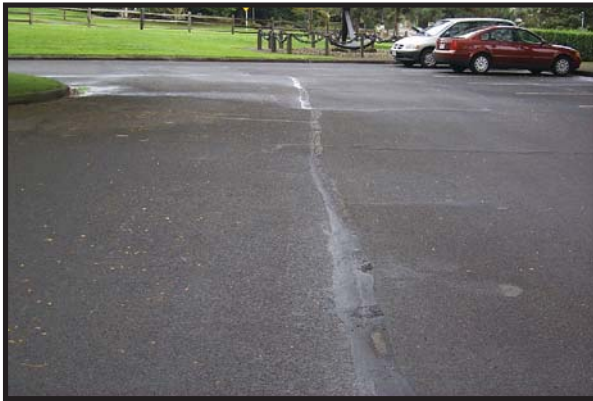
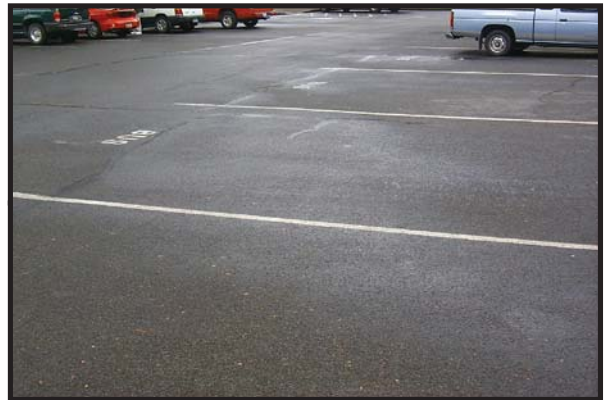
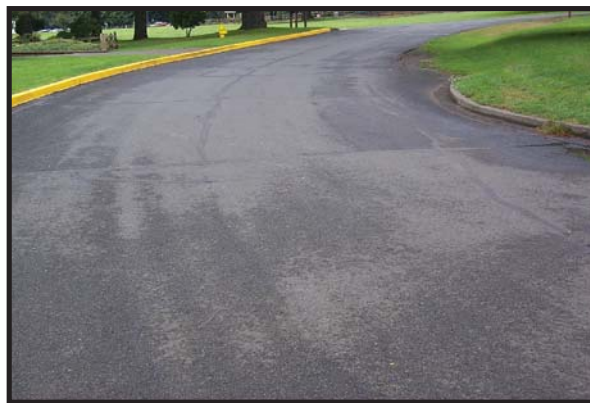
| Route | Public / NonPublic | Date Visited | Area (sq ft) | Lane Miles * | Surface Type | Condition / PCR |
| 0900 | Public | 1/0/1900 | 25928 | 0.45 | AS | FAIR / 73 |

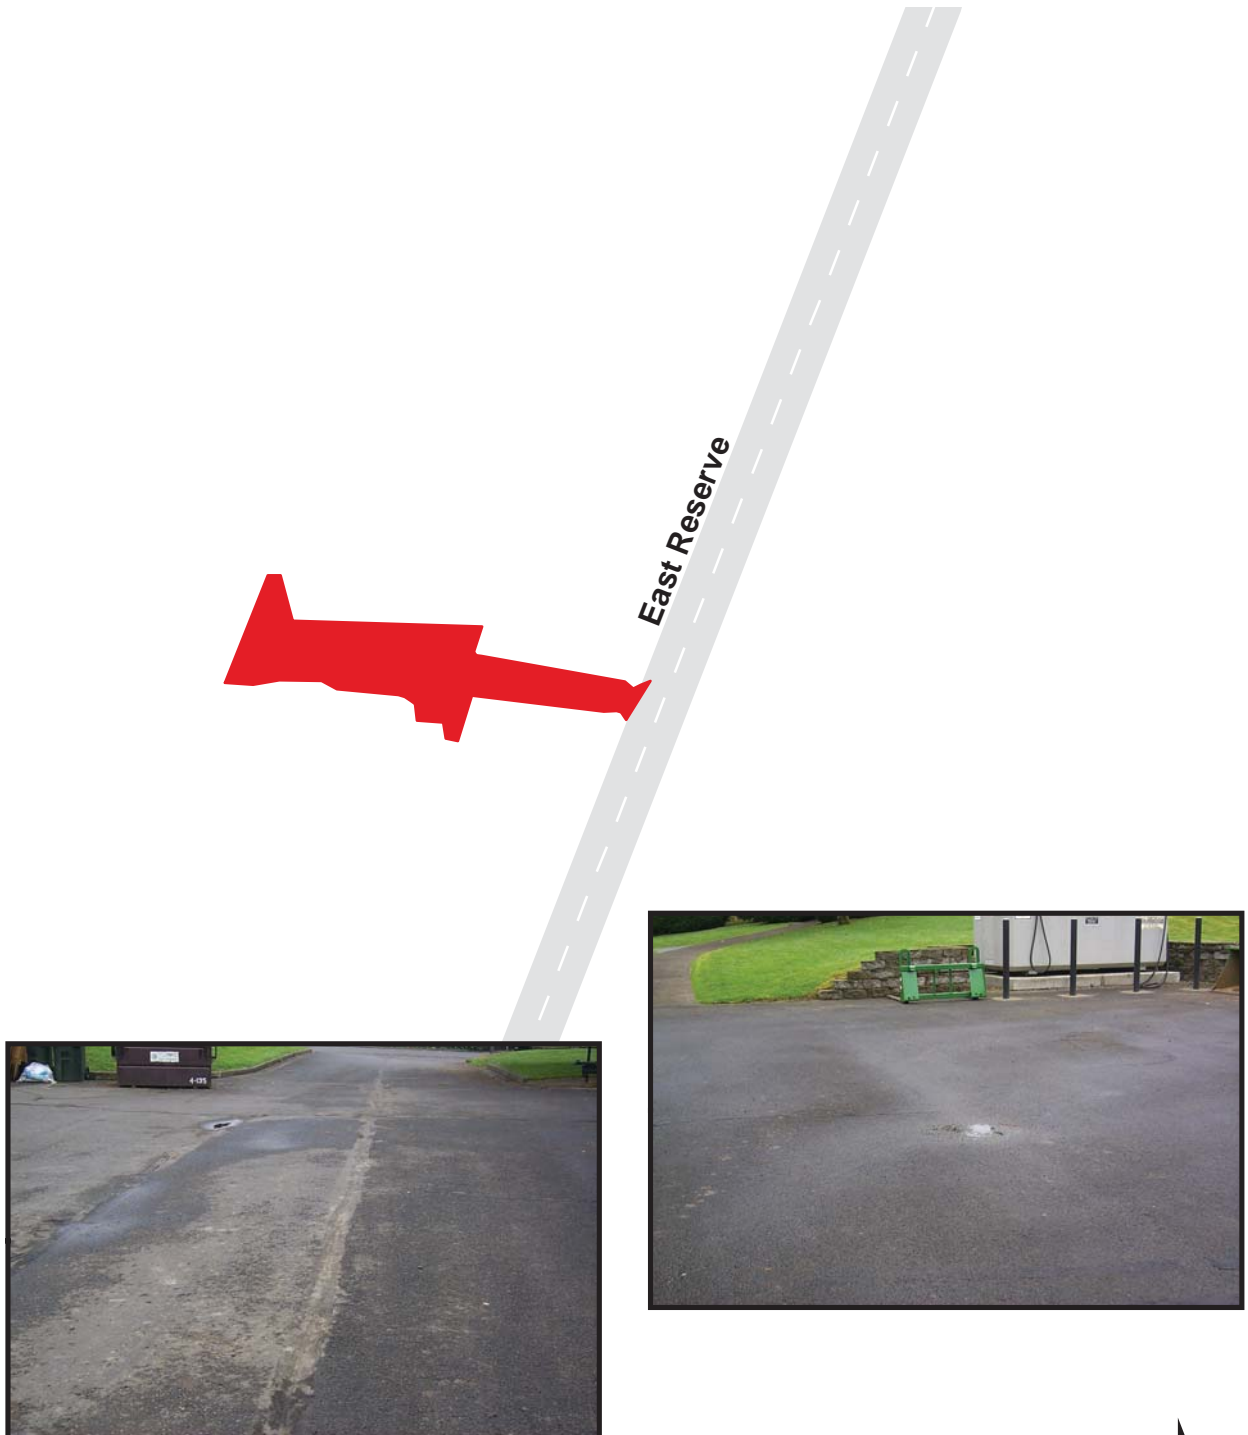
Route 0901

| Route | Public / NonPublic | Date Visited | Area (sq ft) | Lane Miles * | Surface Type | Condition / PCR |
| 0901 | NonPublic | 1/0/1900 | 7401 | 0.13 | AS | FAIR / 73 |

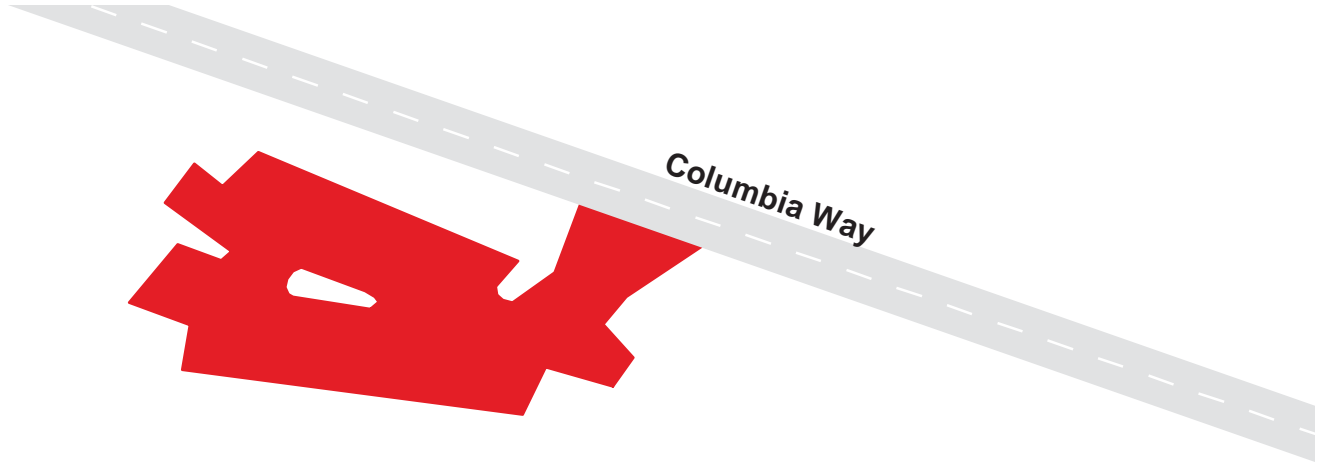
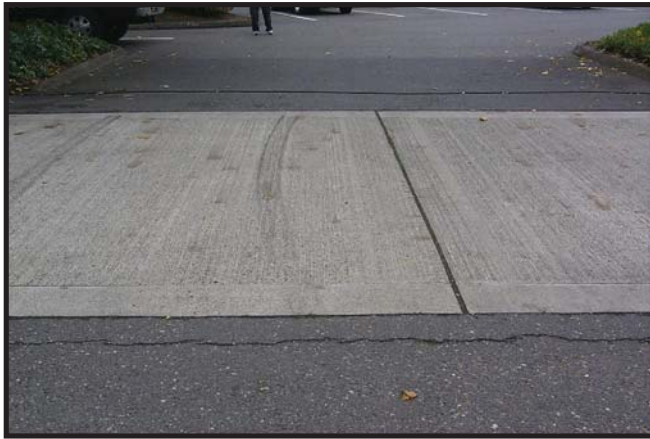
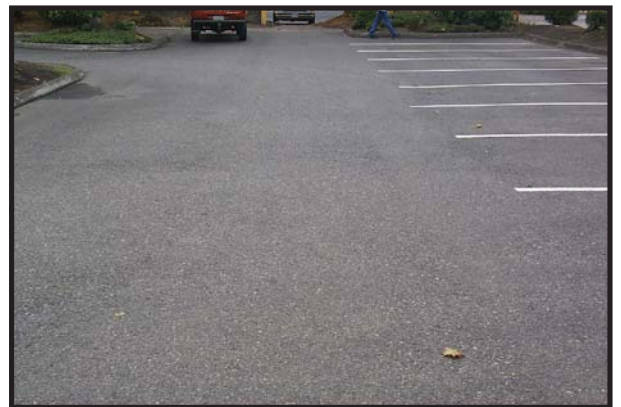
Route 0903A

| Route | Public / NonPublic | Date Visited | Area (sq ft) | Lane Miles * | Surface Type | Condition / PCR |
| 0903A | Public | 1/0/1900 | 10206 | 0.18 | AS | FAIR / 73 |

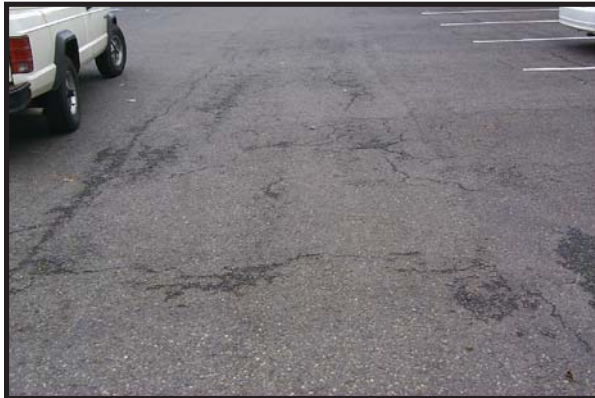
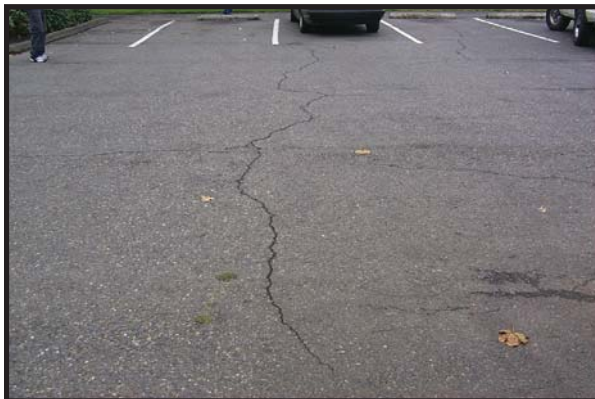
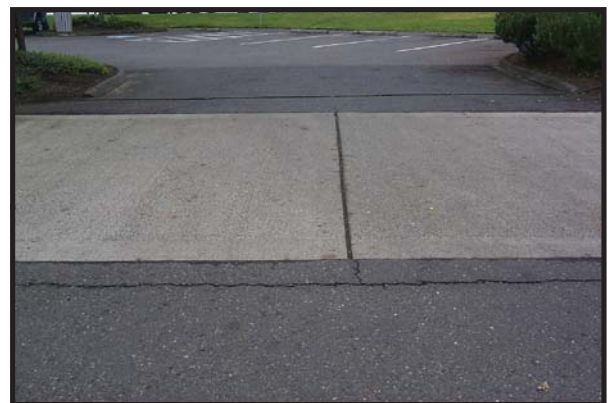
Route 0903B

| Route | Public / NonPublic | Date Visited | Area (sq ft) | Lane Miles * | Surface Type | Condition / PCR |
| 0903B | Public | 1/0/1900 | 9453 | 0.16 | AS | FAIR / 73 |

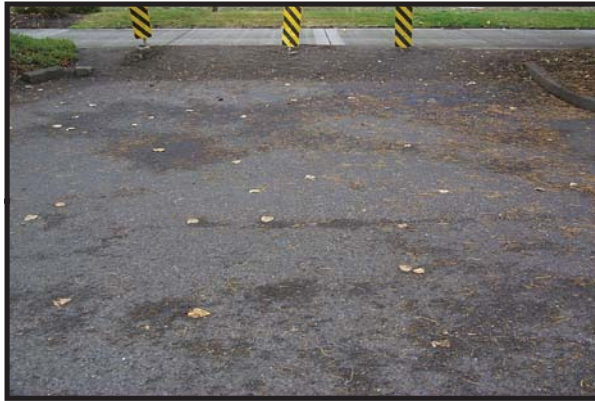
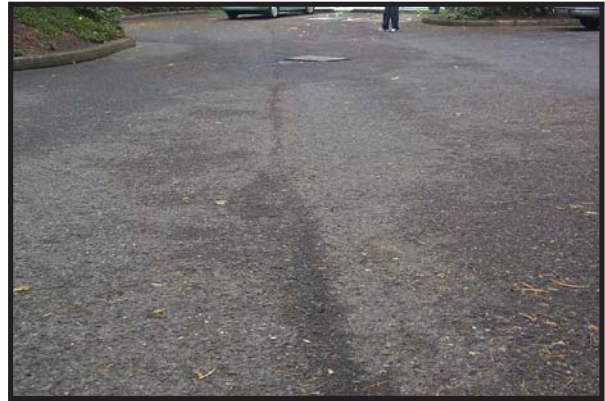
Route 0903C

| Route | Public / NonPublic | Date Visited | Area (sq ft) | Lane Miles * | Surface Type | Condition / PCR |
| 0903C | Public | 1/0/1900 | 6967 | 0.12 | AS | FAIR / 73 |
