The Road Inventory of Fort Washington Park FOWA - 3551

Road Inventory Program

Prepared By:
Federal Highway Administration
Eastern Federal Lands Highway Division
Cycle 3

Fort Washington Park in Maryland

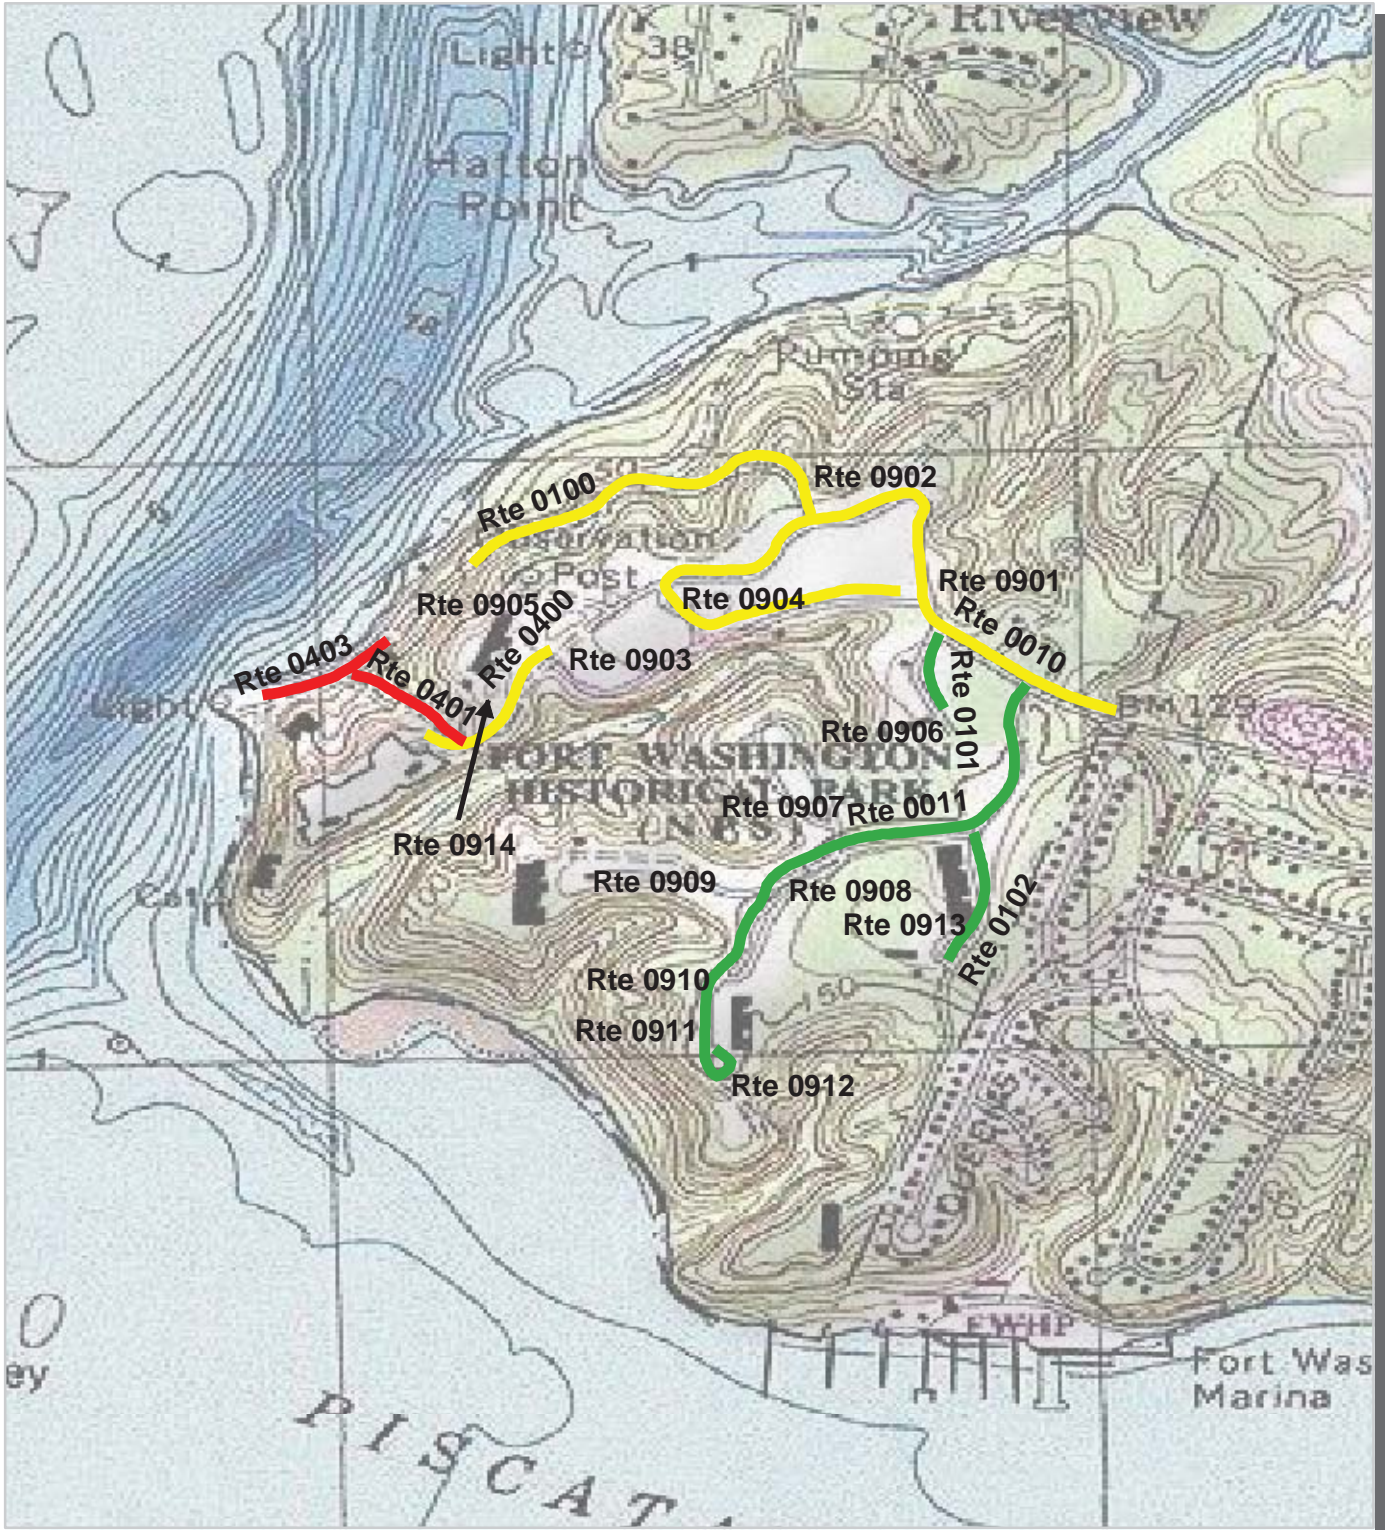
Fort Washington Park Route Condition Key Map PCR - Mile by Mile

PCR	Poor		Fair		Good		Excellent	
		(<=60)		(61 - 84)		(85 - 94)		(95 - 100)

* If the PCR rating is not available for a section, the SCR rating will be displayed. See appendix for definitions and formulas.

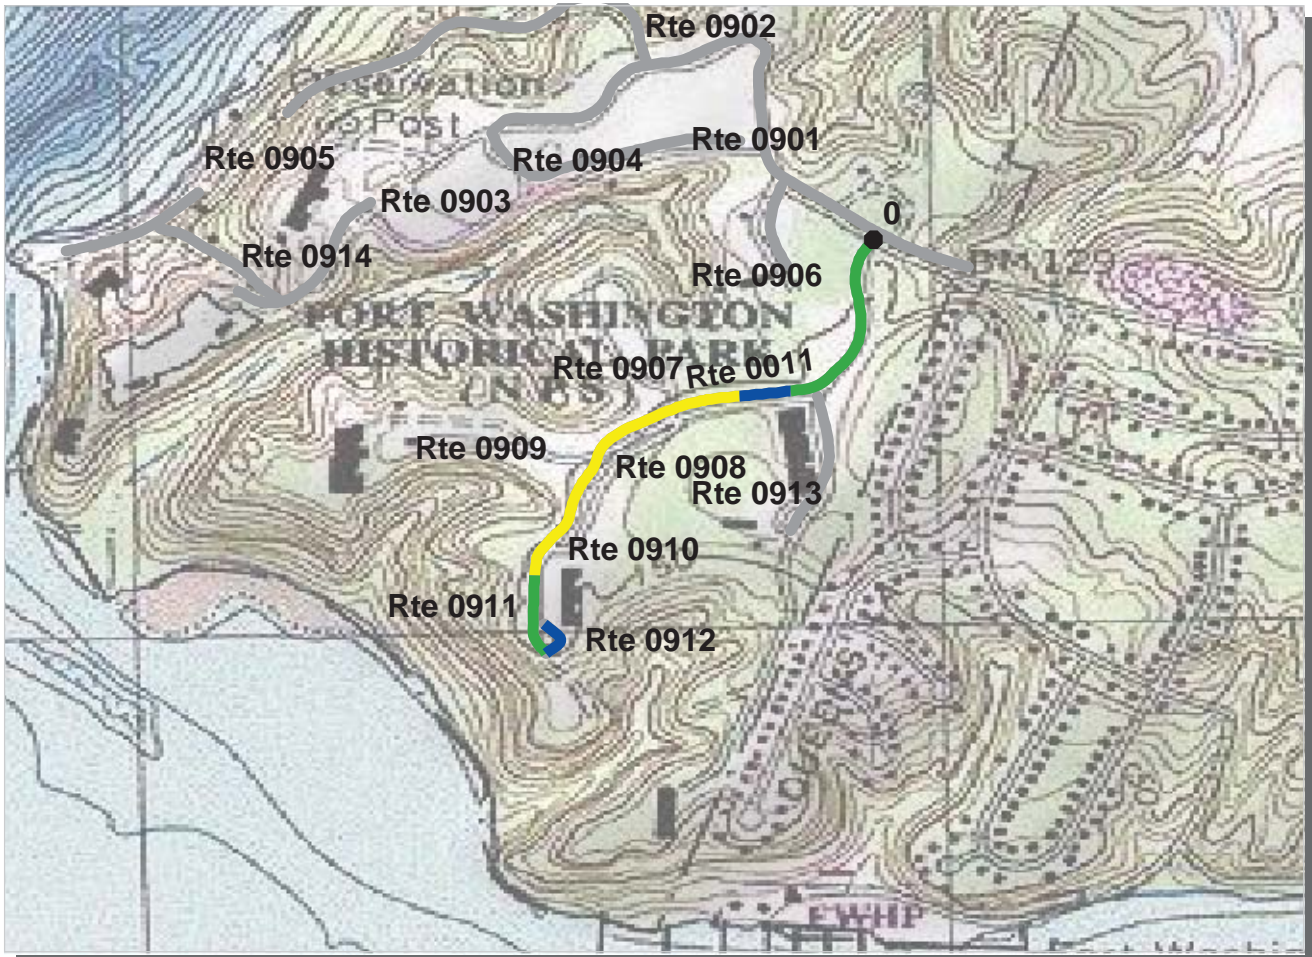
ROUTE: 0011 Warburton Drive **TOTAL LENGTH: 0.61 Miles**

Section Number	0				
Section Length (mi)	0.61				
AADT	**				
SADT	**				
ADT Date	**				
Cross Section Information					
Number of Lanes	2				
Paved Width (ft)	19				
Lane Width (ft)	10				
Shoulder Width (ft)	0				
Roadway Condition Information					
PCR (Pavement Condition Rating)	85				
RCI (Roughness Condition Index)	56				
SCR (Surface Condition Rating)	93				
Alligator Cracking Index	100				
Rutting Index	94				
Patching Index	100				
Transverse Cracking Index	99				
Longitudinal Cracking Index	99				
Shoulder Condition Rating	N/A				
Drainage Condition Rating	GOOD

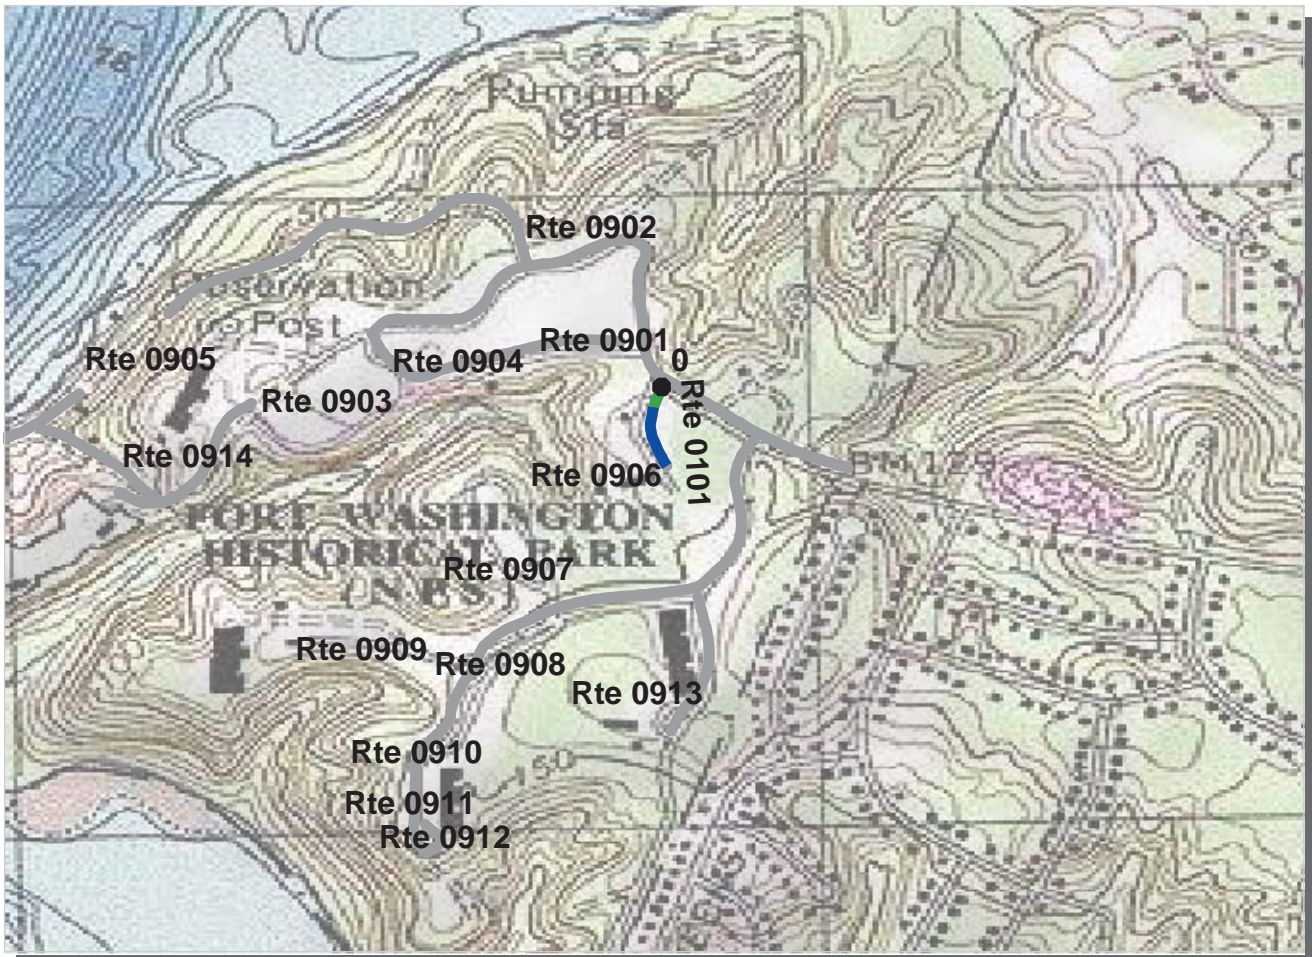
ROUTE: 0101 Old Quarters Access **TOTAL LENGTH: 0.09 Miles**

Section Number	0				
Section Length (mi)	0.09				
AADT	**				
SADT	**				
ADT Date	**				
Cross Section Information					
Number of Lanes	2				
Paved Width (ft)	20				
Lane Width (ft)	10				
Shoulder Width (ft)	0				
Roadway Condition Information					
PCR (Pavement Condition Rating)	93				
RCI (Roughness Condition Index)	NC				
SCR (Surface Condition Rating)	93				
Alligator Cracking Index	100				
Rutting Index	93				
Patching Index	100				
Transverse Cracking Index	100				
Longitudinal Cracking Index	100				
Shoulder Condition Rating	N/A				
Drainage Condition Rating	GOOD

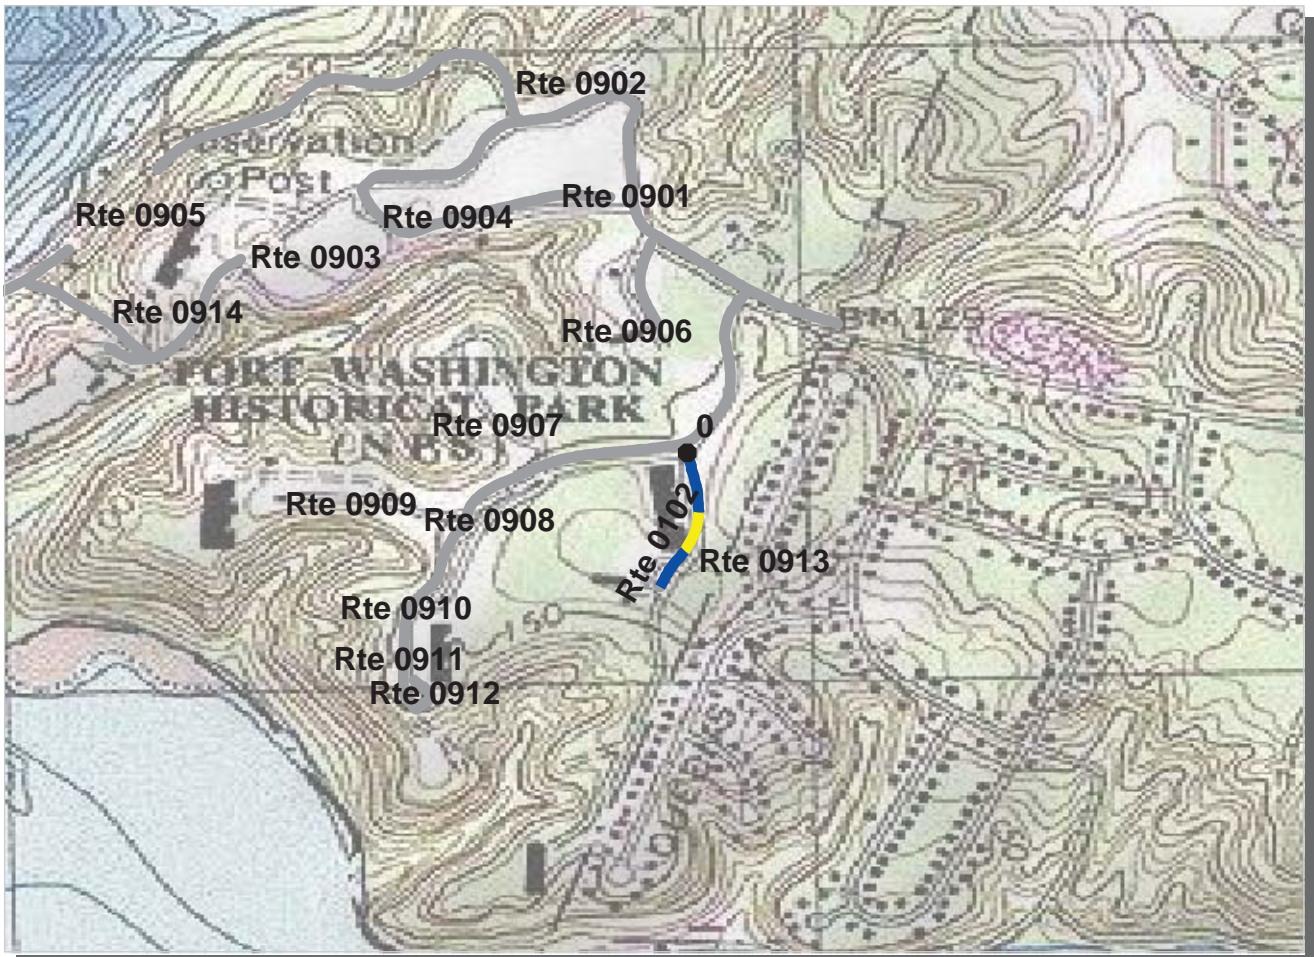
ROUTE: 0102 Ainsworth Drive **TOTAL LENGTH: 0.16 Miles**

Section Number	0				
Section Length (mi)	0.16				
AADT	**				
SADT	**				
ADT Date	**				
Cross Section Information					
Number of Lanes	2				
Paved Width (ft)	19				
Lane Width (ft)	9				
Shoulder Width (ft)	0				
Roadway Condition Information					
PCR (Pavement Condition Rating)	89				
RCI (Roughness Condition Index)	46				
SCR (Surface Condition Rating)	94				
Alligator Cracking Index	100				
Rutting Index	94				
Patching Index	100				
Transverse Cracking Index	100				
Longitudinal Cracking Index	100				
Shoulder Condition Rating	N/A				
Drainage Condition Rating	GOOD

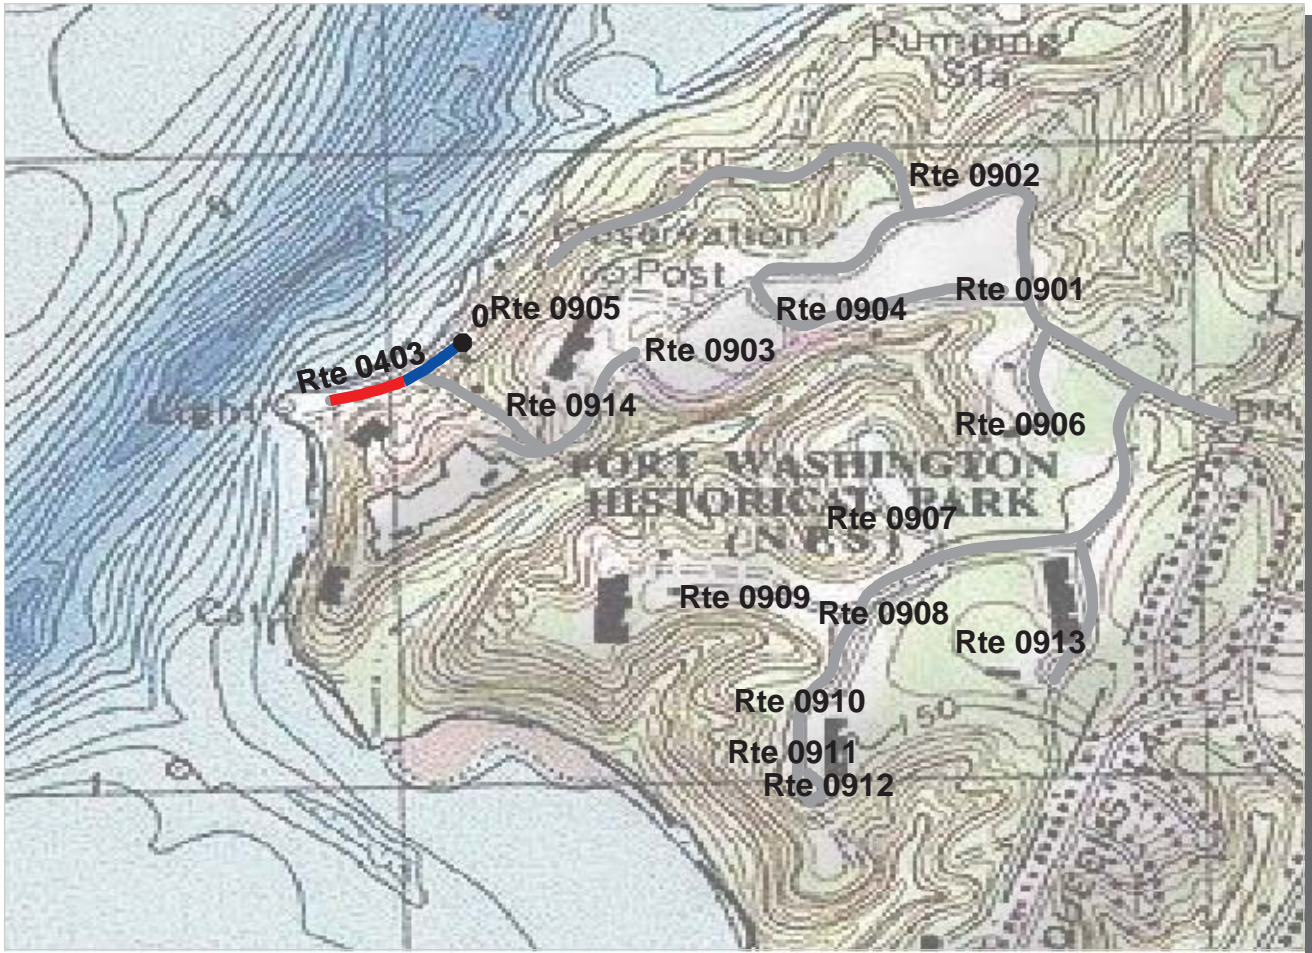
ROUTE: 0403 Lighthouse Service Road TOTAL LENGTH: 0.14 Miles

Section Number	0			
Section Length (mi)	0.14			
AADT	**			
SADT	**			
ADT Date	**			
Cross Section Information				
Number of Lanes	1			
Paved Width (ft)	11			
Lane Width (ft)	11			
Shoulder Width (ft)	5			
Roadway Condition Information				
PCR (Pavement Condition Rating)	60			
RCI (Roughness Condition Index)	NC			
SCR (Surface Condition Rating)	60			
Alligator Cracking Index	100			
Rutting Index	60			
Patching Index	100			
Transverse Cracking Index	100			
Longitudinal Cracking Index	100			
Shoulder Condition Rating	GOOD			
Drainage Condition Rating	GOOD
