The Road Inventory of Friendship Hill National Historic Site FRHI - 4360

Road Inventory Program

Prepared By:
Federal Highway Administration
Eastern Federal Lands Highway Division
Cycle 3

Friendship Hill National Historic Site in Pennsylvania

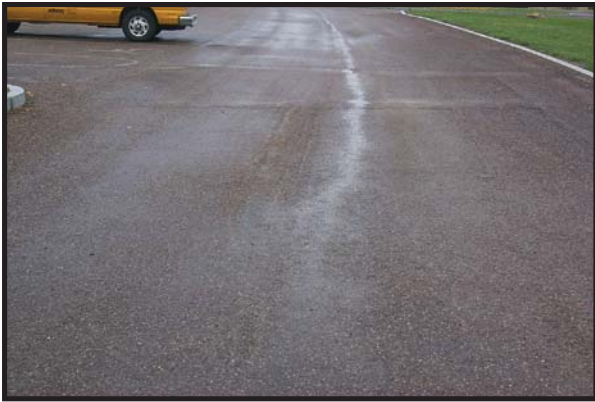
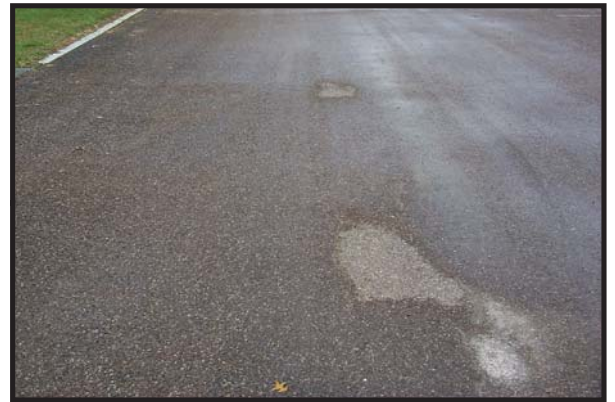
Route 0900

Route	Public / NonPublic	Date Visited	Area (sq ft)	Lane Miles *	Surface Type	Condition / PCR
0900	Public	10/28/2002	33069	0.57	AS	GOOD / 90

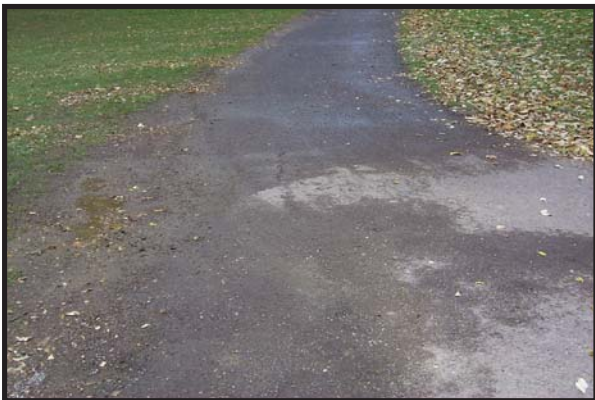
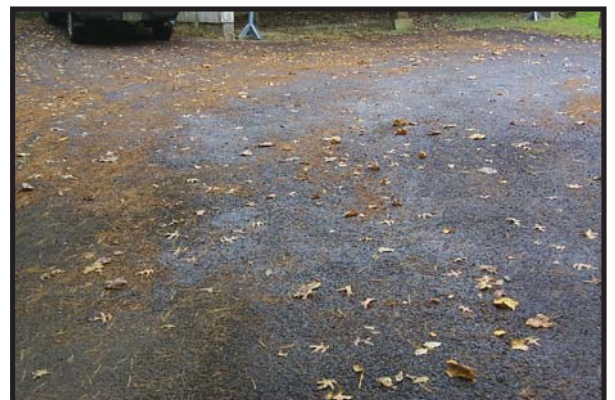
Route 0904

Route	Public / NonPublic	Date Visited	Area (sq ft)	Lane Miles *	Surface Type	Condition / PCR
0904	Public	10/28/2002	3044	0.05	AS	POOR / 45
