**The Road Inventory  
of  
Fredericksburg & Spotsylvania  
National Military Park  
FRSP - 4370**

**Road Inventory Program**

Prepared By:  
Federal Highway Administration  
Eastern Federal Lands Highway Division  
Cycle 3

# Fredericksburg & Spotsylvania National Military Park in Virginia

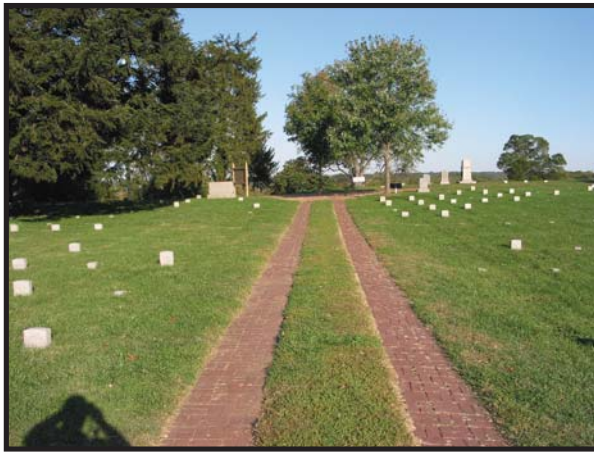
## Route 0900

Route	Public / NonPublic	Date Visited	Area (sq ft)	Lane Miles *	Surface Type	Condition / PCR
0900	Public	10/15/2003	24785	0.43	AS	FAIR / 73

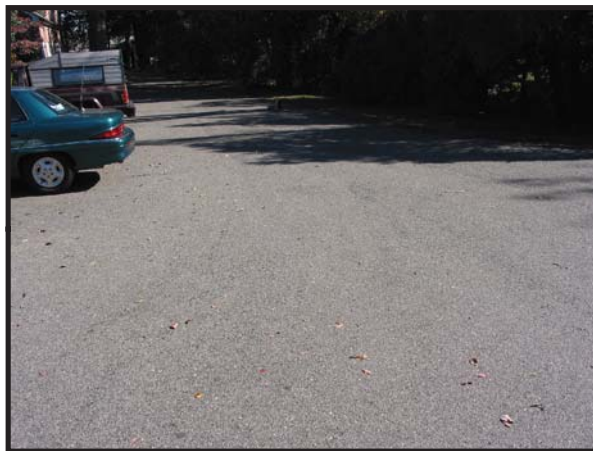
## Route 0904

Route	Public / NonPublic	Date Visited	Area (sq ft)	Lane Miles *	Surface Type	Condition / PCR
0904	Public	10/15/2003	8922	0.15	AS	FAIR / 73

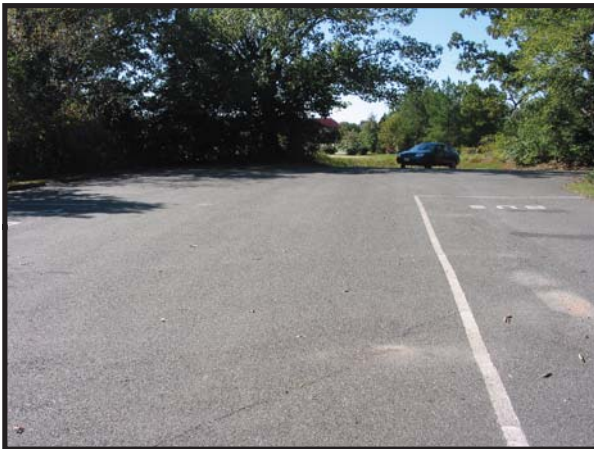
## Route 0905

Route	Public / NonPublic	Date Visited	Area (sq ft)	Lane Miles *	Surface Type	Condition / PCR
0905	Public	10/16/2003	2548	0.04	AS	GOOD / 90

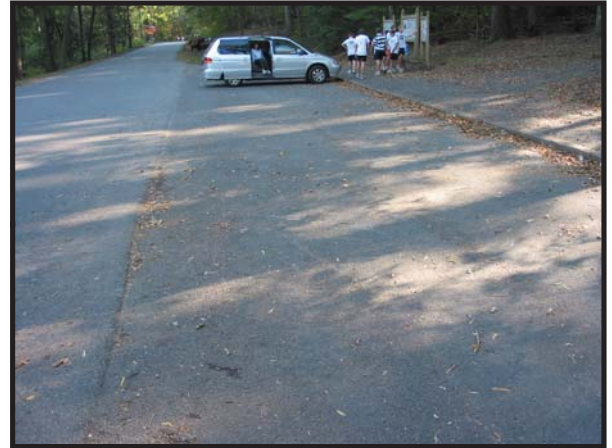
## Route 0906

Route	Public / NonPublic	Date Visited	Area (sq ft)	Lane Miles *	Surface Type	Condition / PCR
0906	Public	10/16/2003	4433	0.08	AS	FAIR / 73

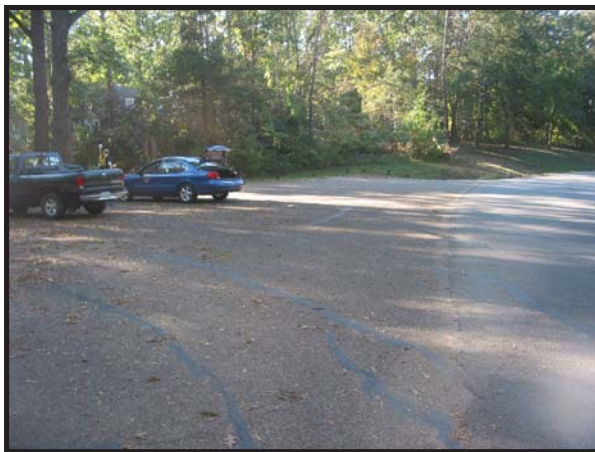
## Route 0907

Route	Public / NonPublic	Date Visited	Area (sq ft)	Lane Miles *	Surface Type	Condition / PCR
0907	Public	10/16/2003	9554	0.16	AS	GOOD / 90

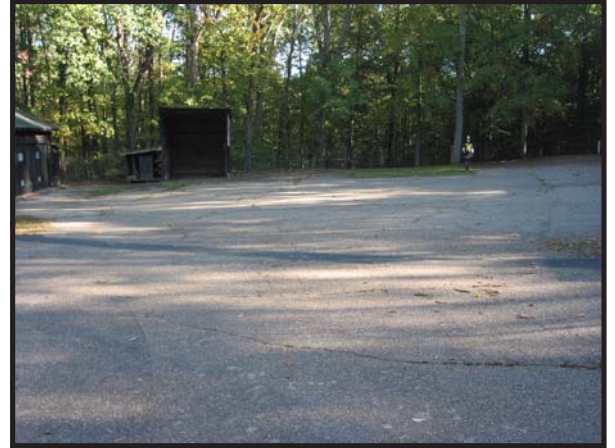
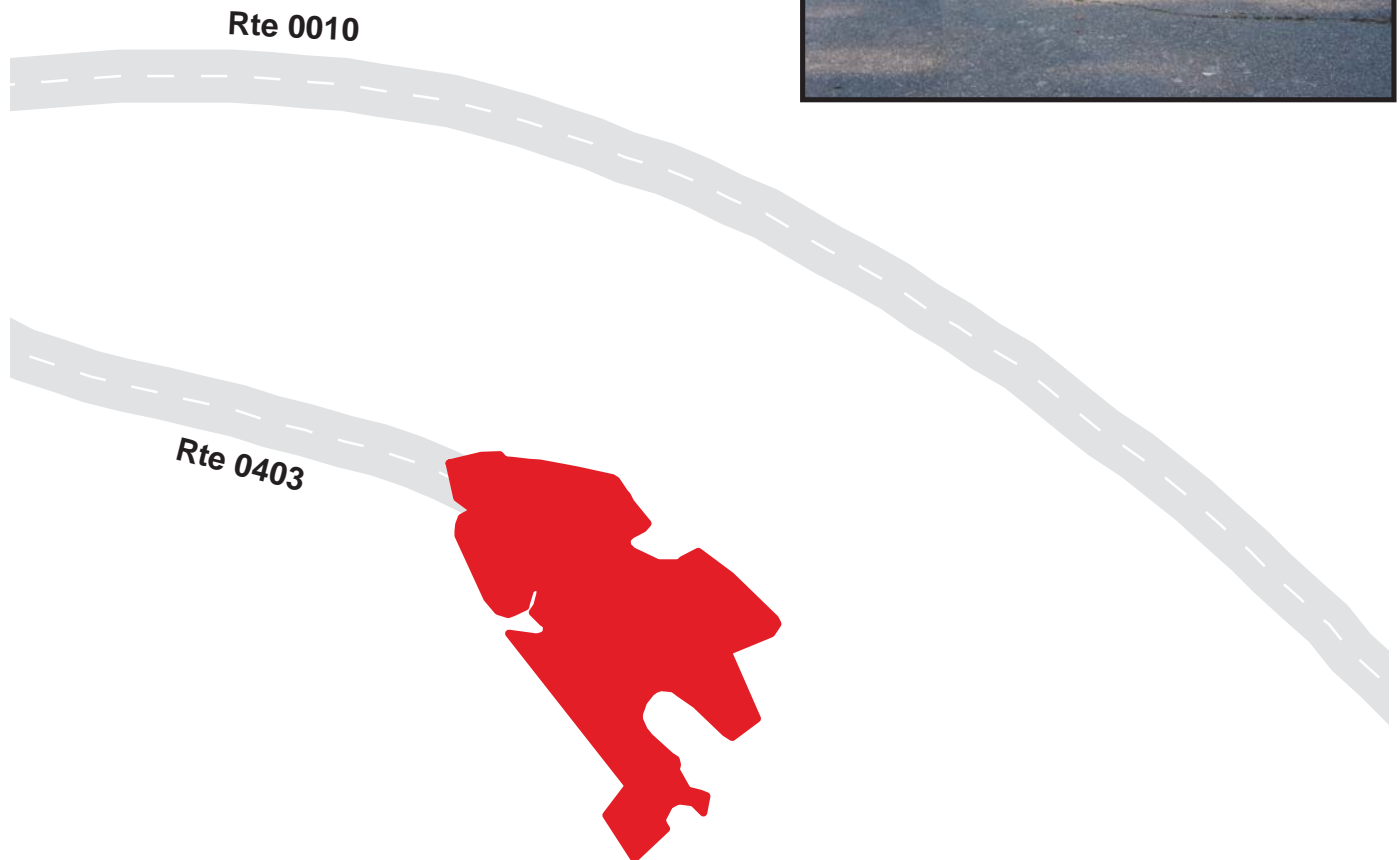
## Route 0908A

Route	Public / NonPublic	Date Visited	Area (sq ft)	Lane Miles *	Surface Type	Condition / PCR
0908A	NonPublic	10/16/2003	11204	0.19	AS	POOR / 45

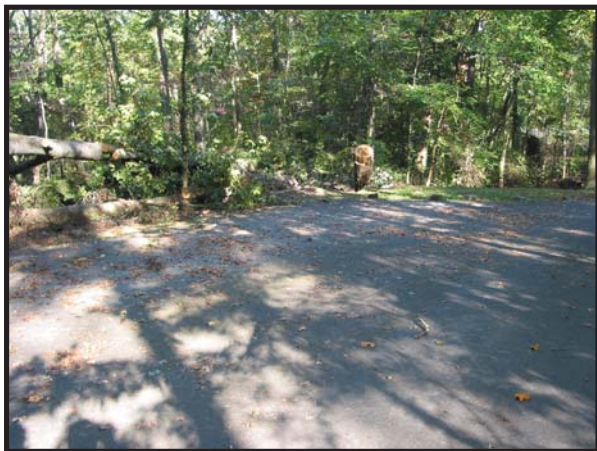
## Route 0910A

Route	Public / NonPublic	Date Visited	Area (sq ft)	Lane Miles *	Surface Type	Condition / PCR
0910A	Public	10/16/2003	14154	0.24	AS	FAIR / 73

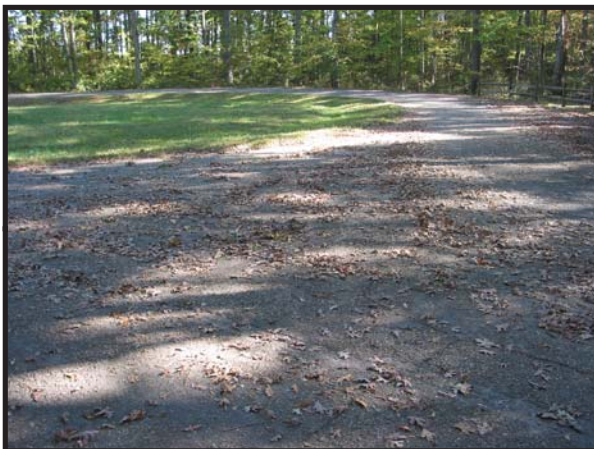
## Route 0912

Route	Public / NonPublic	Date Visited	Area (sq ft)	Lane Miles *	Surface Type	Condition / PCR
0912	Public	10/16/2003	7516	0.13	AS	FAIR / 73

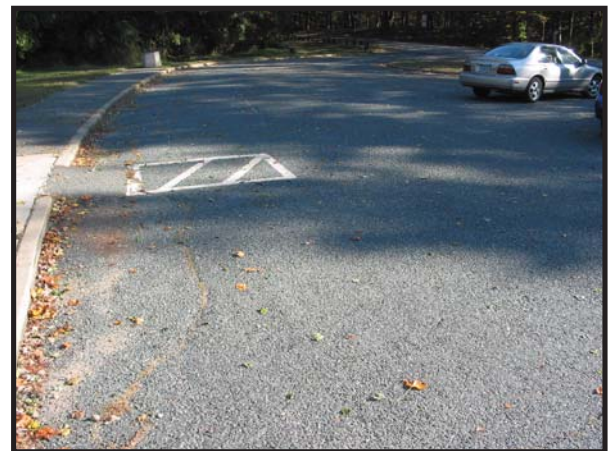
## Route 0913

Route	Public / NonPublic	Date Visited	Area (sq ft)	Lane Miles *	Surface Type	Condition / PCR
0913	Public	10/16/2003	3492	0.06	AS	FAIR / 73

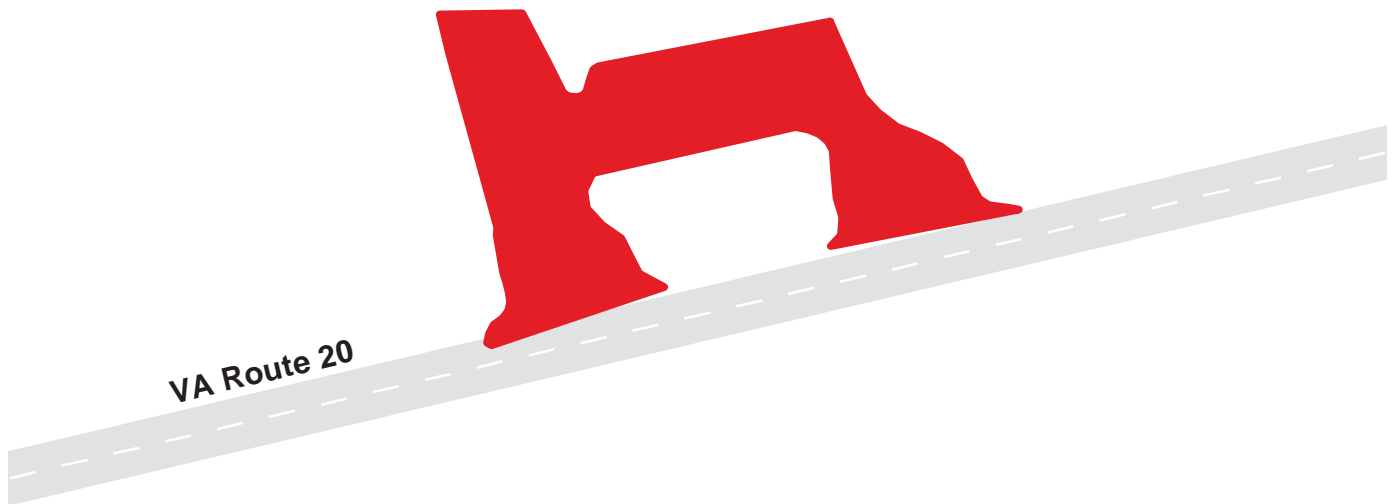
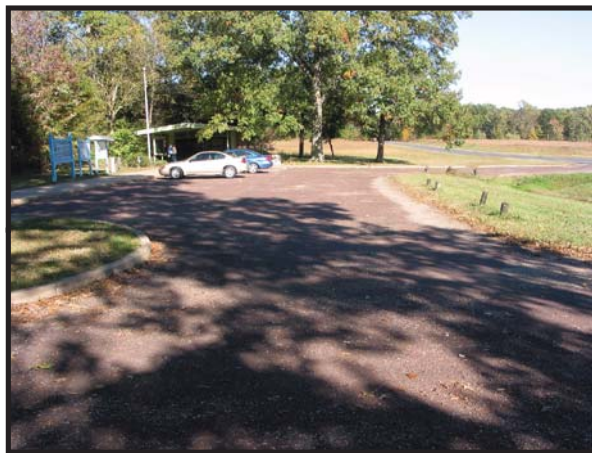
## Route 0916

Route	Public / NonPublic	Date Visited	Area (sq ft)	Lane Miles *	Surface Type	Condition / PCR
0916	Public	10/15/2003	13391	0.23	NC	POOR / 45

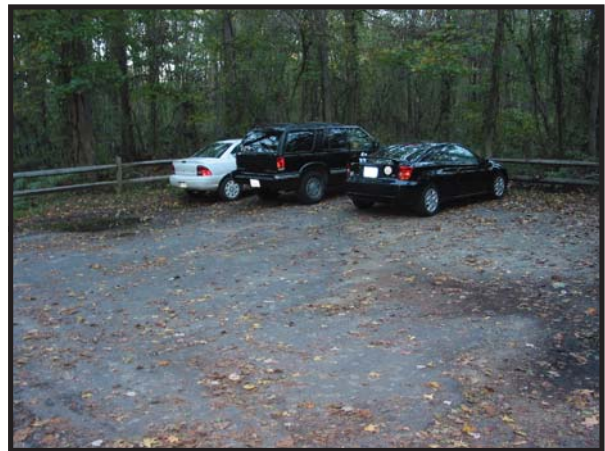
## Route 0920

Route	Public / NonPublic	Date Visited	Area (sq ft)	Lane Miles *	Surface Type	Condition / PCR
0920	Public	10/15/2003	1491	0.03	AS	POOR / 45

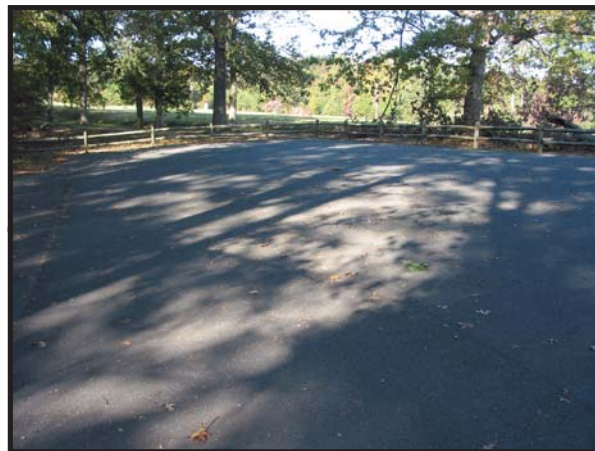
## Route 0923

Route	Public / NonPublic	Date Visited	Area (sq ft)	Lane Miles *	Surface Type	Condition / PCR
0923	Public	10/15/2003	1387	0.02	AS	GOOD / 90

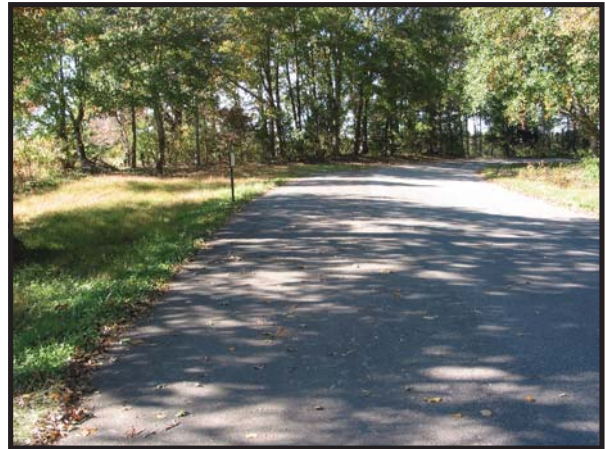
## Route 0924

Route	Public / NonPublic	Date Visited	Area (sq ft)	Lane Miles *	Surface Type	Condition / PCR
0924	Public	10/15/2003	817	0.01	AS	GOOD / 90

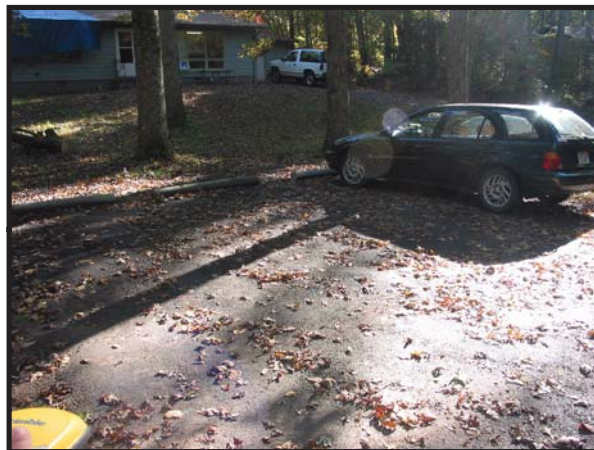
## Route 0931

Route	Public / NonPublic	Date Visited	Area (sq ft)	Lane Miles *	Surface Type	Condition / PCR
0931	Public	10/16/2003	1563	0.03	AS	GOOD / 90

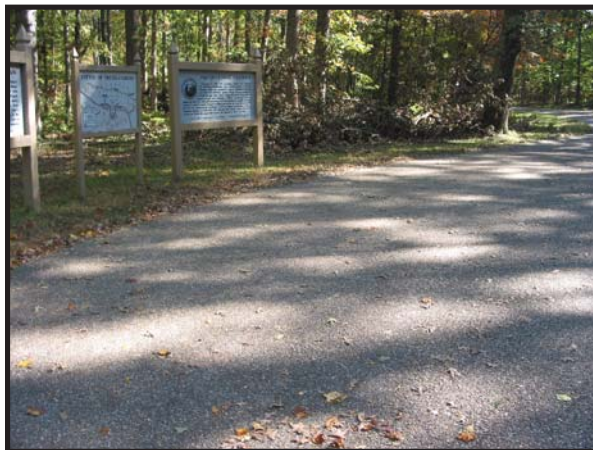
## Route 0932A

Route	Public / NonPublic	Date Visited	Area (sq ft)	Lane Miles *	Surface Type	Condition / PCR
0932A	Public	10/16/2003	2481	0.04	AS	GOOD / 90

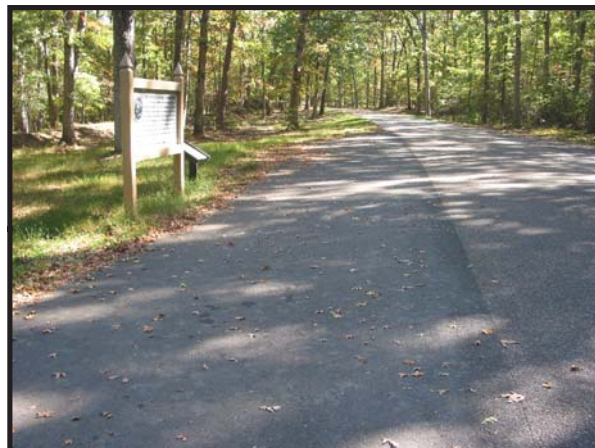
## Route 0932B

Route	Public / NonPublic	Date Visited	Area (sq ft)	Lane Miles *	Surface Type	Condition / PCR
0932B	Public	10/16/2003	1982	0.03	AS	GOOD / 90

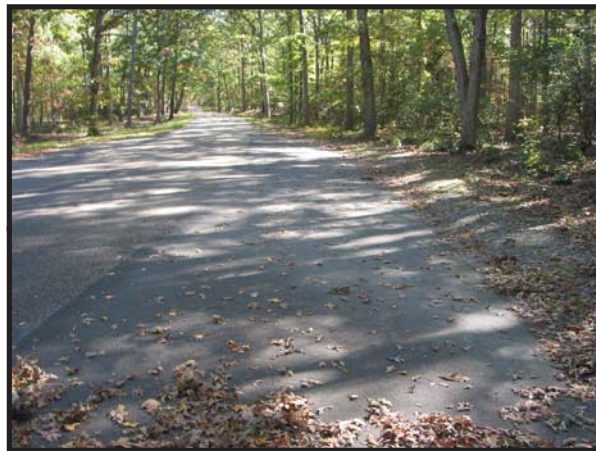
## Route 0933

Route	Public / NonPublic	Date Visited	Area (sq ft)	Lane Miles *	Surface Type	Condition / PCR
0933	Public	10/16/2003	952	0.02	AS	GOOD / 90

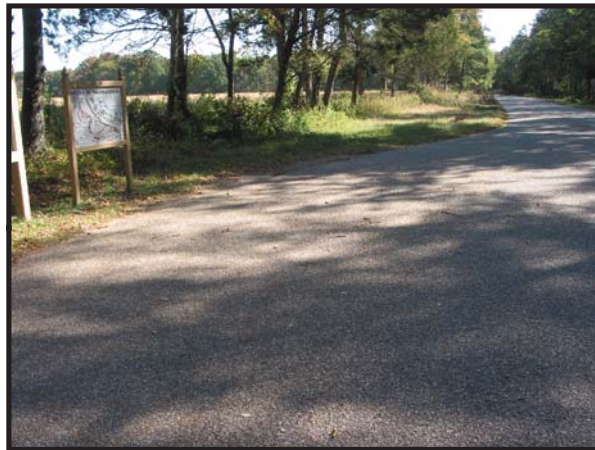
## Route 0934

Route	Public / NonPublic	Date Visited	Area (sq ft)	Lane Miles *	Surface Type	Condition / PCR
0934	NonPublic	10/16/2003	2065	0.04	AS	GOOD / 90

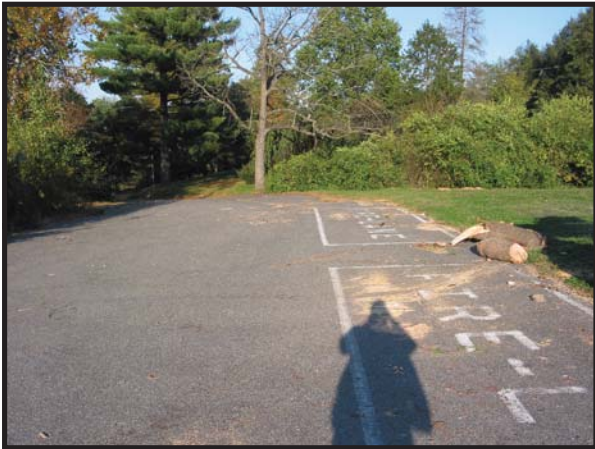
## Route 0935

Route	Public / NonPublic	Date Visited	Area (sq ft)	Lane Miles *	Surface Type	Condition / PCR
0935	Public	10/16/2003	827	0.01	AS	EXCELLENT / 97
