The Road Inventory of Gauley River National Recreation Area GARI - 4781

Road Inventory Program

Prepared By:
Federal Highway Administration
Eastern Federal Lands Highway Division
Cycle 3

Gauley River National Recreation Area in West Virginia

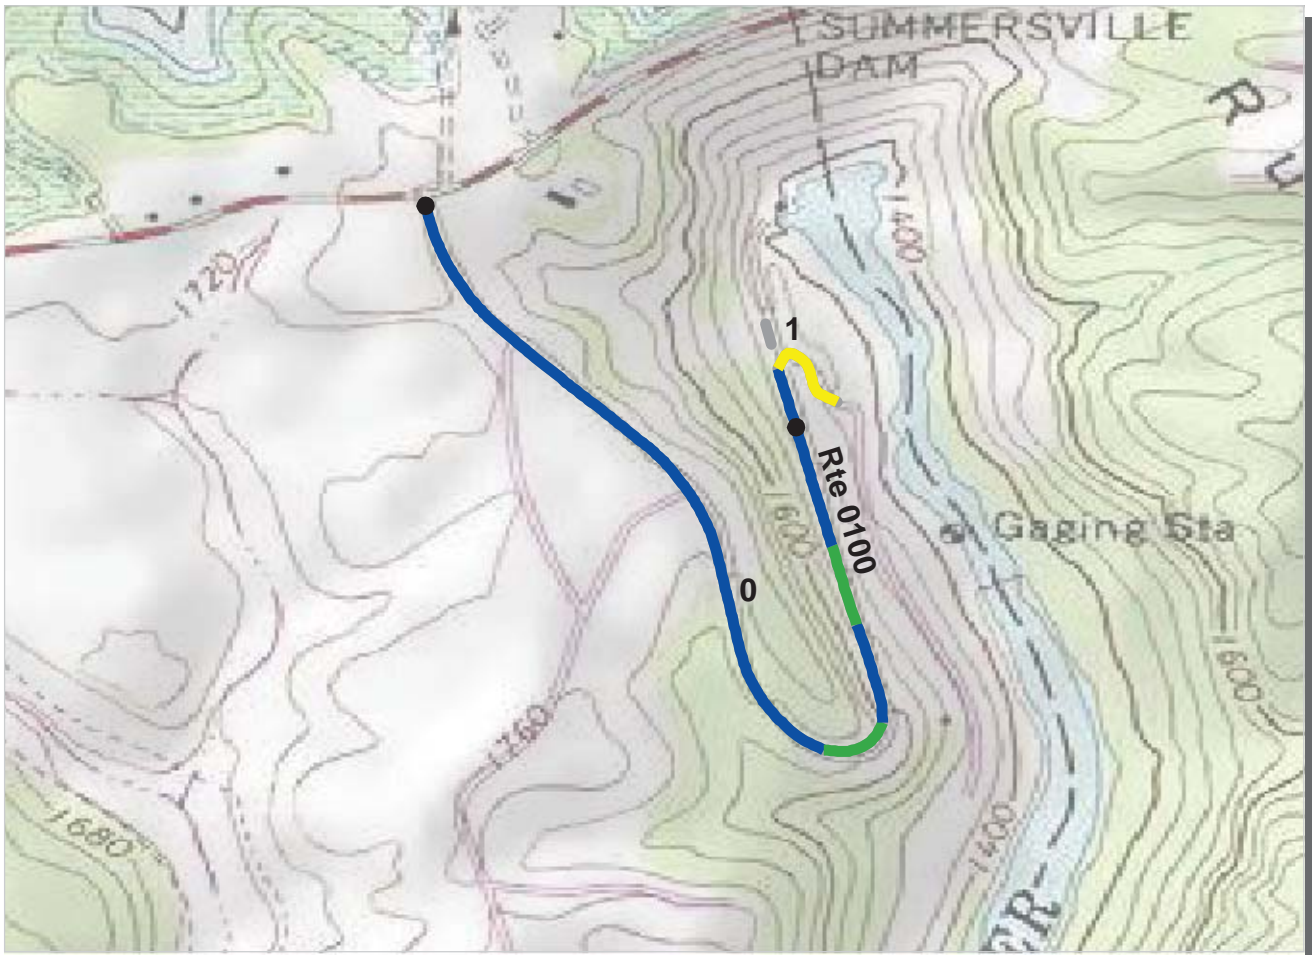
ROUTE: 0100 TAIL WATER ACCESS ROAD **TOTAL LENGTH: 1.16 Miles**

Section Number	0	1			
Section Length (mi)	1.00	0.16			
AADT	**				
SADT	**				
ADT Date	**				
Cross Section Information					
Number of Lanes	2	2			
Paved Width (ft)	19	20			
Lane Width (ft)	9	10			
Shoulder Width (ft)	3	0			
Roadway Condition Information					
PCR (Pavement Condition Rating)	97	80			
RCI (Roughness Condition Index)	98	78			
SCR (Surface Condition Rating)	96	82			
Alligator Cracking Index	100	100			
Rutting Index	96	82			
Patching Index	100	100			
Transverse Cracking Index	99	100			
Longitudinal Cracking Index	100	100			
Shoulder Condition Rating	GOOD	N/A			
Drainage Condition Rating	GOOD	GOOD
